**Project:** The Buchans Remediation Project – Phase II  
Residential and Public Areas Remediation  
Year 1 Construction Report

**Client:** Department of Environment and Conservation

**Consultant:** Hatch Mott MacDonald

**Contractor:** Marine Contractors Inc.

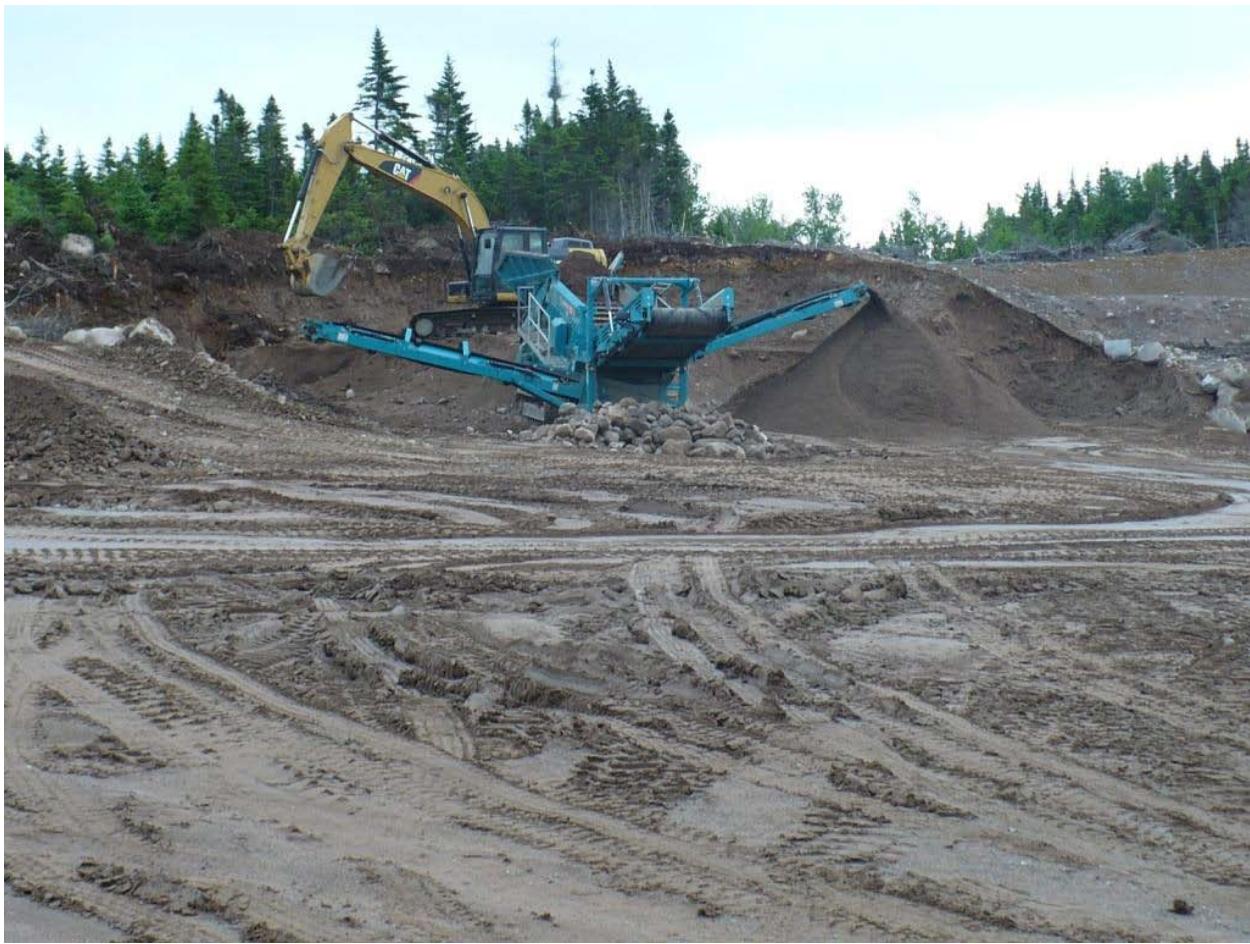
Photo#1

Photograph was taken on June 29, 2012 and shows the contractor utilizing a screening plant to process Class "A" granular materials. The quarry area is located approximately 500 meters northwest of the old Buchans mine site.

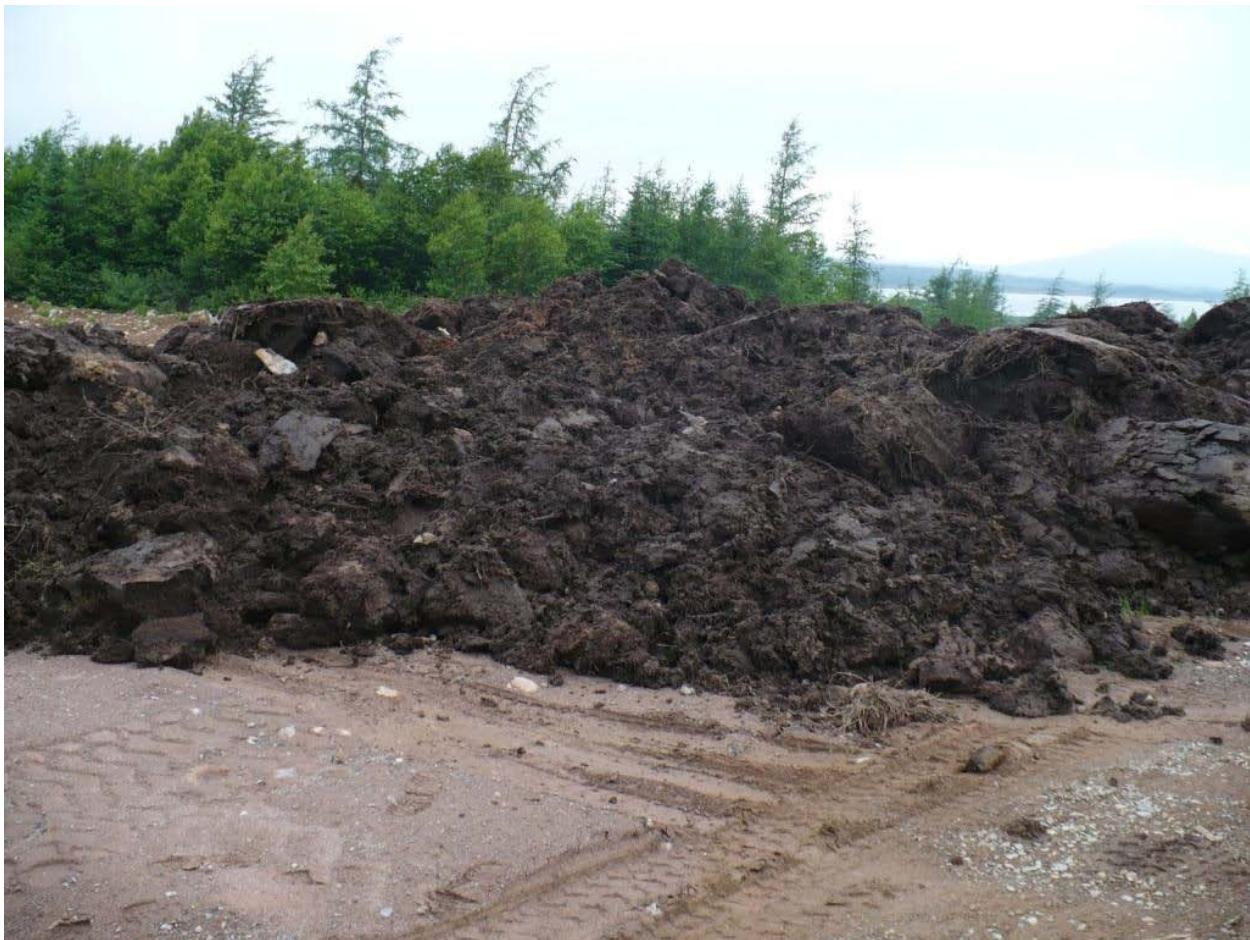
Photo#2

Photograph was taken on June 30, 2012 and excavated peat material to be used in the processing of topsoil. This material was excavated approximately 500 meters northwest of the old Buchans mine site. A screening plant was used to process this material with pit run material to complete the topsoil mixture.

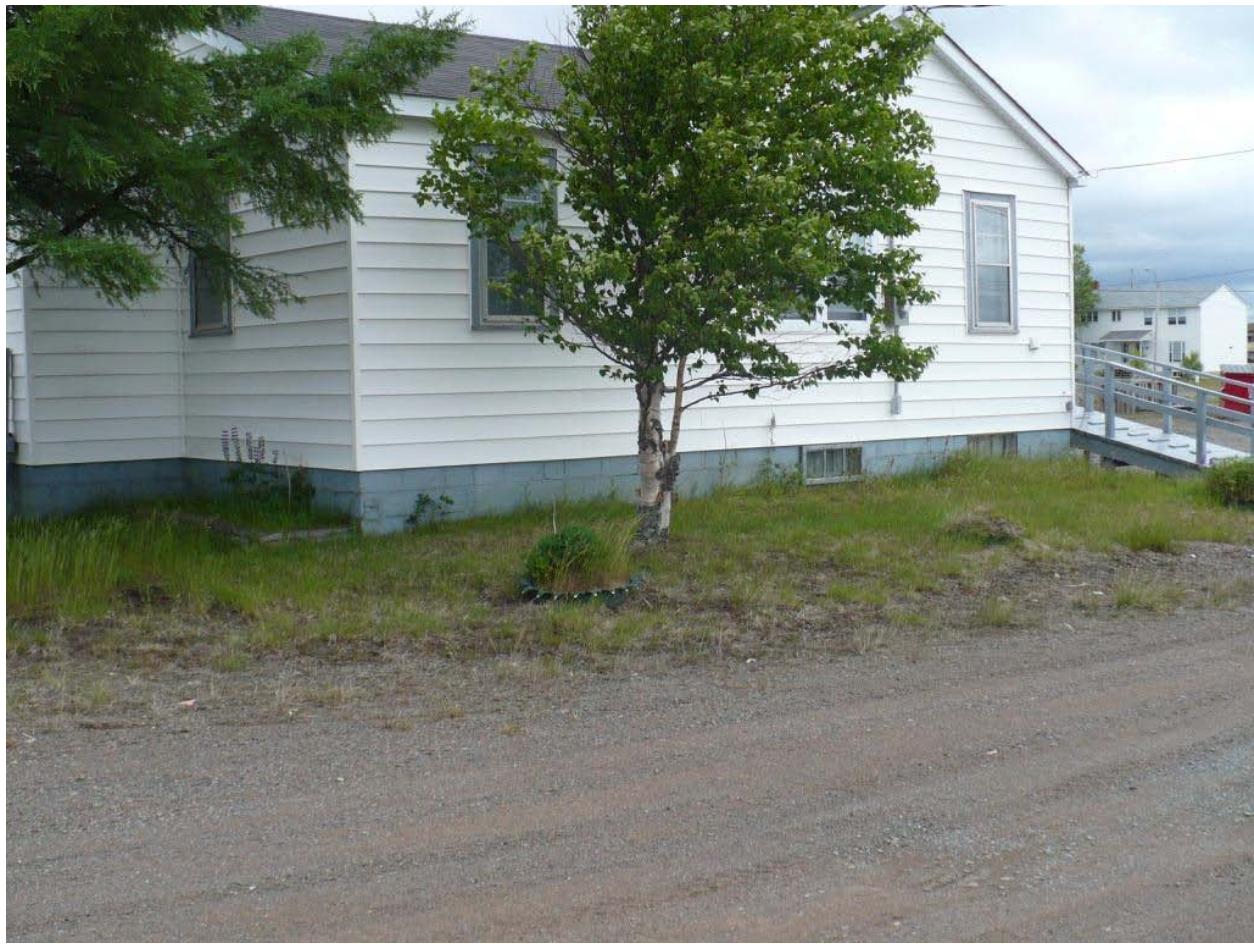
Photo#3

Photograph was taken on June 29, 2012 and shows the property at 14 Main Street prior to remediation. Although there are not many out buildings on this property it is typical of the single family dwelling properties within the town site that are scheduled for remediation.

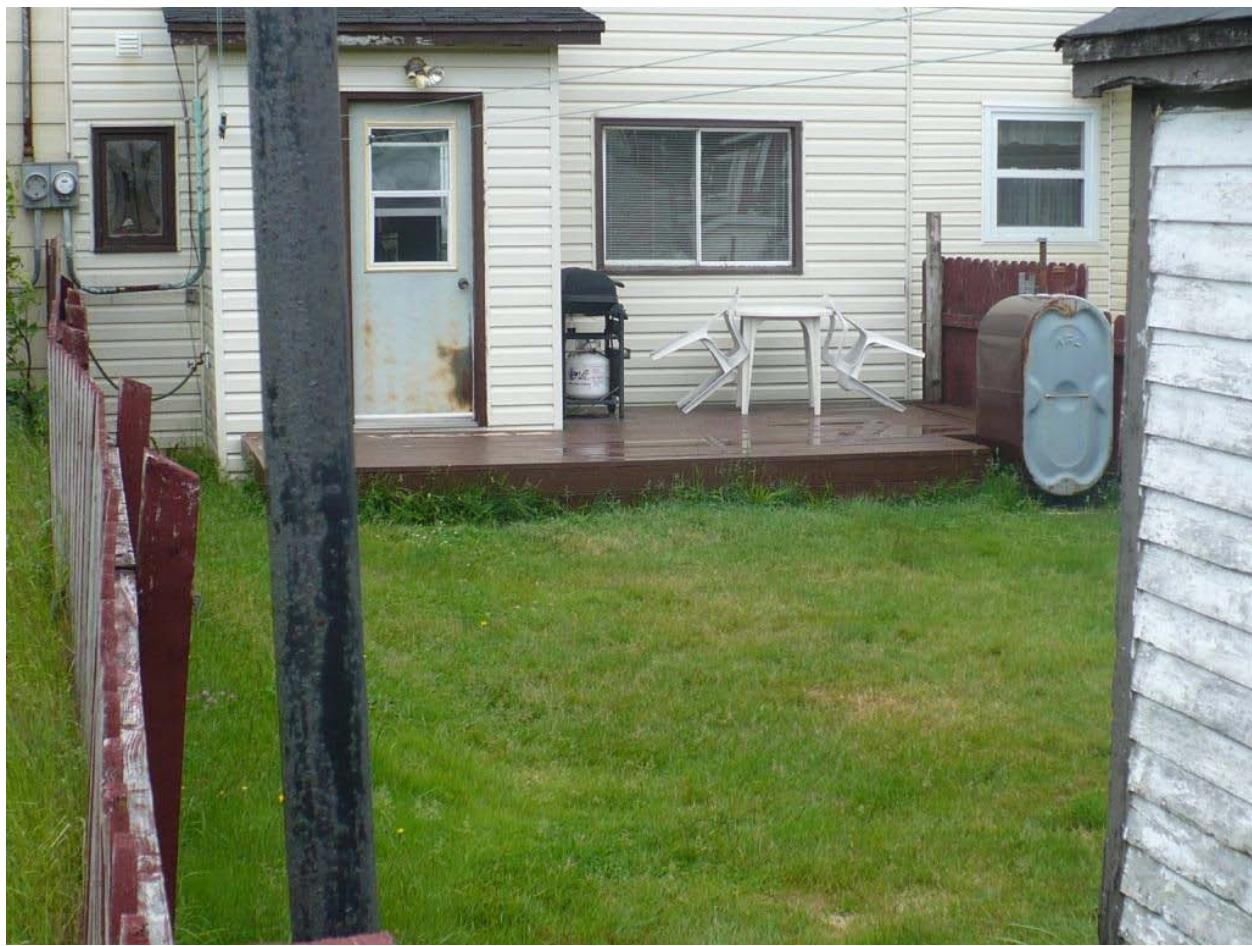
Photo#4

Photograph was taken on June 30, 2012 and shows a typical property in the northeast section of the town site at 37 Williams Turnpike. Many of the properties are small and in tight confines with sheds, decks, oil tanks, fences, trees and shrubs prevalent.

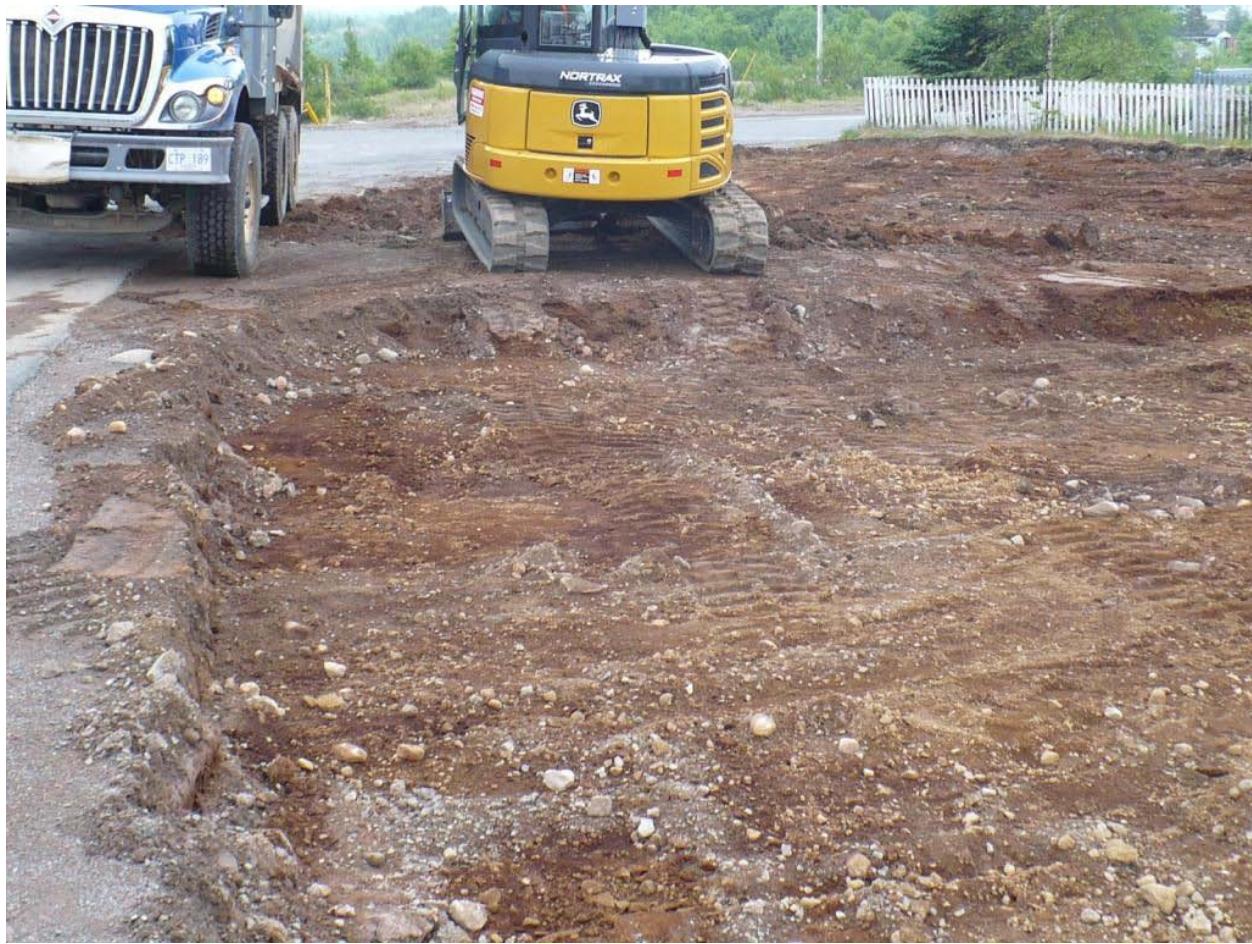
Photo#5

Photograph was taken on June 30, 2012 and shows the town property at the north end of Williams Turnpike undergoing mass excavation as the first step in the remediation process. This area is now ready for the installation of pit run materials prior to the installation of topsoil ad sod. This is the typical excavation method throughout the project.

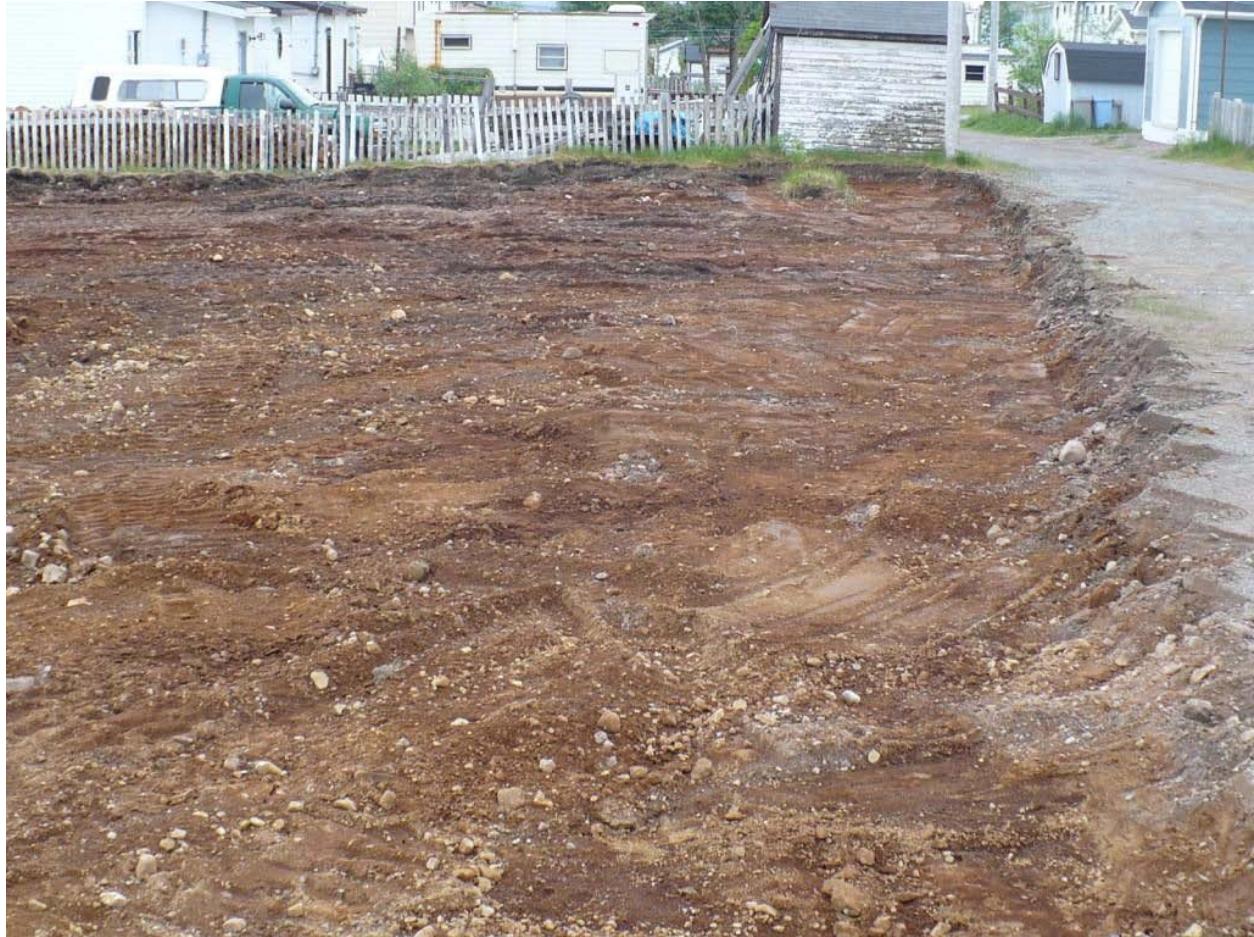
Photo#6

Photograph was taken on June 30, 2012 and shows the town property at the north end of Williams Turnpike undergoing mass excavation as the first step in the remediation process. This area is now ready for the installation of pit run materials prior to the installation of topsoil ad sod.

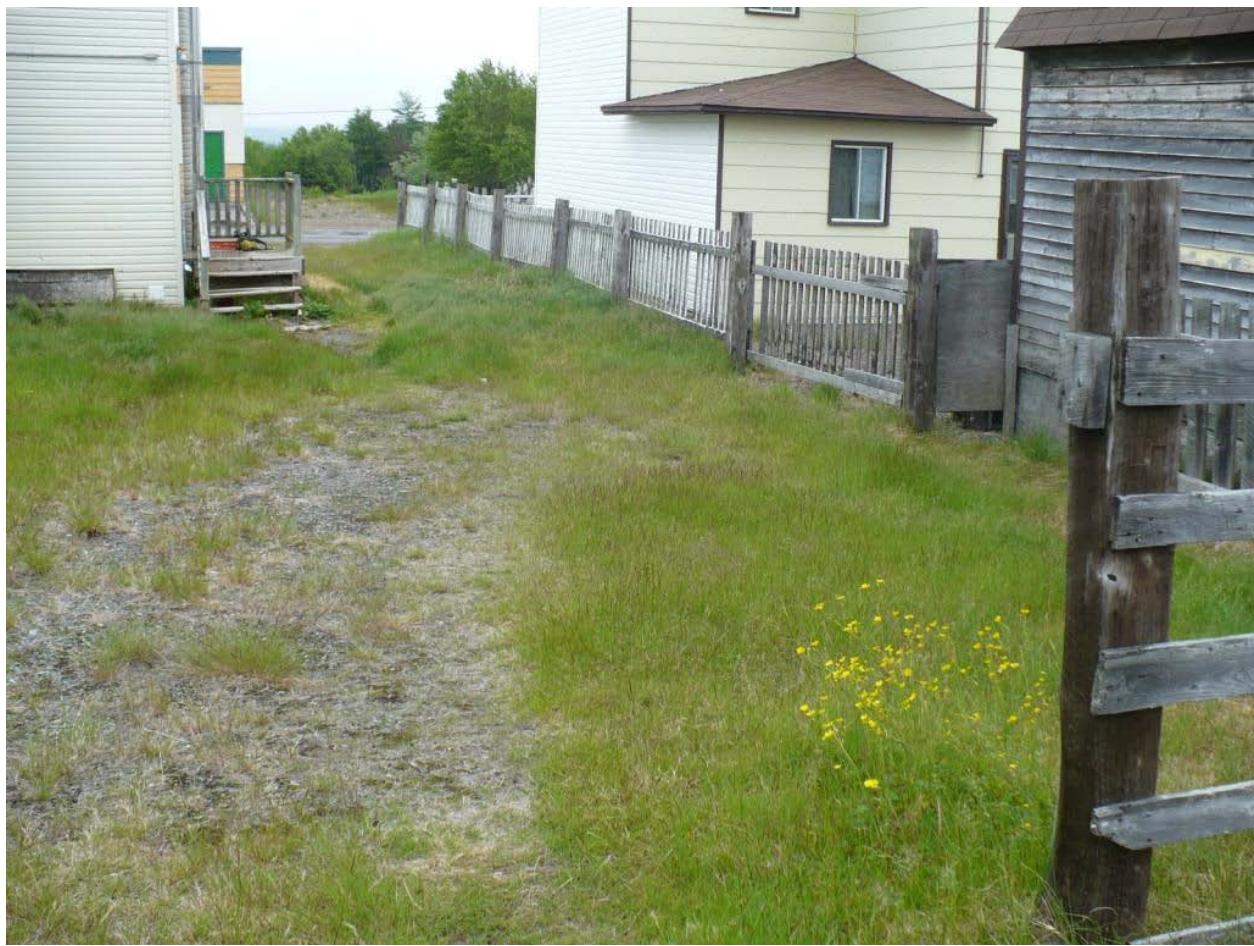
Photo#7

Photograph was taken on June 30, 2012 and shows a typical property prior to the remediation process at 25 Williams Turnpike.

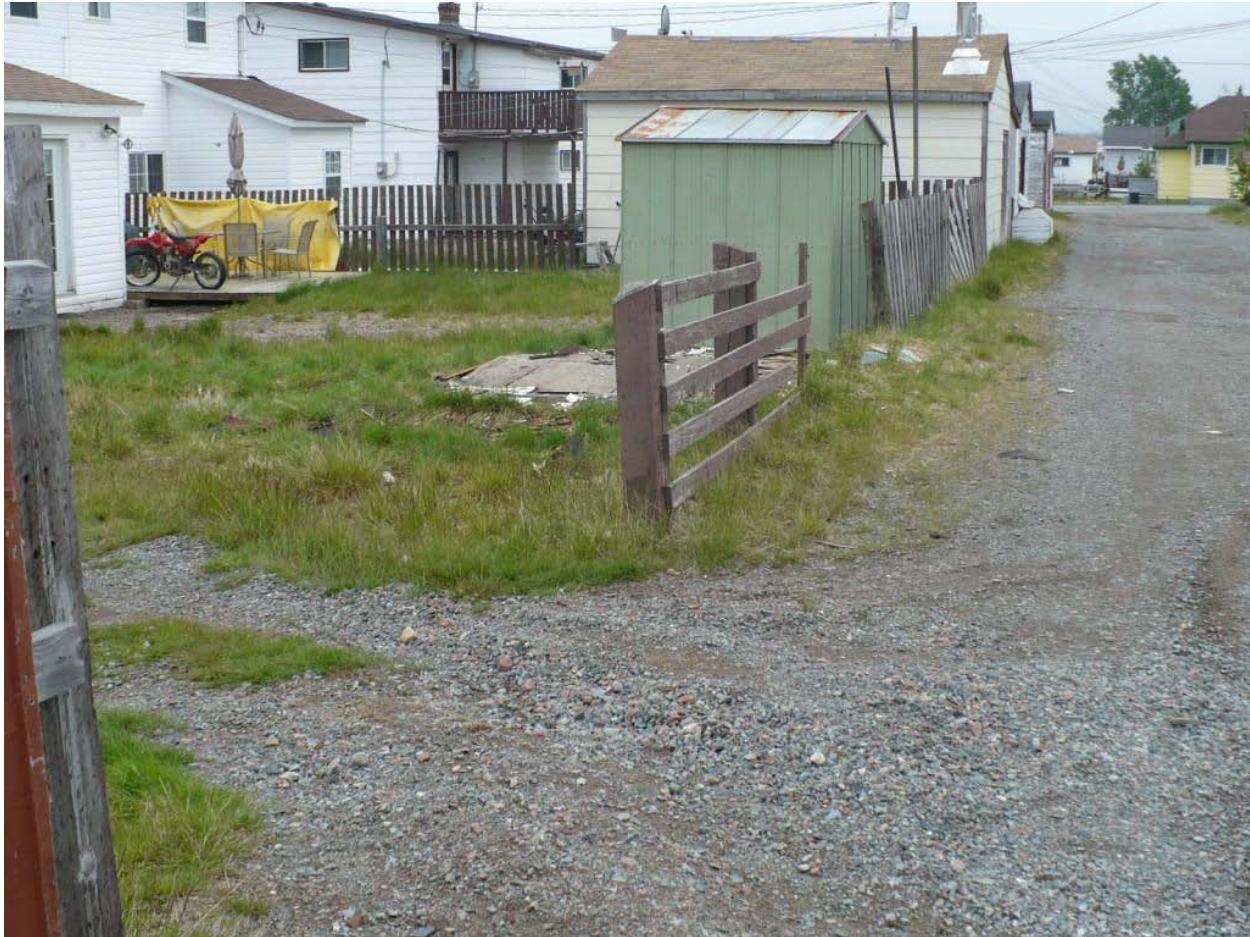
Photo#8

Photograph was taken on June 30, 2012 and shows a typical property prior to the remediation process at 19 Williams Turnpike. This property is shown remediated in the following photo sheets.

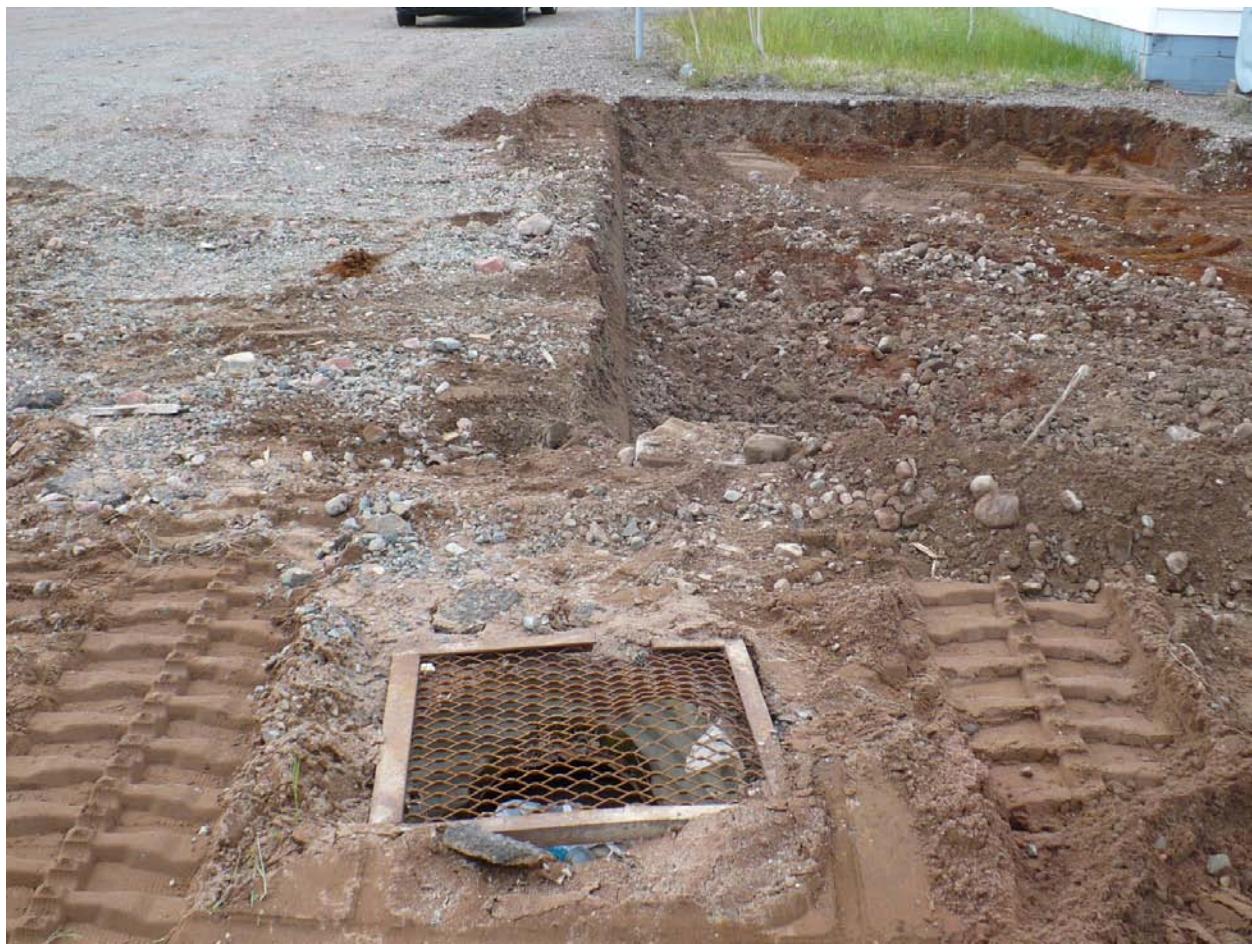
Photo#9

Photograph was taken on July 1, 2012 and shows the typical excavation and backfill requirements around existing municipal infrastructure on Williams Turnpike.

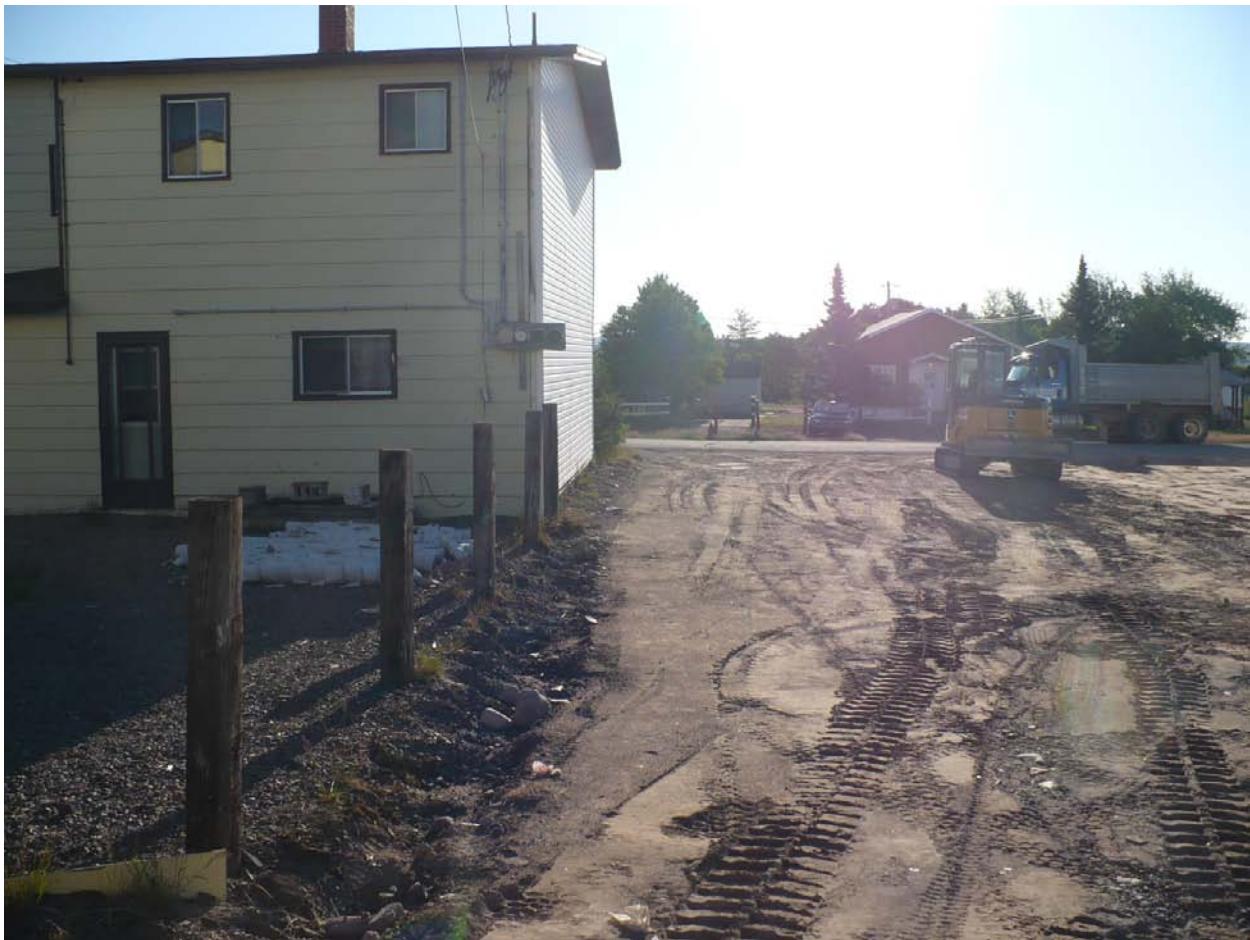
Photo#10

Photograph was taken on July 11, 2012 and shows 21 Williams Turnpike with area fully excavated and backfill operations underway. Processed pit run material is being graded and compacted as per specifications.

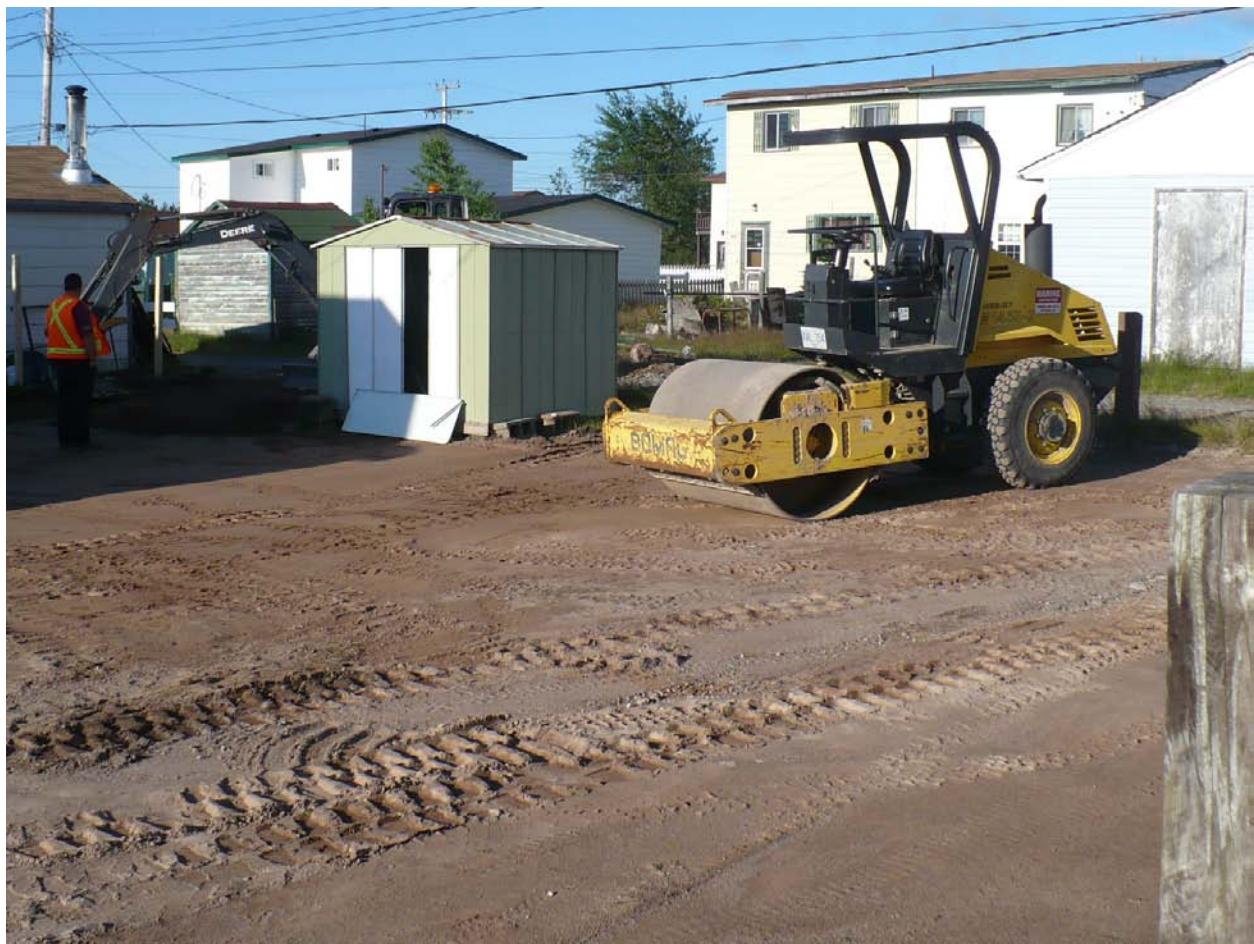
Photo#11

Photograph was taken on July 11, 2012 and shows backfill and compaction operations underway at 19 – 21 Williams Turnpike. Processed pit run material is being graded and compacted as per specifications.

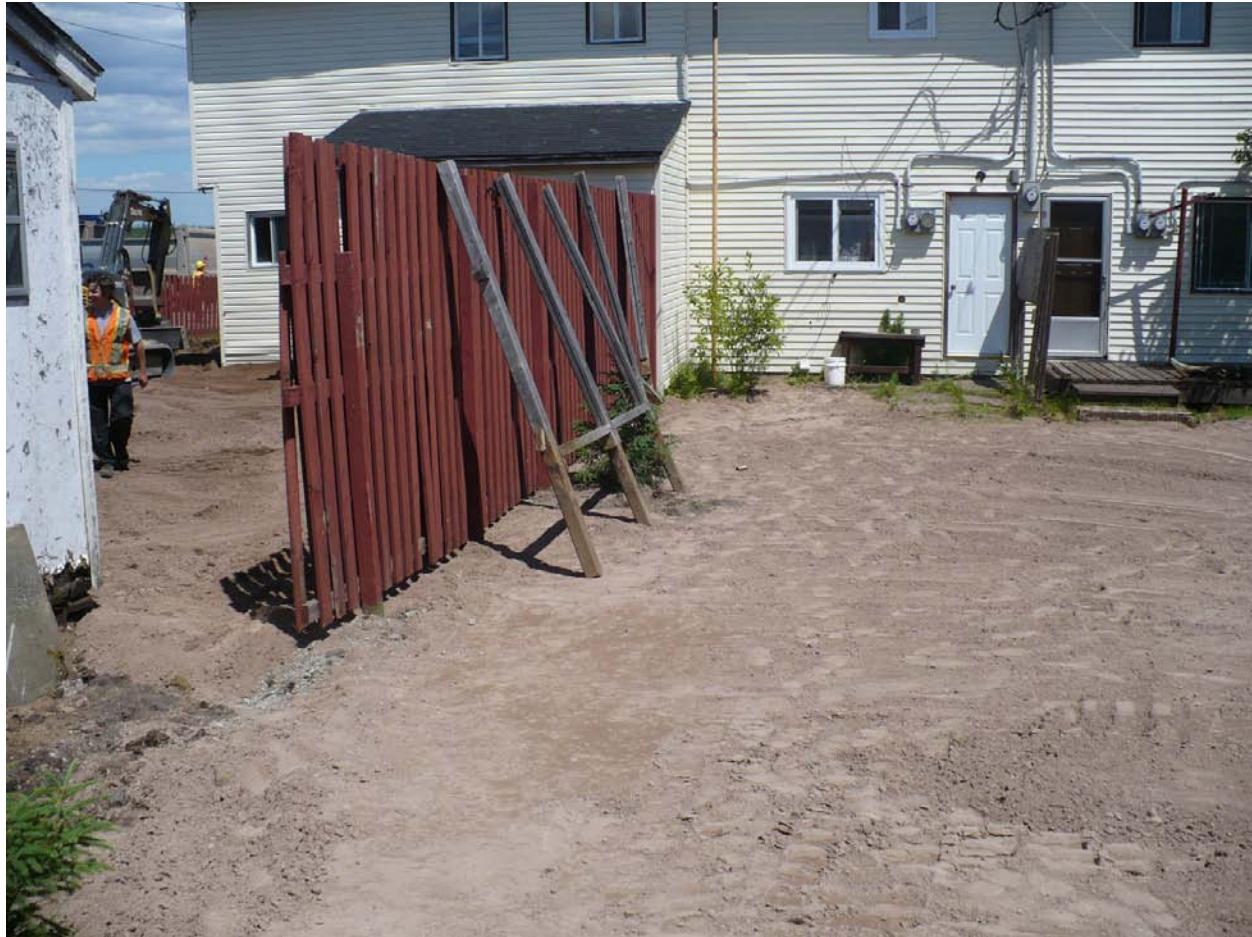
Photo#12

Photograph was taken on July 12, 2012 and shows 29 Williams Turnpike with backfill and compaction operations underway and preparation being made for the installation of sod.

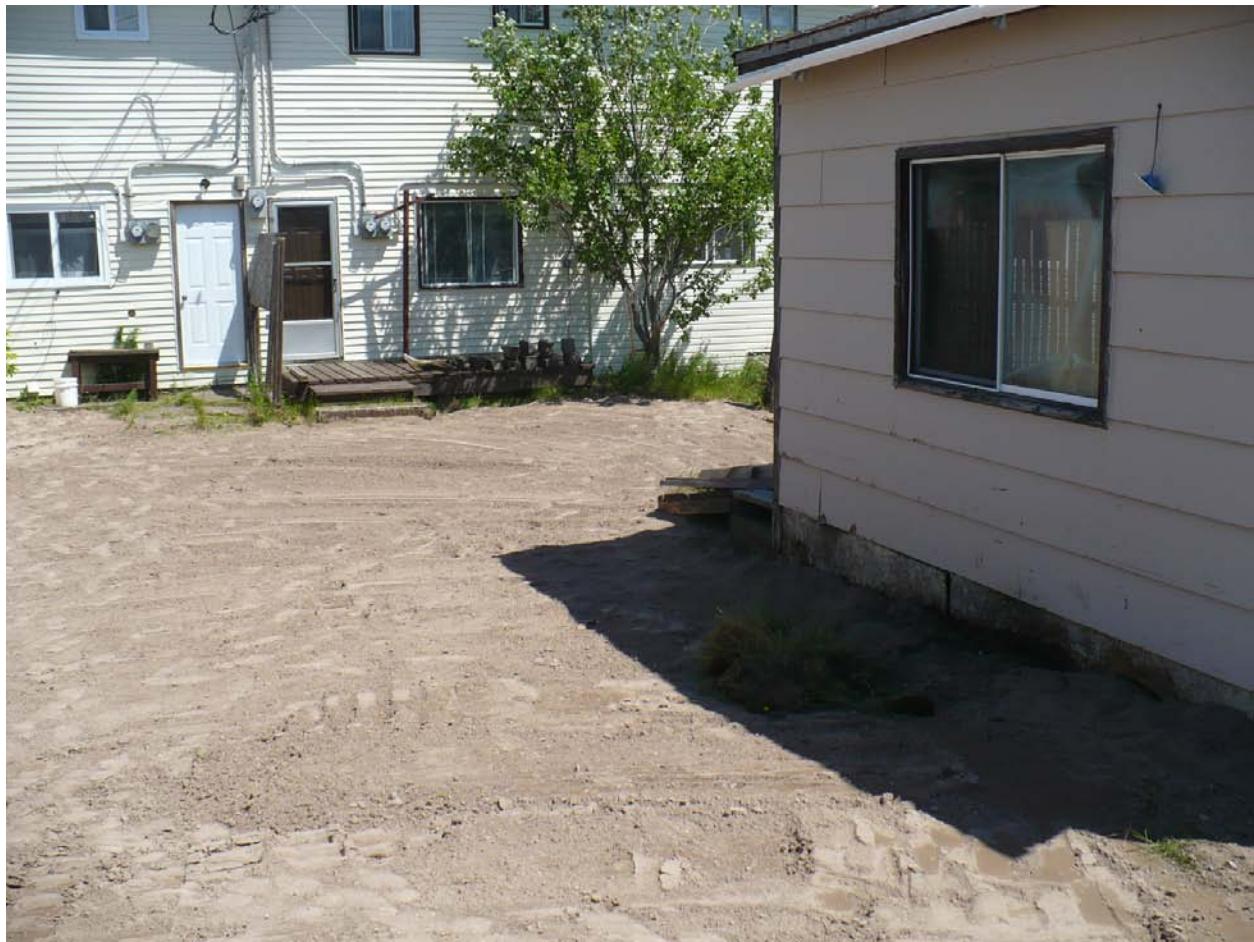
Photo#13

Photograph was taken on July 12, 2012 and shows 27 - 29 Williams Turnpike with backfill and compaction operations underway and preparation being made for the installation of sod.

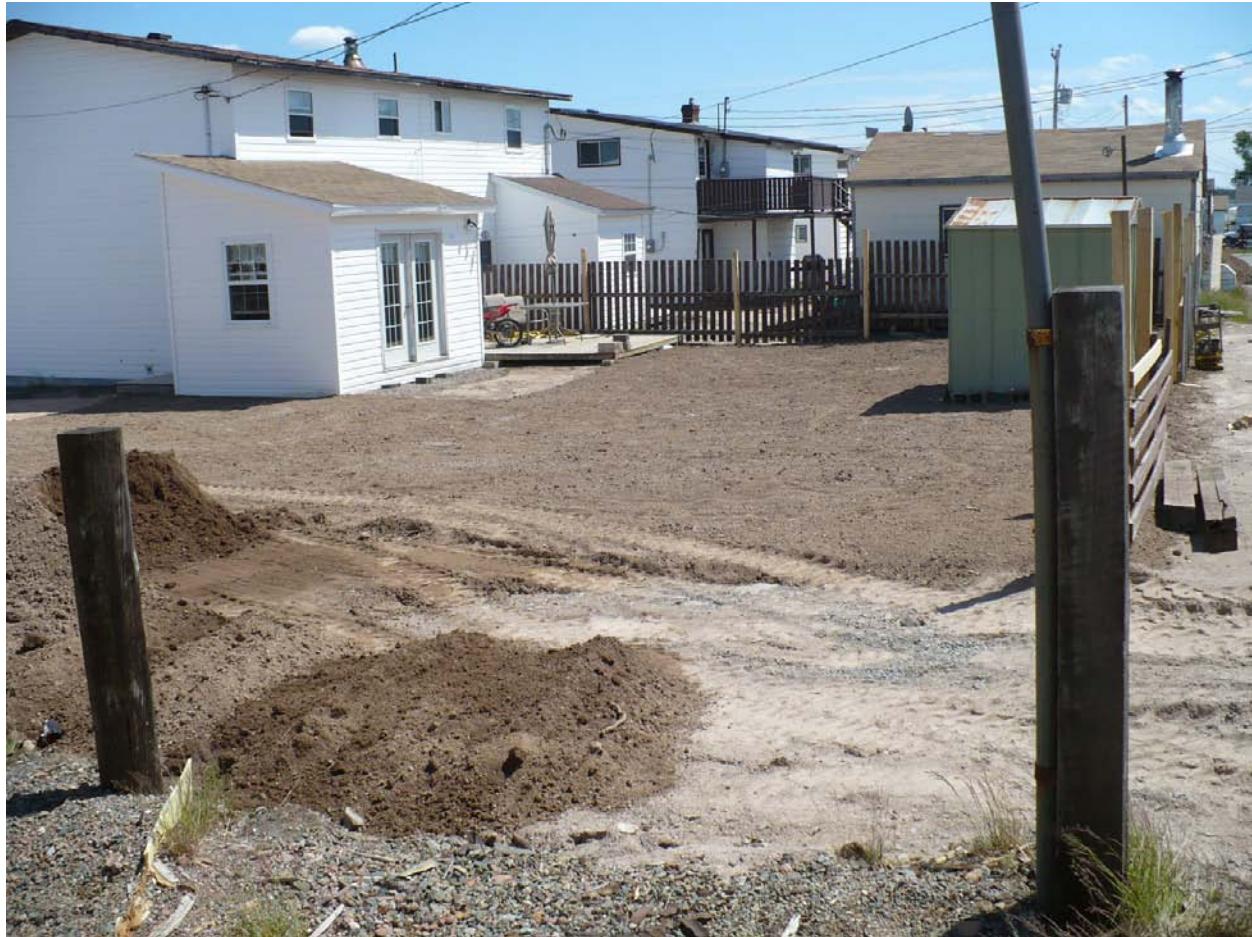
Photo#14

Photograph was taken on July 12, 2012 and shows 19 Williams Turnpike with processed pit run material installed and topsoil installation in progress prior to the installation of sods.

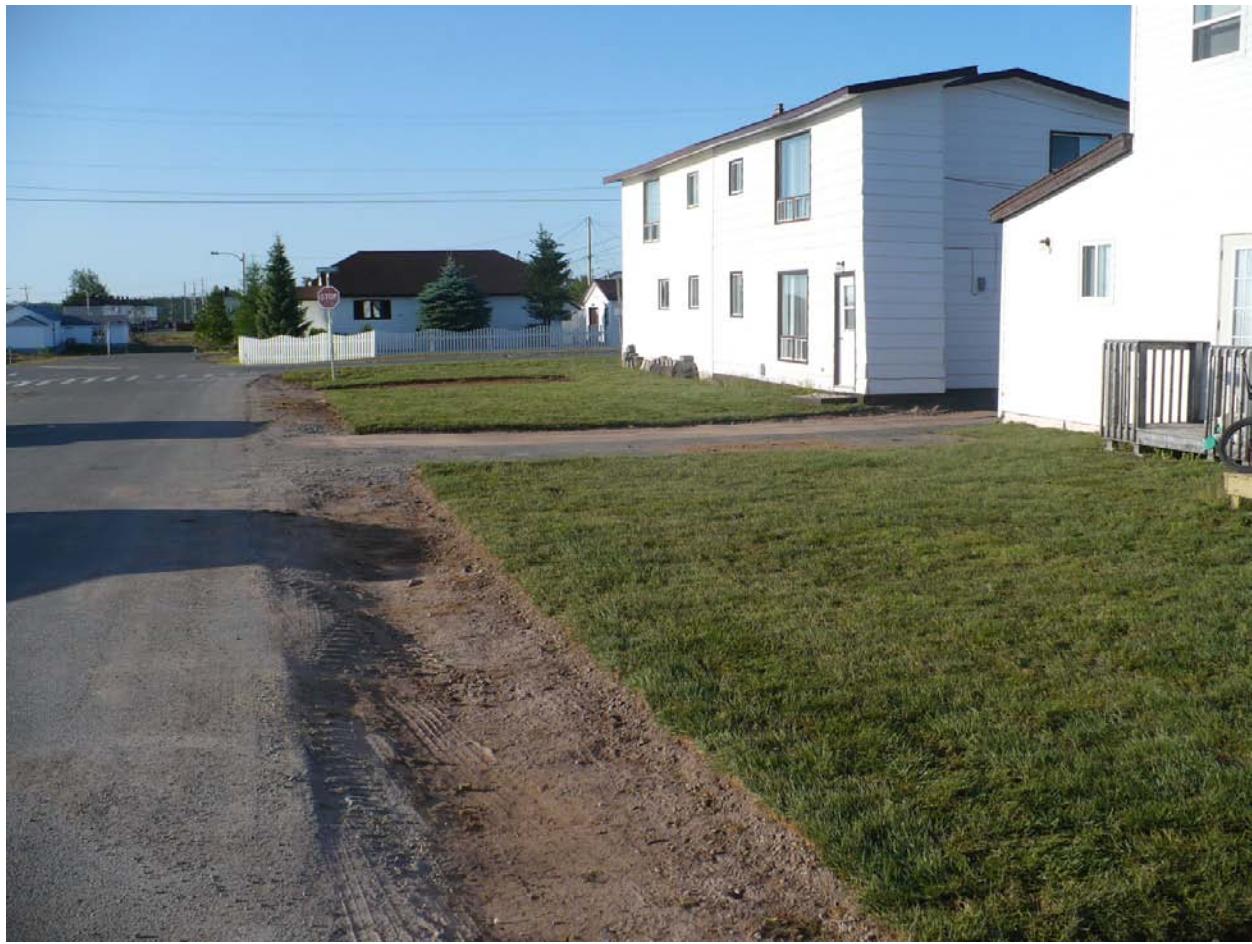
Photo#15

Photograph was taken on July 15, 2012 and shows the front yard areas of 13 - 17 Williams Turnpike with remediation completed.

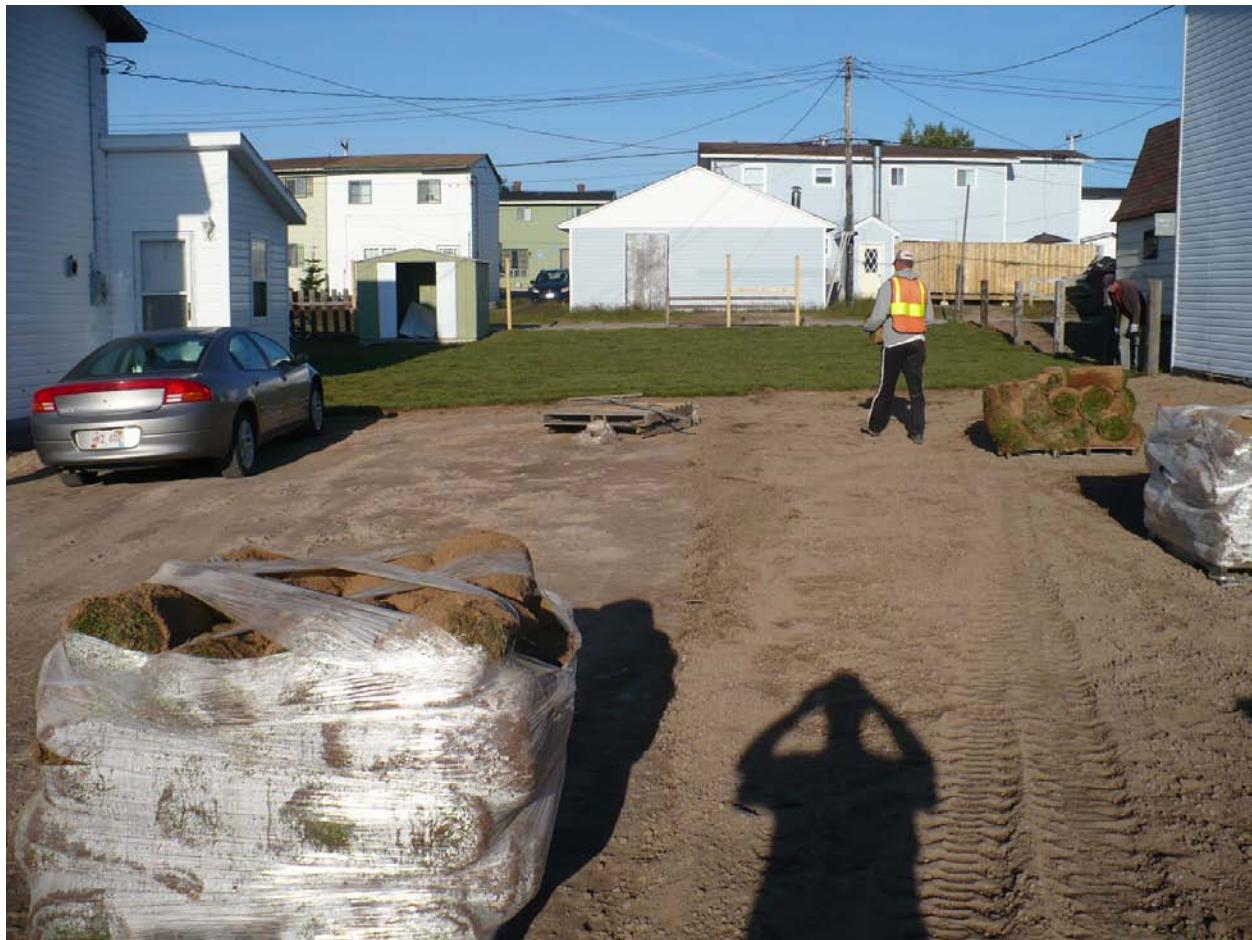
Photo#16

Photograph was taken on July 15, 2012 and shows 19–21 Williams Turnpike with processed pit run material and topsoil installation completed. The contractor is now completing the installation of sods.

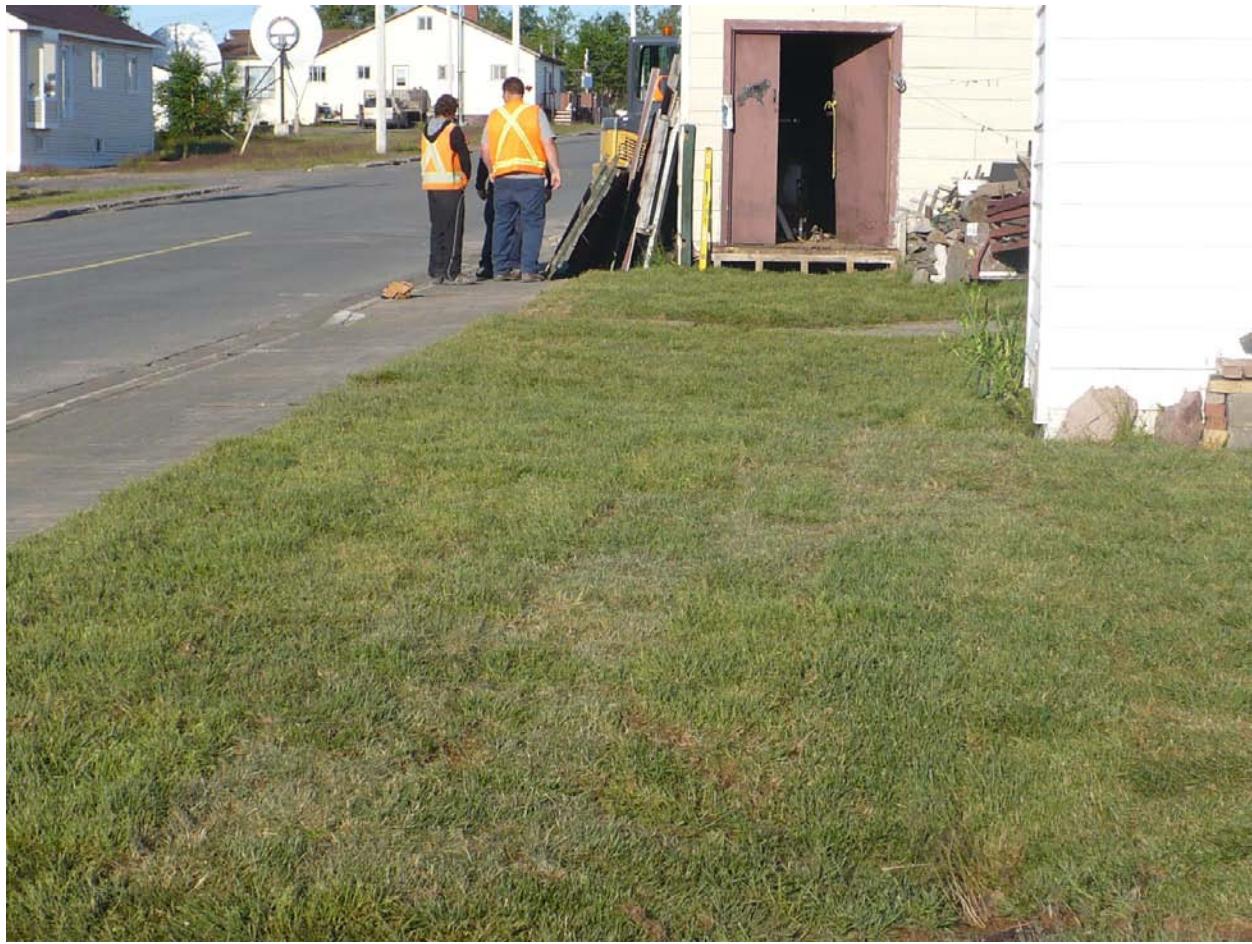
Photo#17

Photograph was taken on July 15, 2012 and shows the side yard areas of 13 Williams Turnpike with remediation completed.

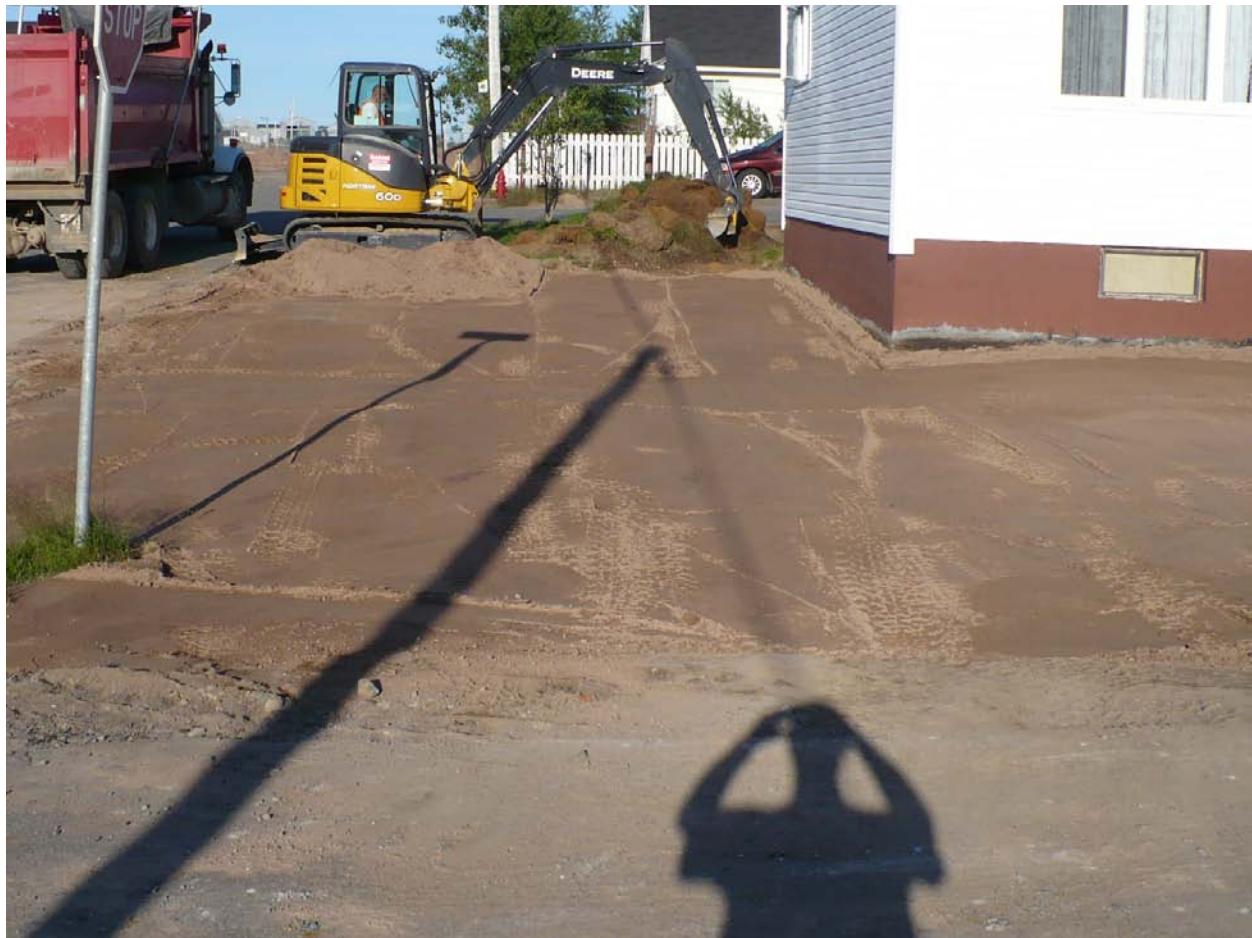
Photo#18

Photograph was taken on July 15, 2012 and shows 63 Church Street under remediation. The side yard area has been excavated and backfilled with Pit run material and topsoil has been installed. The Contractor is removing the old sod and excavated material in preparation for placement of new nursery sod.
