**Project:** The Buchans Remediation Project – Phase II  
Residential and Public Areas Remediation  
Year 1 Construction Report

**Client:** Department of Environment and Conservation

**Consultant:** Hatch Mott MacDonald

**Contractor:** Marine Contractors Inc.

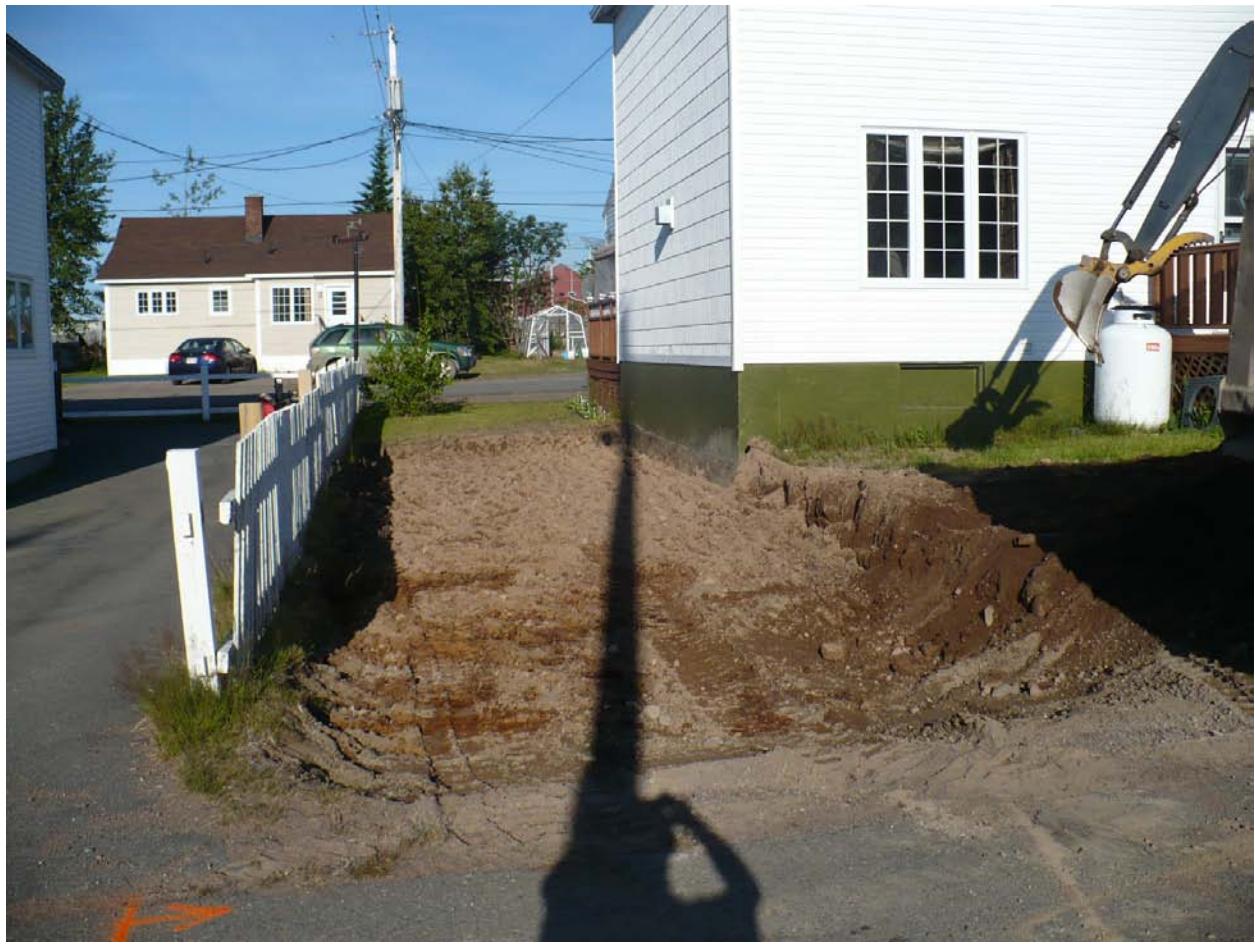
Photo#19

Photograph was taken on July 15, 2012 and shows the excavation of impacted soils along the front and side yards of 73 Church Street.

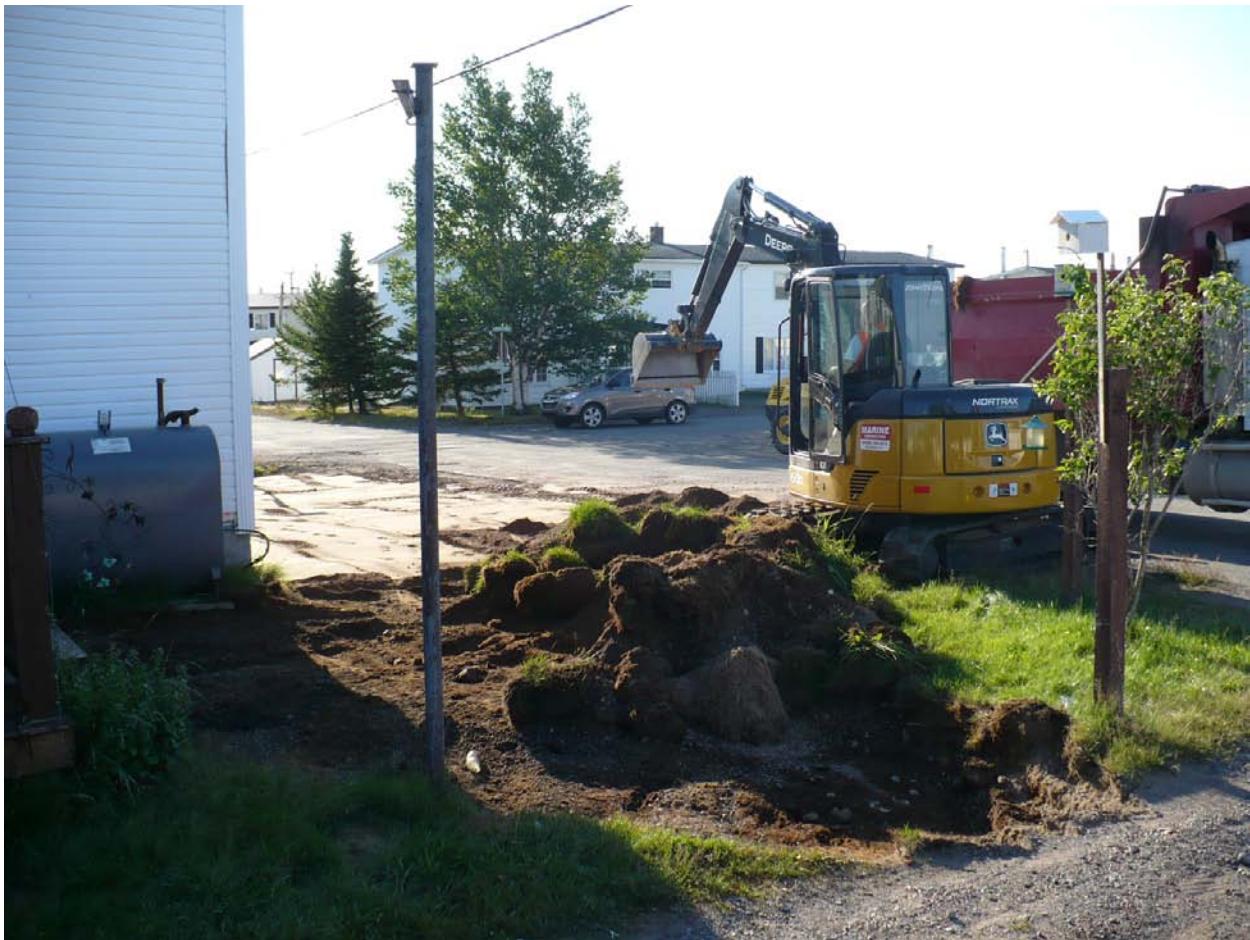
Photo#20

Photograph was taken on July 15, 2012 and shows the start of excavation at 69 Church Street.

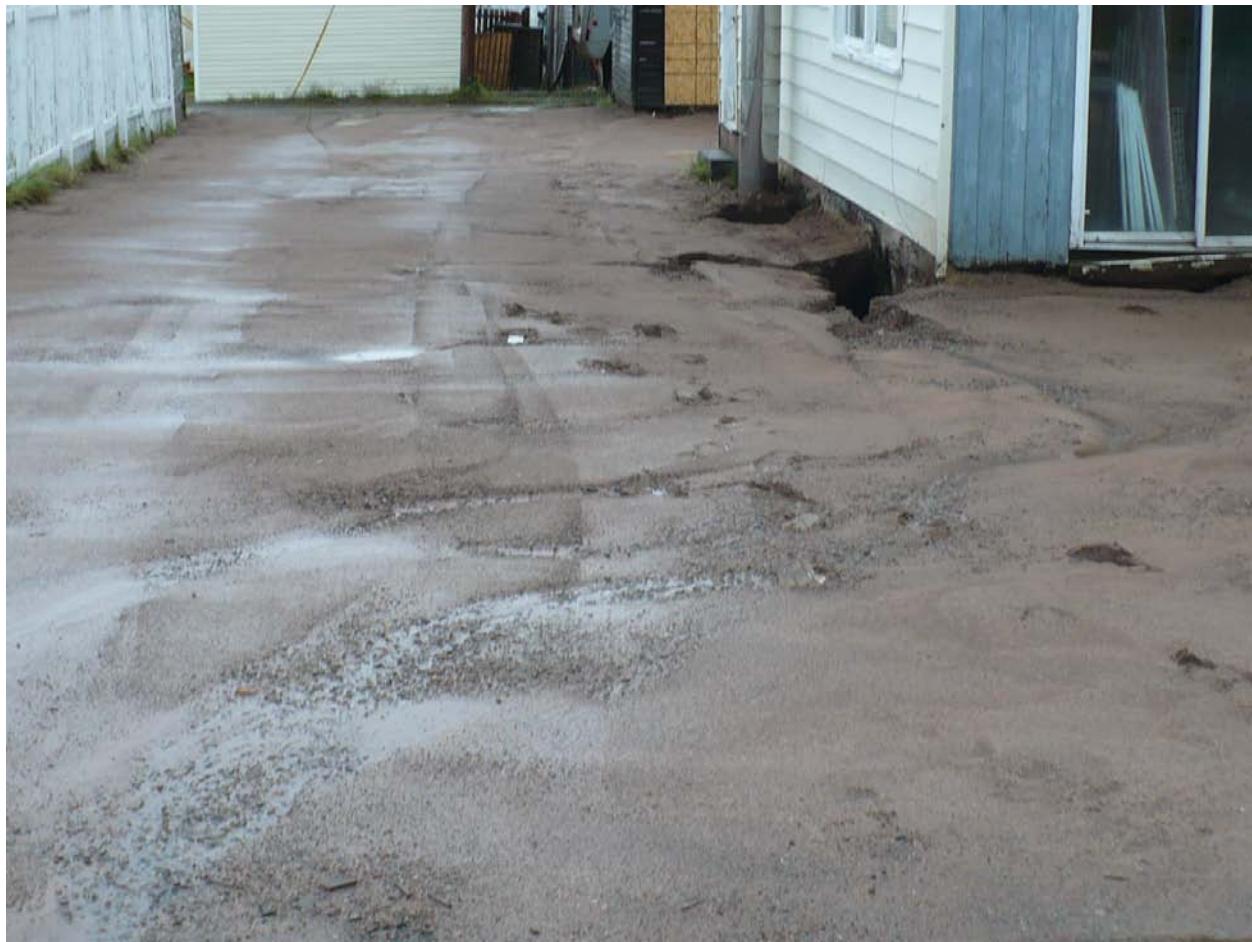
Photo#21

Photograph was taken on July 17, 2012 and shows the rear yard of 40 Church Street after heavy rains. The area had previously been remediated and will require some touch up prior to the installation of sods and Class "A".

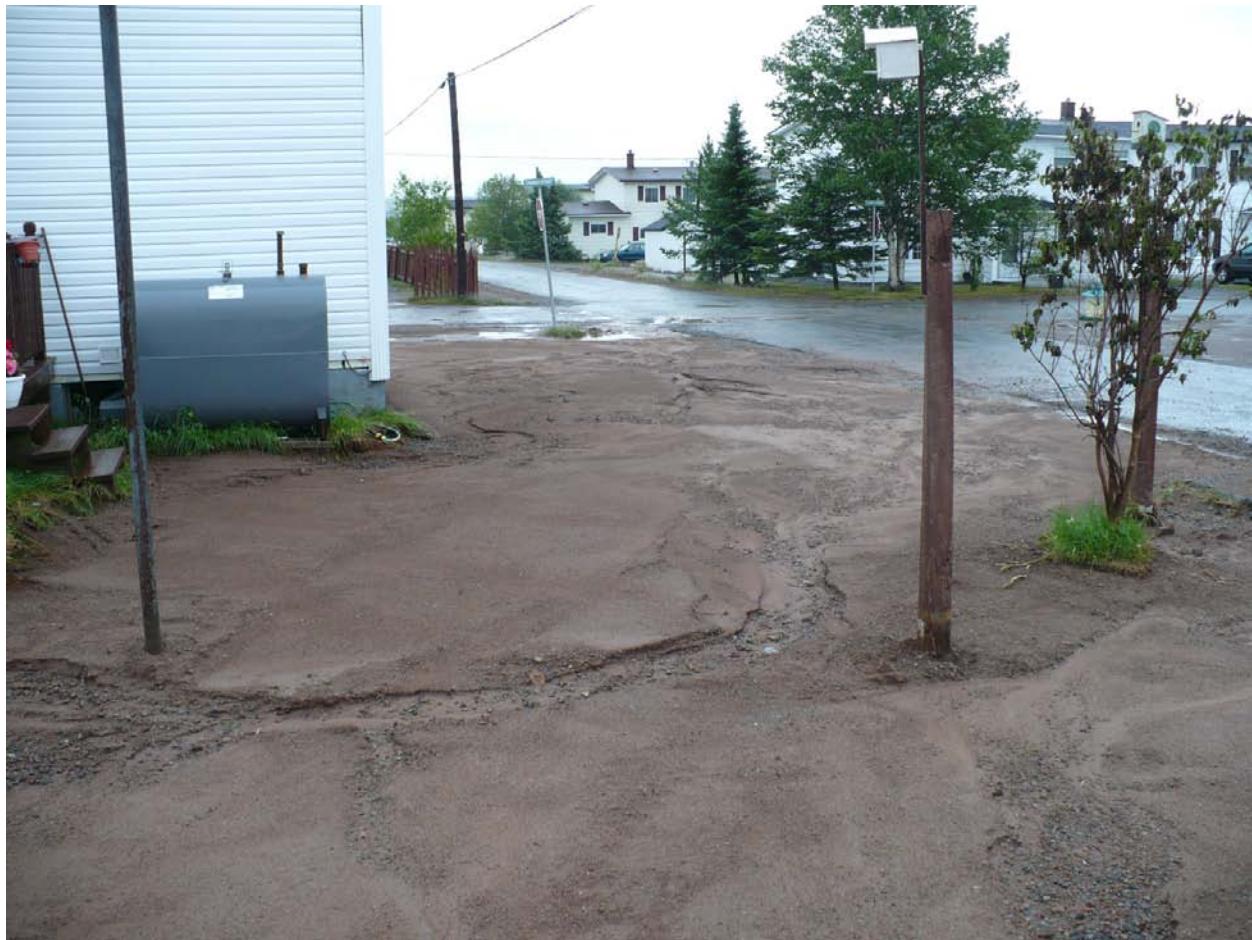
Photo#22

Photograph was taken on July 17, 2012 and shows the side and front yards of 63 Church Street after heavy rains. The area had previously been remediated and will require some touch up prior to the installation of sods and Class "A".

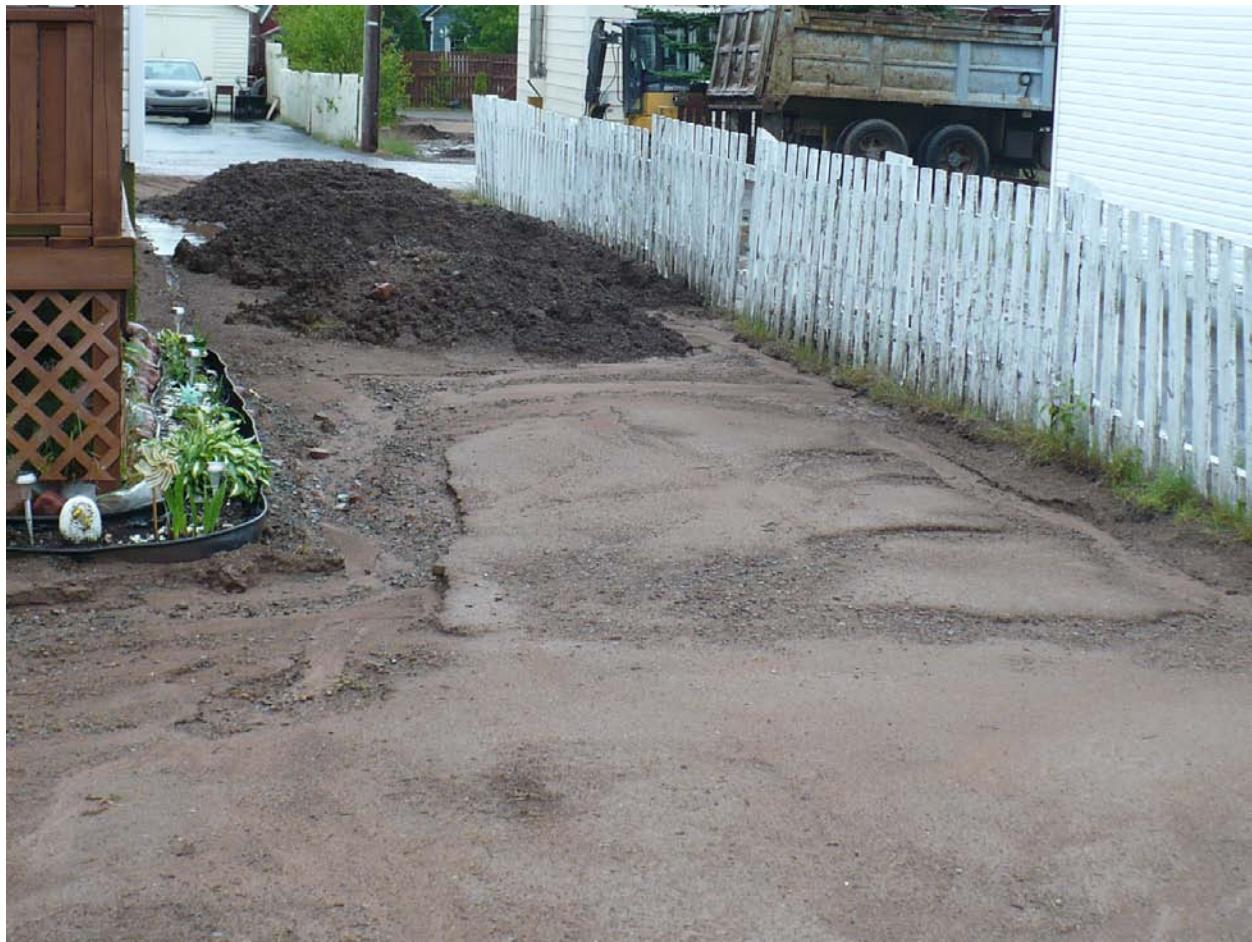
Photo#23

Photograph was taken on July 17, 2012 and shows the partial rear and side yards of 73 Church Street after heavy rains. The area had previously been remediated and will require some touch up prior to the installation of Class "A".

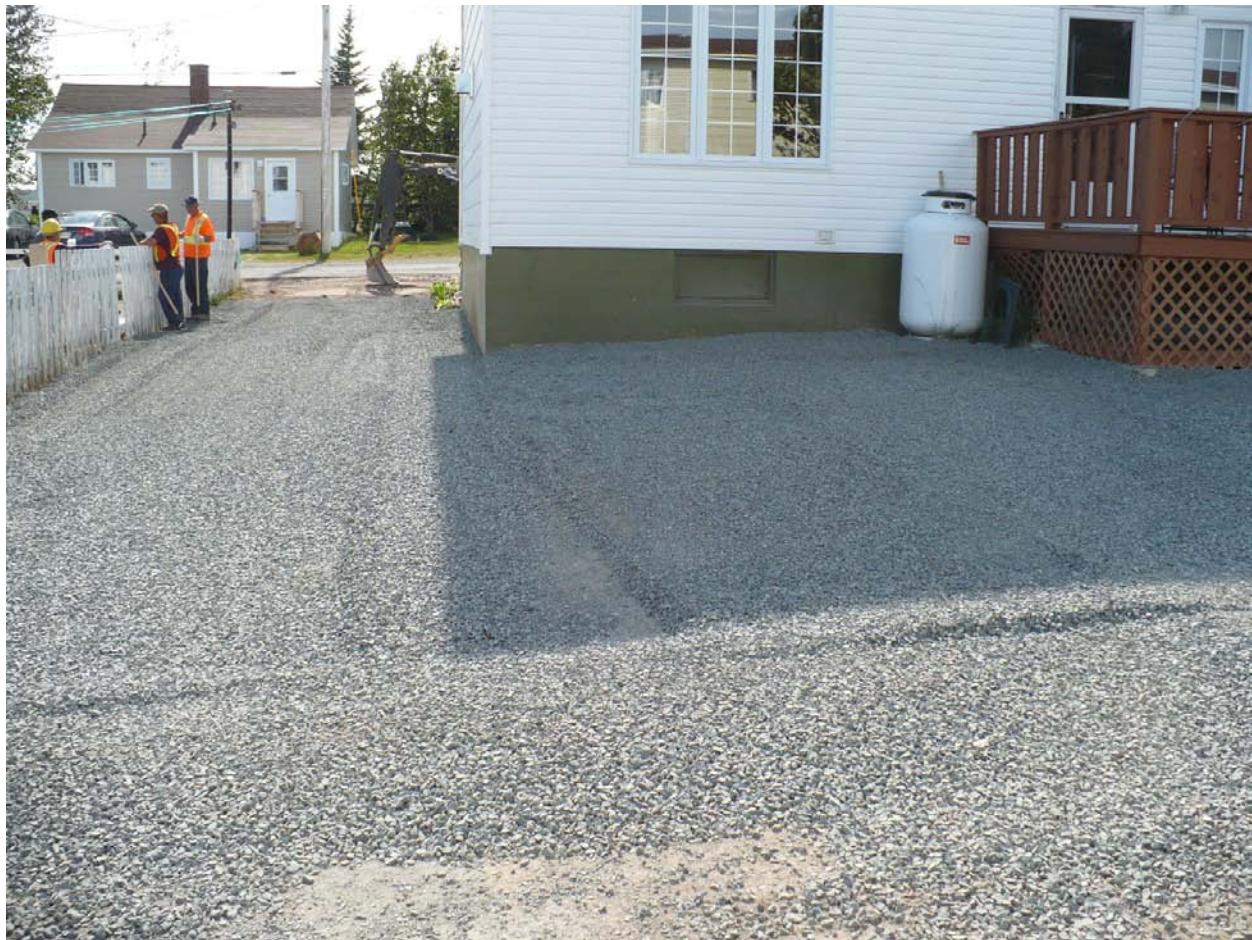
Photo#24

Photograph was taken on July 24, 2012 and shows the side and front yards of 73 Church Street after the remediation effort has been completed. The area had previously been remediated and required some touch up due to damage incurred by heavy rains prior to the installation of Class "A".

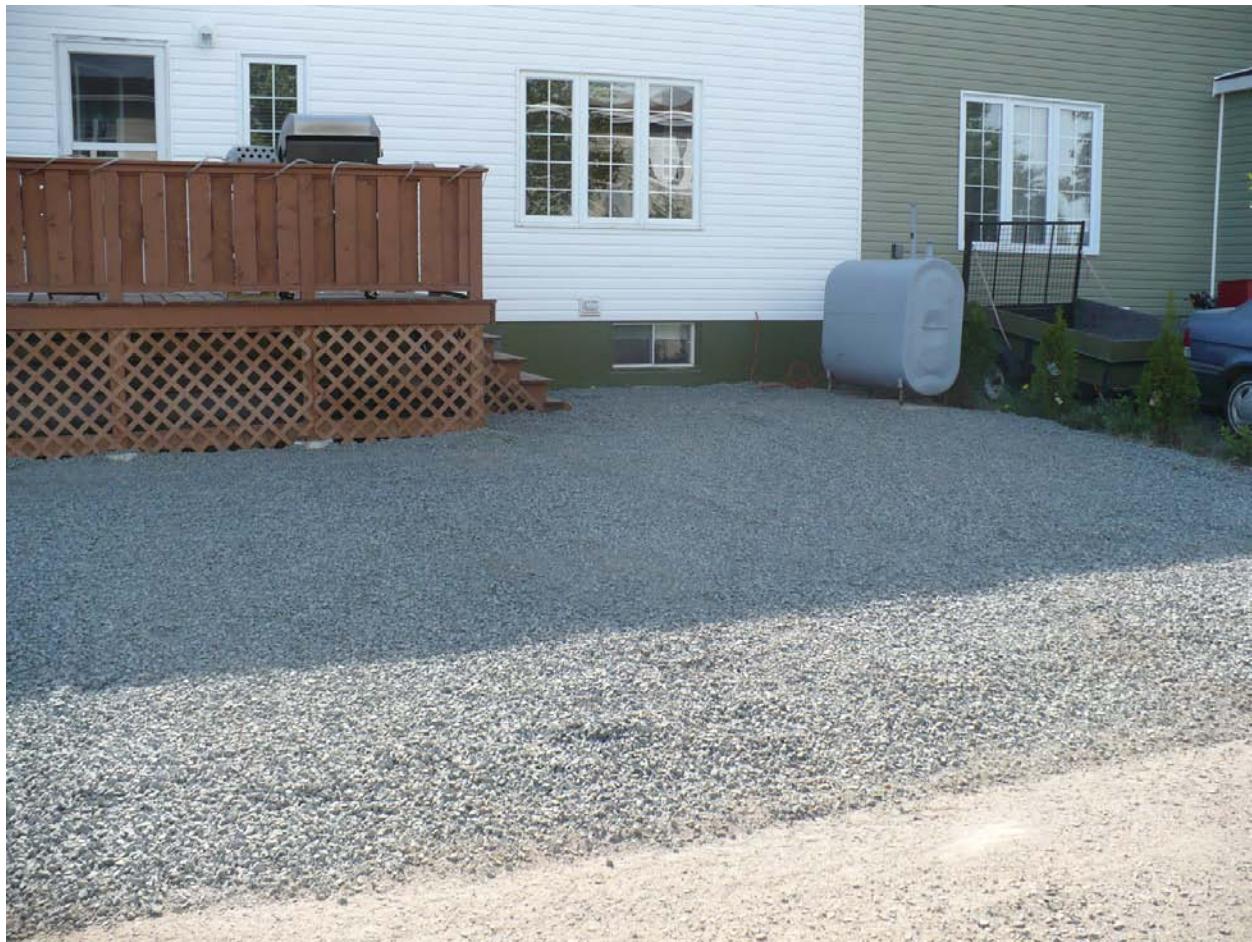
Photo#25

Photograph was taken on July 24, 2012 and shows the side and front yards of 73 and 75 Church Street after the remediation effort has been completed. The area had previously been remediated and required some touch up due to damage incurred by heavy rains prior to the installation of Class "A".

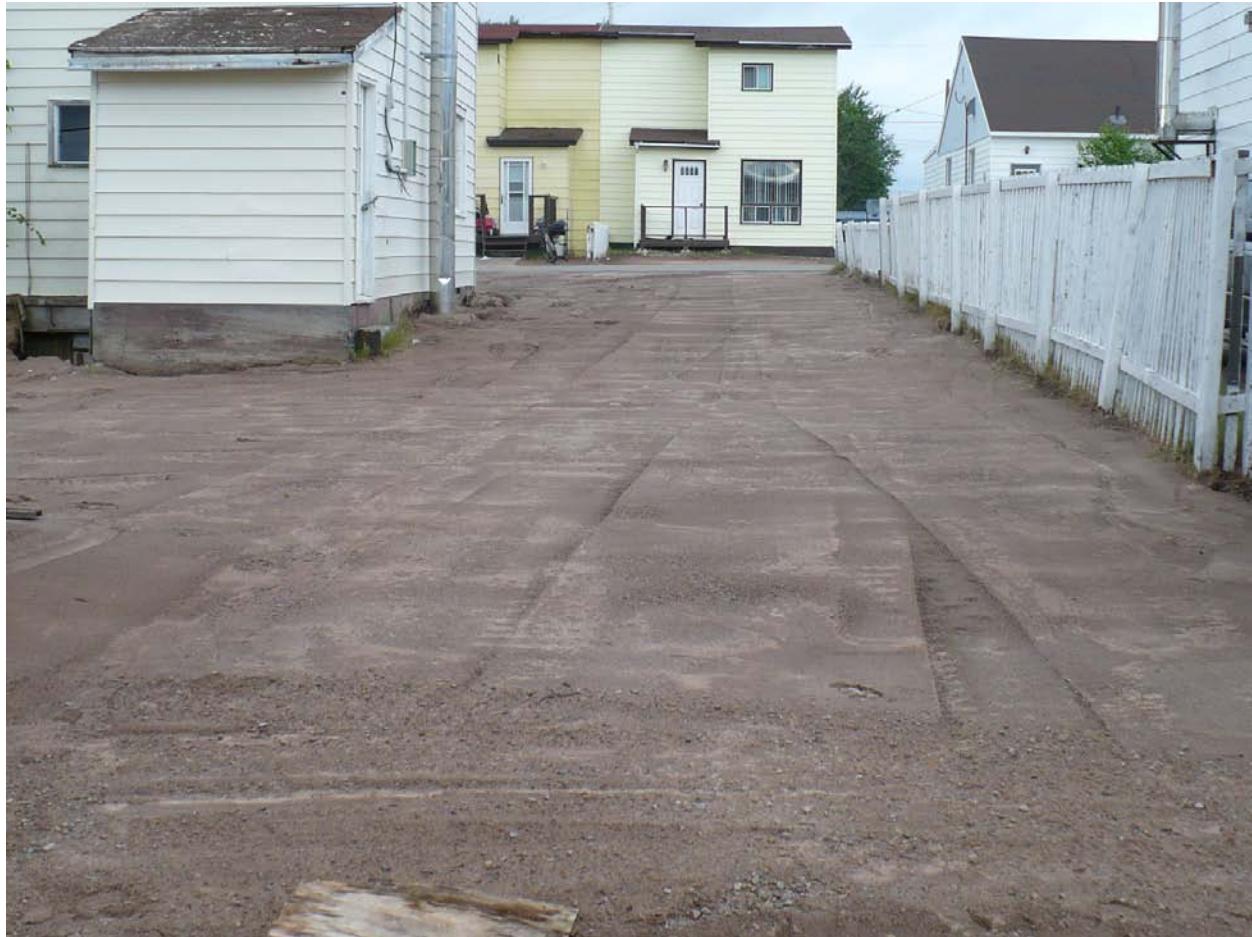
Photo#26

Photograph was taken on July 25, 2012 and shows the side and partial rear yards of 58 Church Street after the installation and compaction of pit run material has been completed.

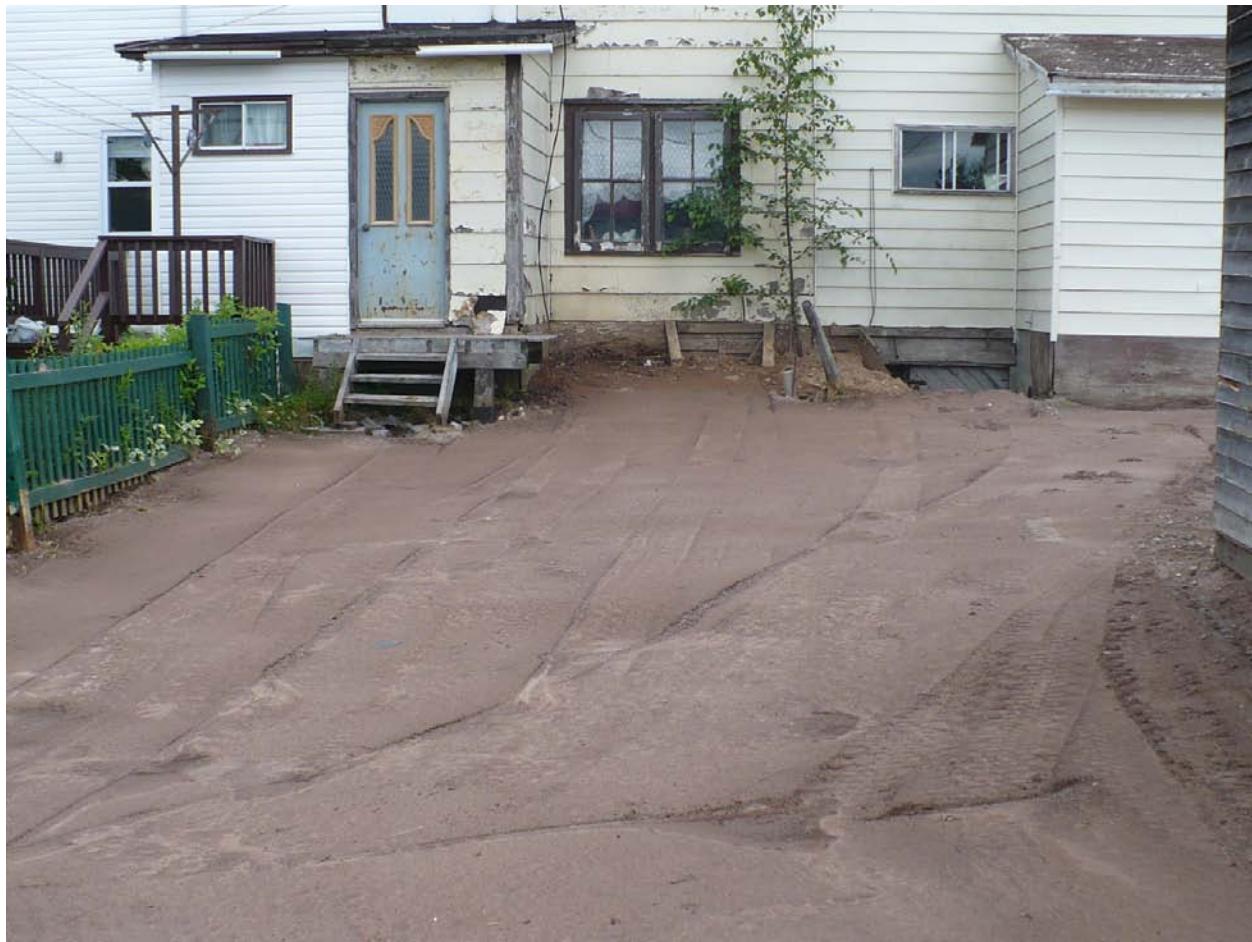
Photo#27

Photograph was taken on July 25, 2012 and shows the side and partial rear yards of 58 Church Street after the installation and compaction of pit run material has been completed.

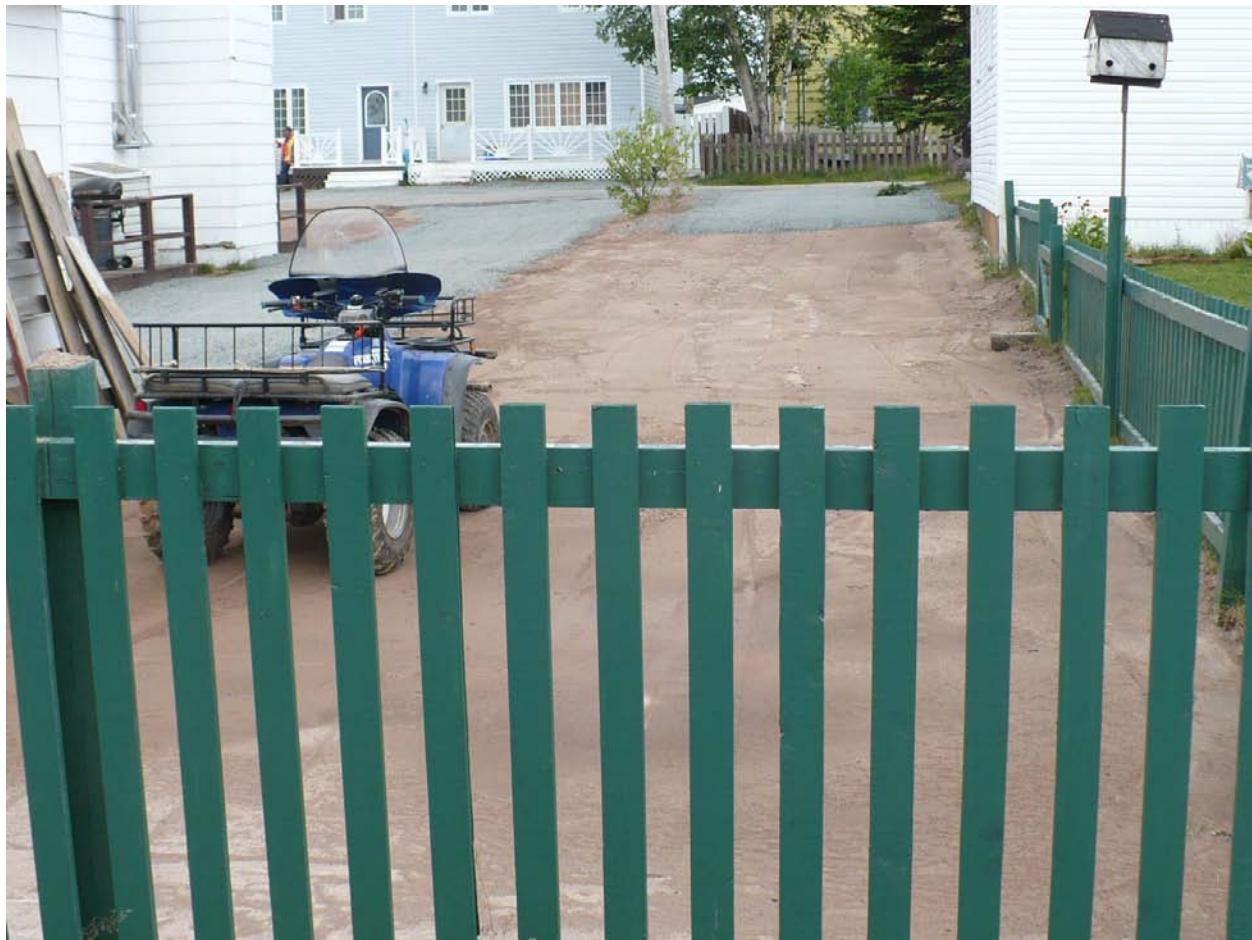
Photo#28

Photograph was taken on July 25, 2012 and shows the side yard of 50 Church Street after the installation and compaction of pit run material has been completed.

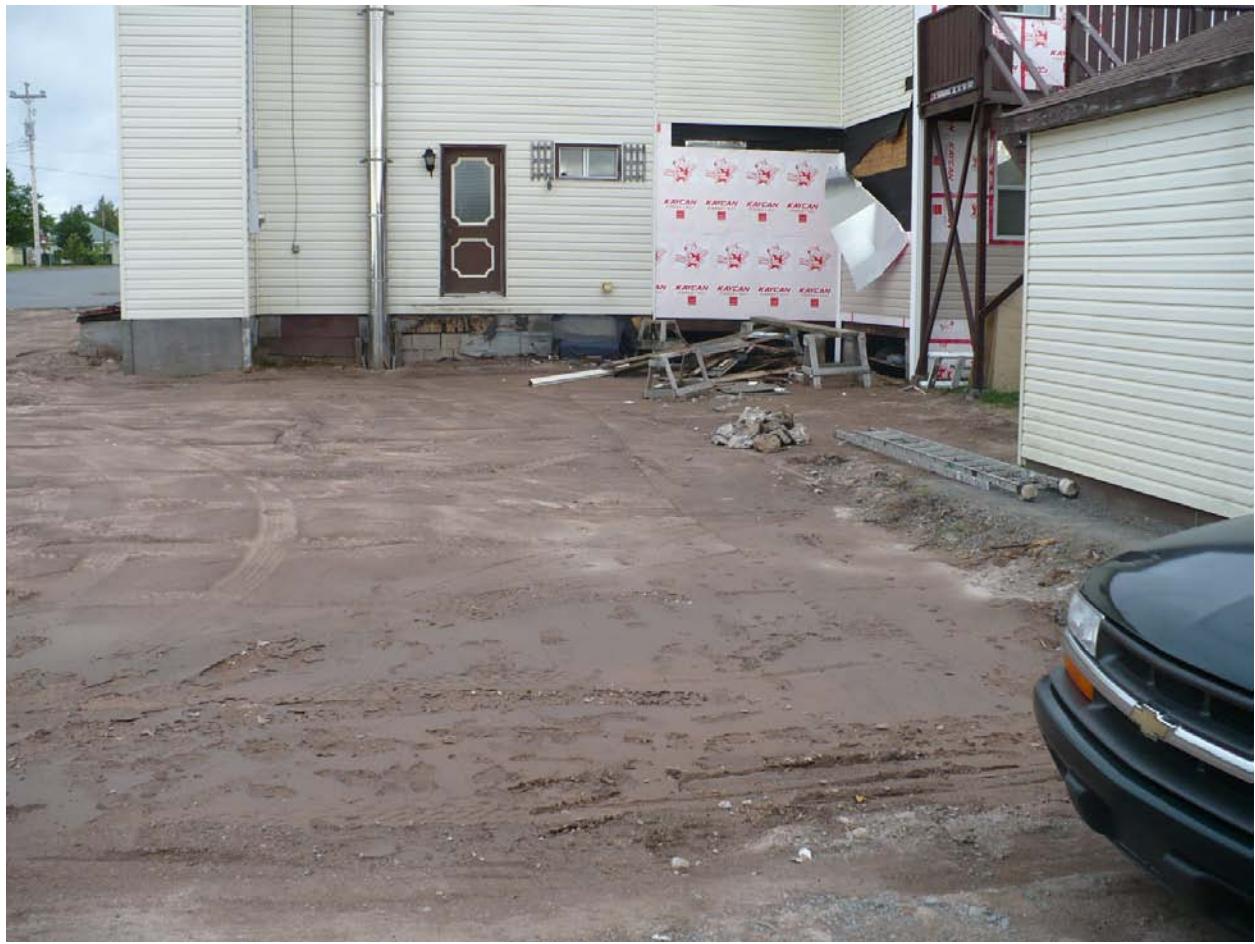
Photo#29

Photograph was taken on July 25, 2012 and shows the side and rear yards of 38 Church Street after the installation and compaction of pit run material has been completed.

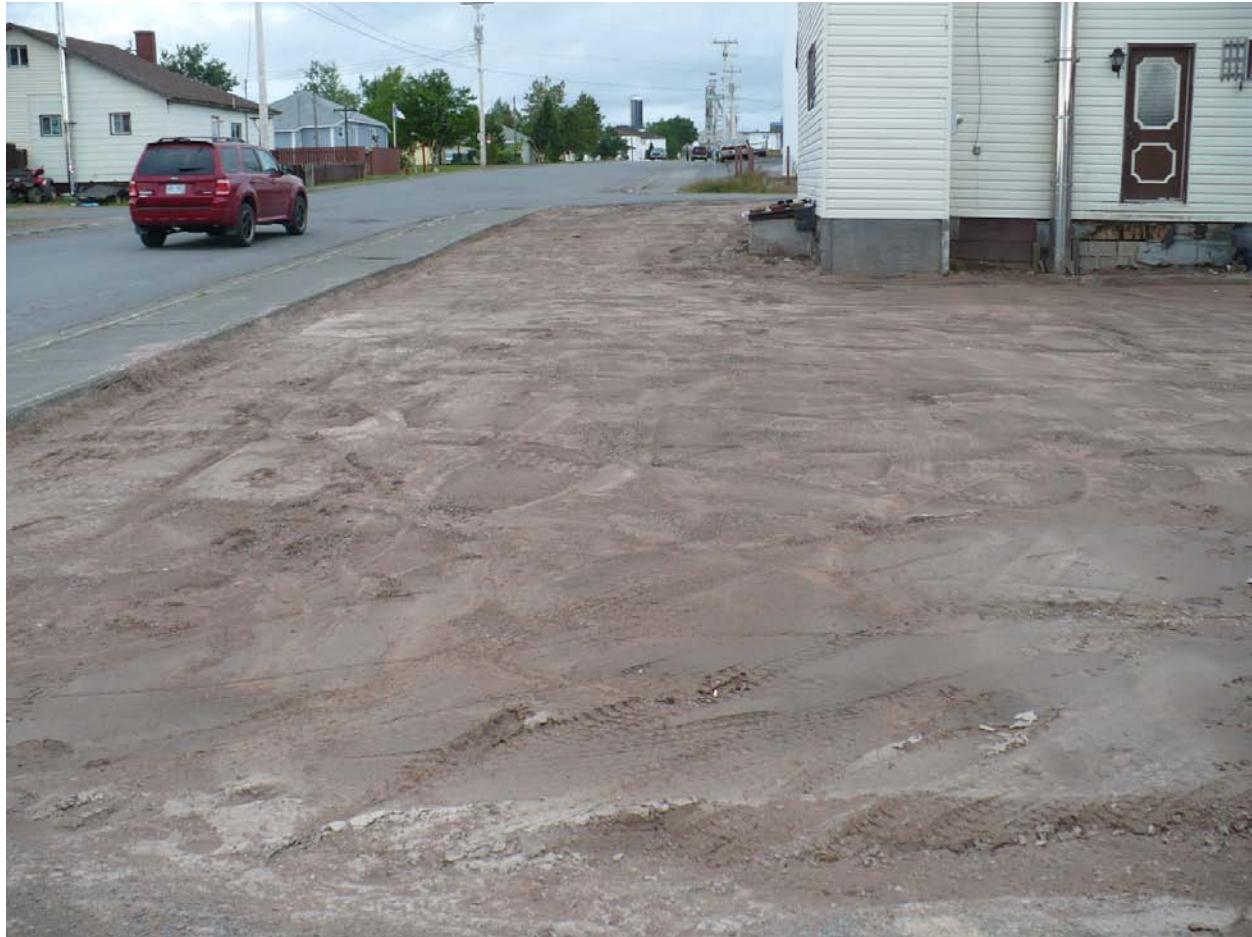
Photo#30

Photograph was taken on July 25, 2012 and shows the side and rear yards of 38 Church Street after the installation and compaction of pit run material has been completed.
