Project: The Buchans Remediation Project – Phase II
Residential and Public Areas Remediation
Year 1 Construction Report

Client: Department of Environment and Conservation

Consultant: Hatch Mott MacDonald

Contractor: Marine Contractors Inc.

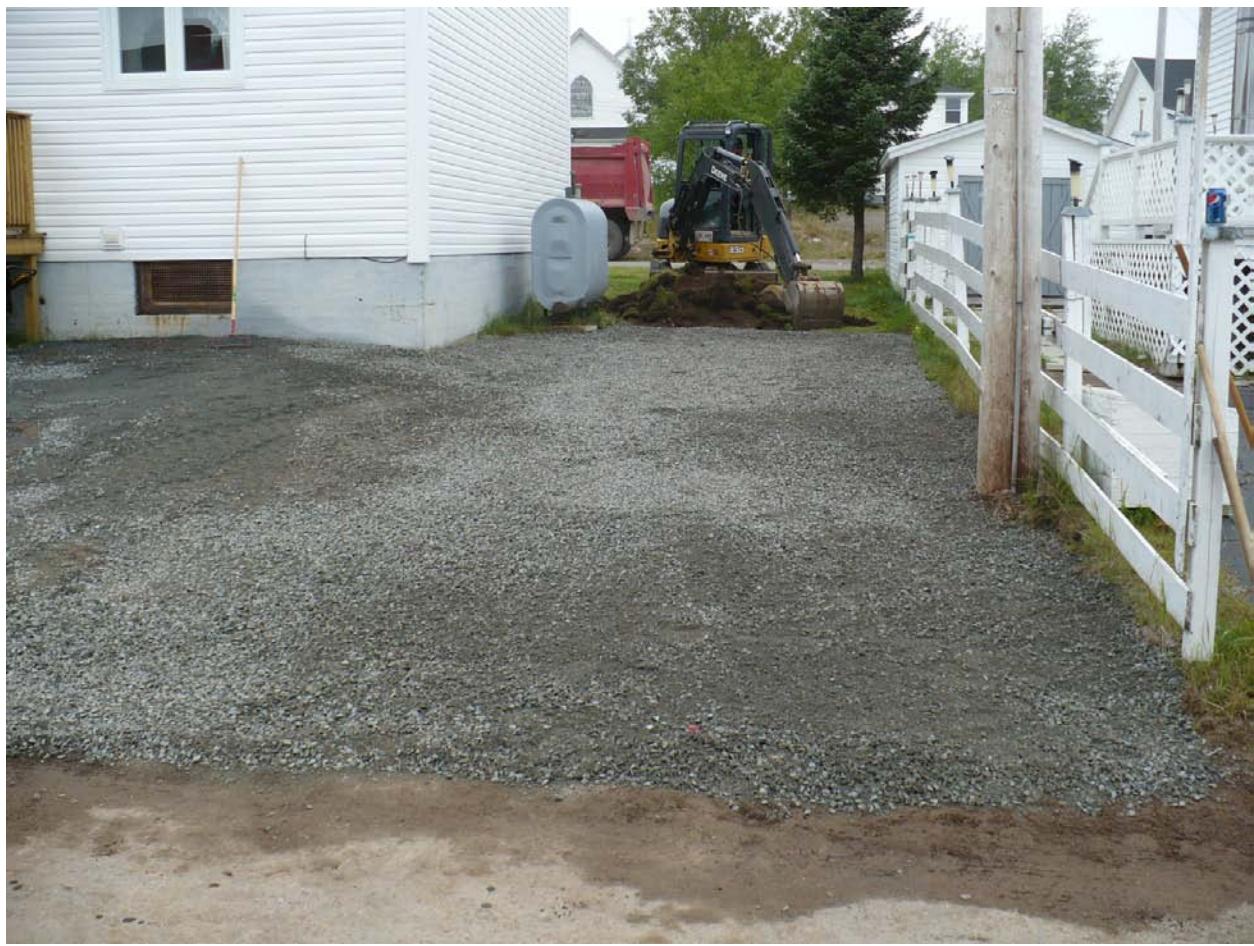
Photo#61

Photograph was taken on August 12, 2012 and shows the installation of Class "A" material on the front and partial side yard of 32 Lundberg Avenue and the ongoing excavation of impacted soils on the back side yard and rear yard.

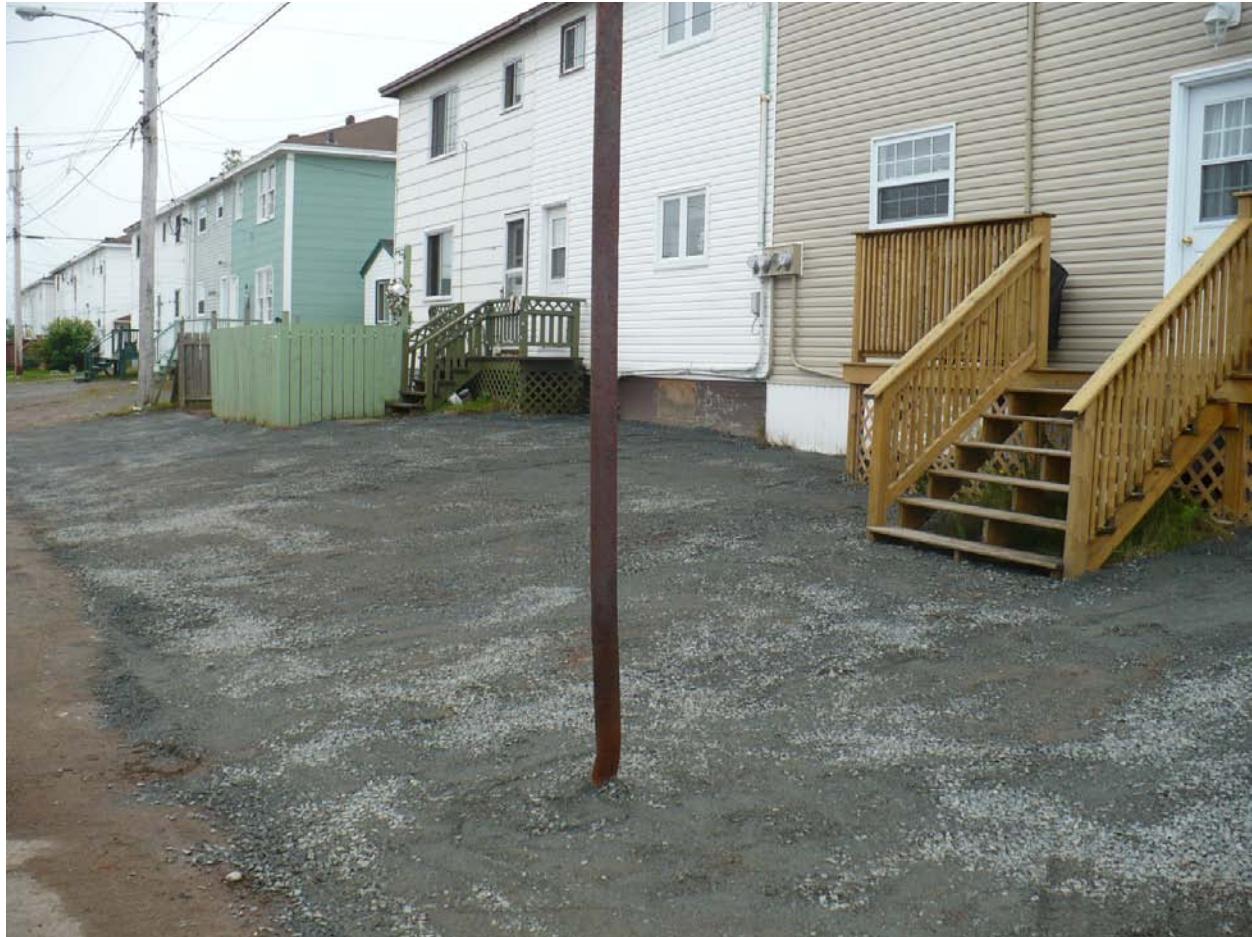
Photo#62

Photograph was taken on August 12, 2012 and shows the Class "A" installation at 30 Lundberg Avenue.

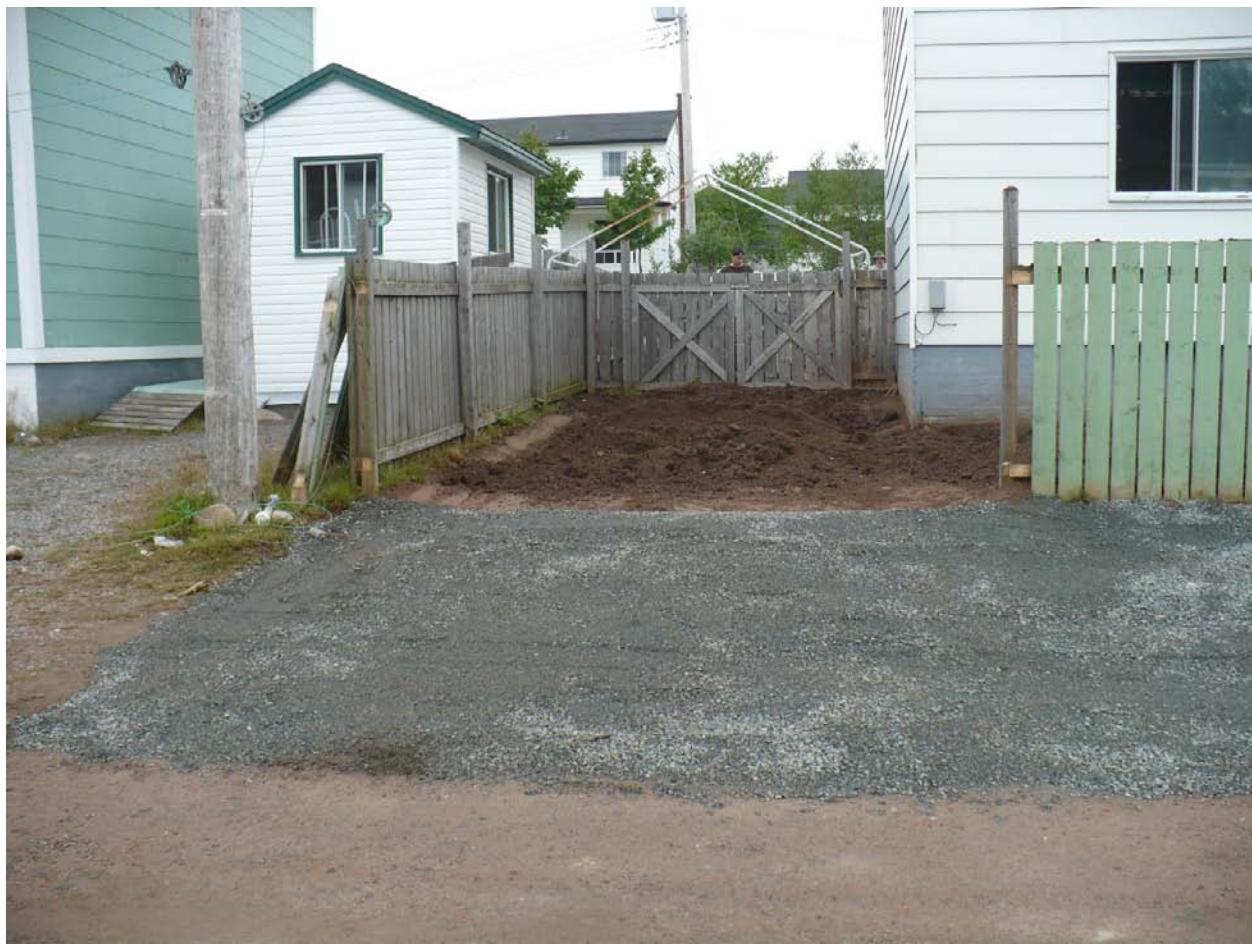
Photo#63

Photograph was taken on August 12, 2012 and shows the installation of topsoil prior to the installation of sod at the side yard of 26 Lundberg Avenue. Note that the Class "A" application has been completed previously.

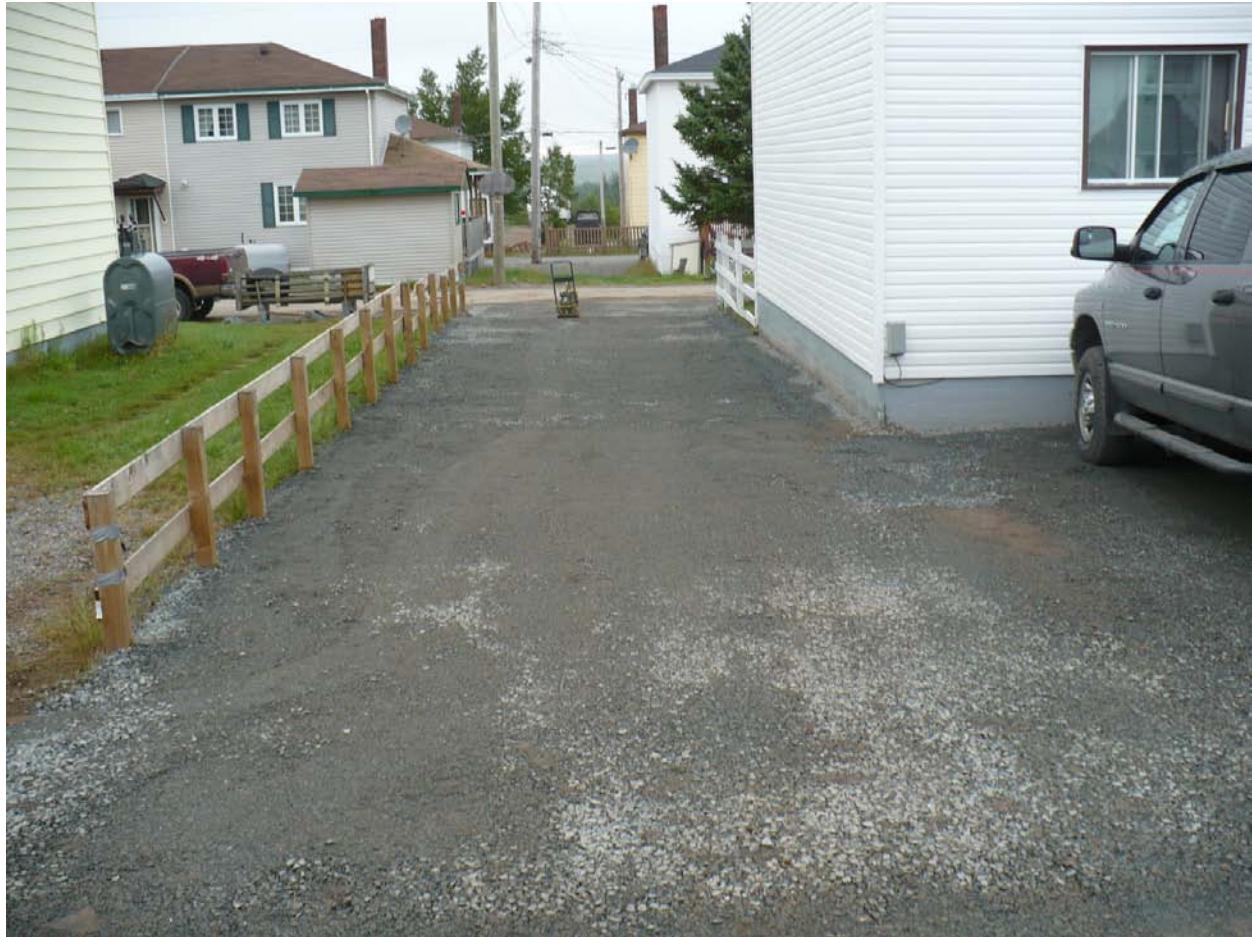
Photo#64

Photograph was taken on August 12, 2012 and shows the Class "A" installation at 23 Pine Street.

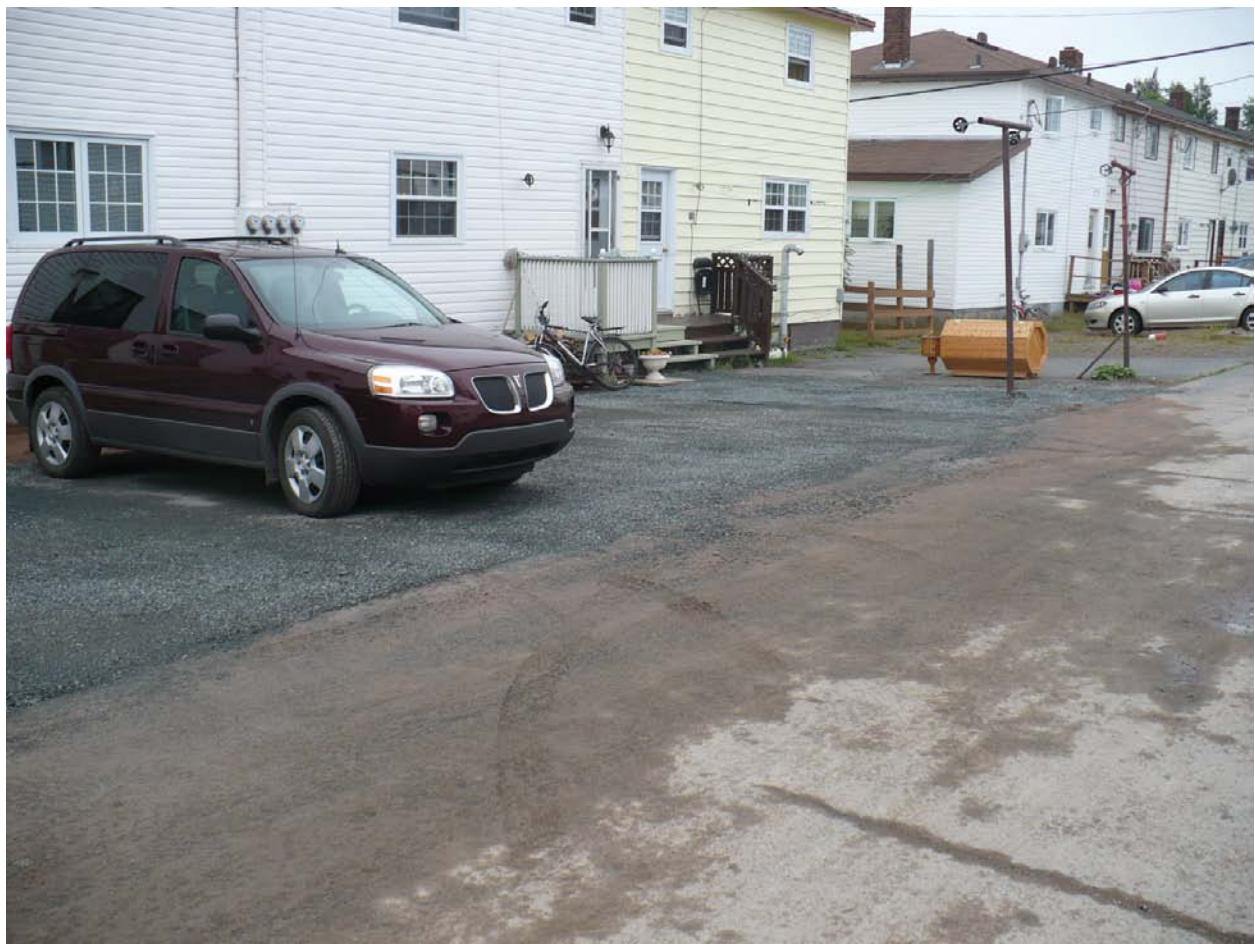
Photo#65

Photograph was taken on August 12, 2012 and shows the Class "A" installation at 21 – 23 Pine Street. Note that material was excavated and placed adjacent to the edge of the paved roadway.

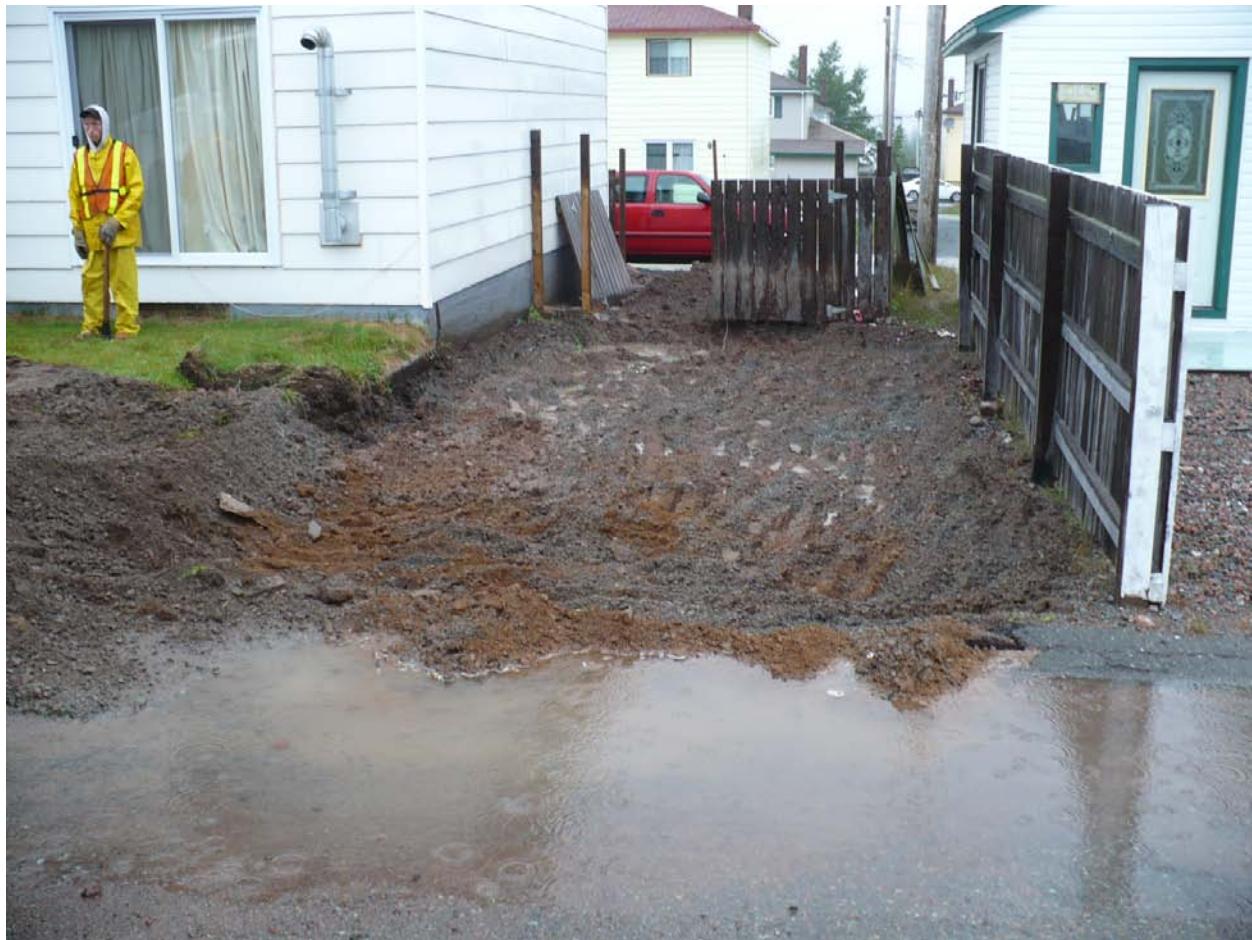
Photo#66

Photograph was taken on August 13, 2012 and shows the excavation of impacted soils to 300 mm depth at 26 Lundberg Avenue.

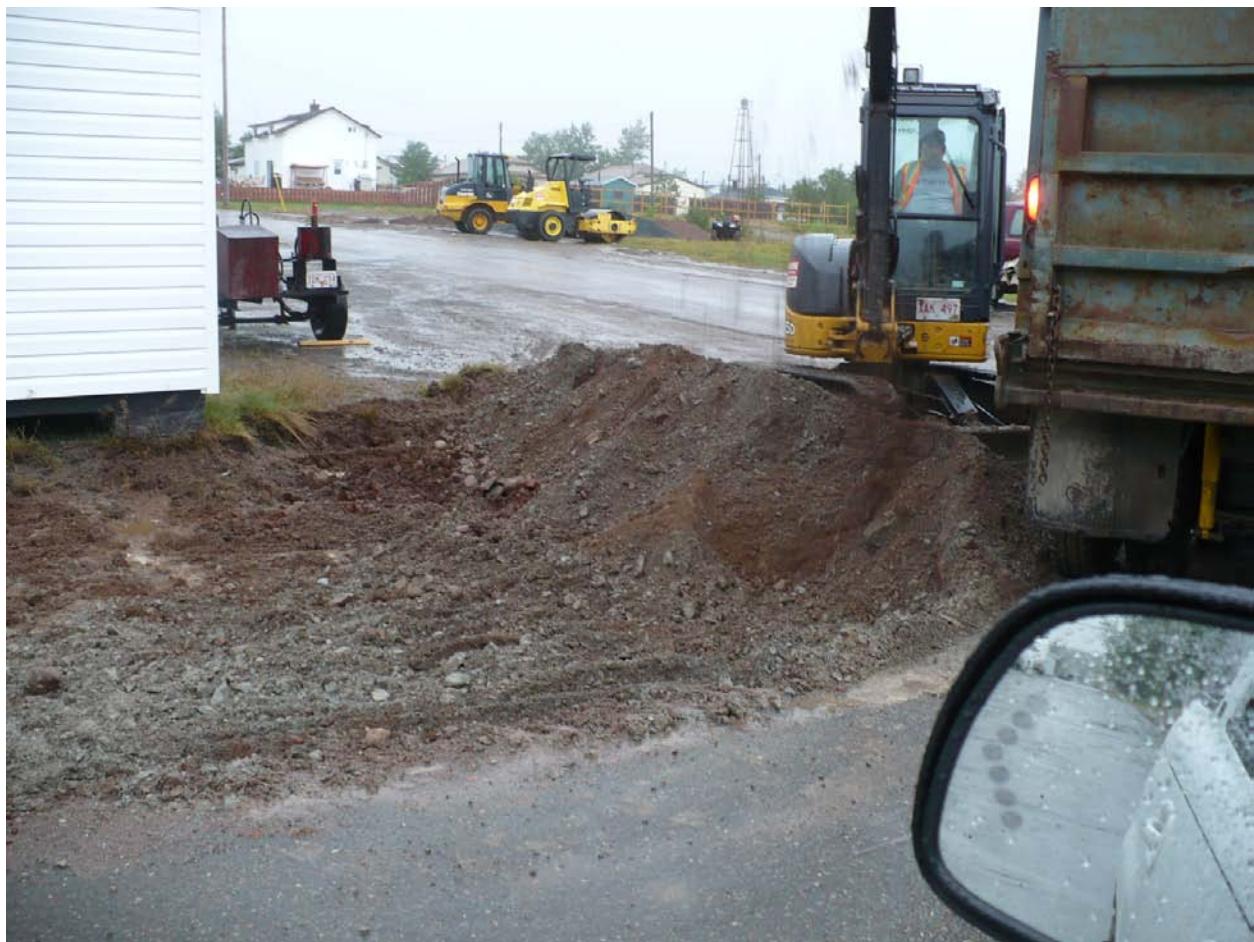
Photo#67

Photograph was taken on August 13, 2012 and shows the excavation of impacted soils to 300 mm depth at 39 Pine Street.

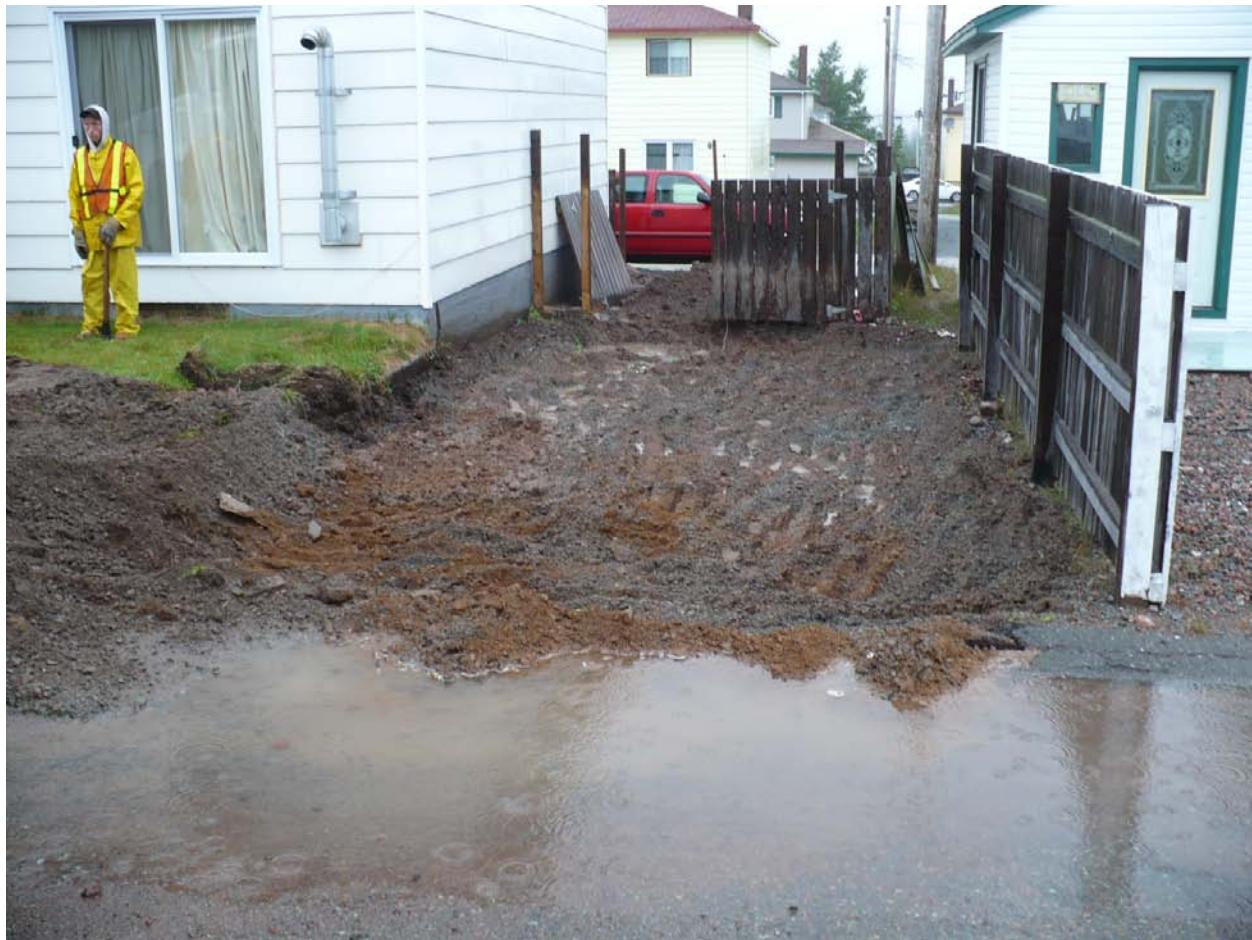
Photo#68

Photograph was taken on August 13, 2012 and shows the excavation of impacted soils to 300 mm depth at 26 Lundberg Avenue.

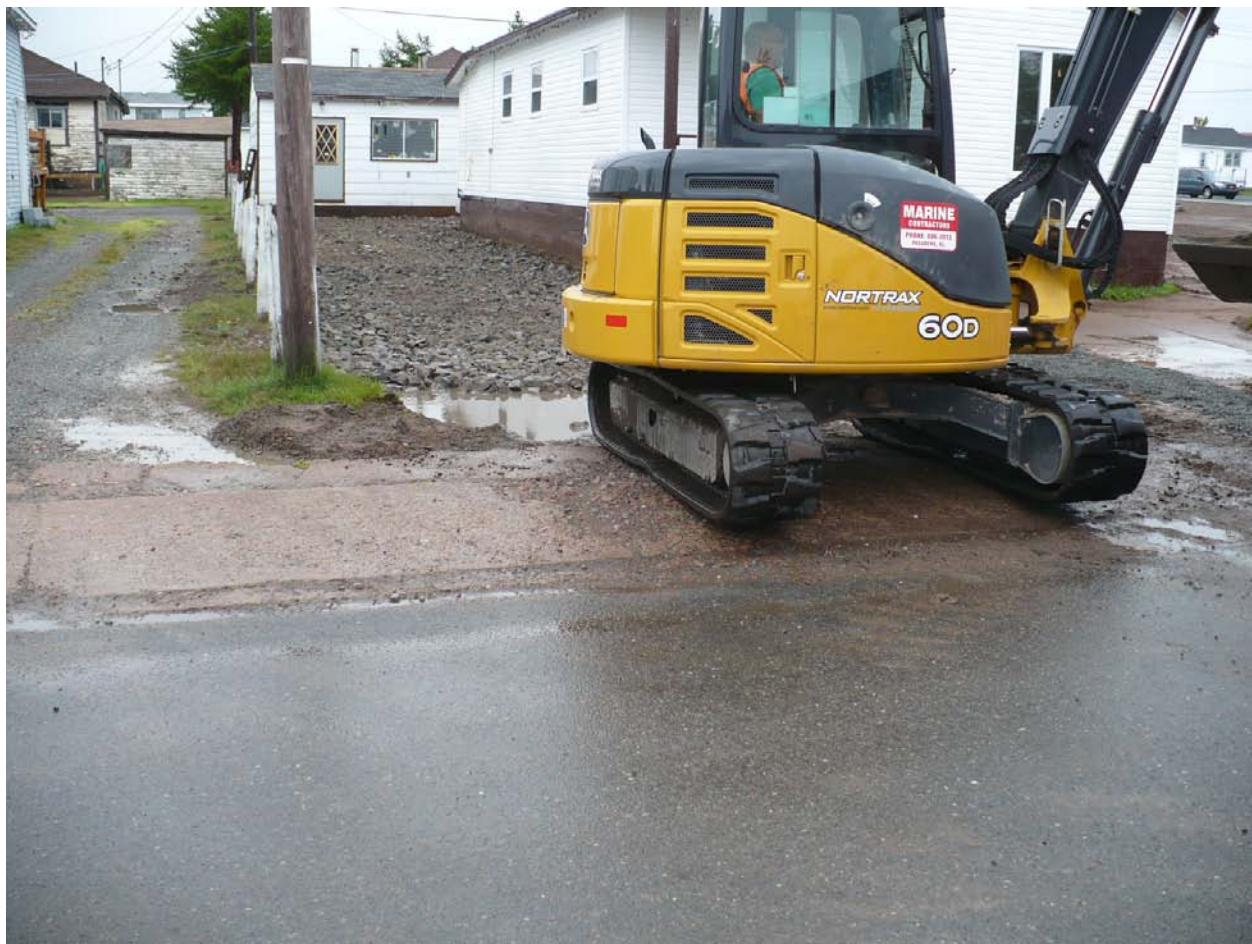
Photo#69

Photograph was taken on August 13, 2012 and shows the excavation of impacted soils to 300 mm depth at 57 Jackson Street. Note the use of Blast Rock Fill material to alleviate high water level issues and to provide soil stabilization measures.

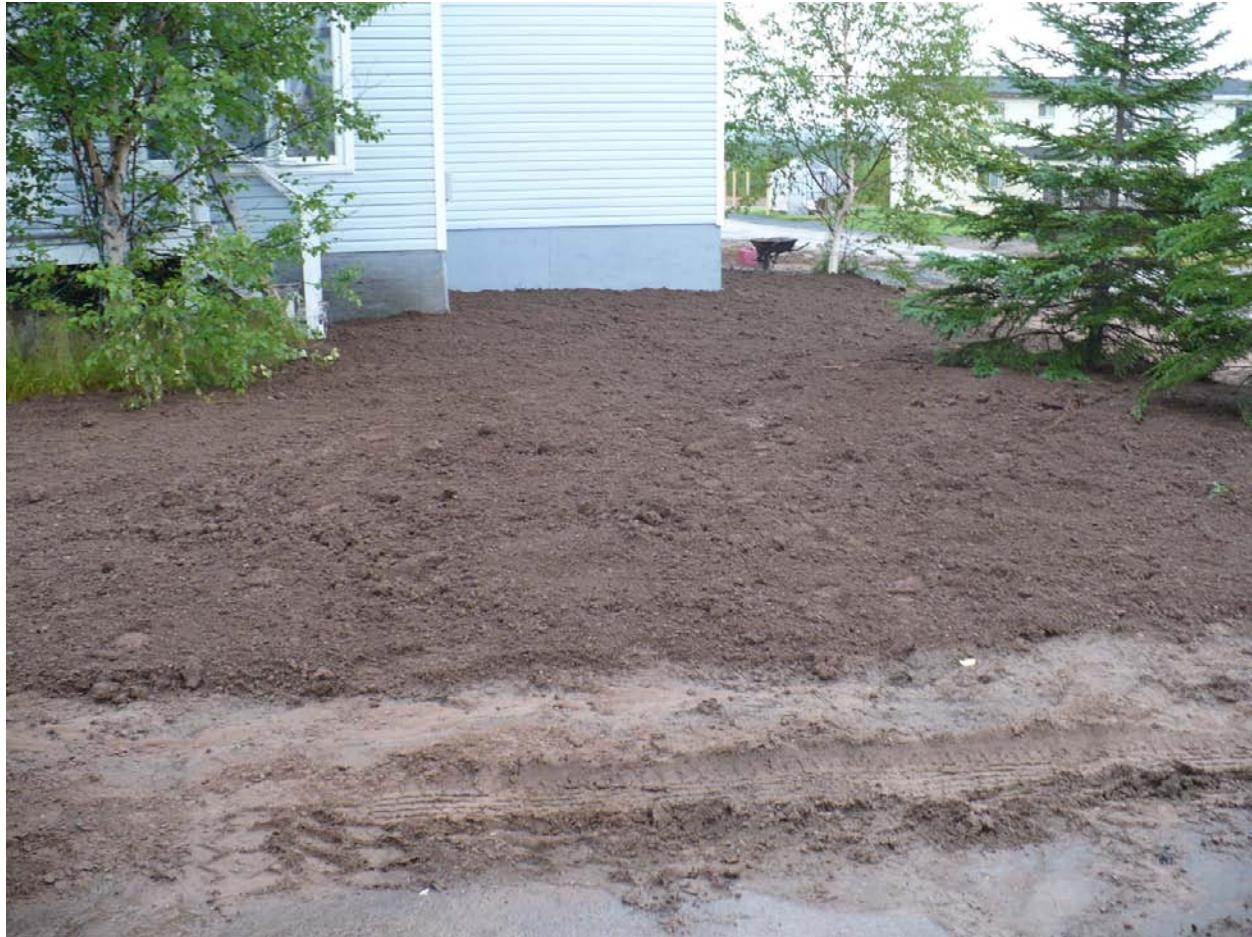
Photo#70

Photograph was taken on August 11, 2012 and shows the installation of topsoil material prior to sod installation at 30 East Street.

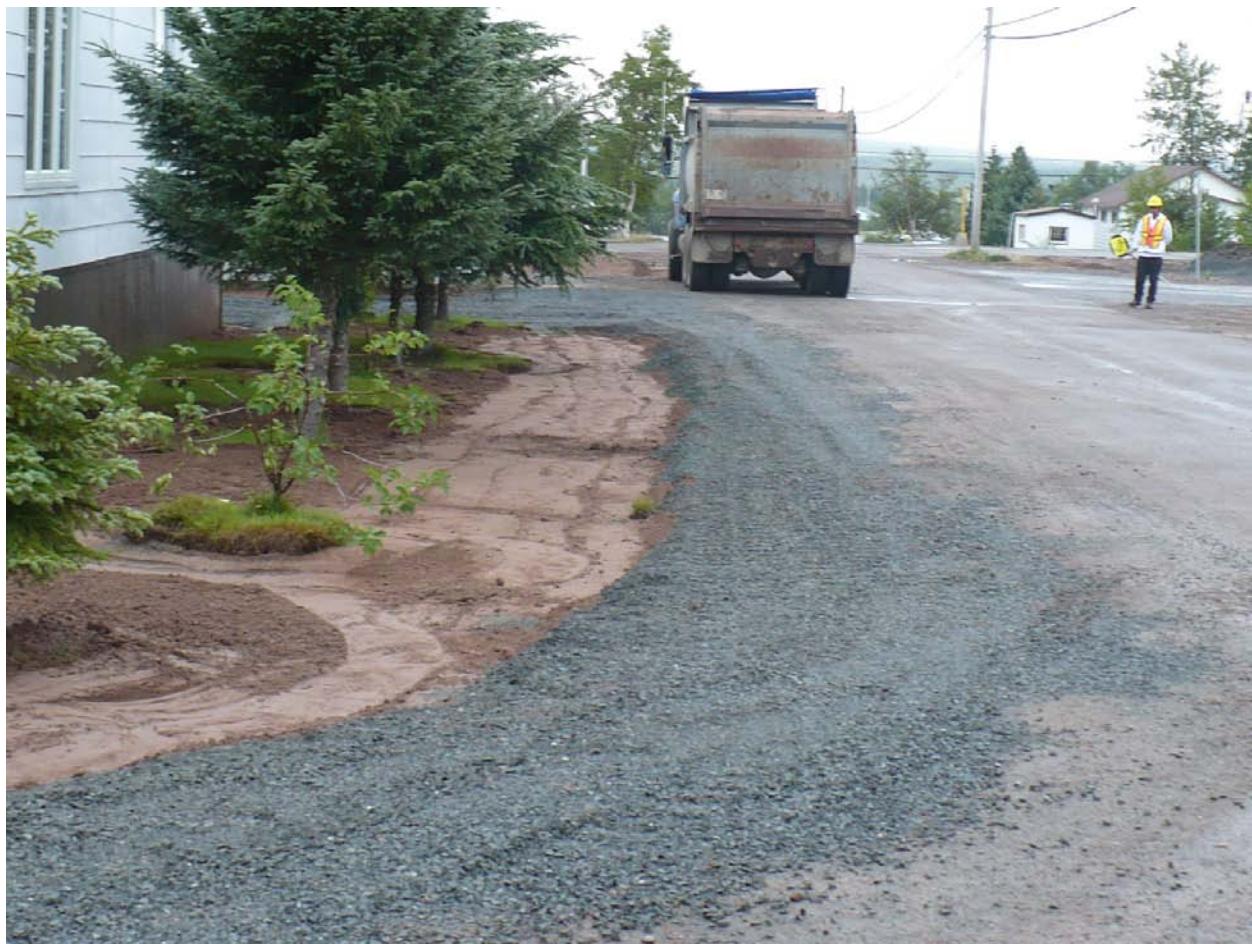
Photo#71

Photograph was taken on August 16, 2012 and shows the property at 2 Center Street after topsoil and Class "A" has been installed. The area under the trees still need to be completed with sod installation.

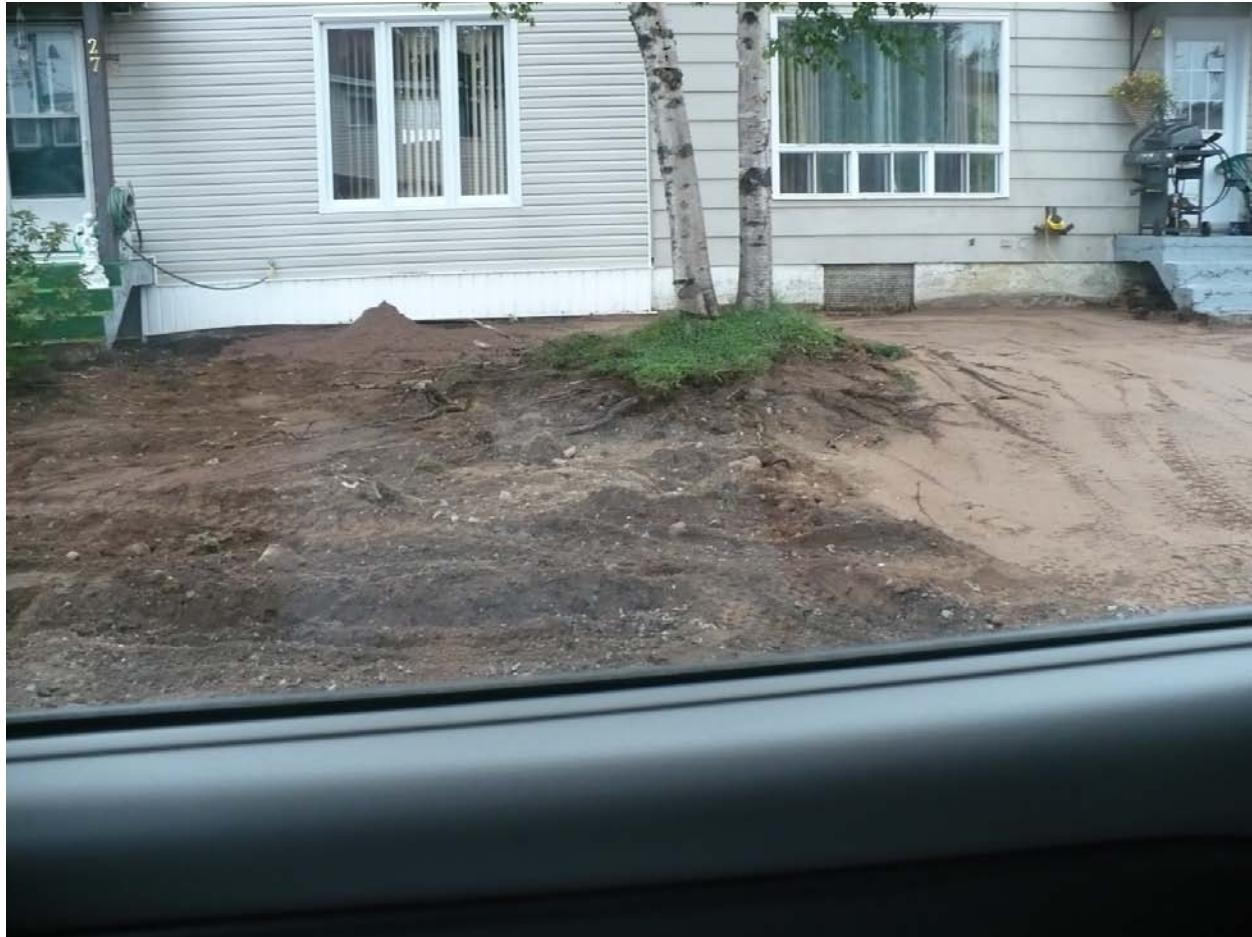
Photo#72

Photograph was taken on August 16, 2012 and shows the excavation of impacted soils at 27 Pine Street. The area to the right of the photo has been completely excavated and backfilled with Imported Common material and still requires Class "A" installation.

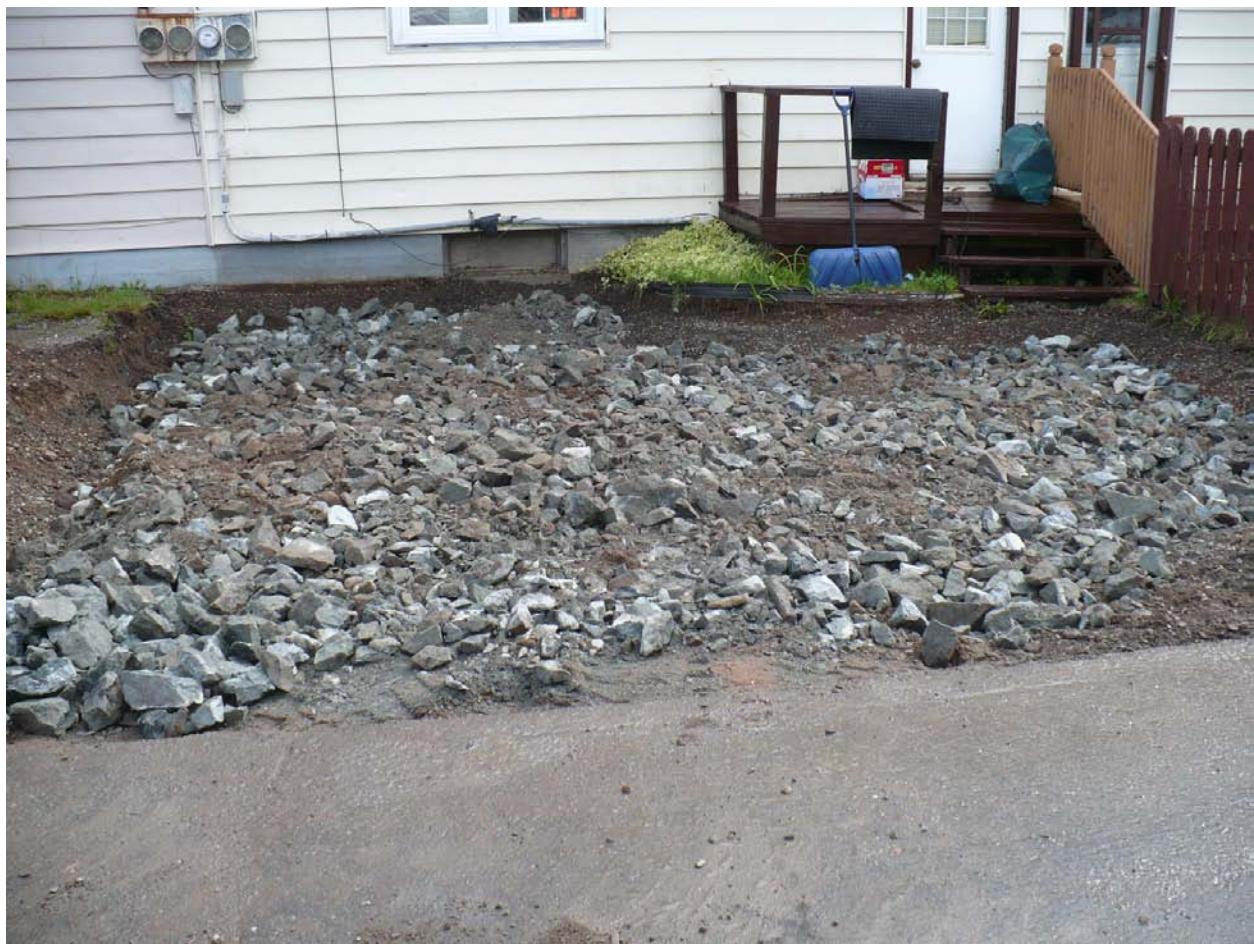
Photo#73

Photograph was taken on August 24, 2012 and shows the property at 11 Pine Street with excavation of impacted materials completed and imported rock fill installed as a soil stabilization measure.

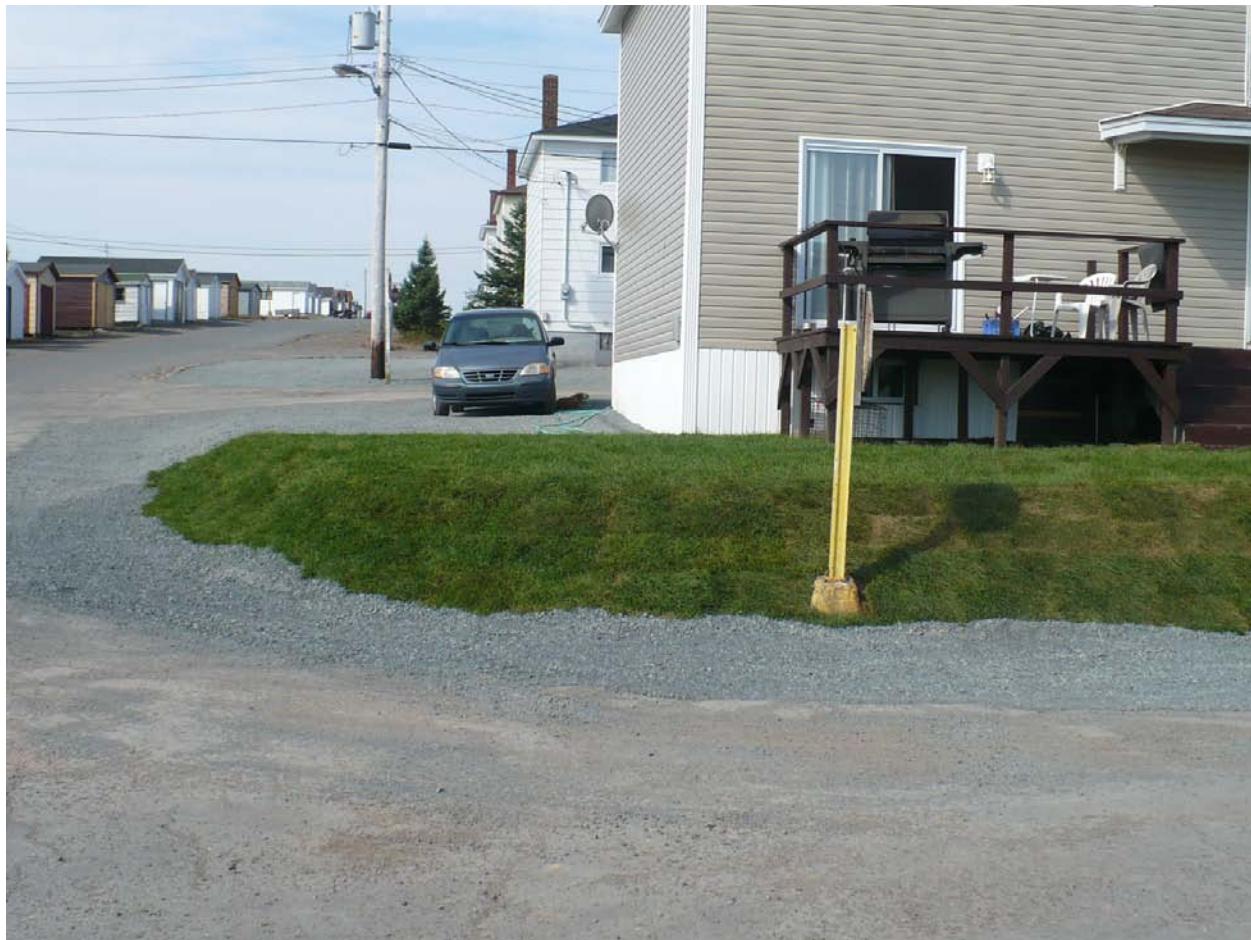
Photo#74

Photograph was taken on August 27, 2012 and shows the property at 1 Pine Street after Class "A" and sod installation has been completed. Note that the excavation of impacted materials and the Class "A" installation extends to the edge of the existing asphalt roadways. Also note the property at 2 Lundberg Avenue in the background that has been excavated and backfilled with imported common material and topped with Class "A".

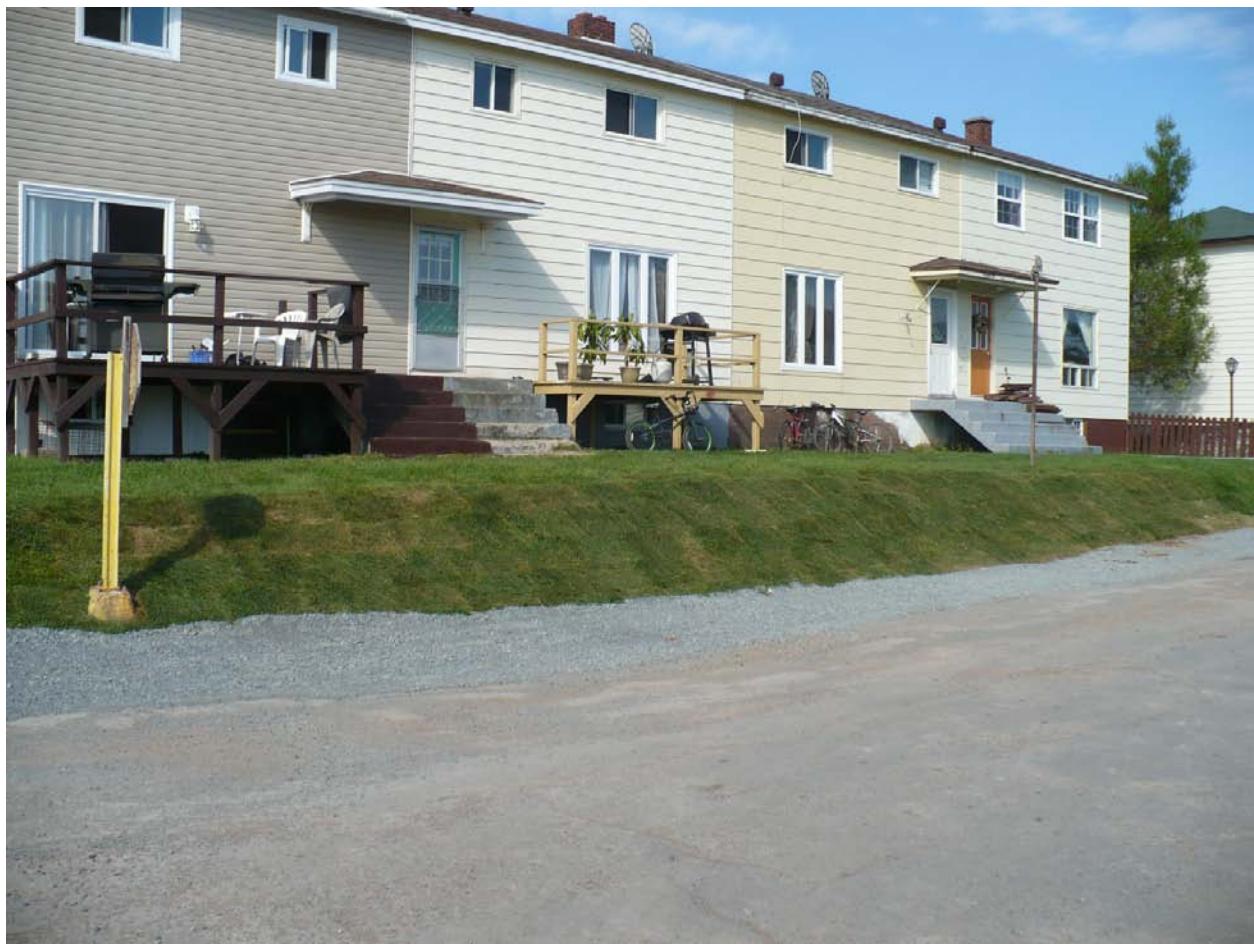
Photo#75

Photograph was taken on August 27, 2012 and shows the property at 1 - 7 Pine Street with excavation of impacted materials completed and Class "A" and sod installation completed. Note that the excavation of impacted materials and the Class "A" installation extends to the edge of the existing asphalt roadways.

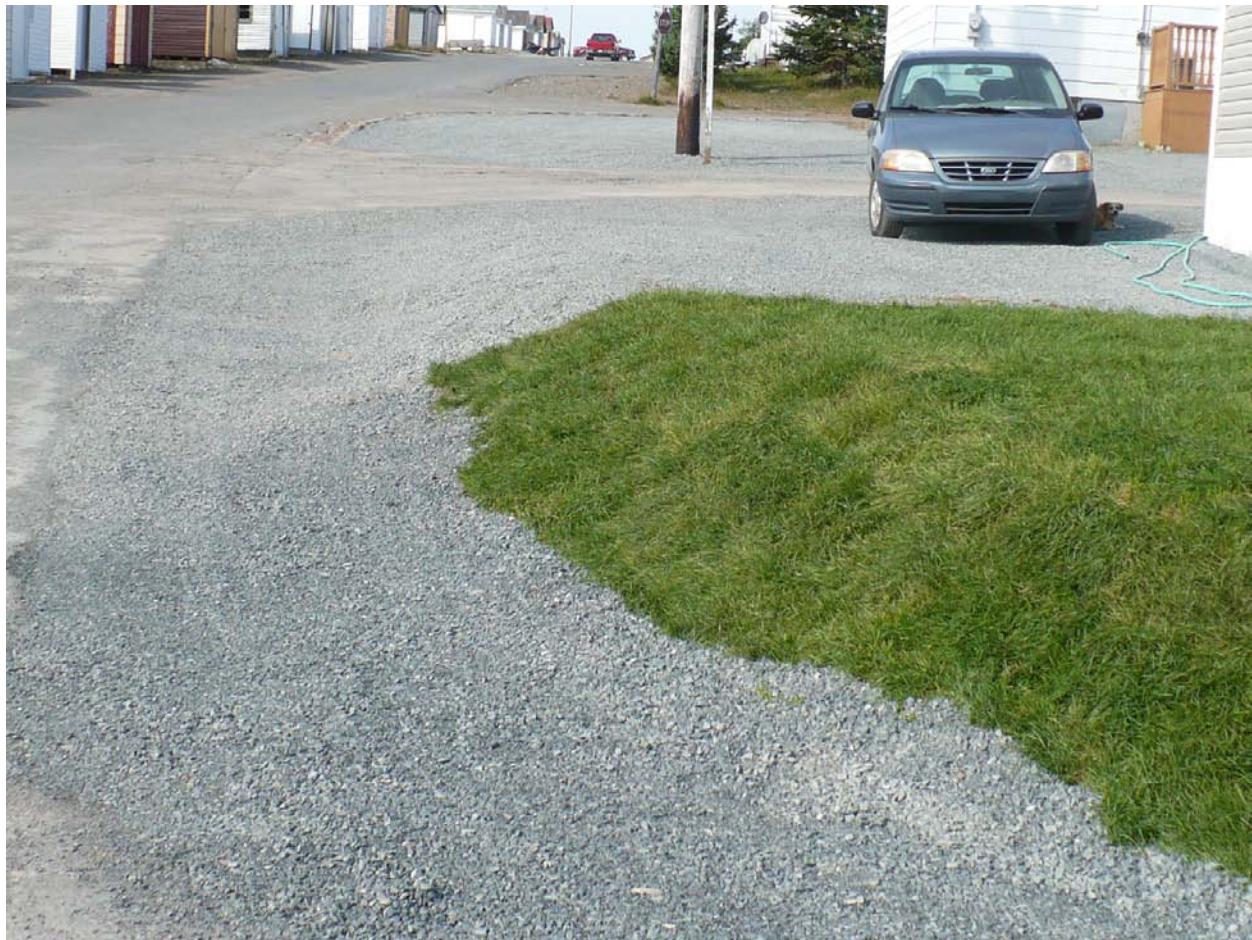
Photo#76

Photograph was taken on August 27, 2012 and shows the property at 1 Pine Street after Class "A" and sod installation has been completed. Note that the excavation of impacted materials and the Class "A" installation extends to the edge of the existing asphalt roadways. Also note the property at 2 Lundberg Avenue in the background that has been excavated and backfilled with imported common material and topped with Class "A".

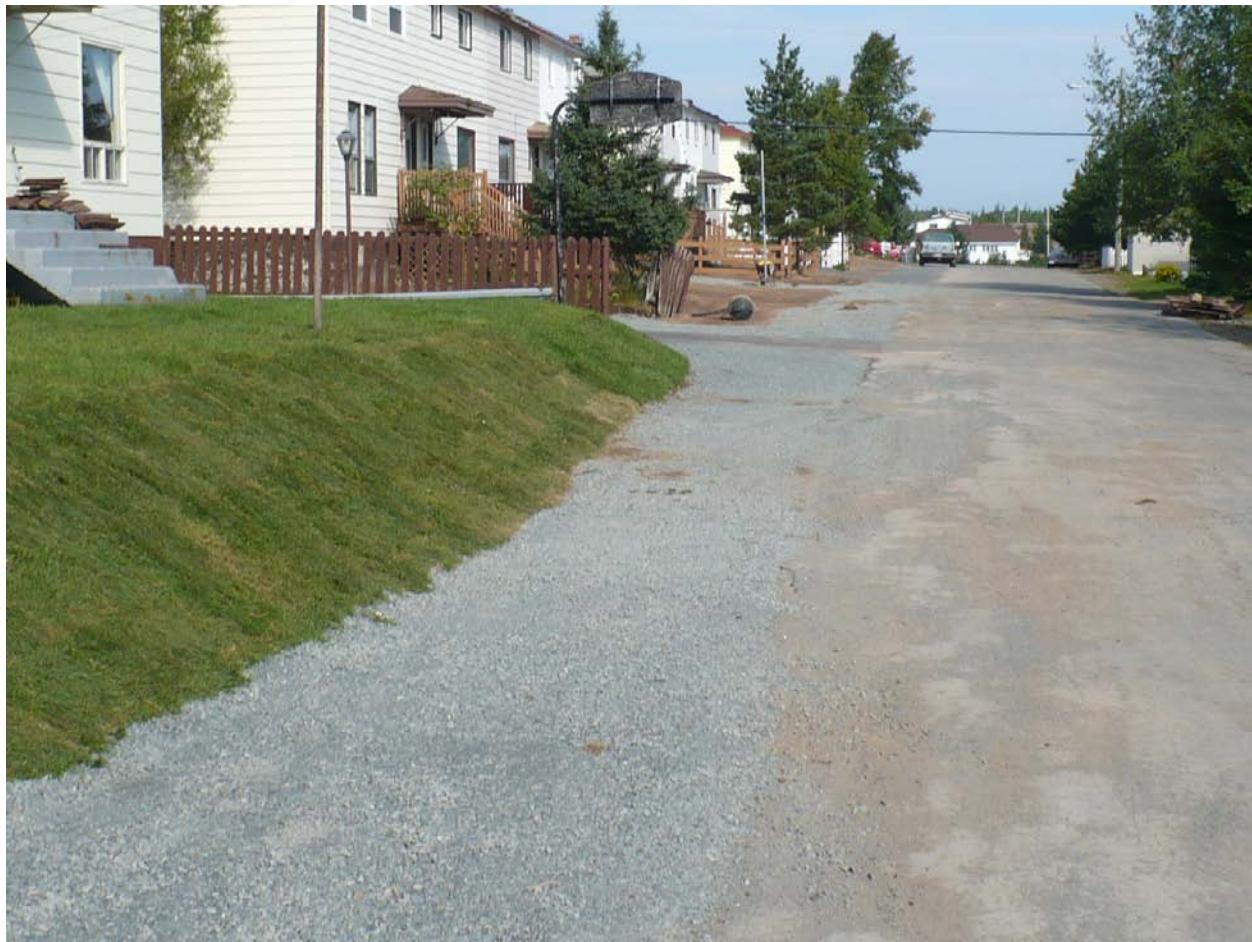
Photo#77

Photograph was taken on August 27, 2012 and shows the property at 5 - 7 Pine Street with excavation of impacted materials completed and Class "A" and sod installation completed. In the background are the properties of 9 – 15 Pine Street with construction completed in the same manner as 1 – 7 Pine Street. Note that the excavation of impacted materials and the Class "A" installation extends to the edge of the existing asphalt roadways.

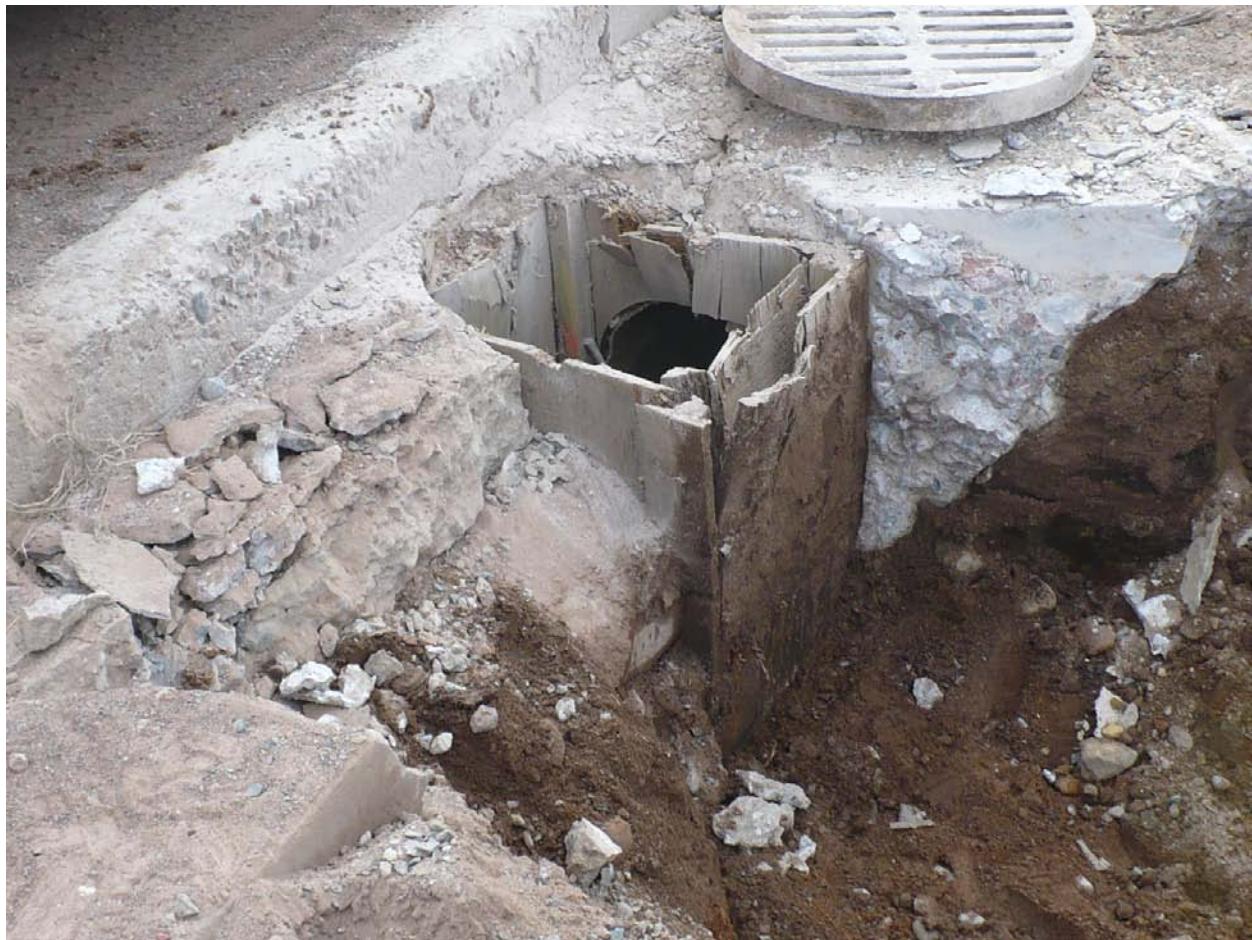
Photo#78

Photograph was taken on August 28, 2012 and shows the existing catch basin conditions on Jackson Avenue. This area is scheduled for a drainage upgrade to alleviate possible drainage issues created in a previous phase. Replacement of these catch basins will be a part of this work.
