Project: The Buchans Remediation Project – Phase II
Residential and Public Areas Remediation
Year 1 Construction Report

Client: Department of Environment and Conservation

Consultant: Hatch Mott MacDonald

Contractor: Marine Contractors Inc.

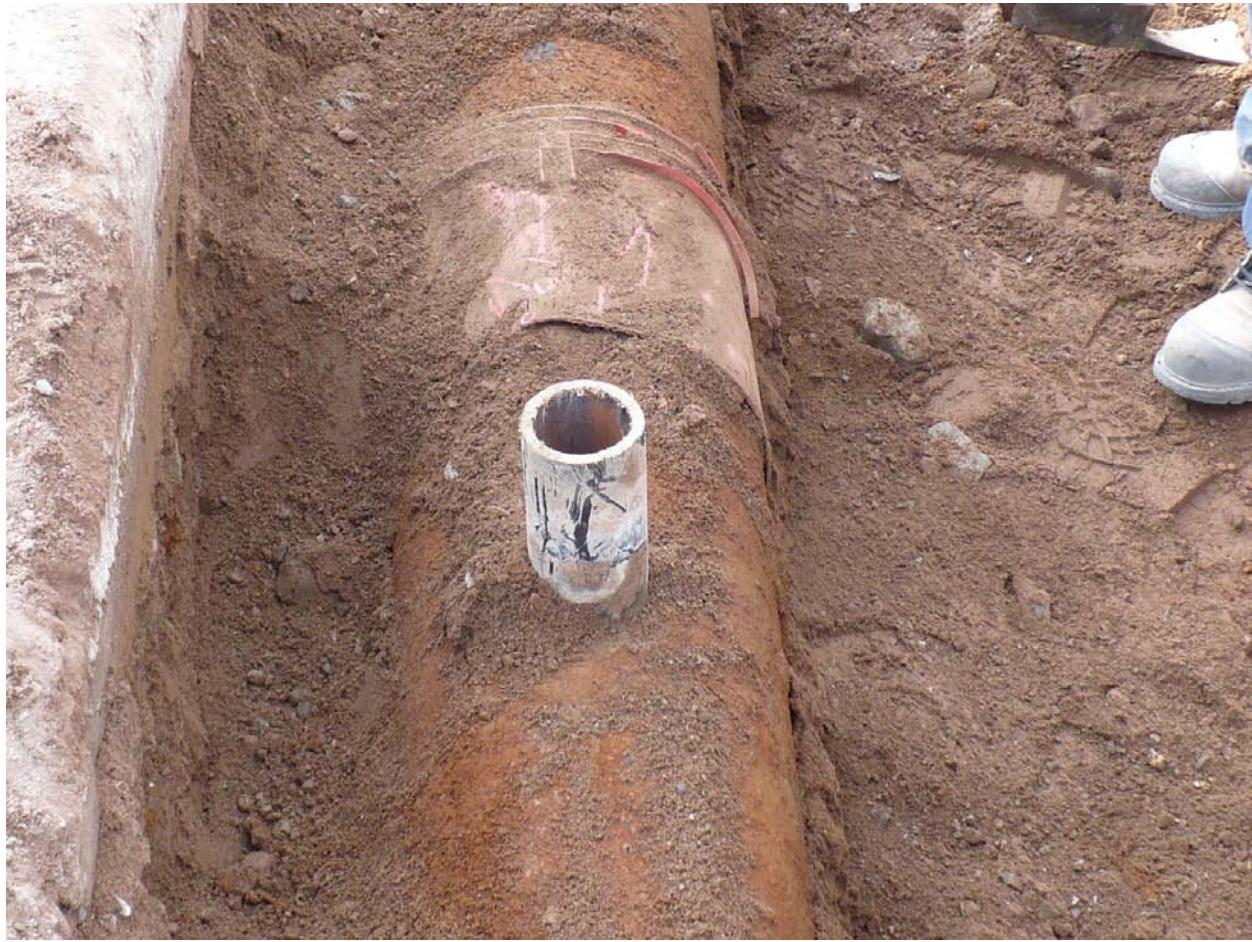
Photo#79

Photograph was taken on August 28, 2012 and shows existing storm drainage piping along the west side of Jackson Avenue. Storm Drainage upgrades from the ball park area are tied into this storm system.

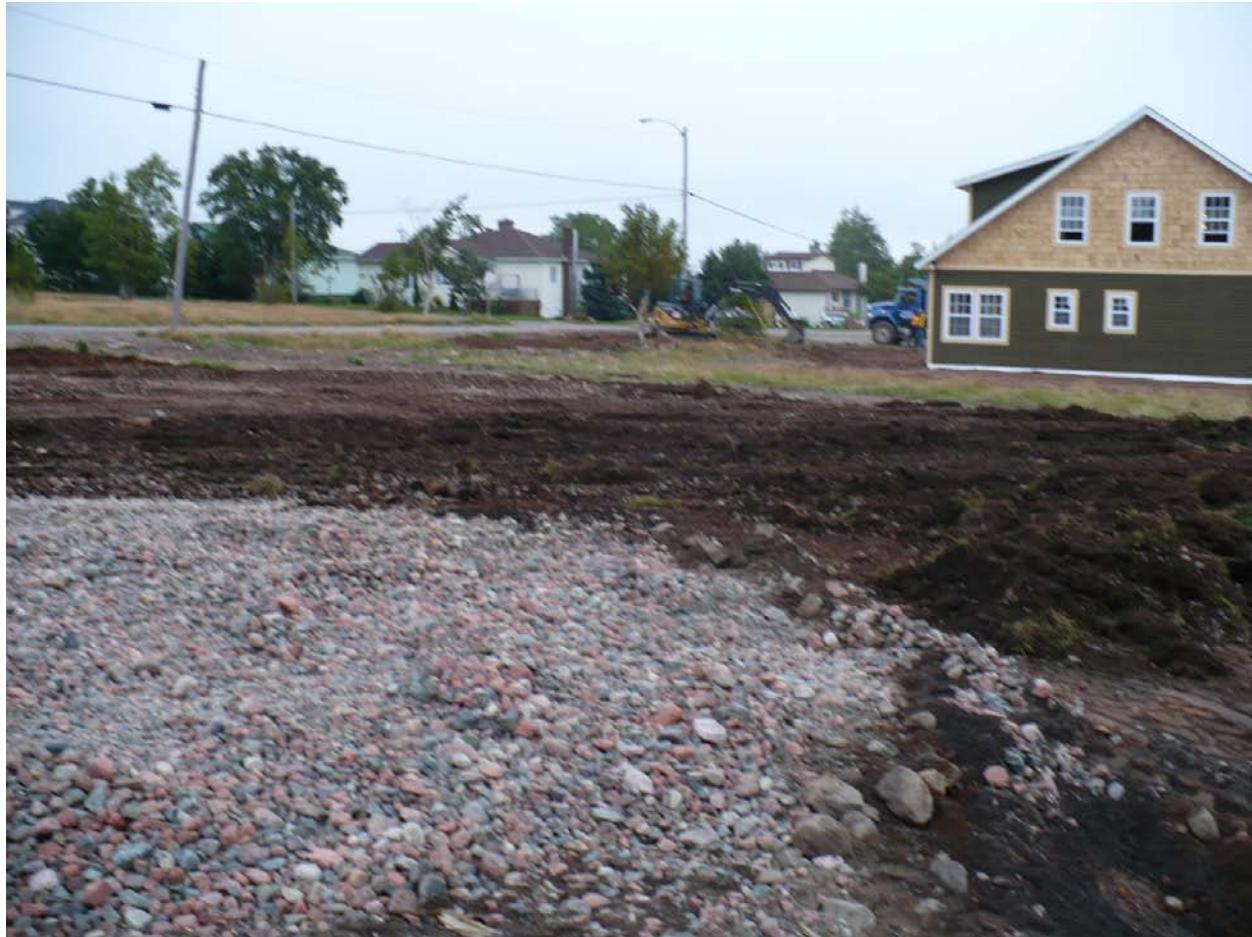
Photo#80

Photograph was taken on September 6, 2012 and shows the regrading of the empty lot along Water Street near the tennis courts. This area was re-instated with imported fill material and a combination of Class "A" and Topsoil/sod to ensure the 300 mm coverage over the impacted soils in the area.

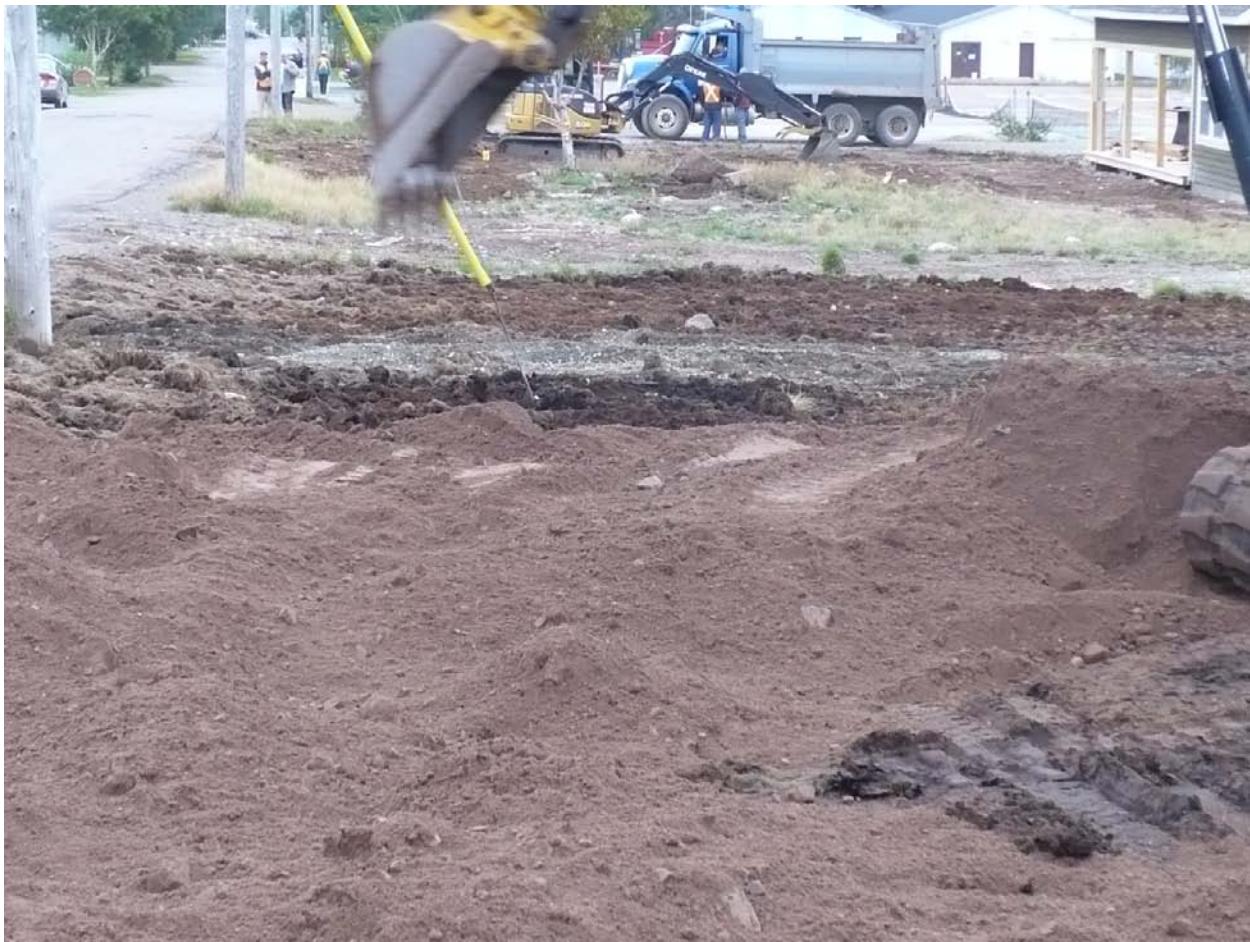
Photo#81

Photograph was taken on September 6, 2012 and shows the start of the installation of topsoil at the empty lot along Water Street near the tennis courts.

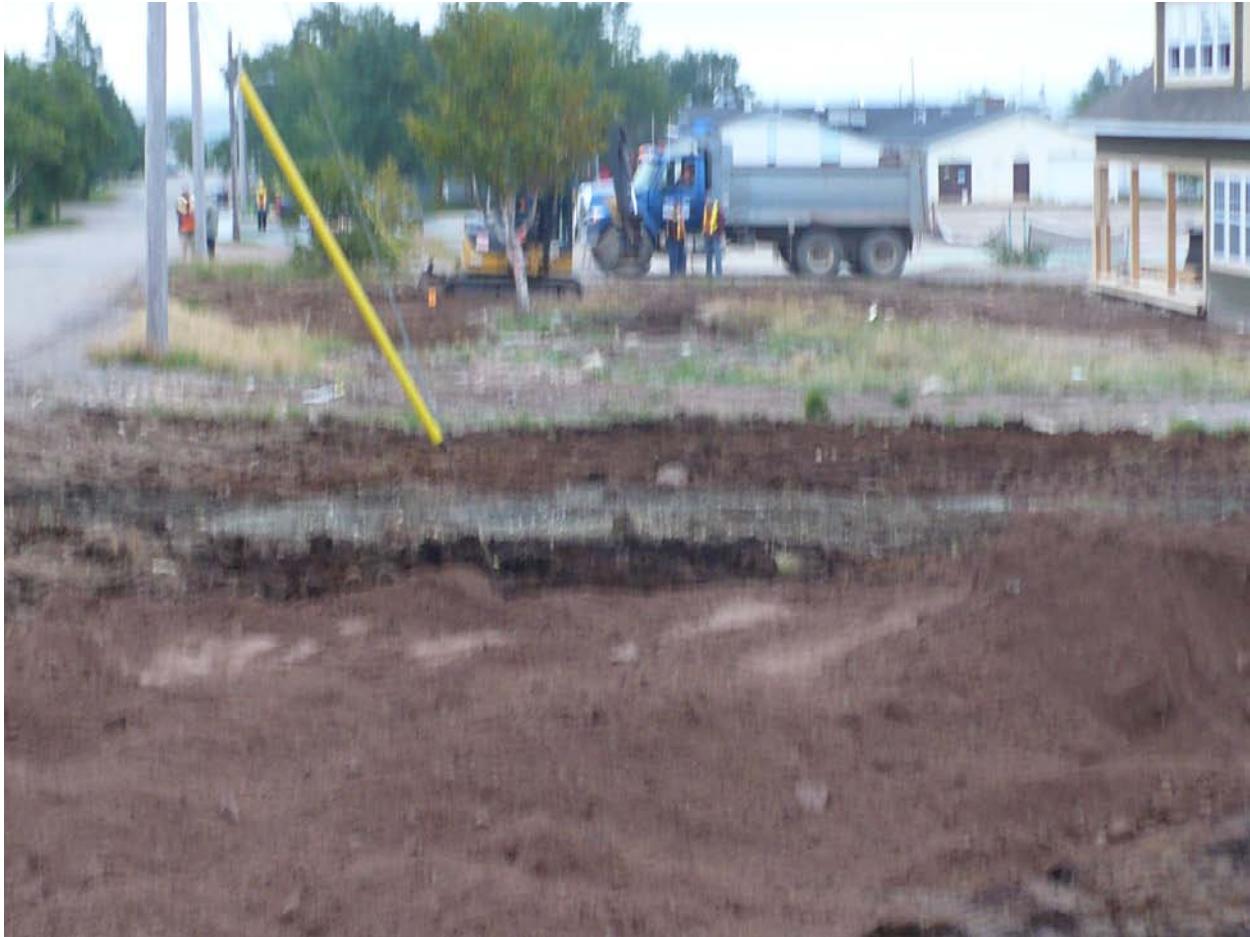
Photo#82

Photograph was taken on September 6, 2012 and shows the excavation of impacted materials on the newly developed housing lot near the tennis courts.

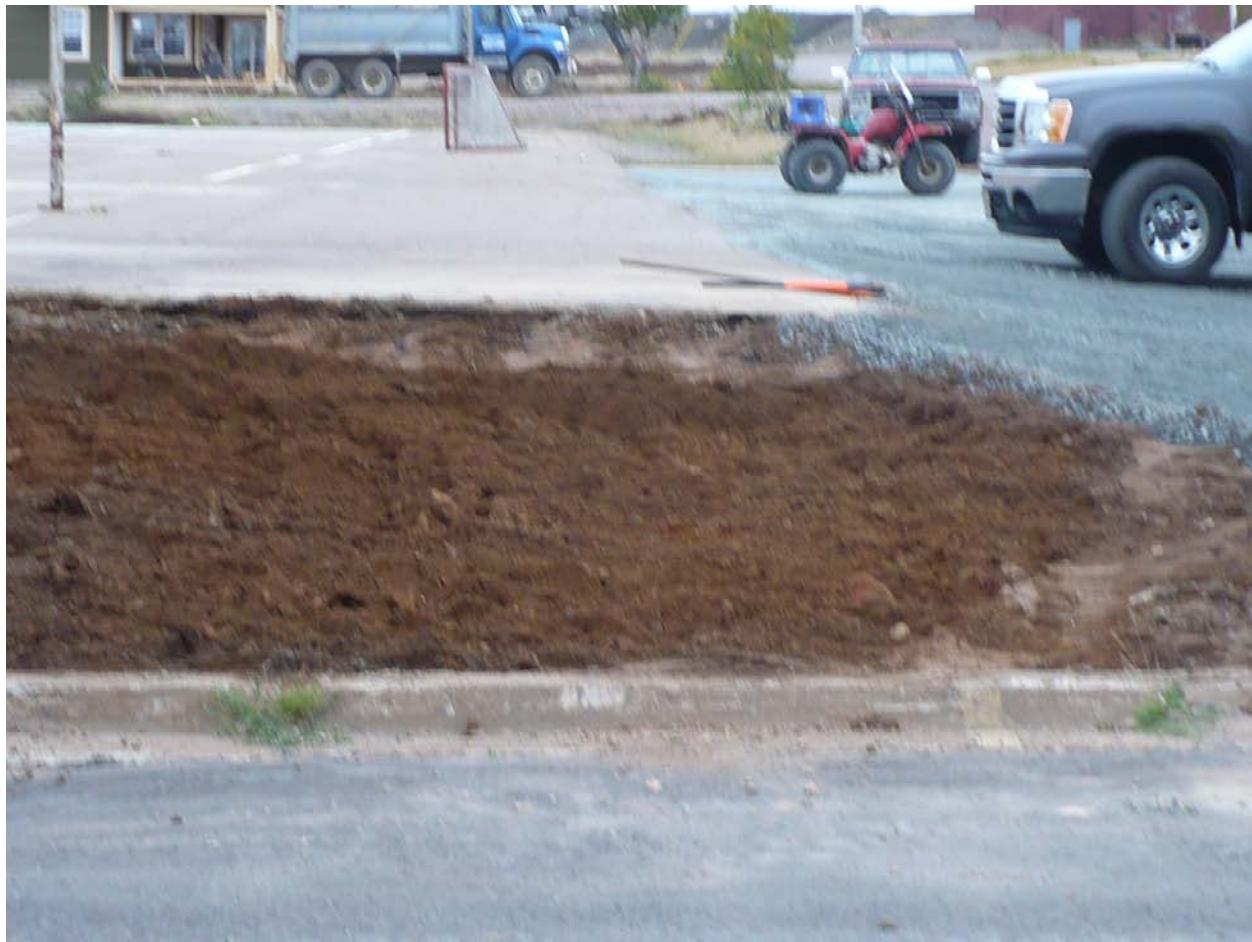
Photo#83

Photograph was taken on September 6, 2012 and shows the start of the installation of topsoil at the east side of the tennis courts along Water Street. Sod installation will follow this procedure. Note that the area had previously had imported common material installed. The area at the front or north side of the tennis courts had previously had Class "A" installed.

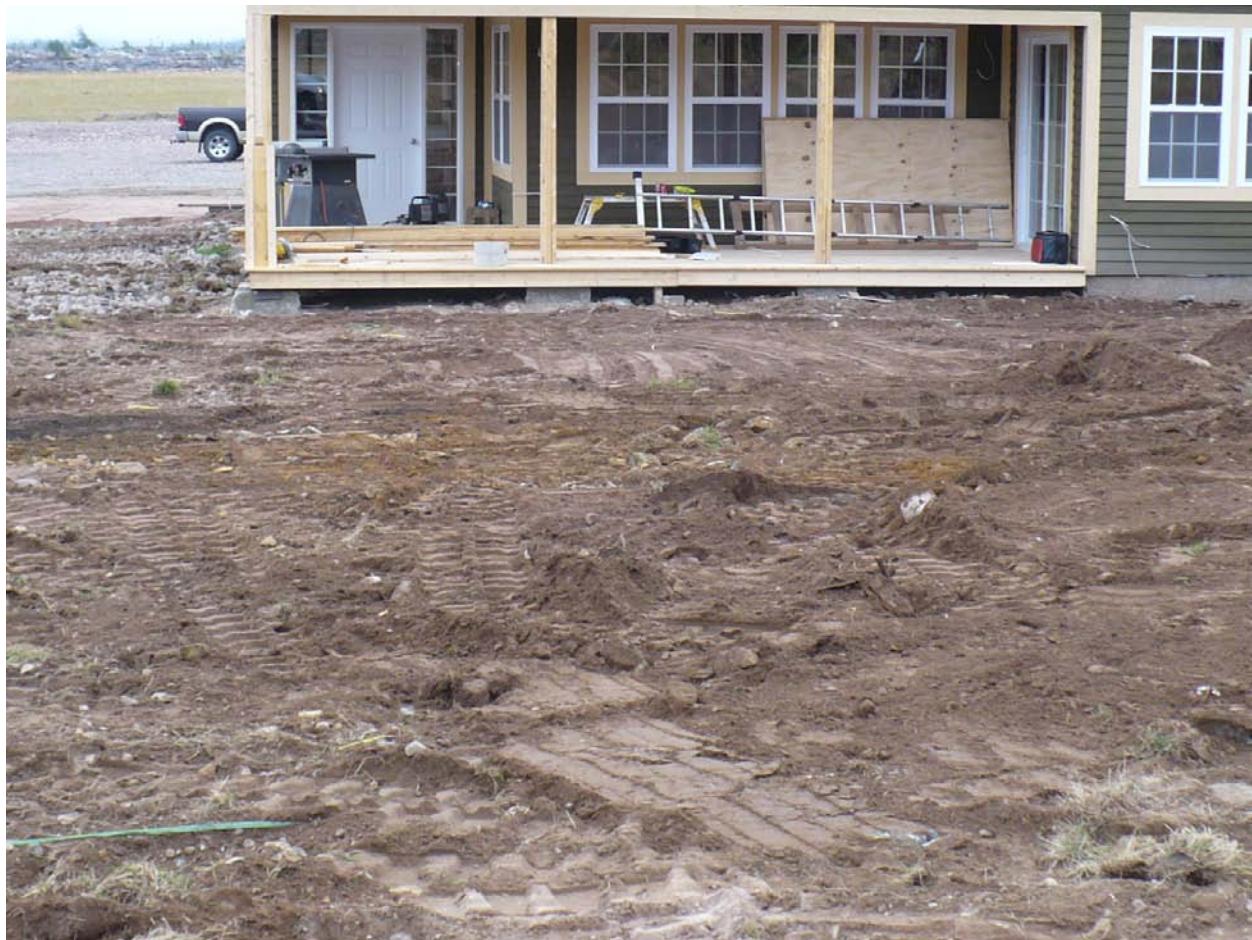
Photo#84

Photograph was taken on September 6, 2012 and shows the installation of imported common fill material on the north and east side of the newly developed house near the tennis courts on Water Street.

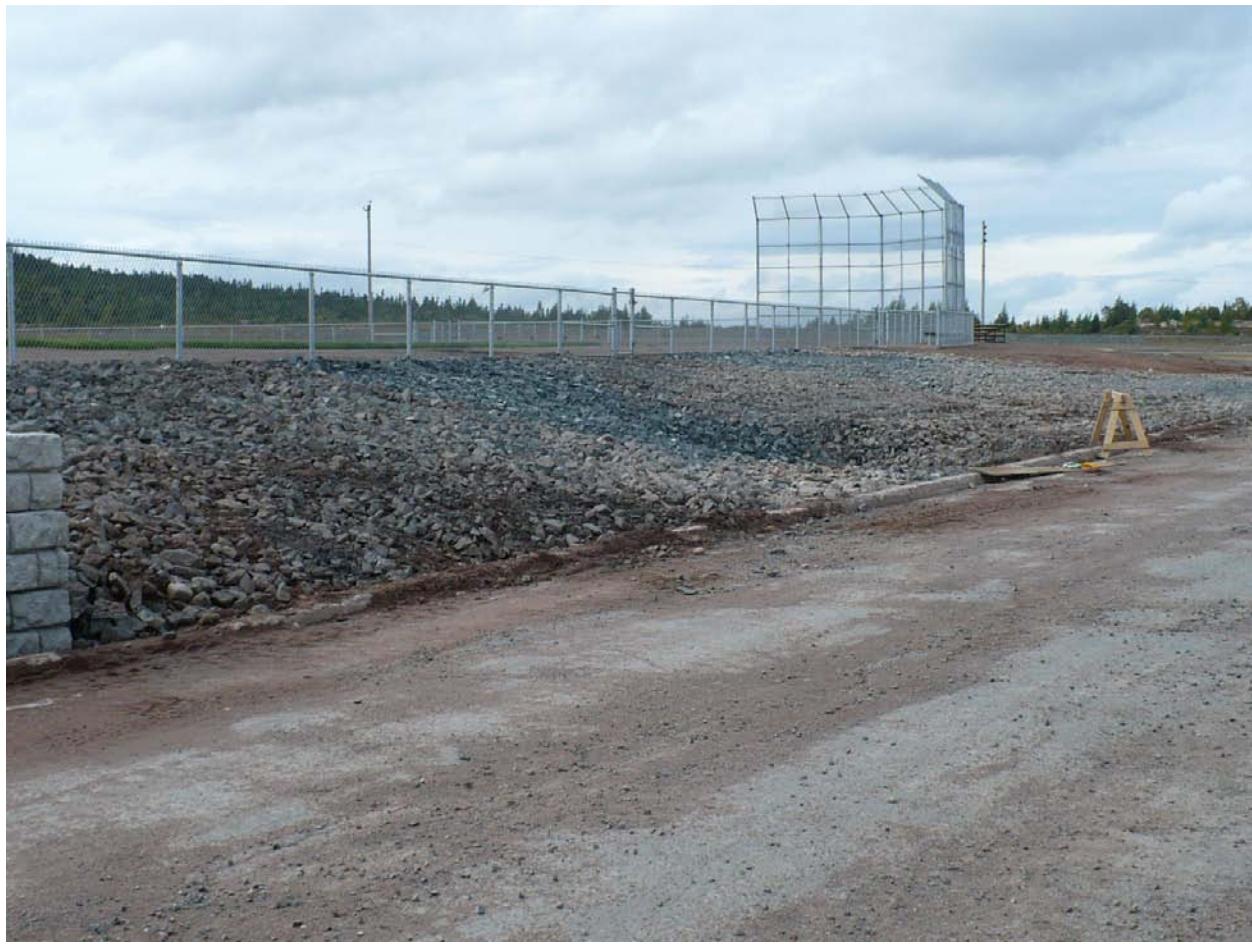
Photo#85

Photograph was taken on September 21, 2012 and shows the installation of imported rock fill material along the east side of the ball park completed in a previous phase. This area had been prone to erosion and the rock fill has been added as a soil stabilization measure.

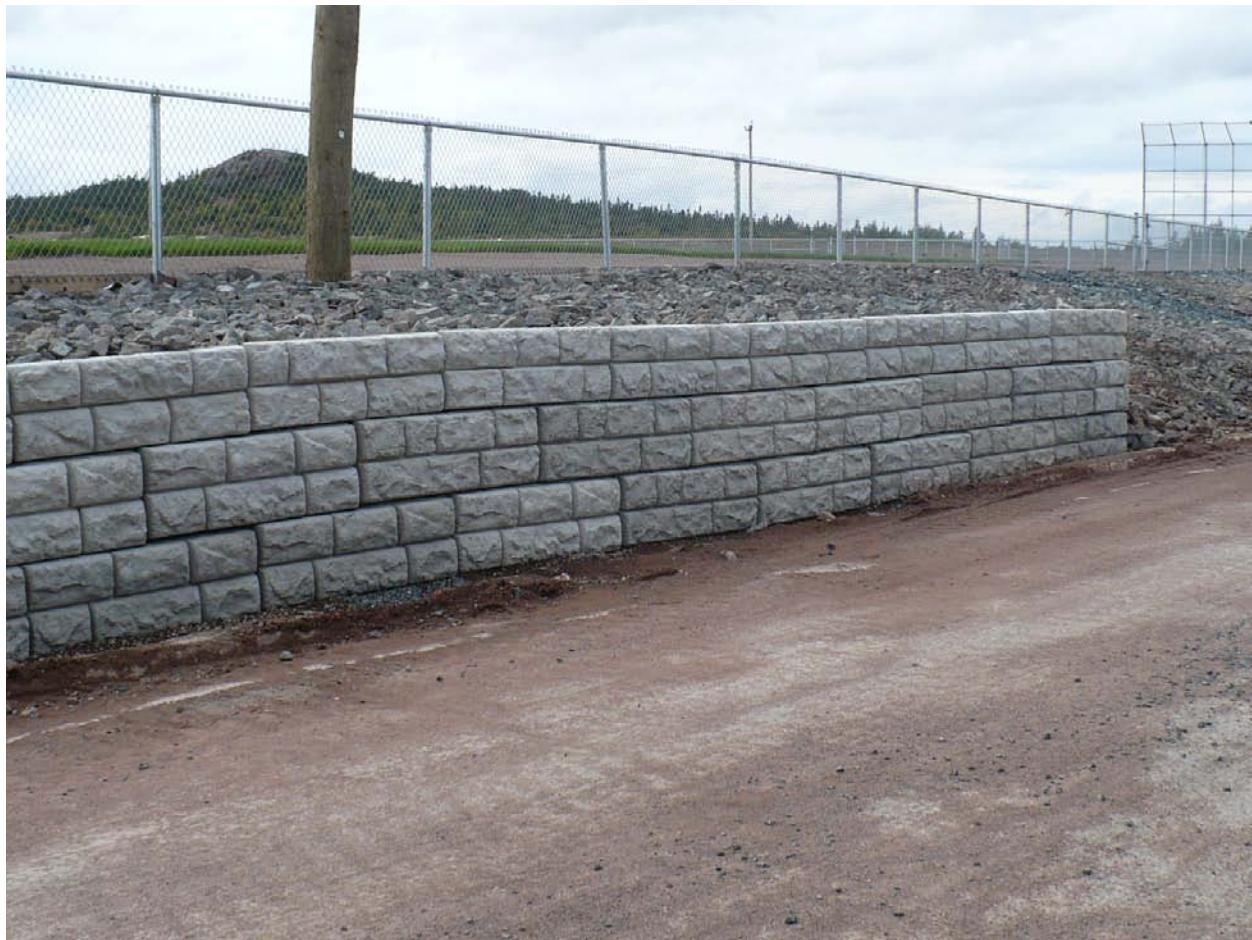
Photo#86

Photograph was taken on September 21, 2012 and shows the installation of a concrete block retaining wall and imported rock fill material on east side of previously completed ballpark.

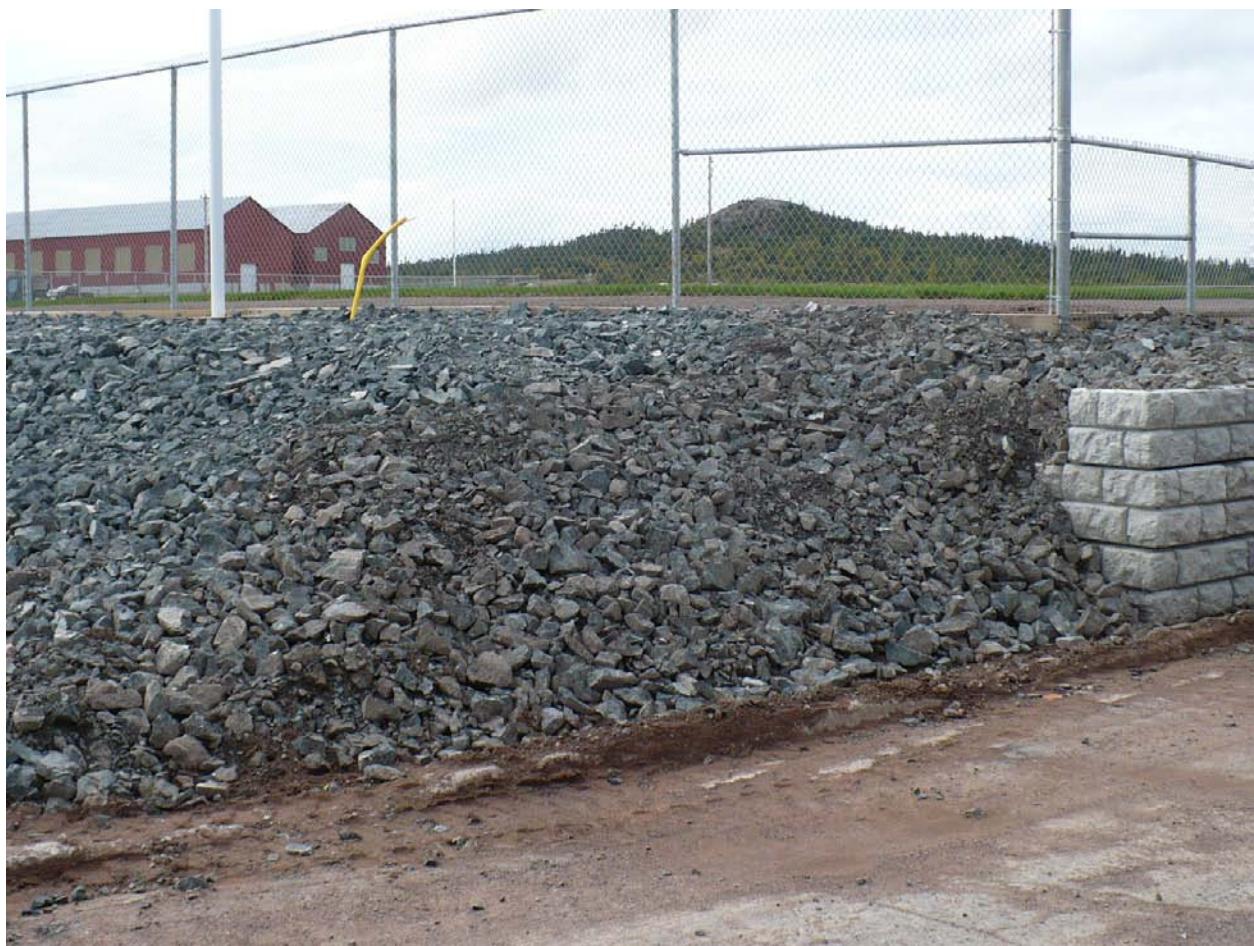
Photo#87

Photograph was taken on September 21, 2012 and shows the installation of a concrete block retaining wall and imported rock fill material on south side of previously completed ballpark.

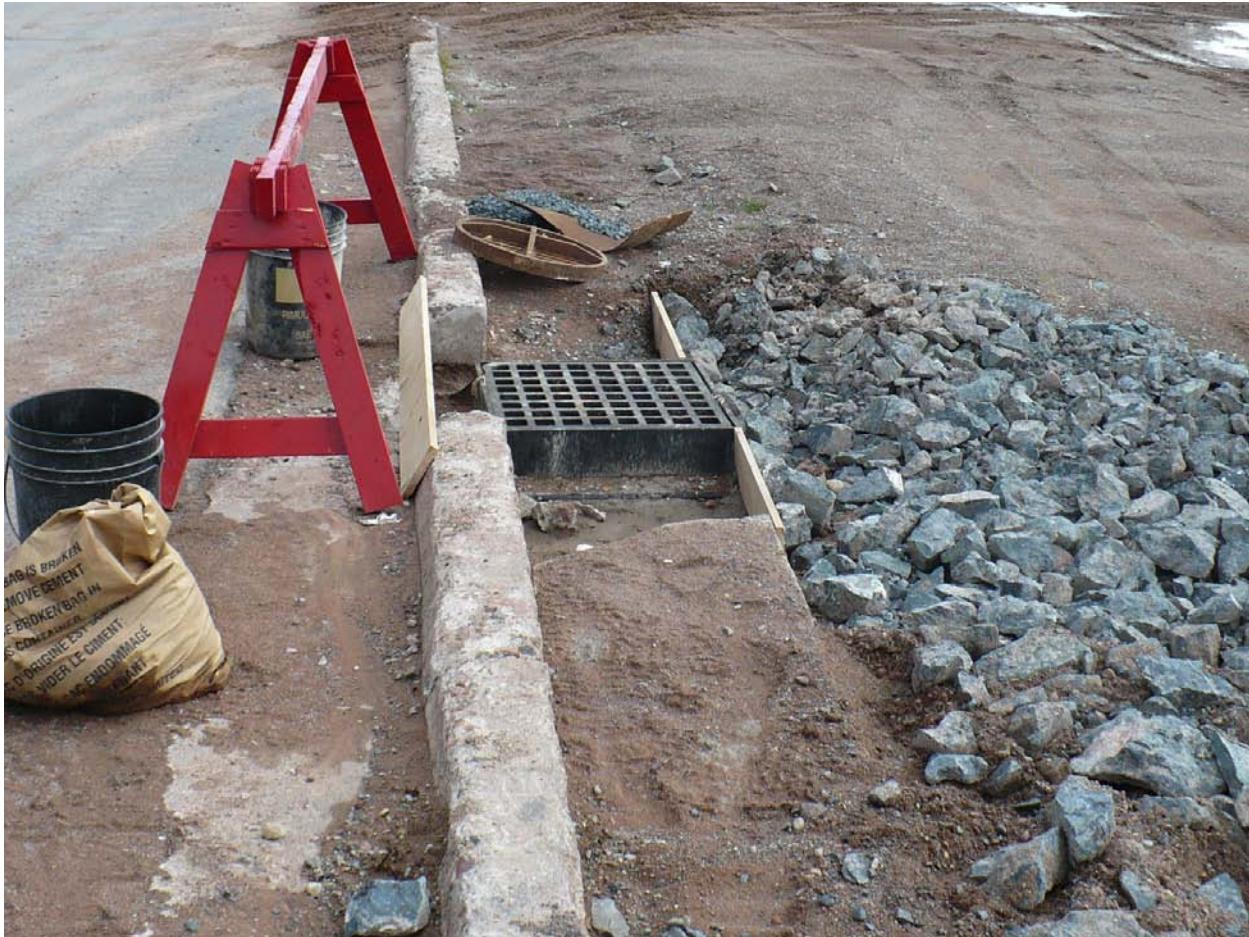
Photo#88

Photograph was taken on September 21, 2012 and shows the installation of a new catch basin on the existing storm drainage system on the south side of the previously completed ballpark.

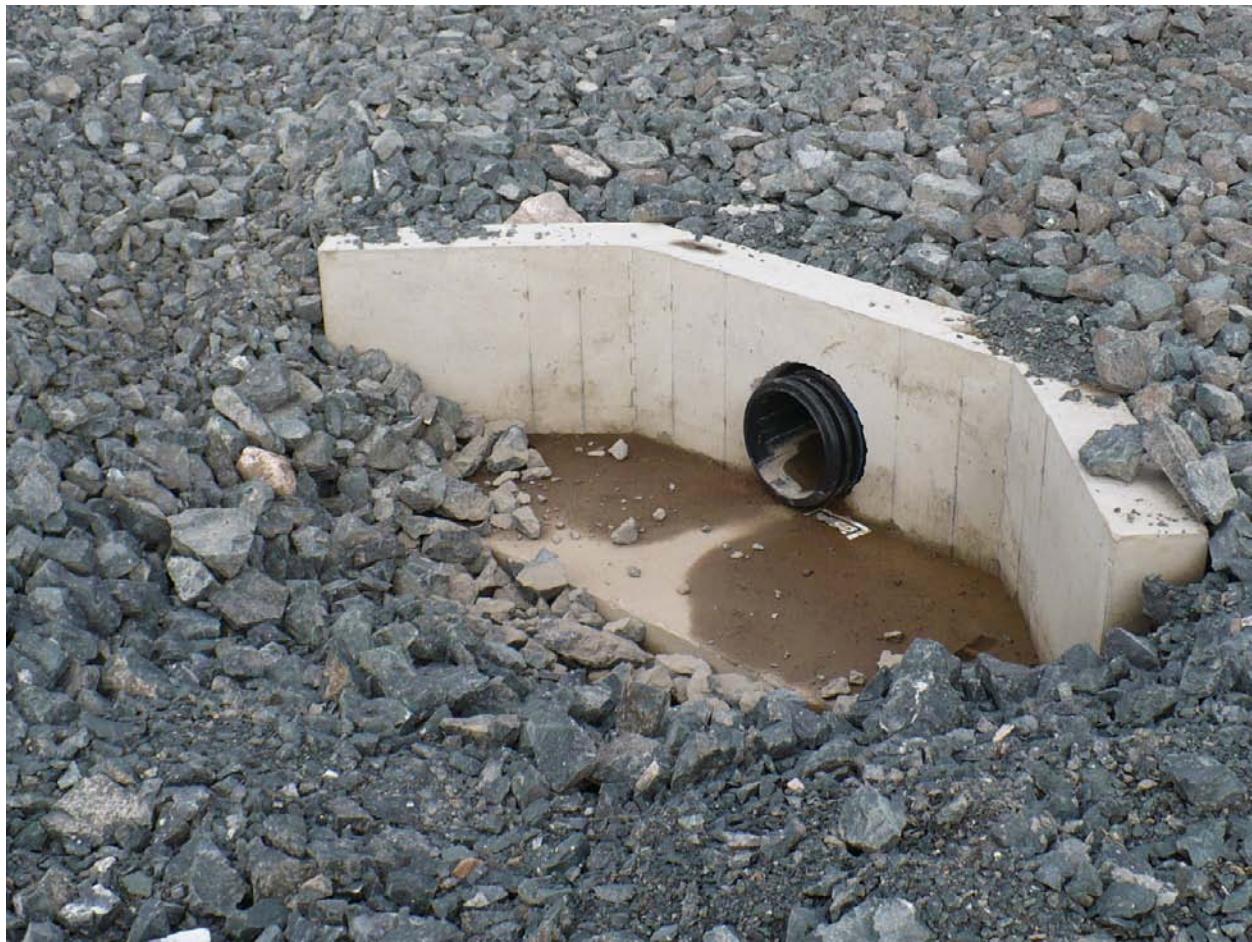
Photo#89

Photograph was taken on September 21, 2012 and shows the installation of a concrete headwall and ditch inlet on the south side of previously completed ballpark. This ditch inlet will discharge into the existing storm sewer system along Jackson Street.

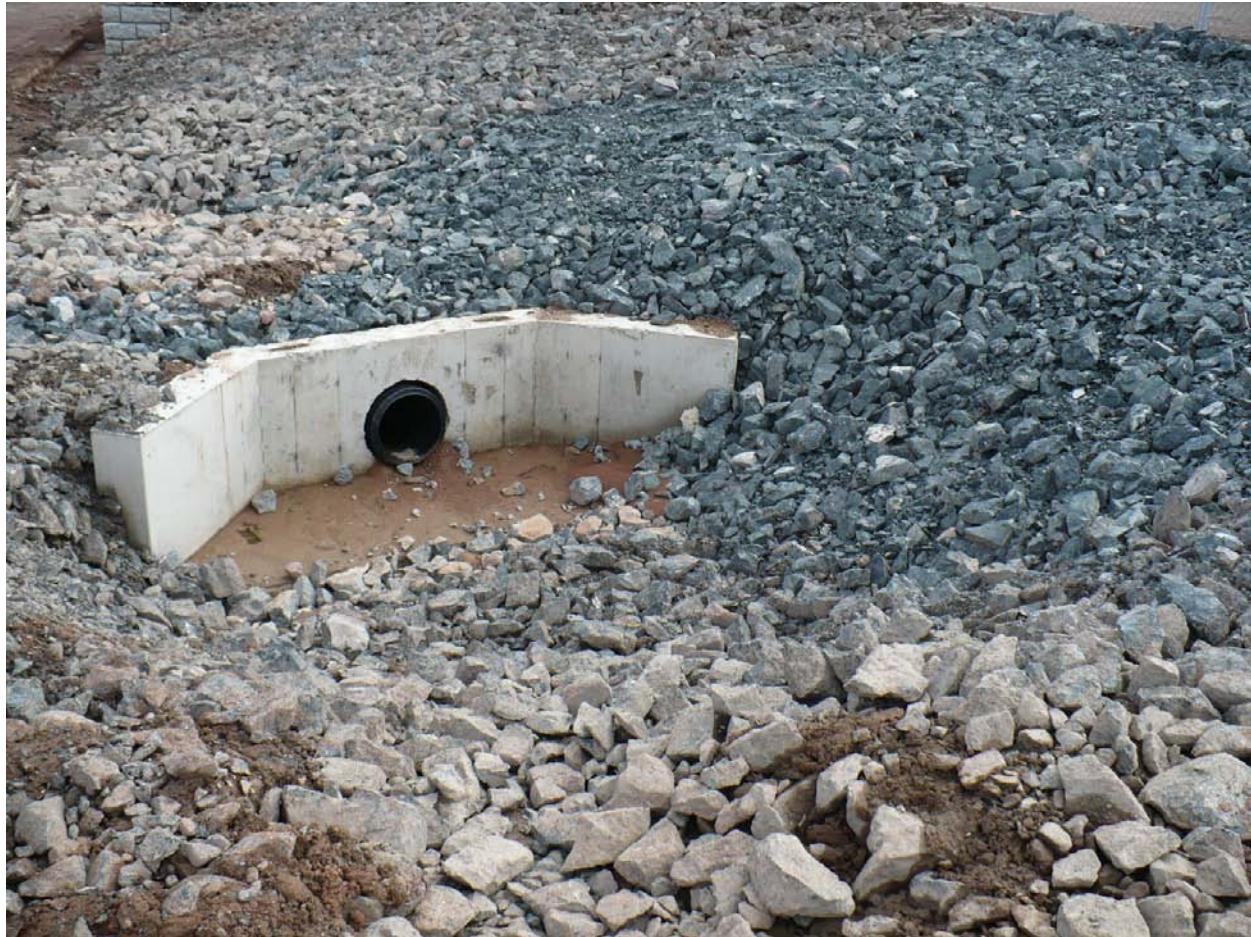
Photo#90

Photograph was taken on September 21, 2012 and shows the installation of a concrete headwall and ditch inlet on the east side of previously completed ballpark on Jackson Street. This ditch inlet will discharge into the existing storm sewer system along Jackson Street.
