# Real-Time Water Quality Deployment Report

## Teck Duck Pond Operations

2018

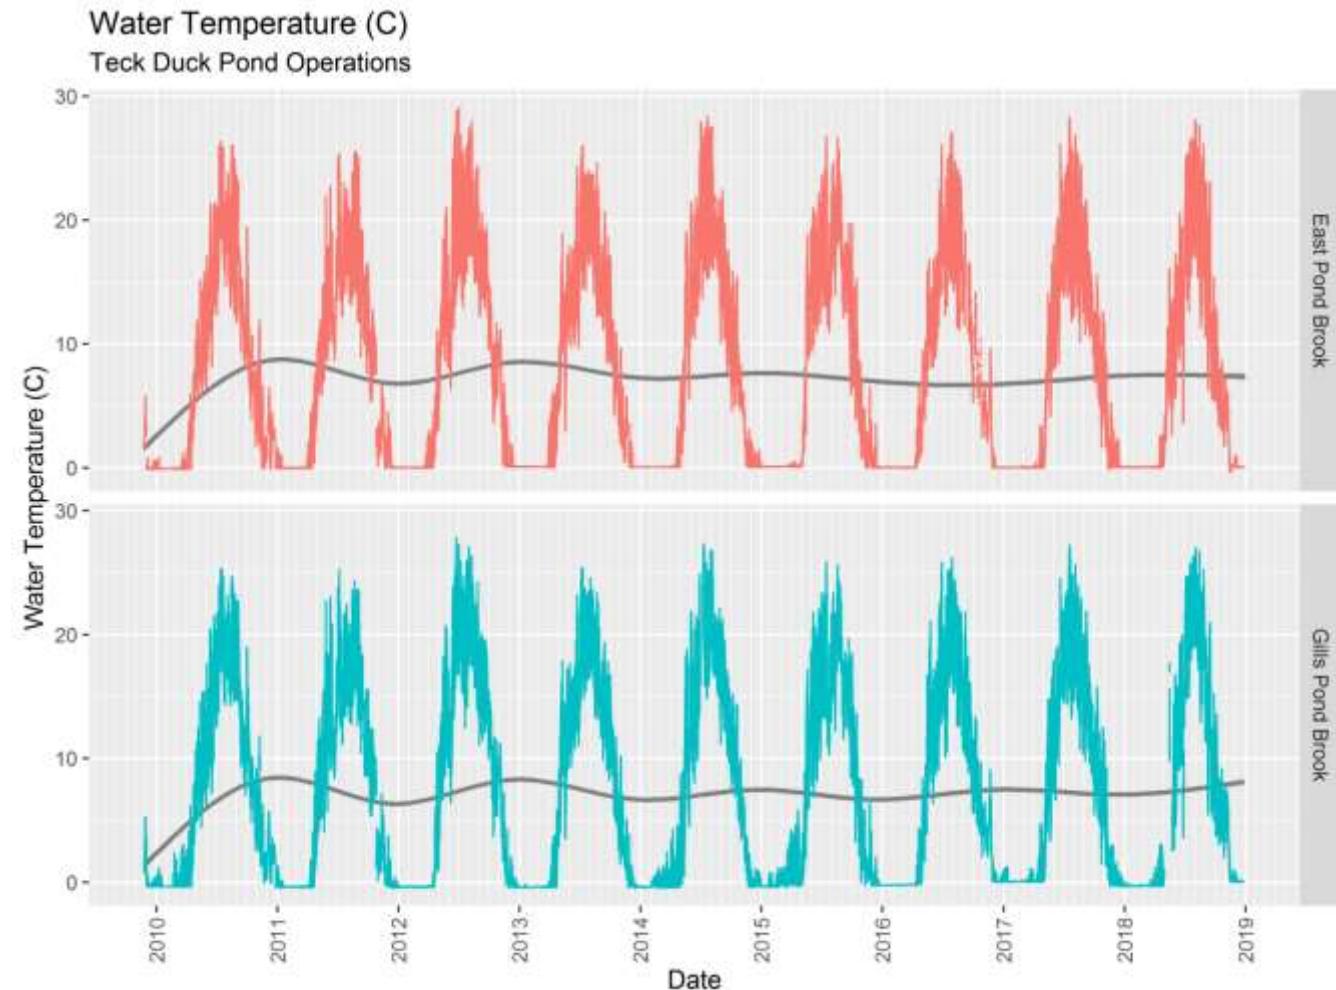
**Figure 1: Water Temperature at Teck DPO**

Water temperatures in 2018 were slightly lower than mean temperatures from the previous eight years (see Table 1). This is likely annual variation and of no immediate concern.

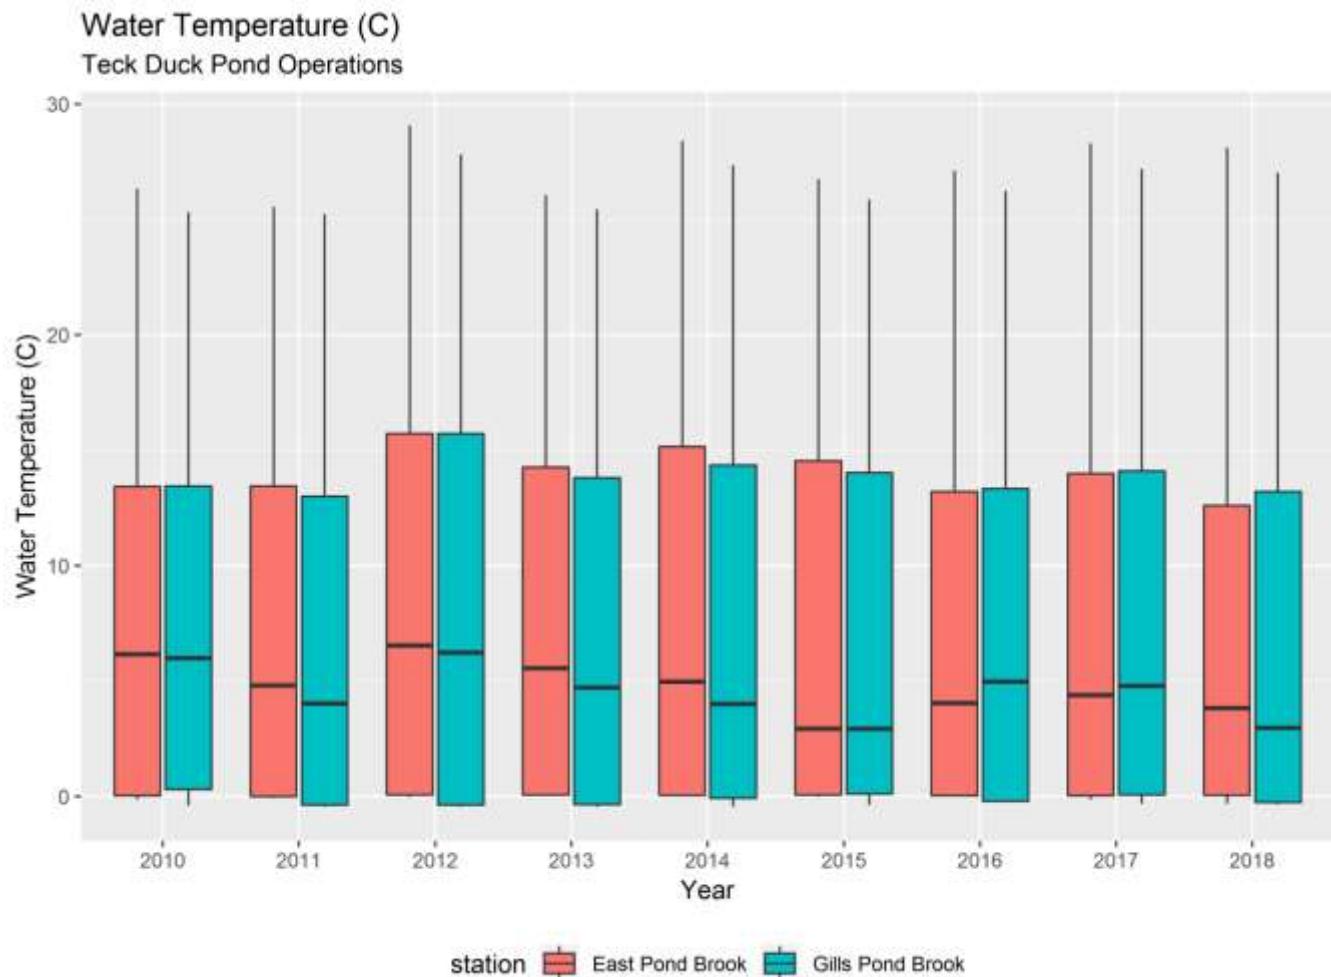
**Figure 2: Boxplots of water temperature at Teck DPO from 2010 to 2018**

Figure 2 shows the range in water temperatures at EPB and TGPB stations since 2010. In that time span, 2018 saw the second lowest temperatures where 2015 was the coolest.

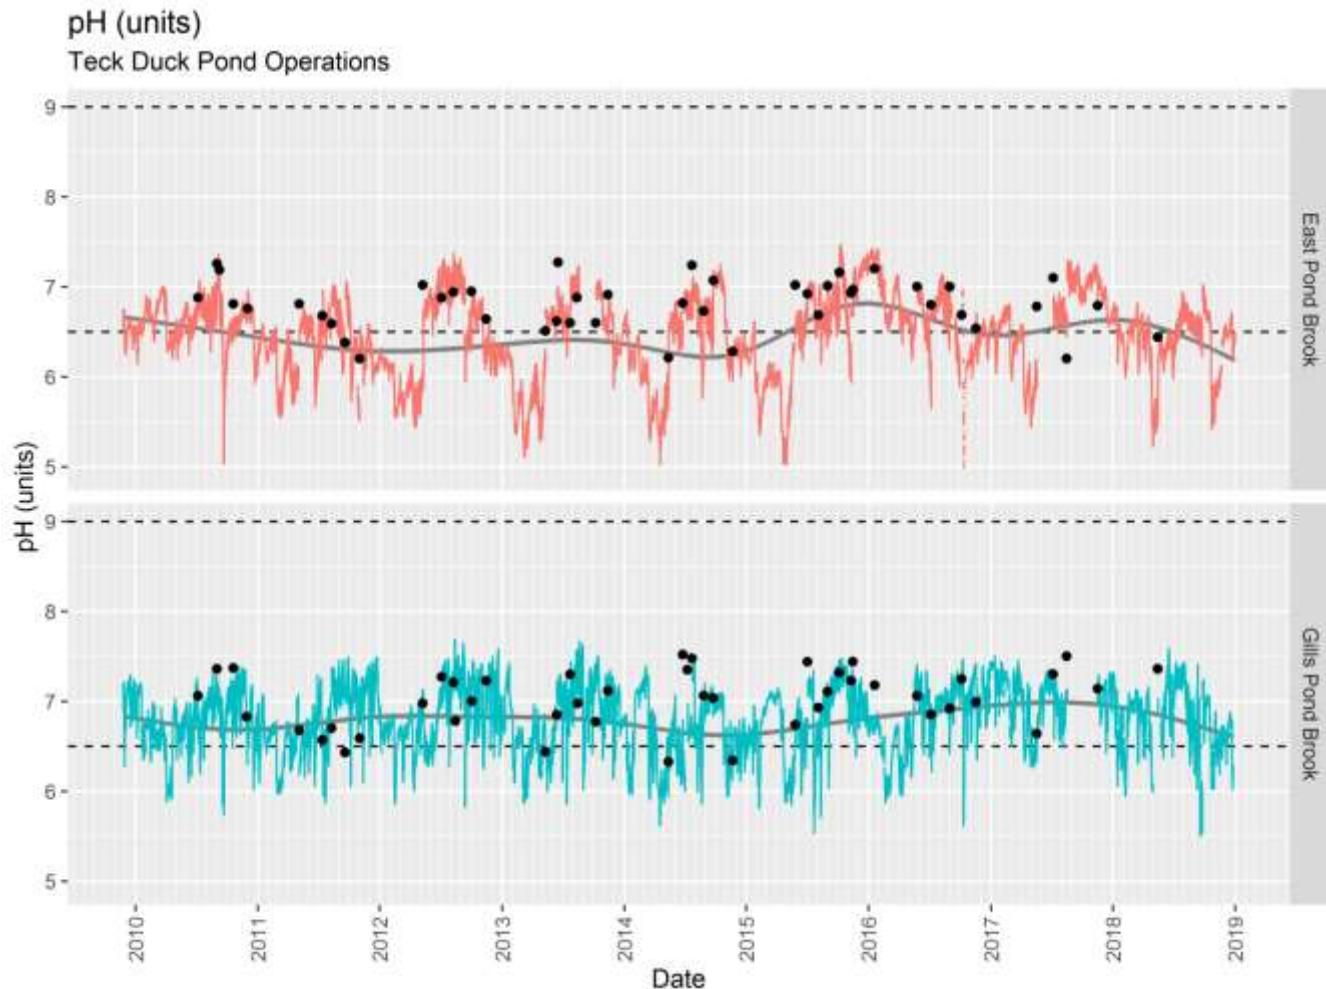
**Figure 3: pH at Teck DPO**

Figure 3 shows that pH levels at East Pond Brook typically fall at, or somewhat below, the CCME guidelines for the protection aquatic organisms (dashed lines). pH levels at Gills Pond Brook typically fall at, or somewhat above, CCME guidelines.

Ambient waters on the island of Newfoundland tend to be acidic due to geochemical processes. As such, the ambient waters of East Pond Brook are slightly acidic. Gills Pond Brook waters, however, are highly influenced by treated effluent discharged from an upstream polishing pond. These waters are treated to maintain a near-basic pH of 7.0

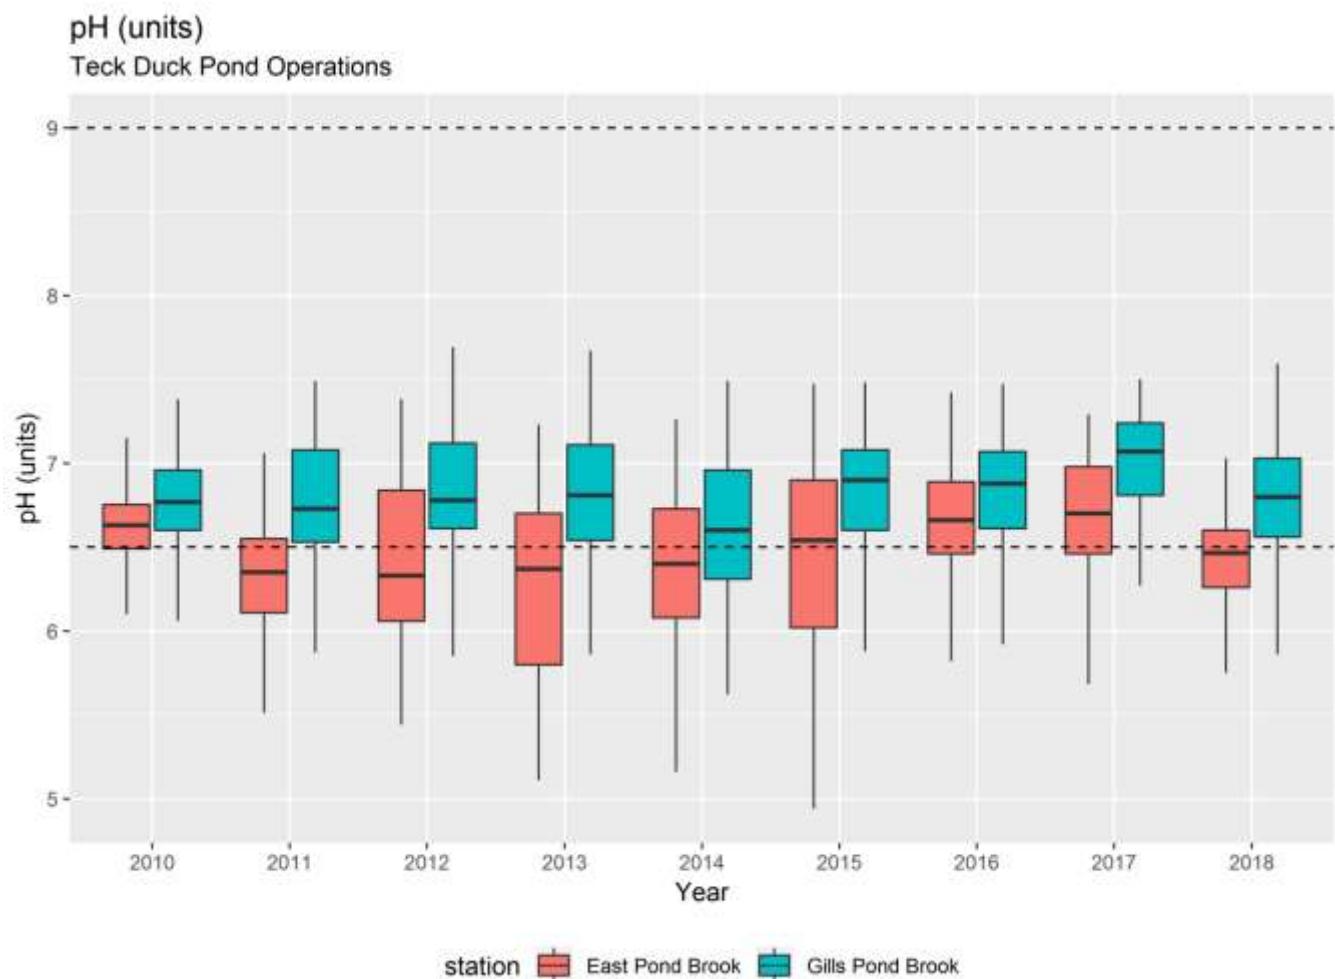
**Figure 4: Boxplots of pH at Teck DPO from 2010 to 2018**

pH values in 2018 were somewhat lower than those observed in 2017 at both stations, as seen in Figure 4. Declines in pH are still within historical levels.

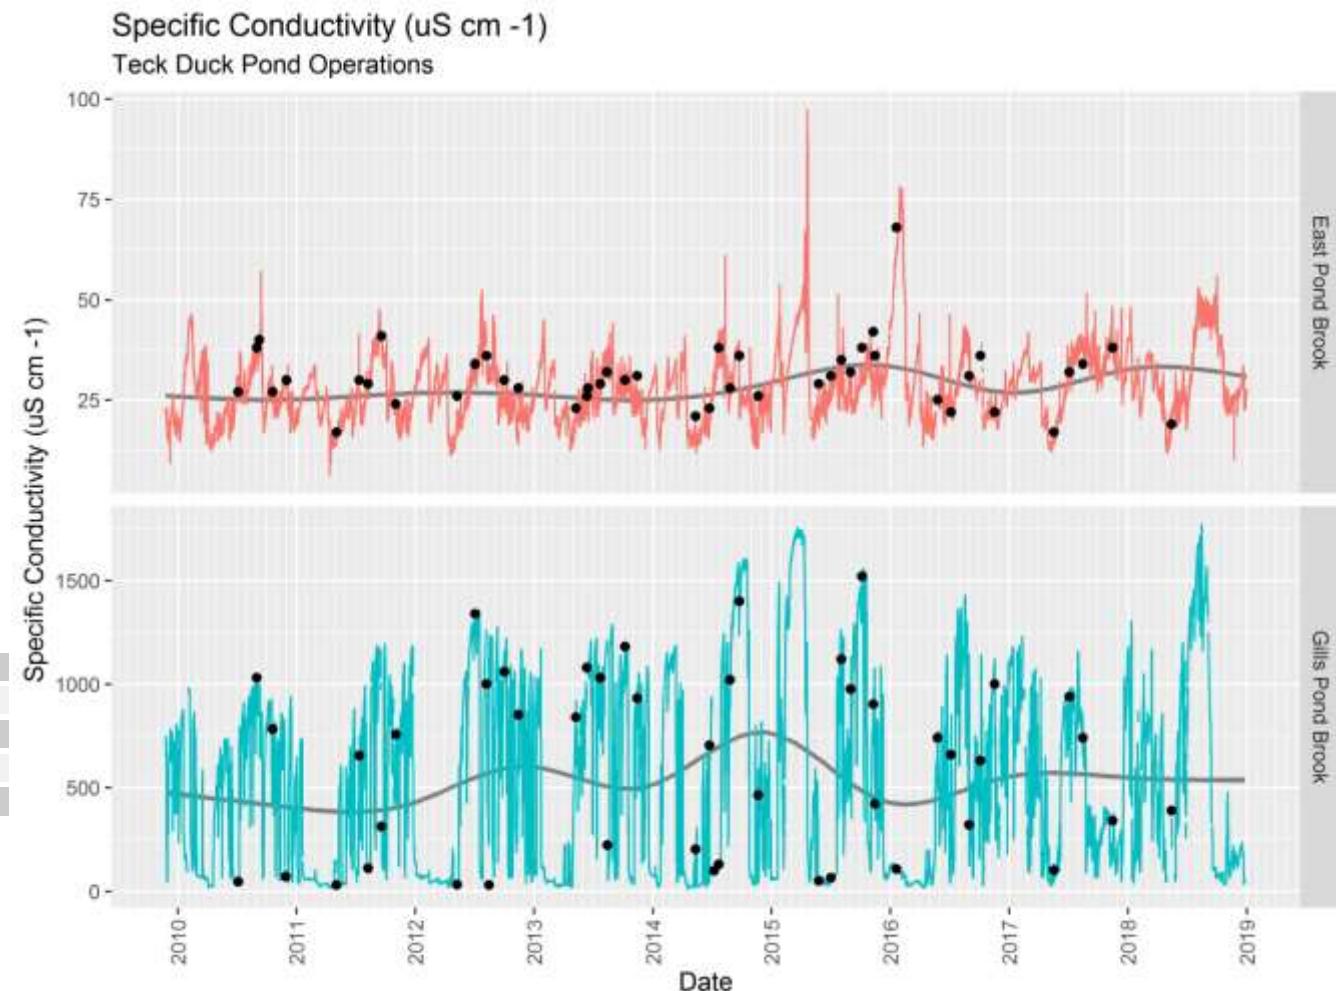
Figure 5: Specific Conductivity at Teck DPO

A slow and long term rising trend in conductivity appears to be occurring at East Pond Brook, as shown by the trend line in Figure 5. The driving force behind this increase may be related to a number of factors such as atmospheric deposition of dust from industrial activity in the area, soil disturbance from nearby logging activities, or movement of dissolved solid-laden groundwater from the tailings management area higher in the watershed.

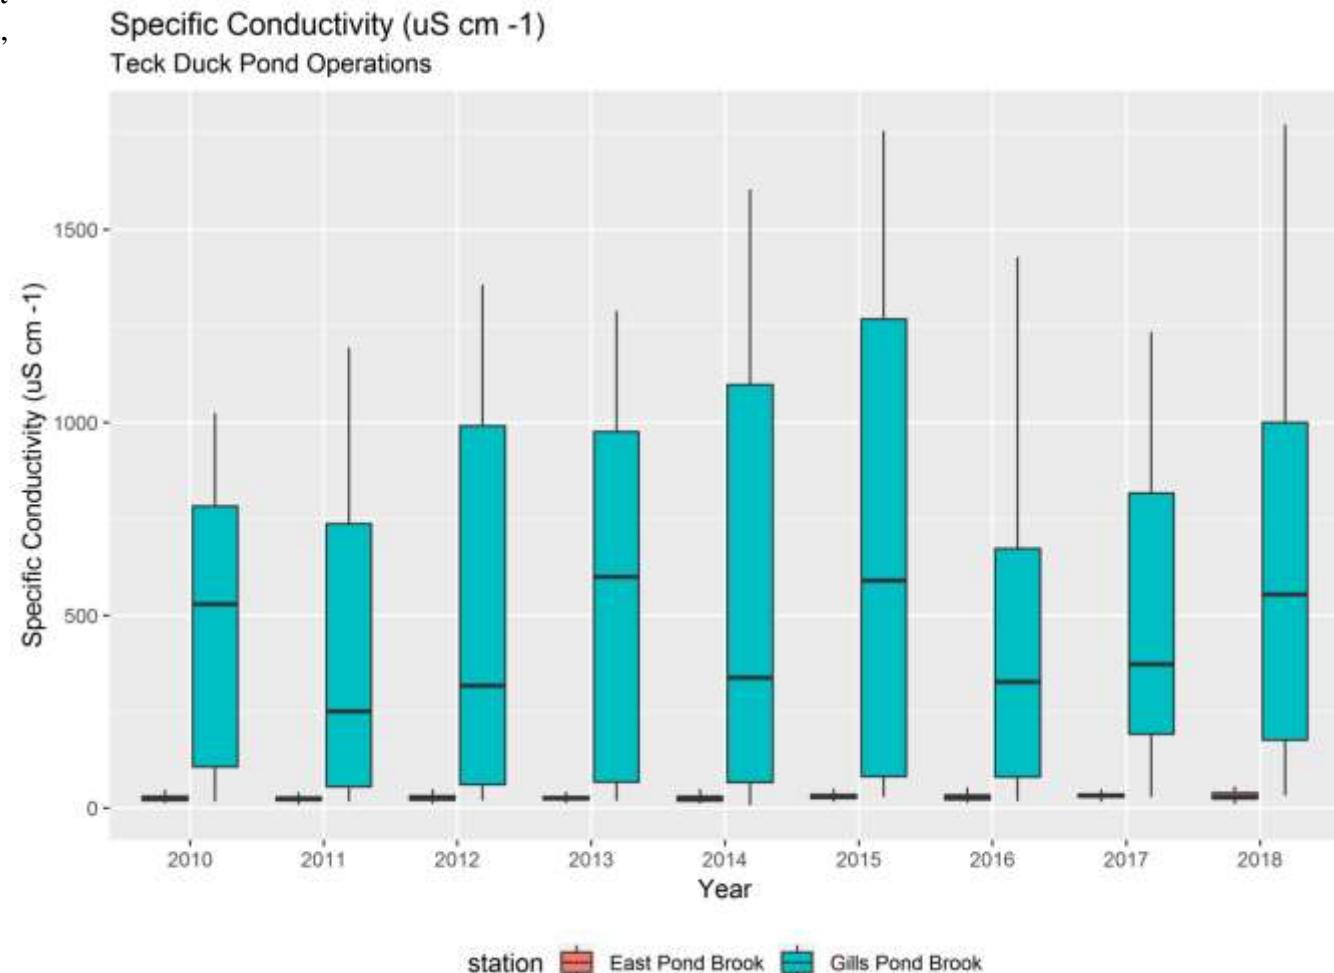
**Figure 6: Boxplots of specific conductivity at Teck DPO from 2010 to 2018**

The influence of polishing pond effluent on water quality in Gill's Pond Brook is evident in Figure 6. Without polishing pond effluent, specific conductivity levels at EPB and TGPB stations would report values similar to one another. Specific conductivity at TGPB station, however, is substantially higher than EPB station which barely registers on the plot to the right.

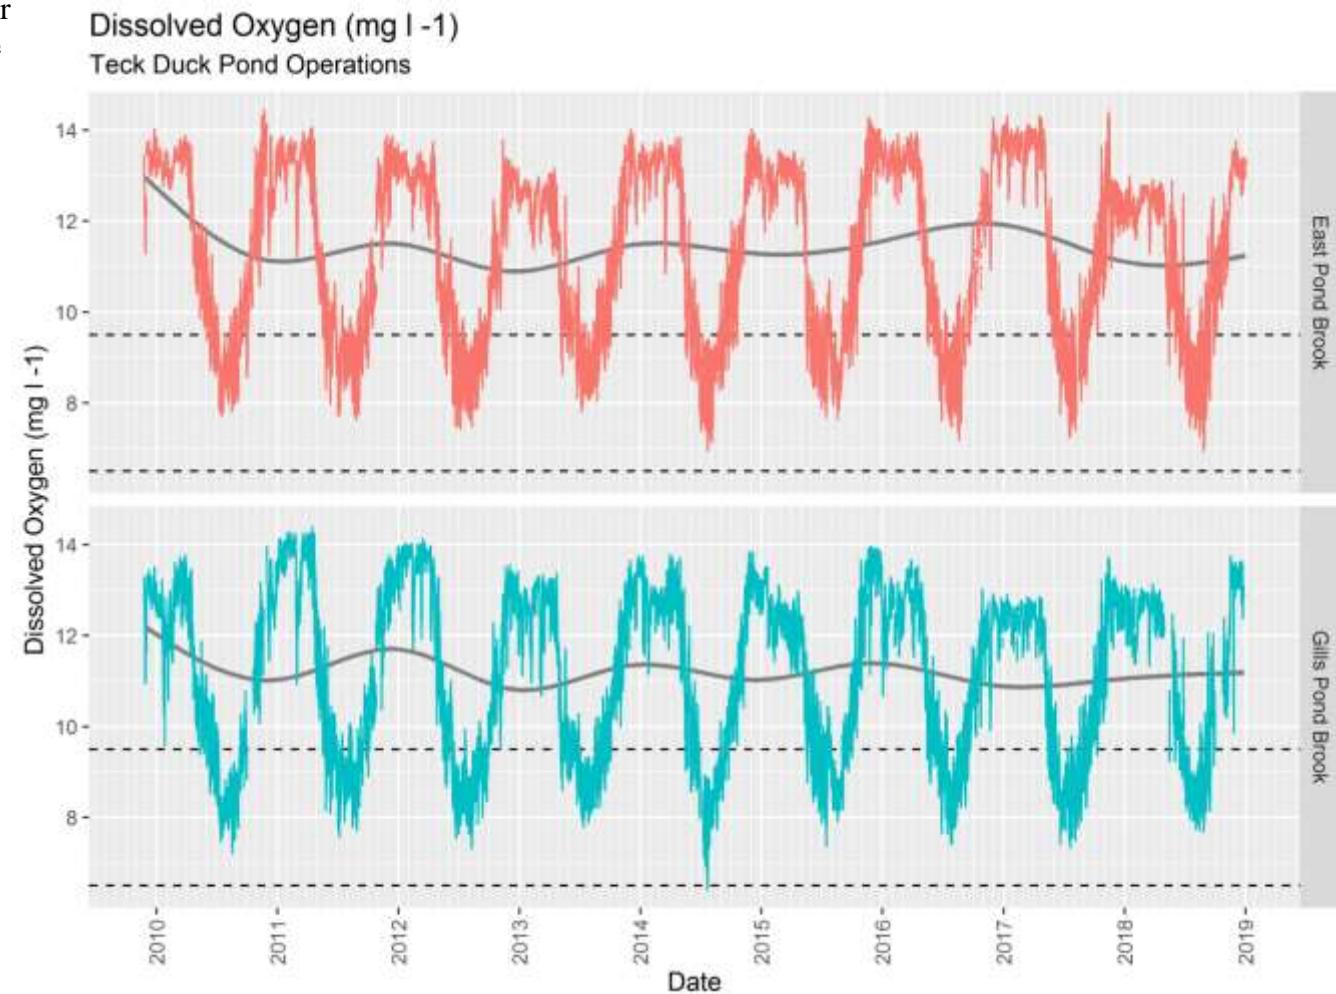
**Figure 7: Dissolved oxygen at Teck DPO**

In 2018, all dissolved oxygen values were found to be within CCME guidelines (dashed lines in Figure 7), even during warm-water periods when oxygen concentrations are typically low.

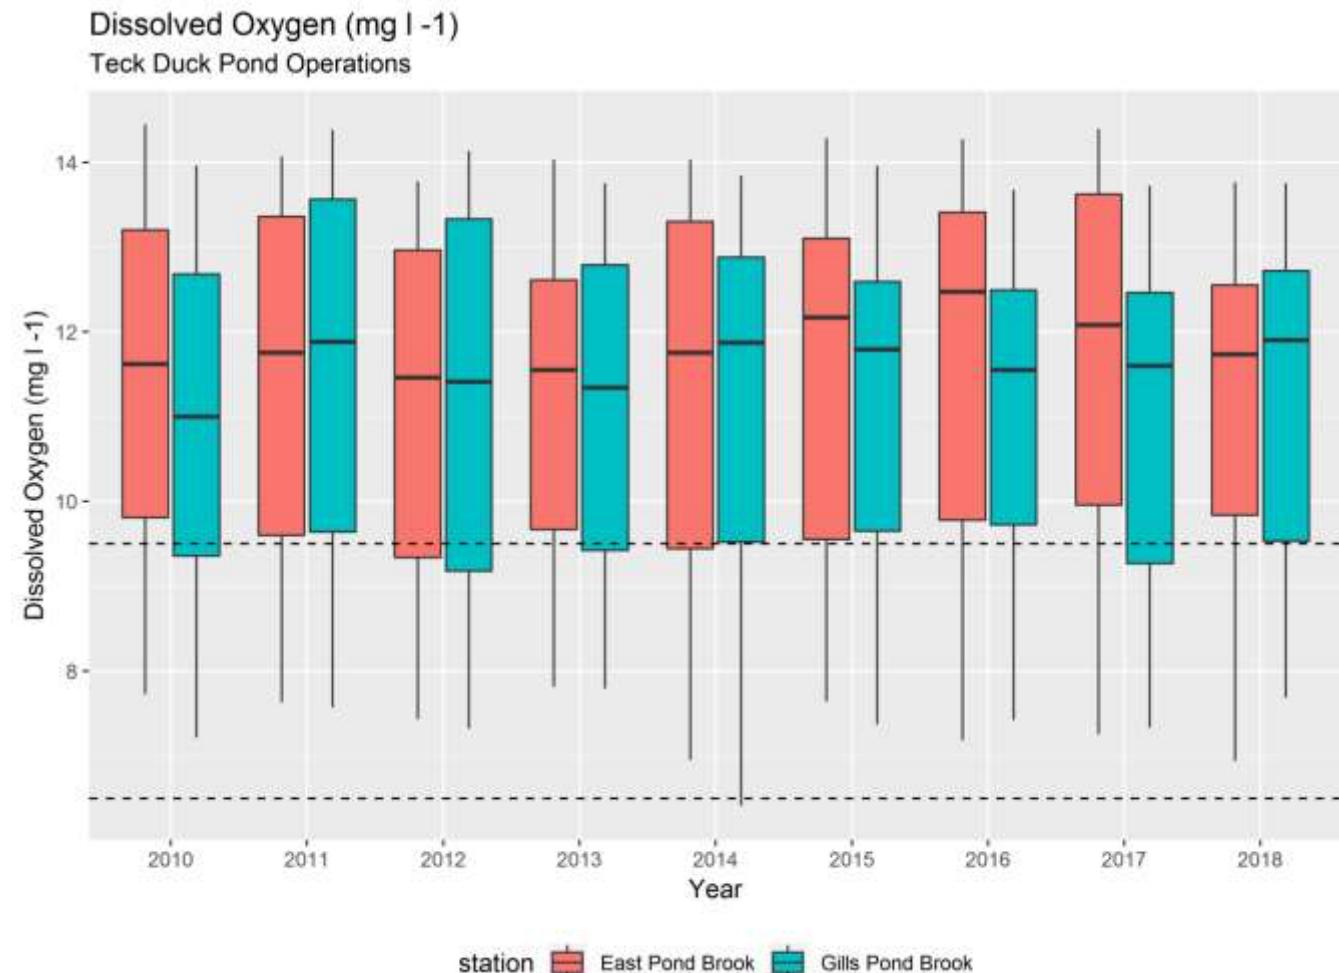
**Figure 8: Boxplots of dissolved oxygen at Teck DPO from 2010 to 2018**

As seen in Figure 8, dissolved oxygen concentrations have not changed in any considerable up- or downward trend since monitoring began. Each box, which represents the central 75% of values, is generally greater than the least-conservative CCME guideline of 9.5 mg/l for the protection of aquatic biota (black, dashed lines).

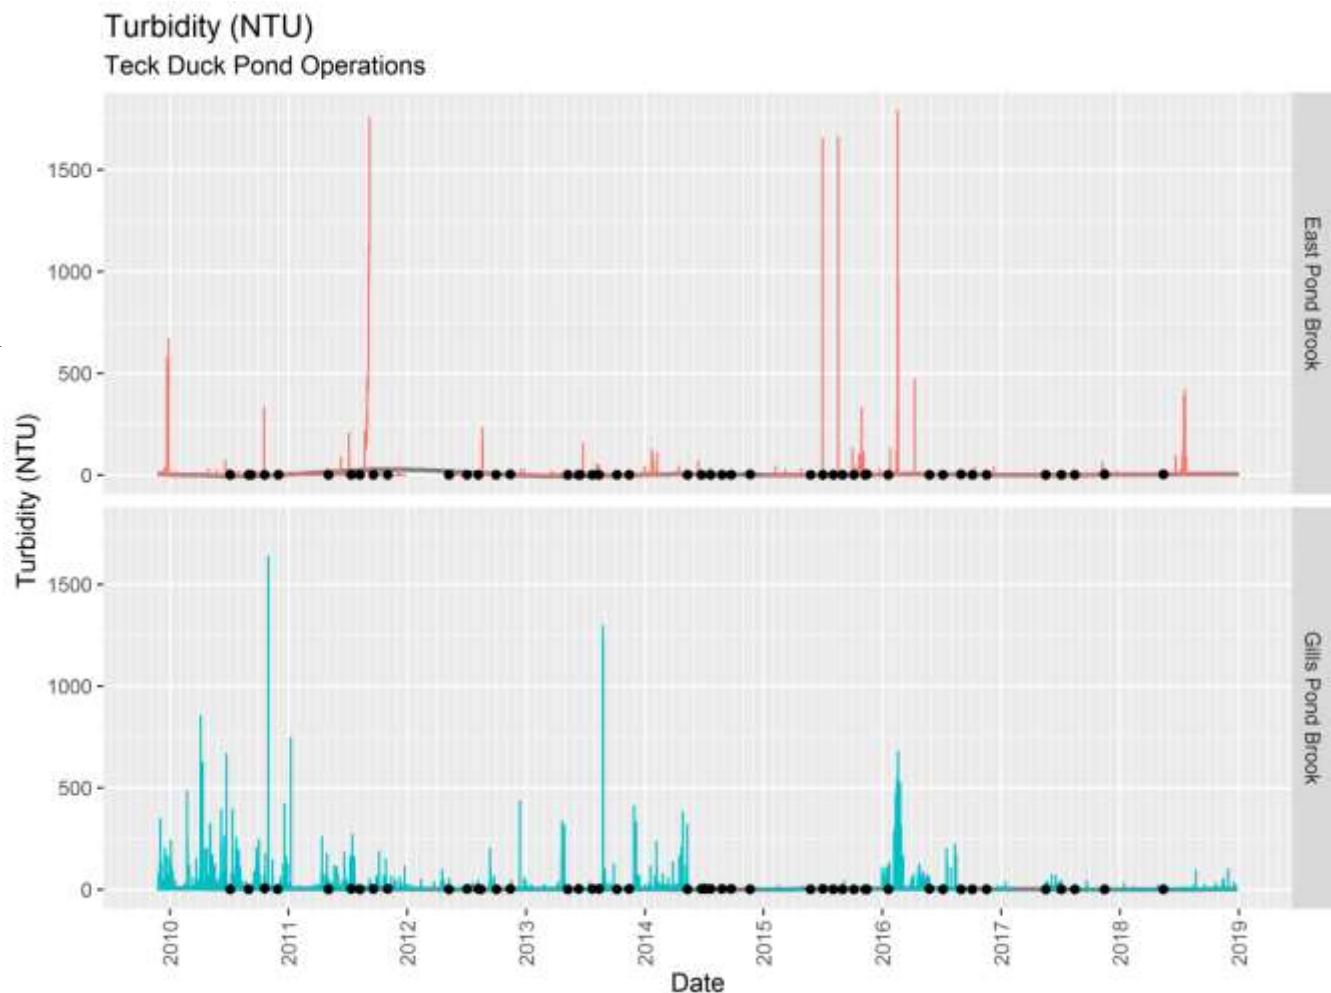
Figure 9: Turbidity at Teck DPO from 2010 to 2018

Despite median values of 0 NTU, Figure 9 shows that there are some notable periods of higher turbidity. At TGPB station, these periods are especially obvious from 2010 to mid-2014. Following this period, turbidity events became fewer in number and lower in magnitude. In 2018, only a small number of turbidity events were encountered at either station.

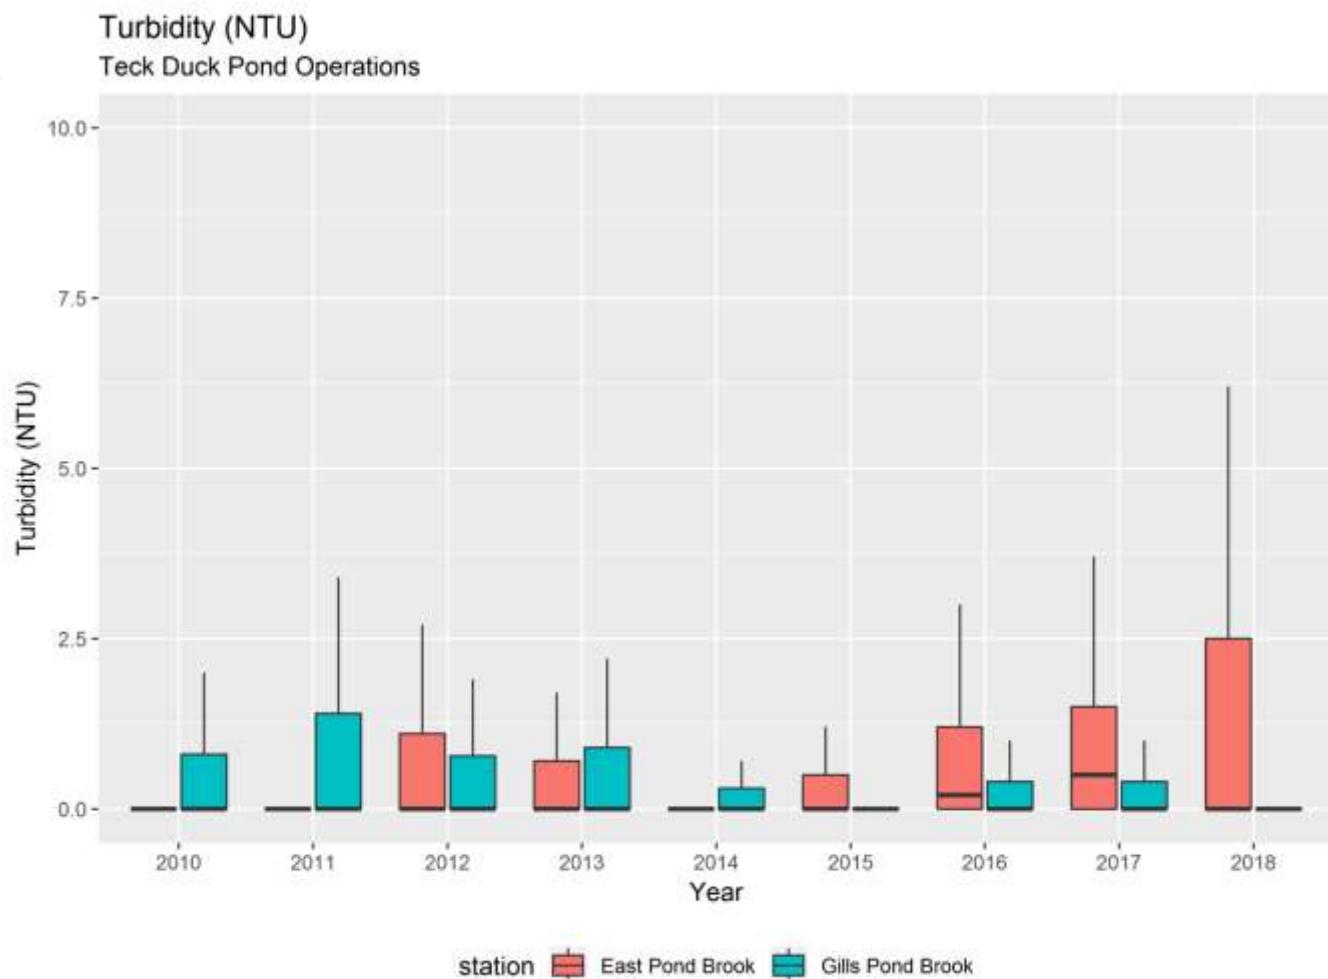
**Figure 10: Boxplots of turbidity at Teck DPO from 2010 to 2018**

Within each boxplot, a central, horizontal black bar indicates median turbidity. Median values are generally located at 0 NTU, except for East Pong Brook in 2016 and 2017. Those two years seemed to indicate a rising trend in turbidity but median turbidity once again fell to 0.0 NTU in 2018.

Nevertheless, the upper range of turbidity values at East Pond Brook continued to increase from 2015 to 2018.

The mechanisms responsible for this increase is not known but possible explanations could be closure work at Teck DPO or logging in the area.

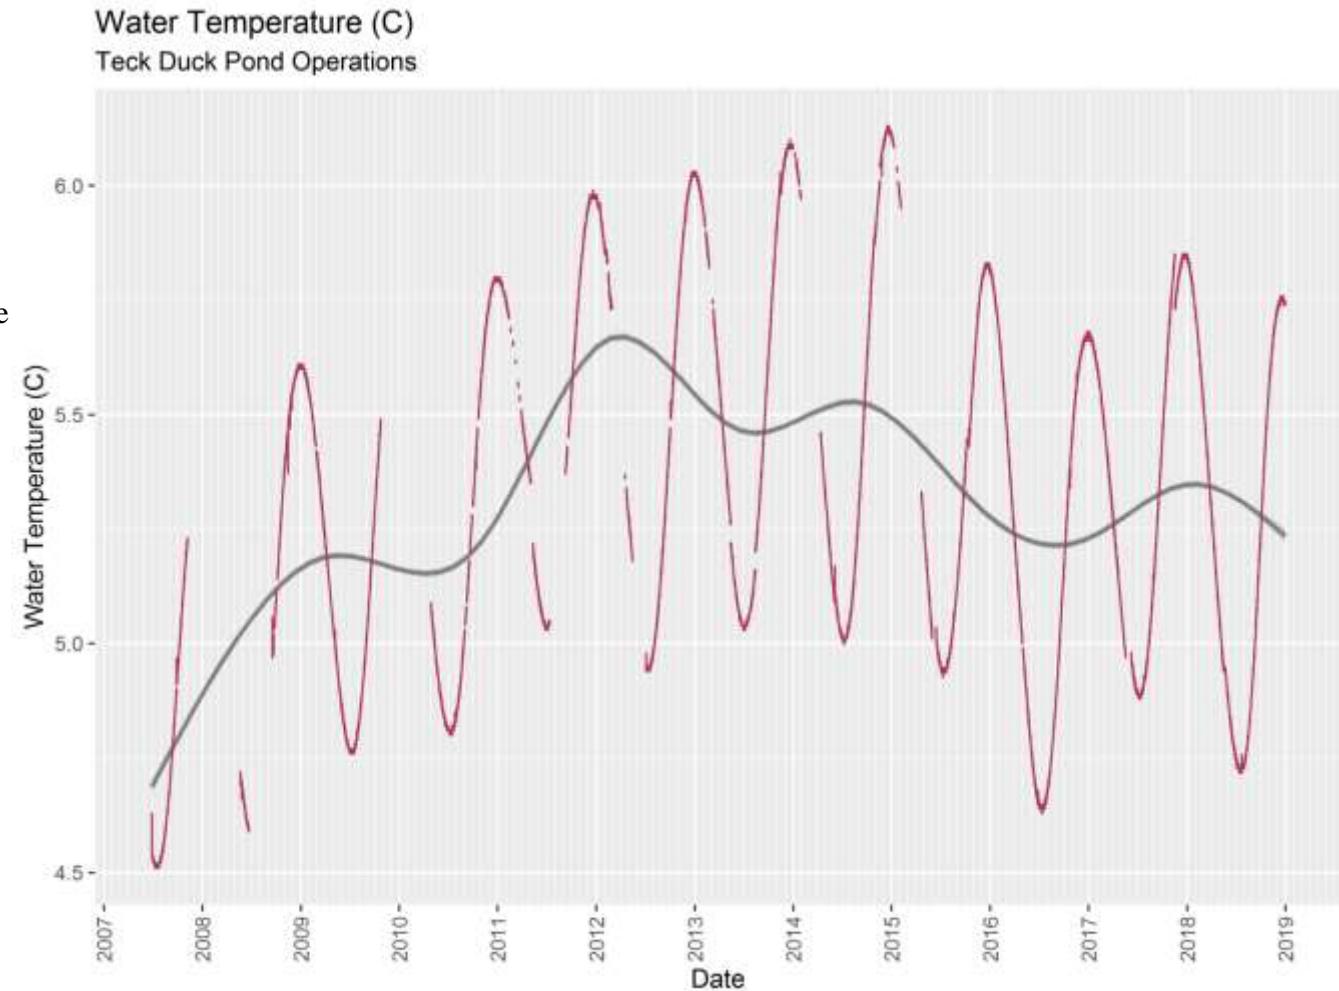
**Figure 11: Water temperature at Well after Tailings Dam, Teck DPO**

Figure 11 shows that annual low temperatures tend to occur in mid-July and annual high temperatures tend to occur in mid-December.

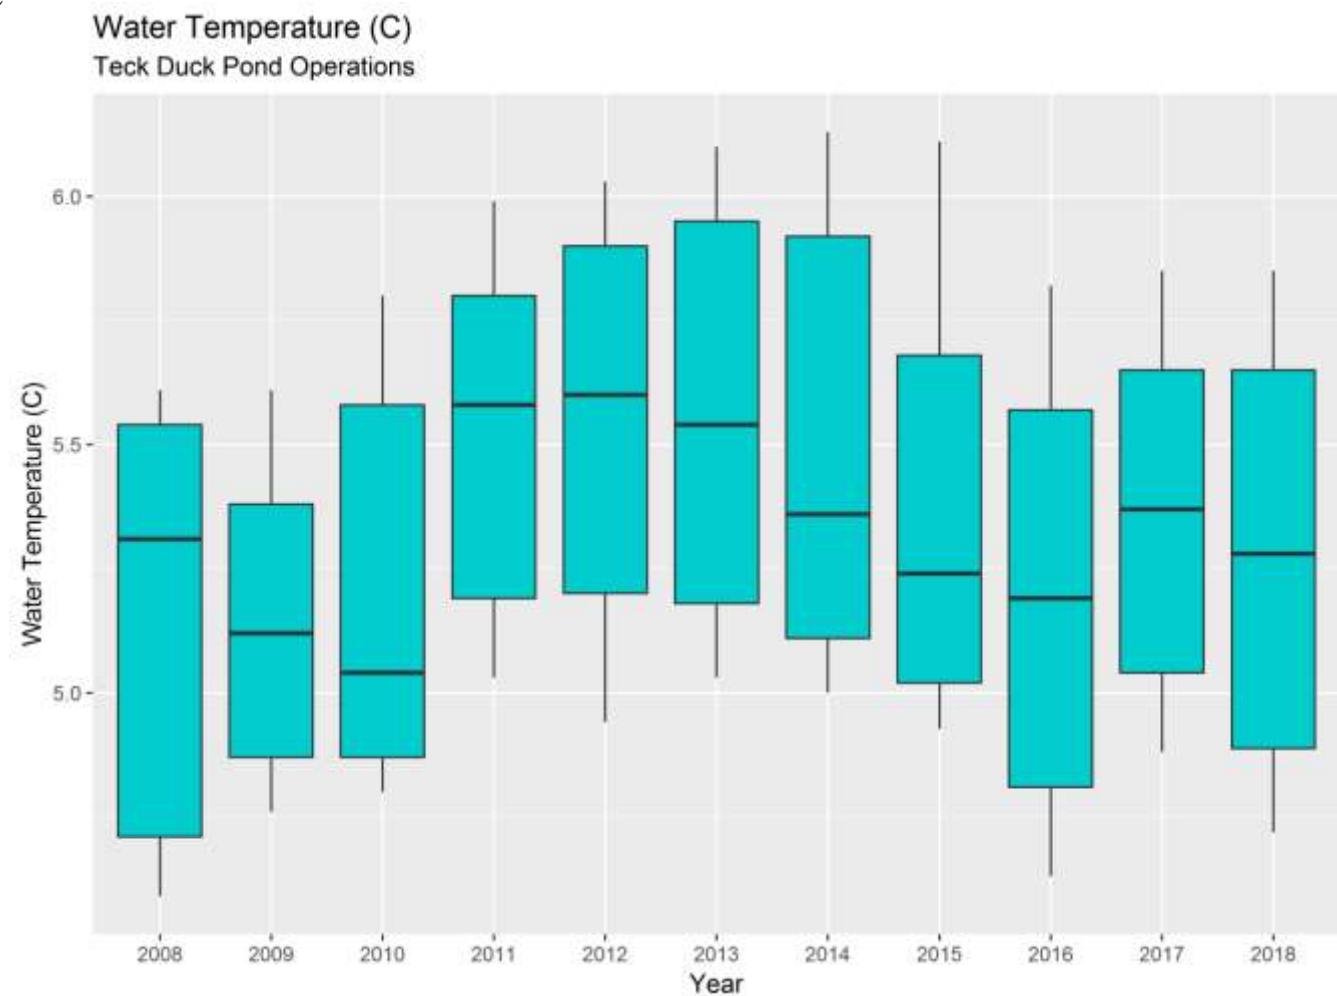
**Figure 12: Boxplots of water temperature at Well after Tailings Dam, Teck DPO**

Figure 12 shows the consistency of water temperatures from 2008 to 2018 where there is considerable overlap in ranges from one year to the next. No notable trend is obvious at this time.

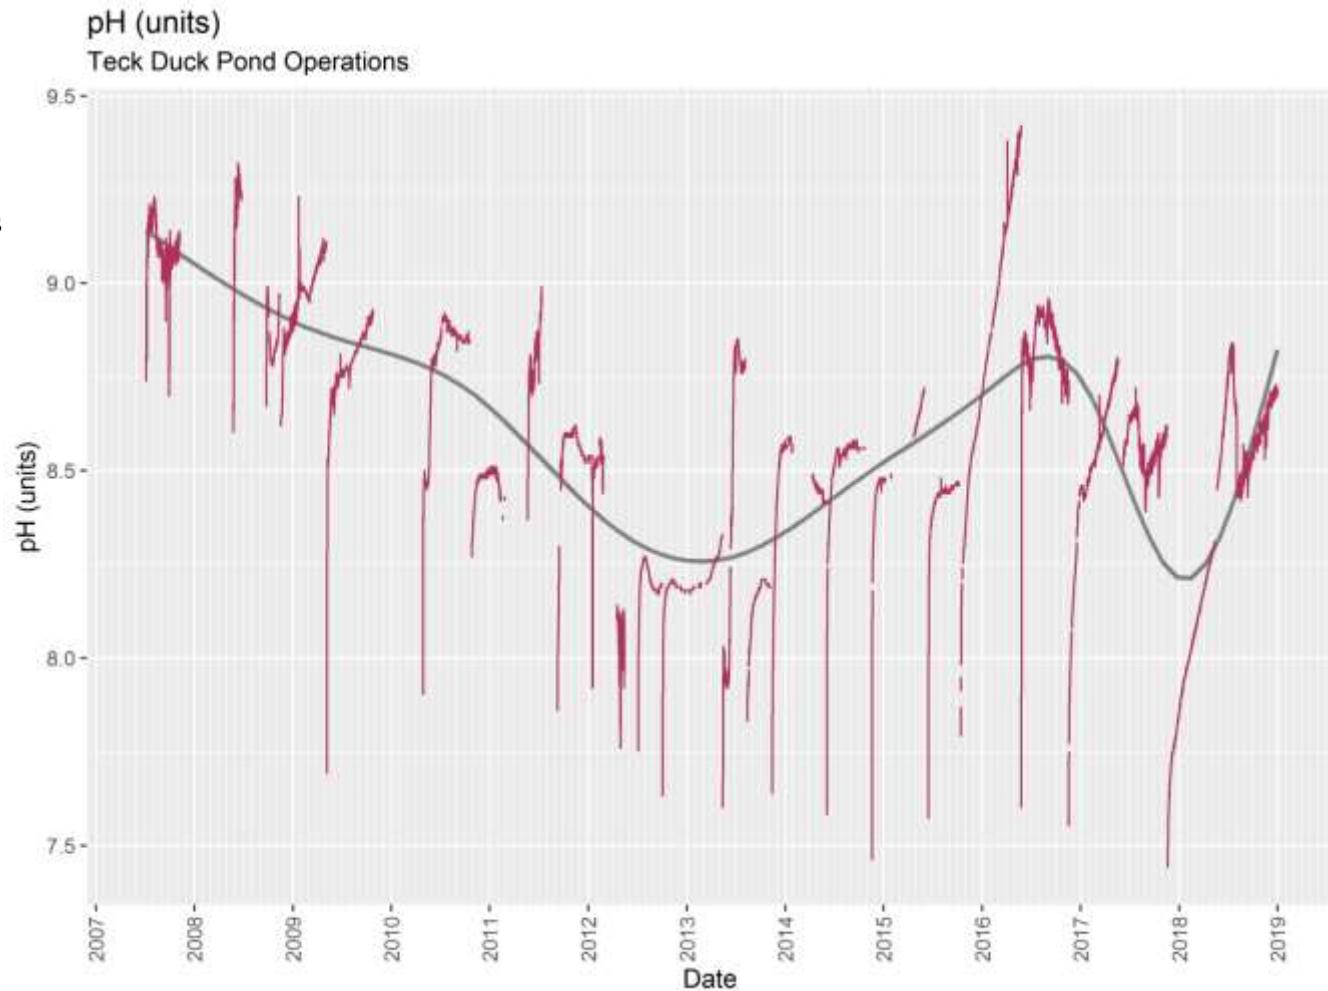
Figure 13: pH at Well after Tailings Dam, Teck DPO

Readily apparent in Figure 13 is the long period of time it takes for pH to stabilize in the well following routine maintenance. This effect can be attributed to factors such as sensor stabilisation or chemical change resulting from aquifer water being pulled into the borehole. The rising trend can take upwards of a month to stabilize.

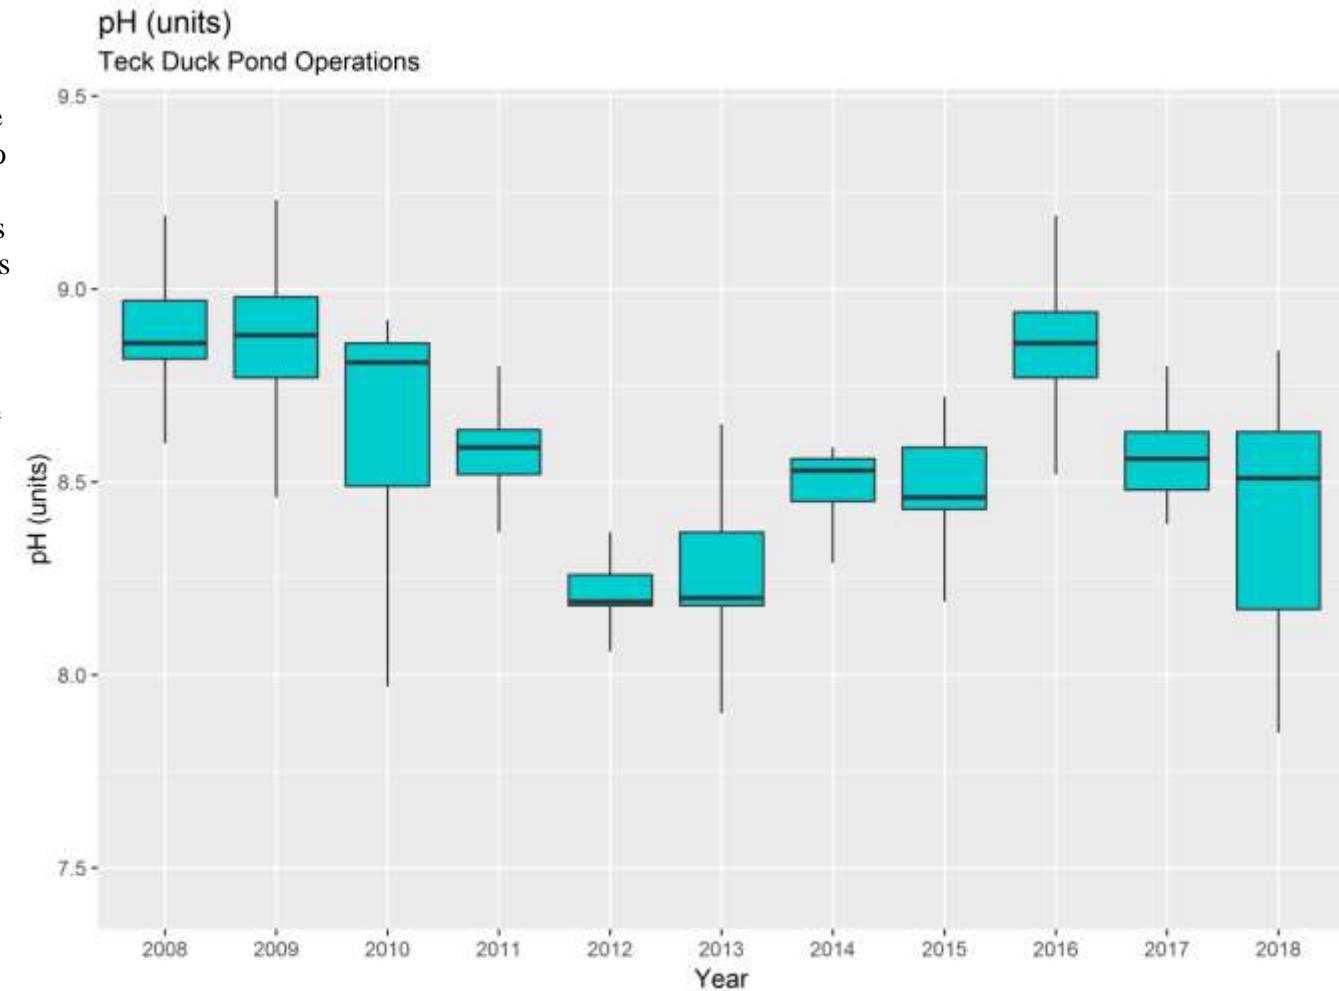
**Figure 14: Boxplots of specific conductivity at Well after Tailings Dam, Teck DPO**

pH levels within the well tend to be alkaline in nature. Interestingly, Figure 14 appears to mirror an opposite and inverse relationship with water temperature (Figure 11). In years where water temperature is cooler, pH levels tend to be more alkaline and when water is warmer, conditions appears to be more acidic. It is unclear if this is coincidental or if there is an actual relationship between the two parameters.

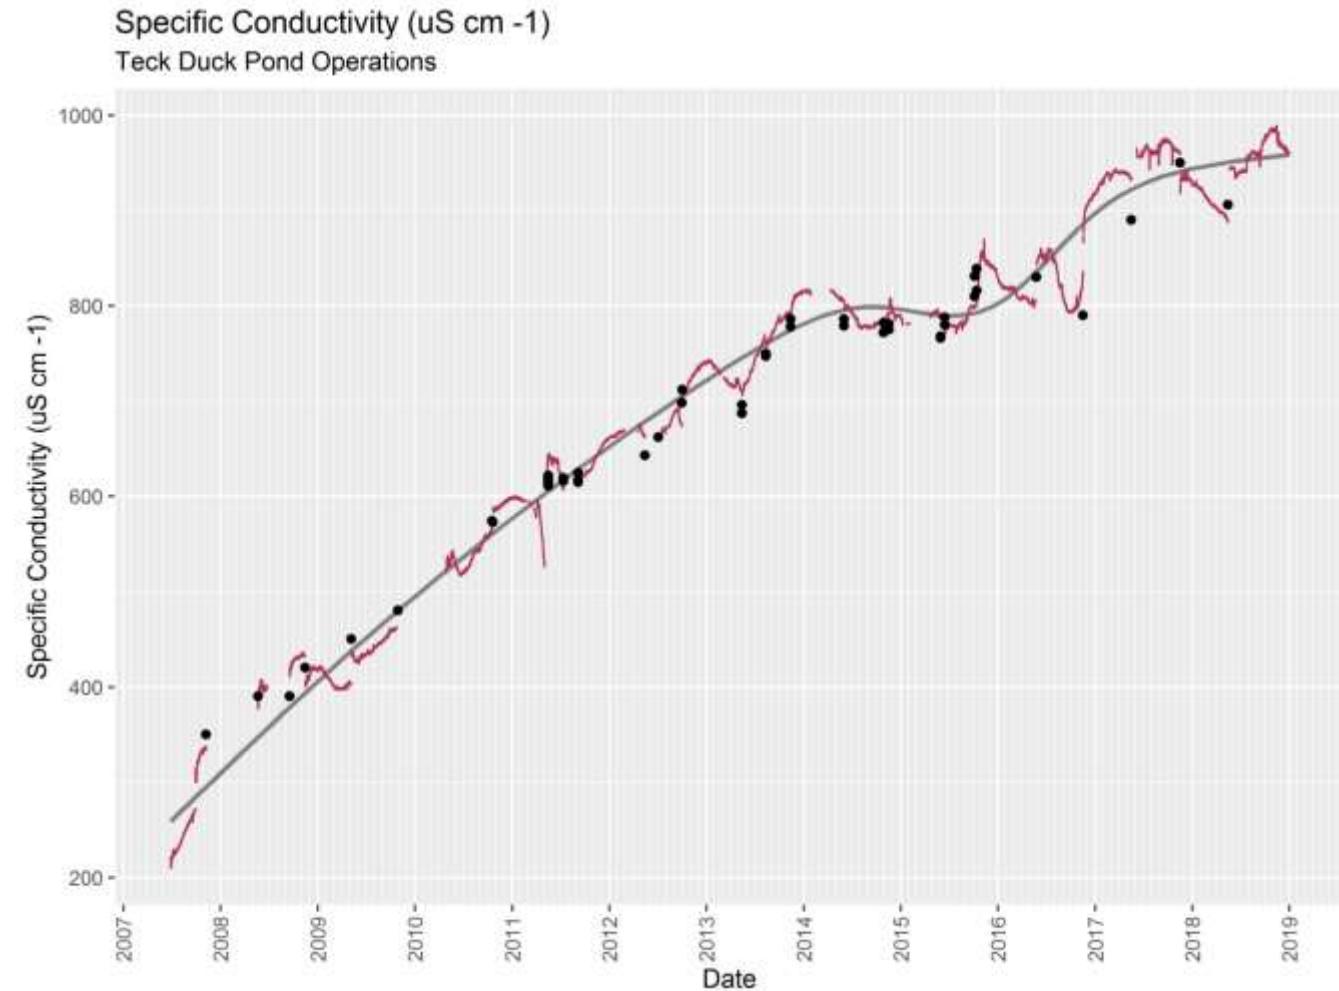
**Figure 15: Specific Conductivity at Well after Tailings Dam, Teck DPO**

In 2018, specific conductivity values continued to rise above historical values, as seen in Table 9 and in Figure 15.

A plateau phase from 2014 to late 2015 was observed prior to a rising trend from 2016 onwards. At this time, water level in the tailings management area was lowered to perform long-term stabilization work. A lower water level and deposition of materials may have resulted in the sudden increase in conductivity.

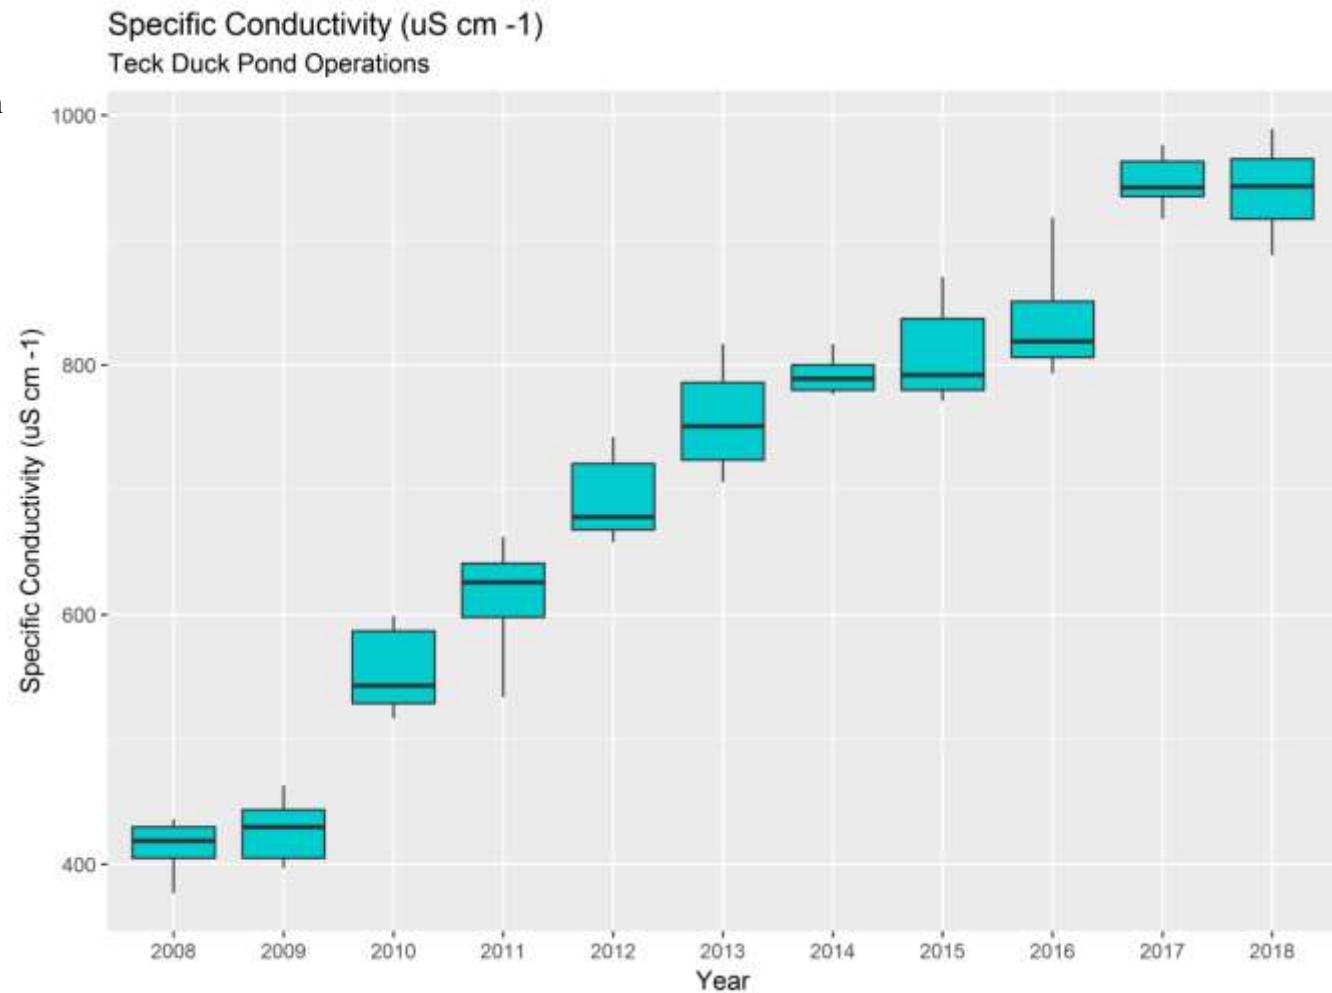
**Figure 16: Boxplots of specific conductivity at Well after Tailings Dam, Teck DPO**

In Figure 16, 2017 and 2018 show a distinct and separate tendency from the plateau period seen from 2014 to 2016. This tendency likely resulted from work within the tailings management area as discussed in the previous Figure 15.
