# Real-Time Water Quality Deployment Report

## Teck Duck Pond Operations

2018

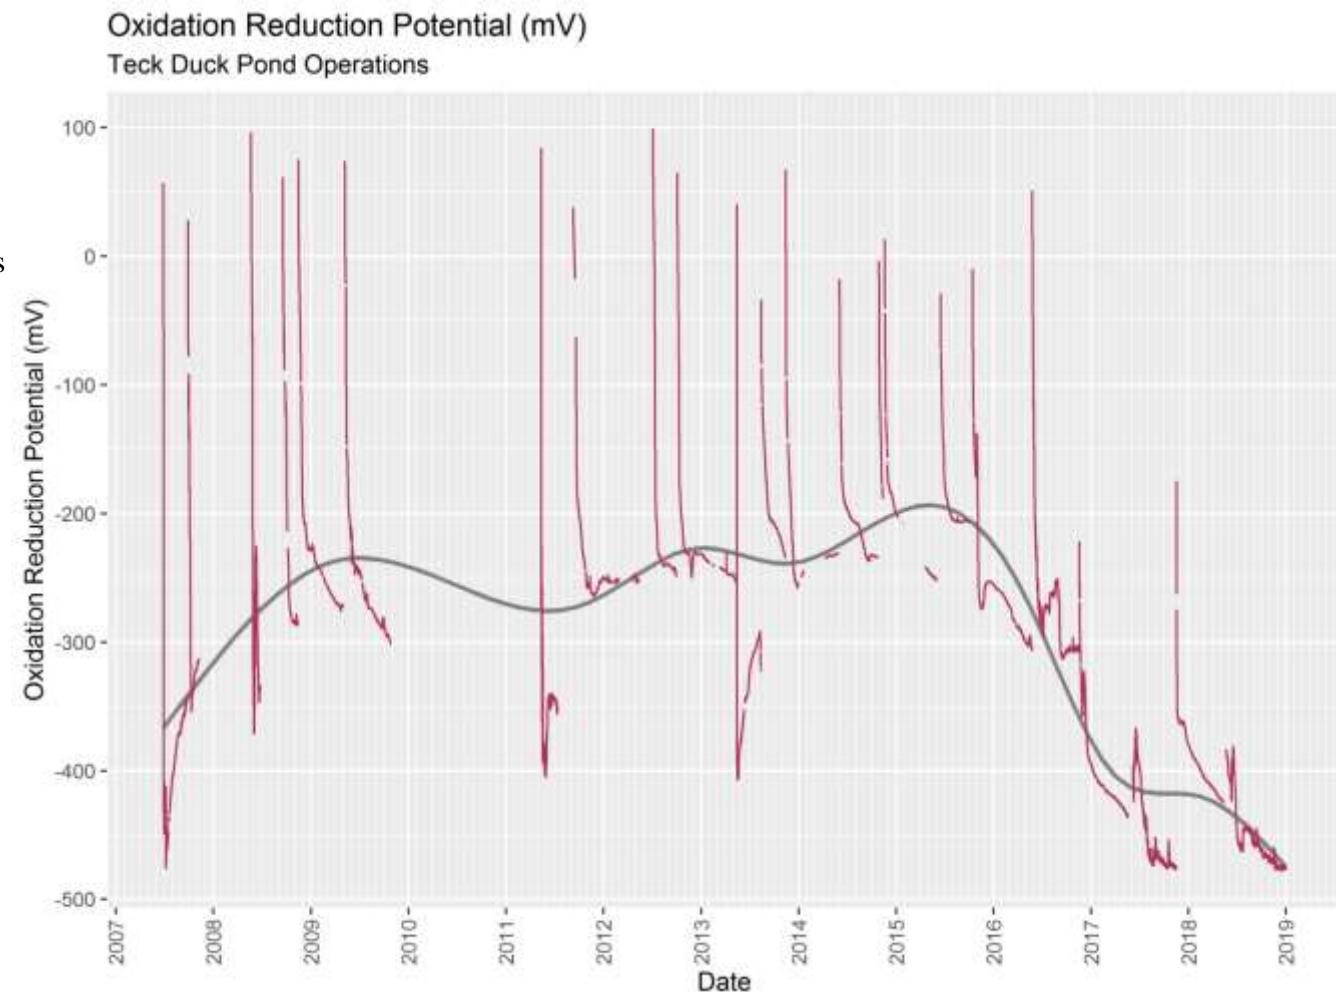
**Figure 17: ORP at Well after Tailings Dam, Teck DPO**

Much like pH, ORP tends to take a number of days to settle following routine maintenance as depicted in Figure 17. From 2007 to 2016, post-maintenance ORP values were found to be oxidative ( $> 0$  mV) for a brief period before quickly falling to reductive levels ( $< 0$  mV).

There is an indication that ORP values are becoming more reductive over time. From 2015 to 2018, stable ORP values began to fall lower and even post-maintenance ORP values were no longer oxidative.

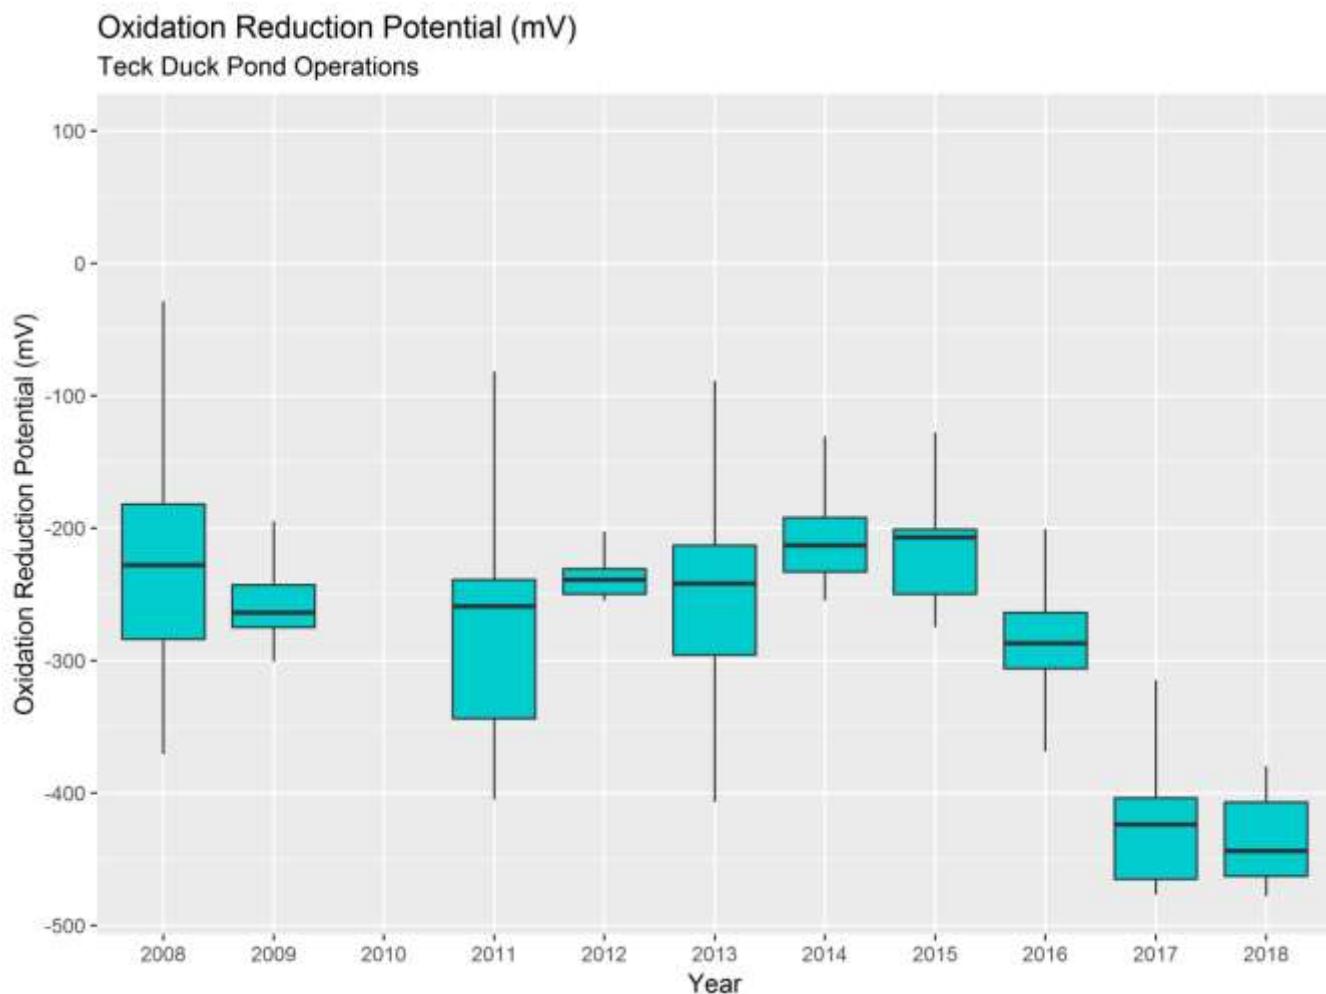
**Figure 18: Boxplots of ORP at Well after Tailings Dam, Teck DPO**

Figure 18 readily shows a decline in ORP from 2016 and into 2018. This decline follows a period of plateau in specific conductivity and could be indicative of a particular chemical change in the aquifer.

Notably, the change from 2017 to 2018 was more subtle.

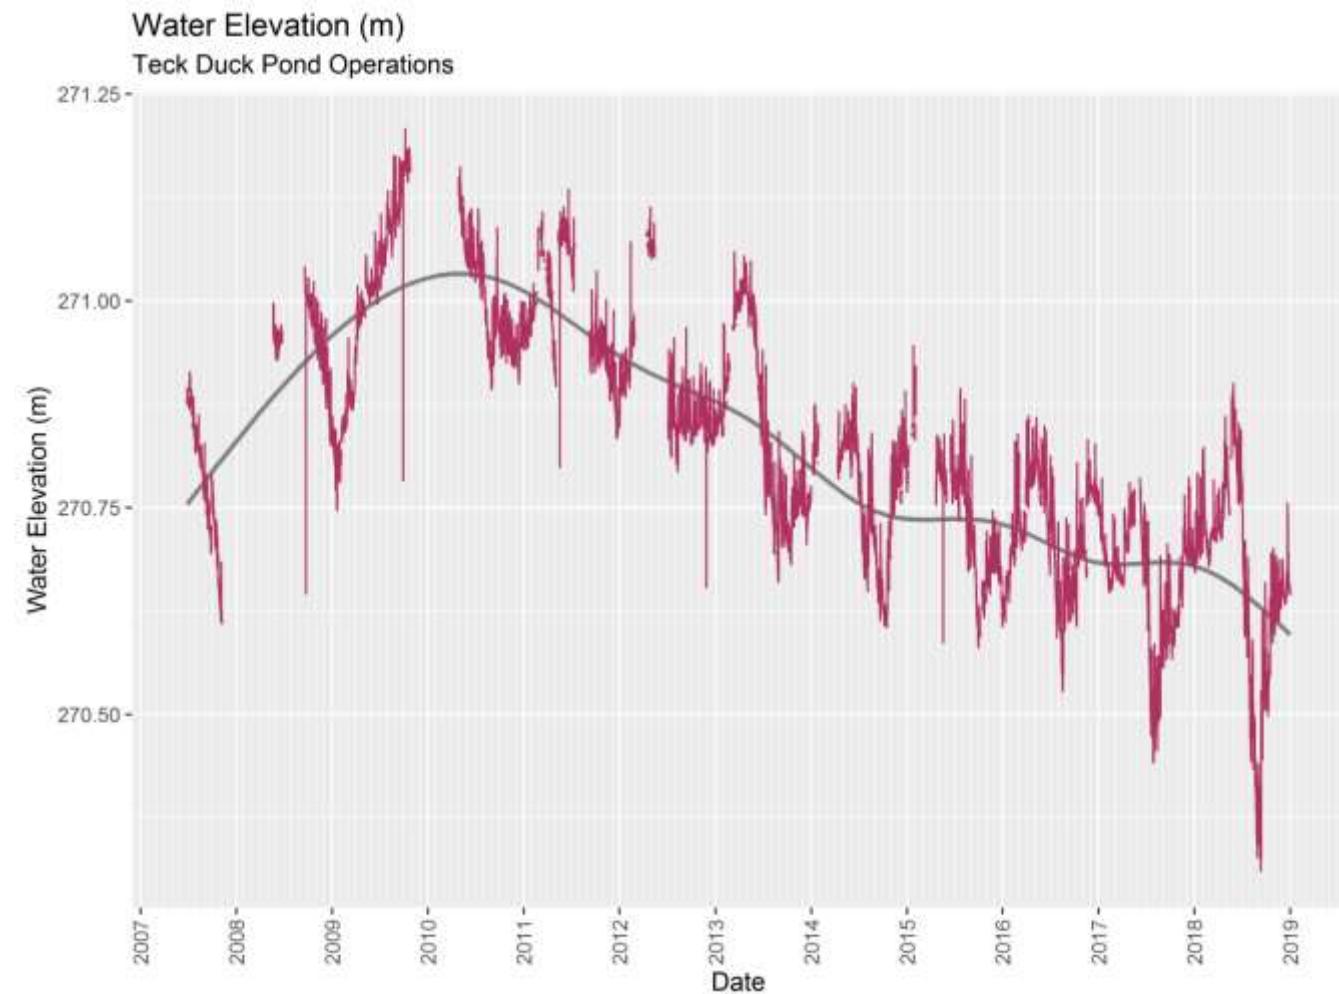
**Figure 19: Water elevation at Well after Tailings Pond, Teck DPO**

Water elevation indicates the surface of the aquifer above sea level. Water level peaked in 2009 and declined until 2017 when a small uptick was observed in the latter part of 2017 into mid-2018 (Figure 19) before continuing to decline once again.

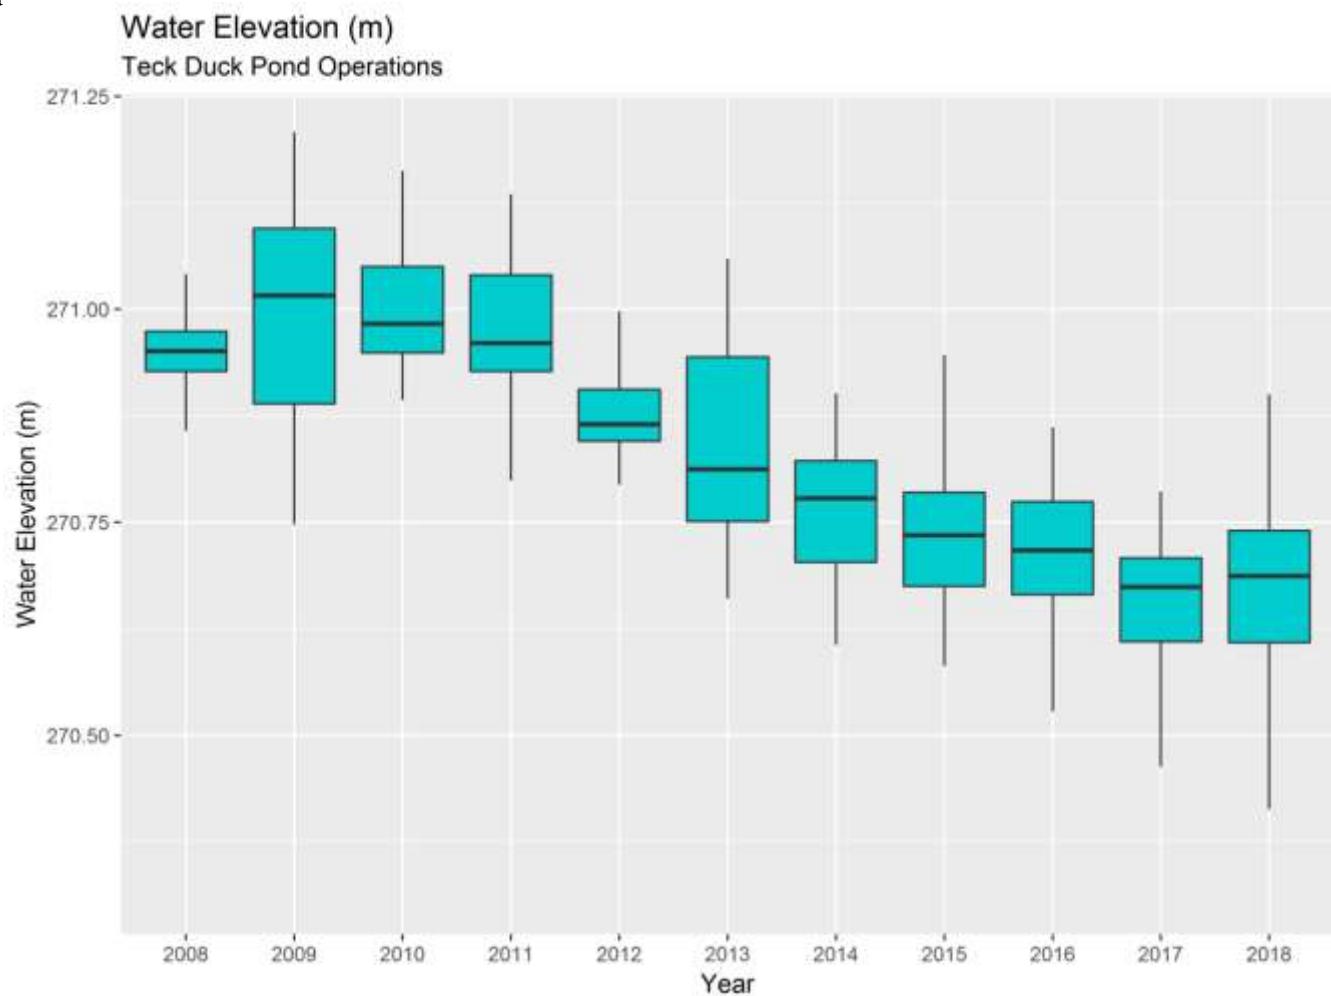
**Figure 20: Boxplots of water elevation at Well after Tailings Pond, Teck DPO**

Figure 20 succinctly illustrates the long-term decline in water level from 2009 to 2017 and the uptick observed in 2018.
