MEMORANDUM

RE: **Reconnaissance Survey – Proposed Central Waste Management Site (Norris Arm)**

Reconnaissance Survey - Proposed Central Waste Disposal Site

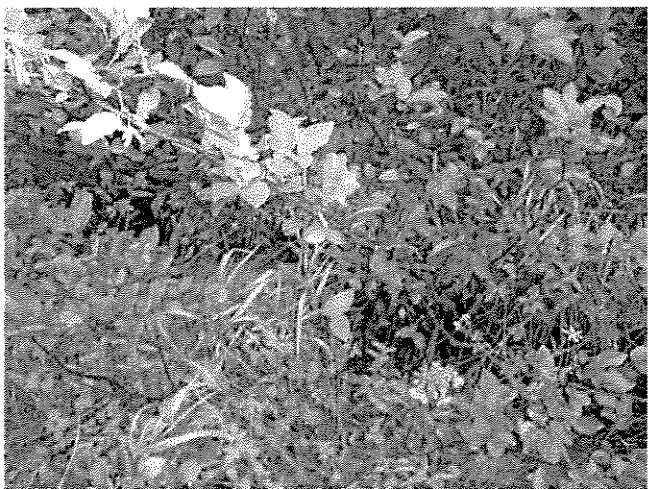
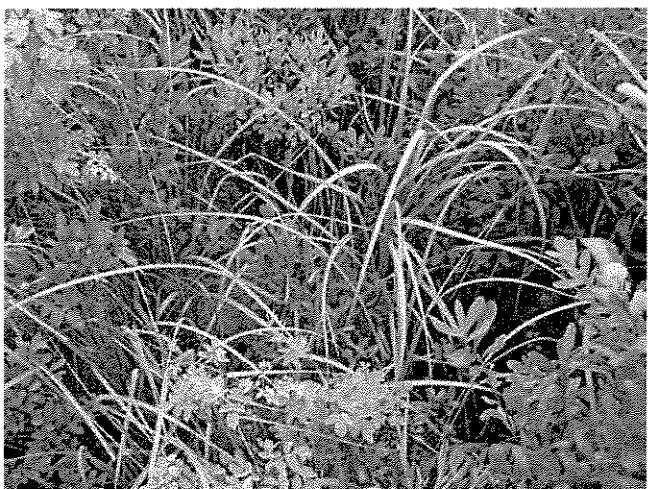
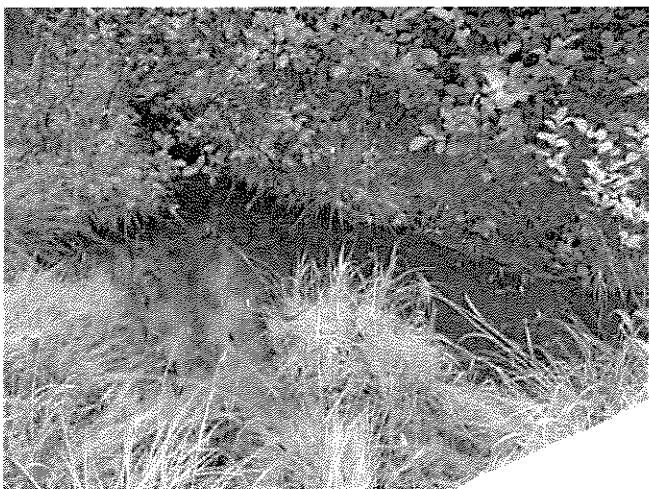
Three small streams that are not shown on 1:50,000-scale topographic mapping were found. All three are very small (i.e., < 1 metre wide) and flowed in a northward direction through areas of fen (in two cases: Photos 07, 08, 09 and 10) or alders (in one case: Photo 11). No standing waterbodies were observed.

07-Brook Through Fen

08-Brook Through Fen

09-Brook Through Fen

10-Brook Through Fen

1. There may be an issue with the streams on the site. DFO will want to know if they are fish habitat in reference to their no net loss guiding principle for habitat conservation. Based on our observations, the streams are suitable habitat for brook trout, but none were observed and it has not been determined if any are present. Water Resources Management Division of DOE will also require permitting for any work within 15 m of a waterbody or wetland, so further delineation of these features may be required.
2. There were no obvious issues with wildlife or avifauna determined from the site visit.
3. The vegetation types are typical of cut-over areas, and no issues were identified in that respect.

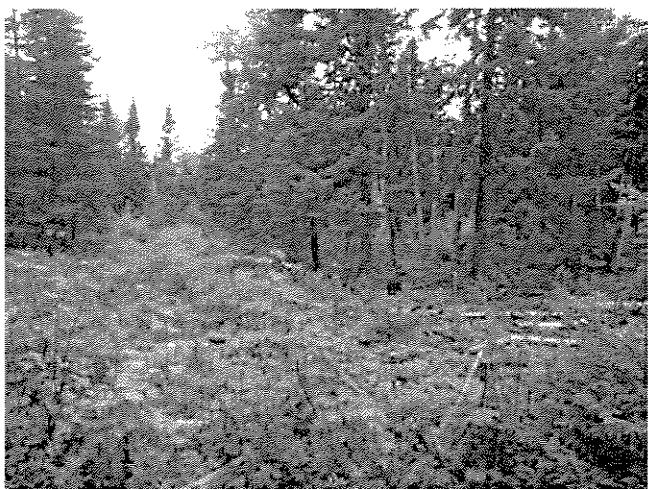
01-Typical Cutover

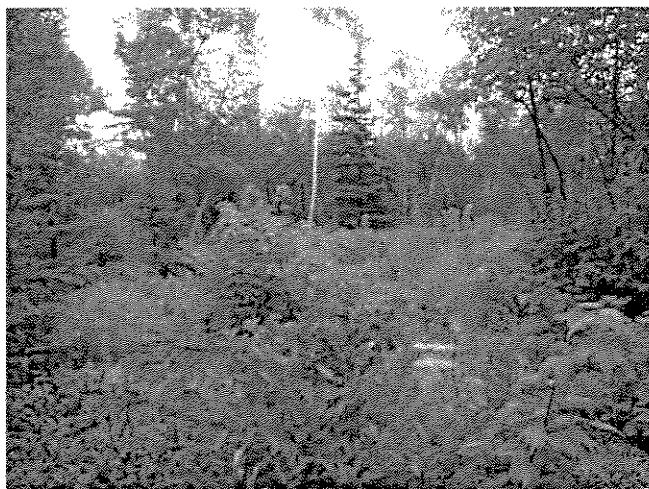
02-Typical Cutover

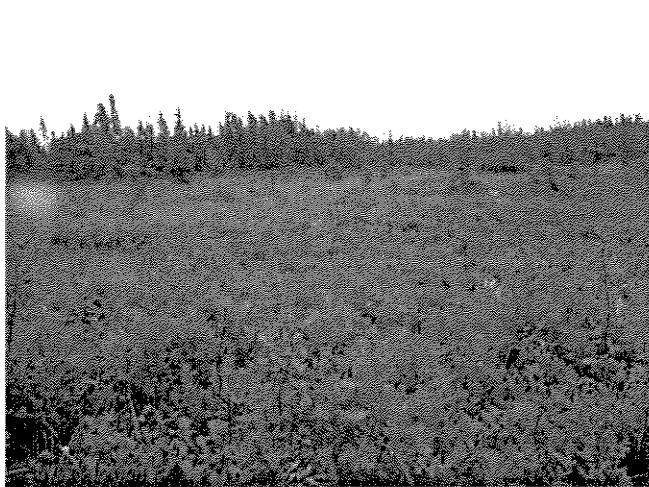
Interspersed among the forested areas are wetland features that are predominantly sloped fens (Photos 04, 05, and 06). Compared to bog, fens are relatively nutrient-rich due to inputs of surface water draining from upland areas. Fens tend to support a higher proportion of grasses and sedges rather than sphagnum mosses that are generally associated with more nutrient-poor bogs.

04-Typical Wetland

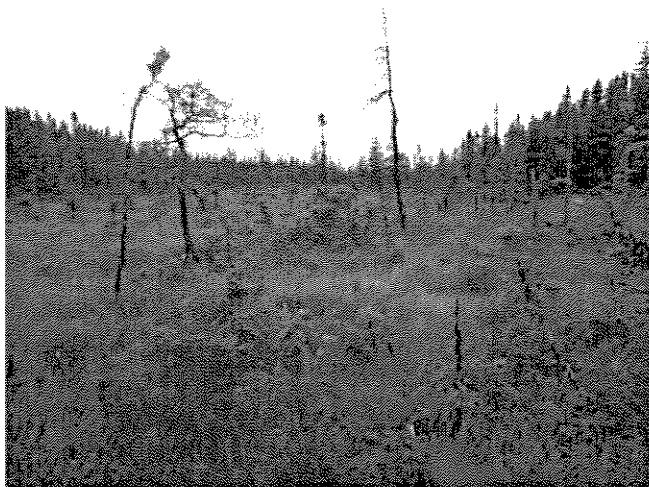
05-Treed Fen

06-Treed Fen
