### **Hydrogeological Report DSO2 and DSO3 Sectors Schefferville (Québec) and Elross Lake (Newfoundland and Labrador)**

**NEW MILLENNIUM  
CAPITAL CORP.**

## **DIRECT-SHIPPING ORE PROJECT**

**Survey of Fish Habitat along the Railway Line and Main  
Access Road, DSO Project**

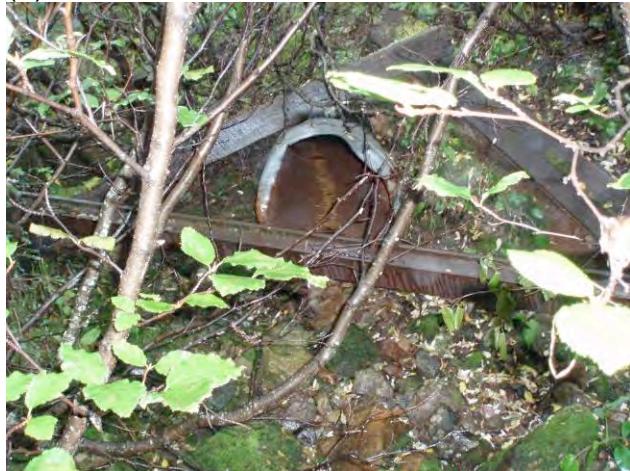
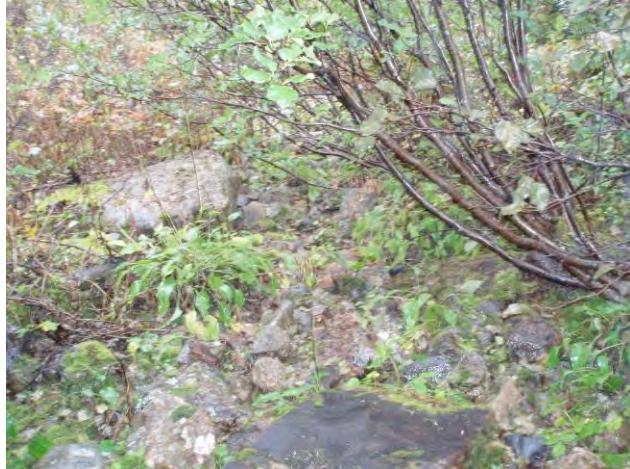
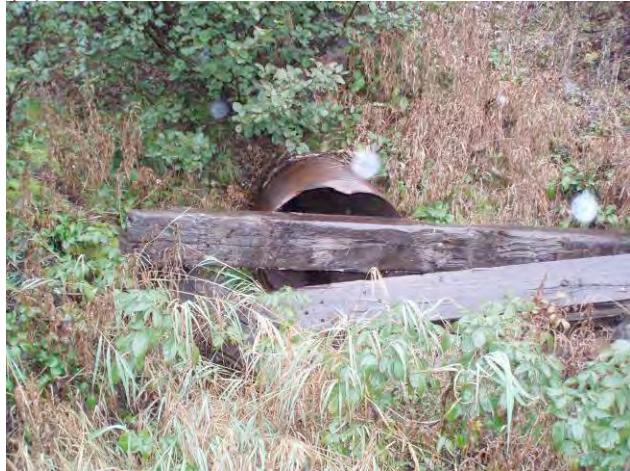
RLC-3a is a culvert found by GHI: no stream bed was observed and no characterization was carried out (Photos RLC-3A: 1-3).

RLC-3a (view from upstream)

RLC-3a (view looking downstream)

RLC-3a (view from downstream)

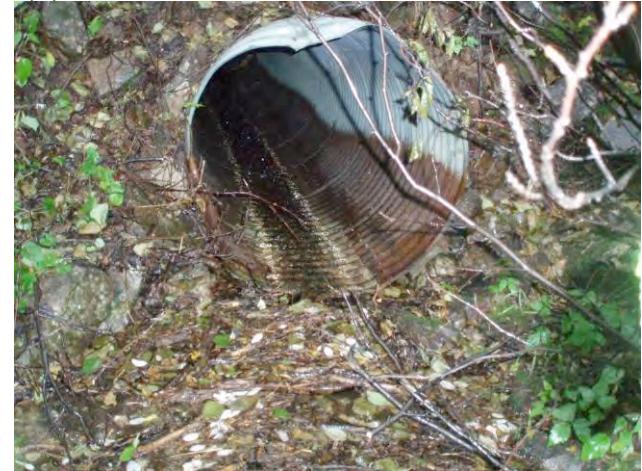
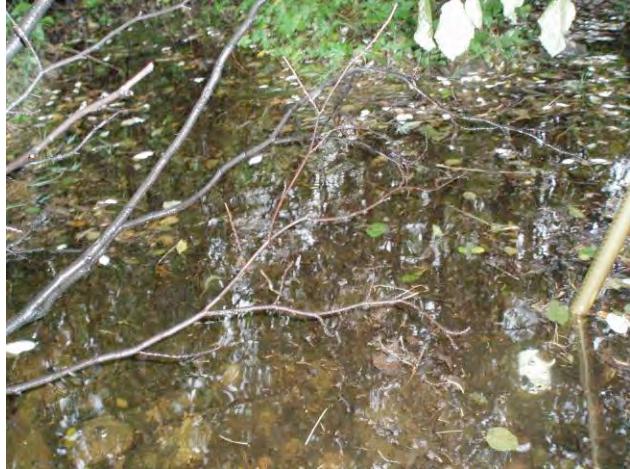
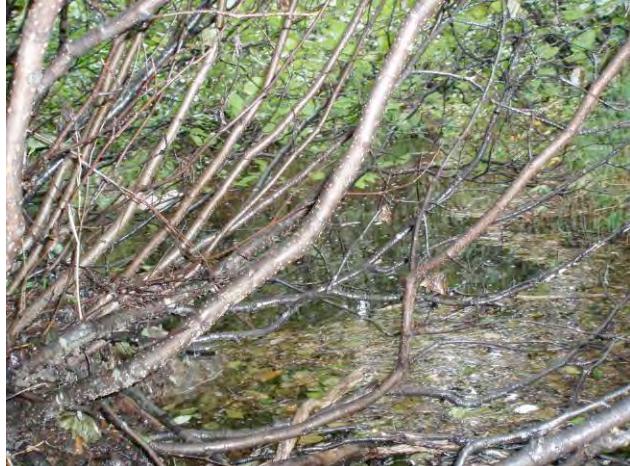
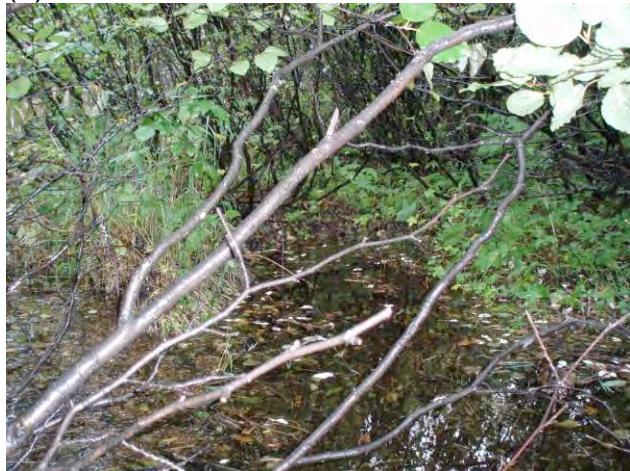
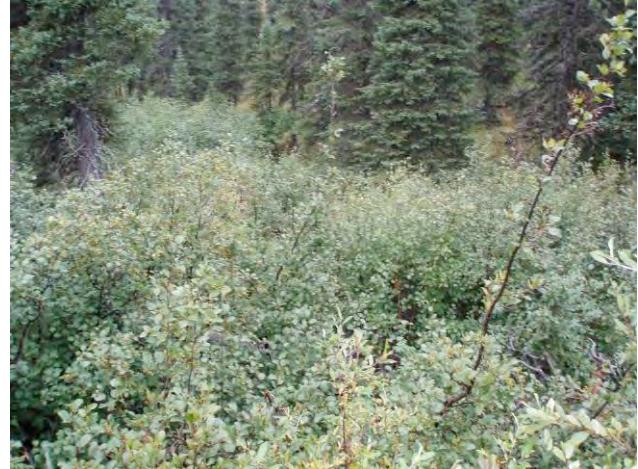
RLC-5a is a culvert found by GHI. The characterization of this station was carried out at two points, one in the upstream segment and the other in a segment of the channel with a uniform bed downstream from the culvert.

RLC-5a (view looking upstream)

RLC-5a (view looking downstream)

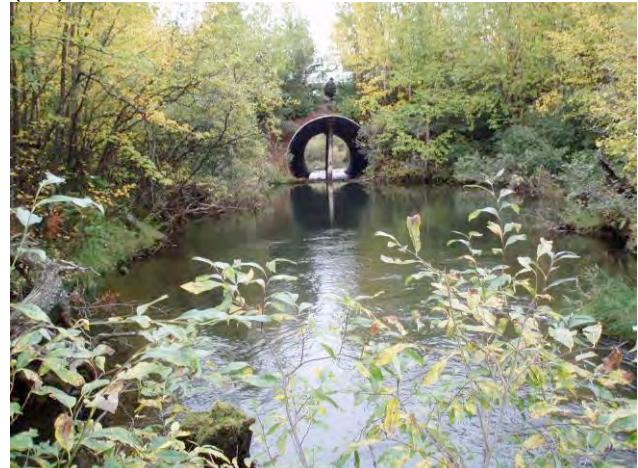
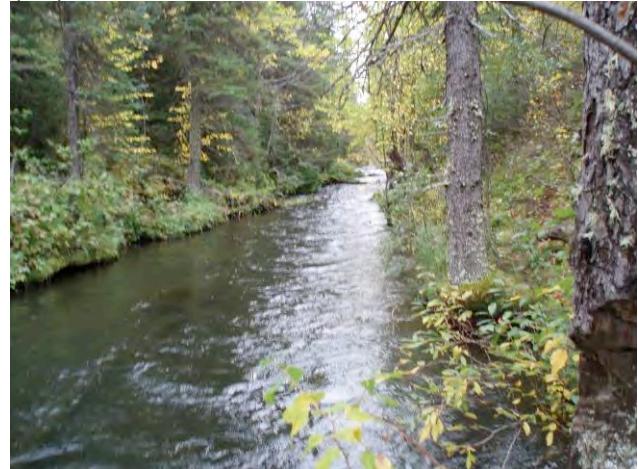
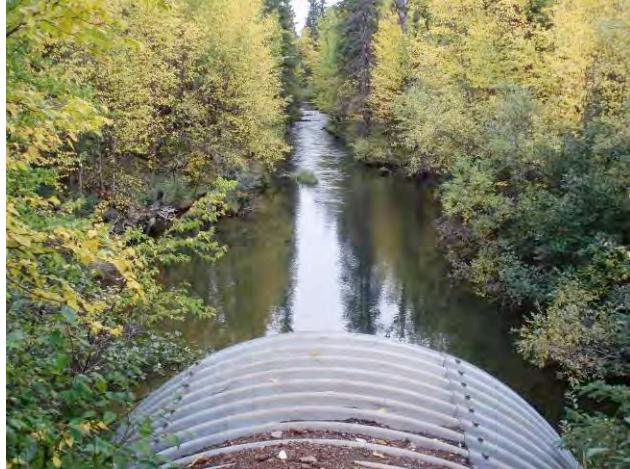
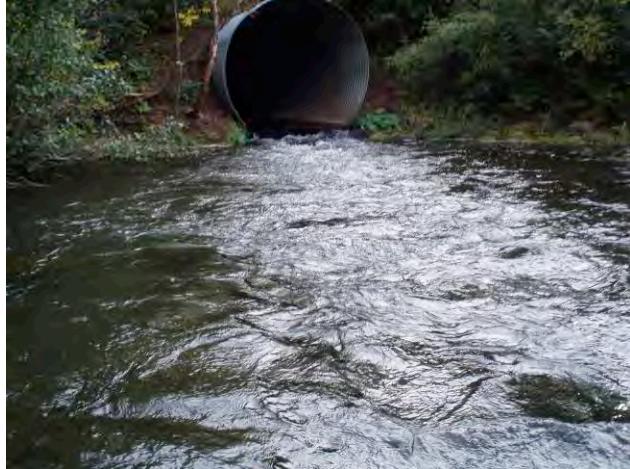
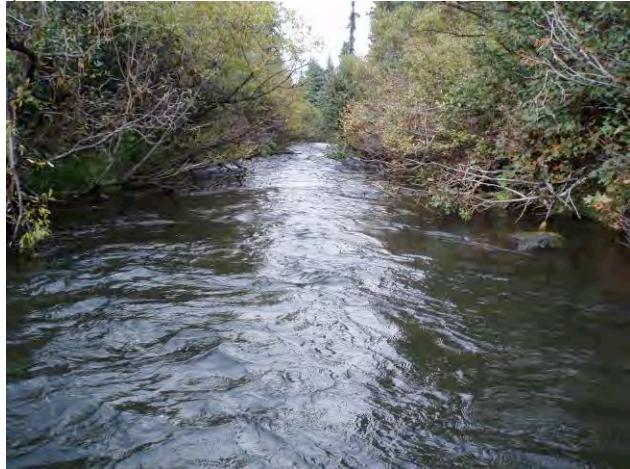
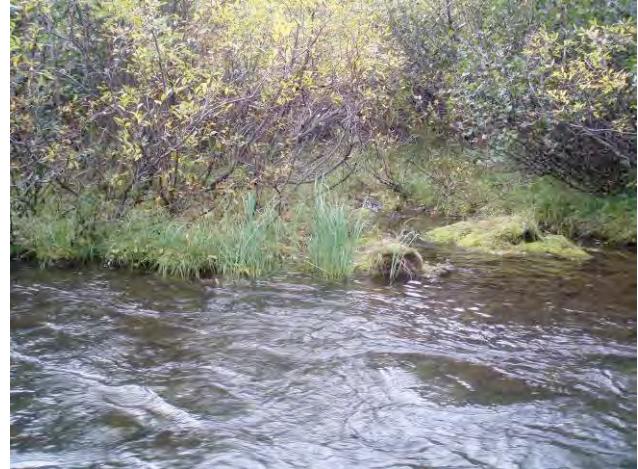
During this fish habitat survey, brook trout were observed in four streams, i.e. stations AR-2, RLC-26, RLC-27 (upstream) and RLC-27a (Table 2). Station RLC-26 seems to be a spawning ground for brook trout. No fish was observed at the various points of station AR-1, but the data collected indicate that it is a very suitable habitat for fish. According to Michel Ashini-Goupil, fish are historically present in this segment. Evidence of fishing (old earthworm jar) was also found at this spot.

RLC-26 (view from upstream)

RLC-26 (view looking upstream)

RLC-26 (view from downstream)

RLC-26 (view looking downstream)

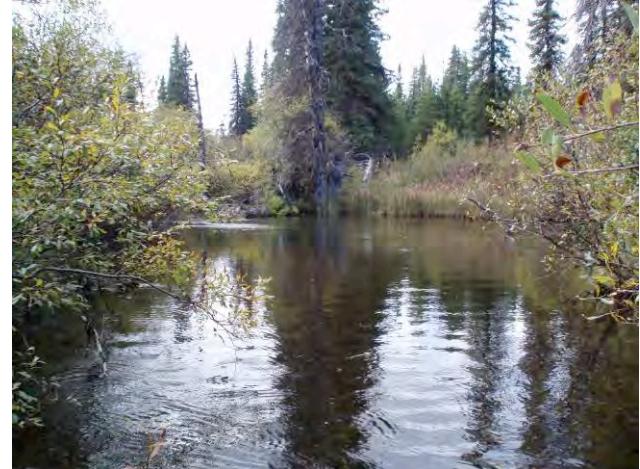
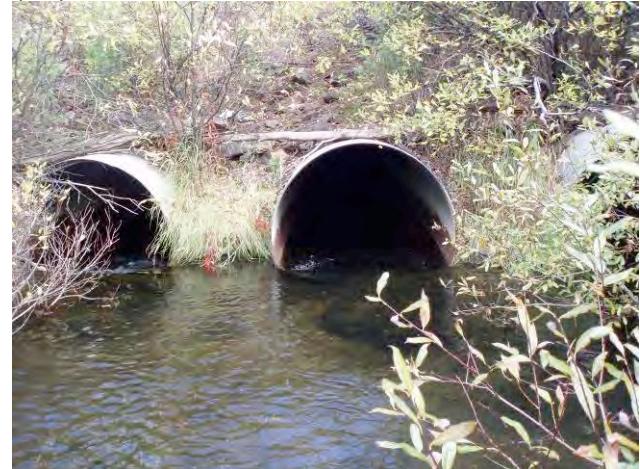
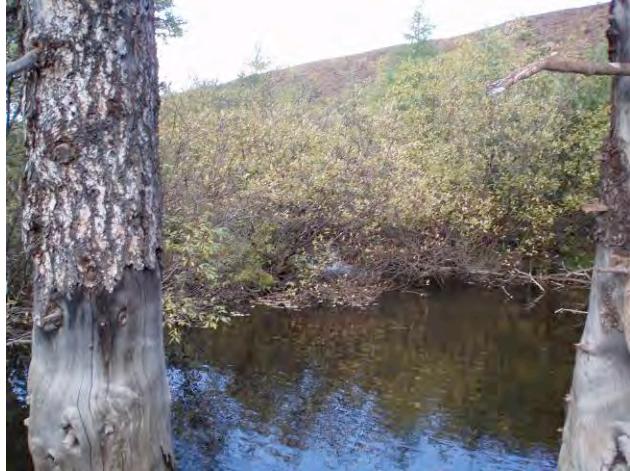
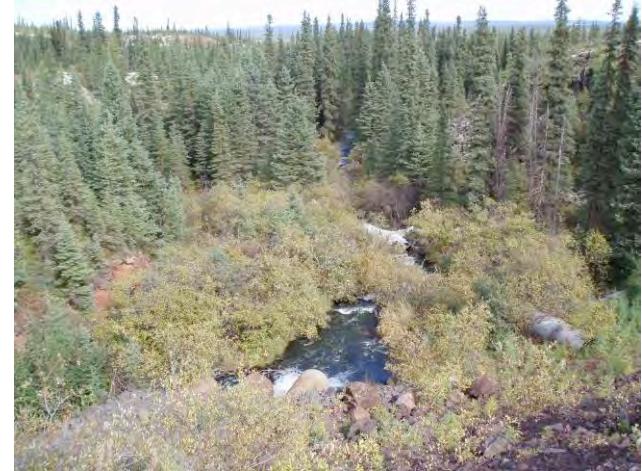
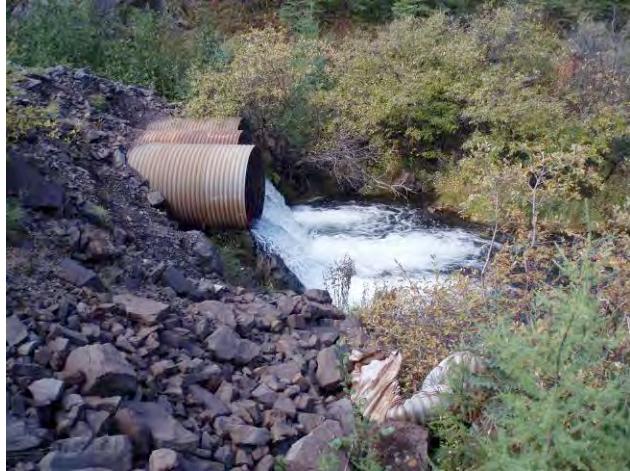
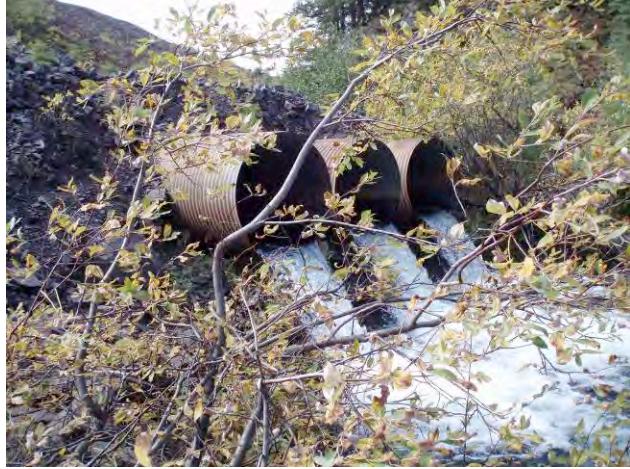
Obstacles were observed at seven sampling points. The culverts at stations AR-1 and AR-2 create significant waterfalls, which are impassable to fish. Natural obstacles created by a cascade downstream from the culvert at AR-1 Upstream-2 and a waterfall created by the culvert at station AR-1 Upstream-3 limit fish movement. There is a partial obstruction at the culvert inlets at stations 27 and 27A that limits fish passage part of the year.

AR-1 (view looking upstream)

AR-1 (view looking downstream)

AR-1 (view from downstream)

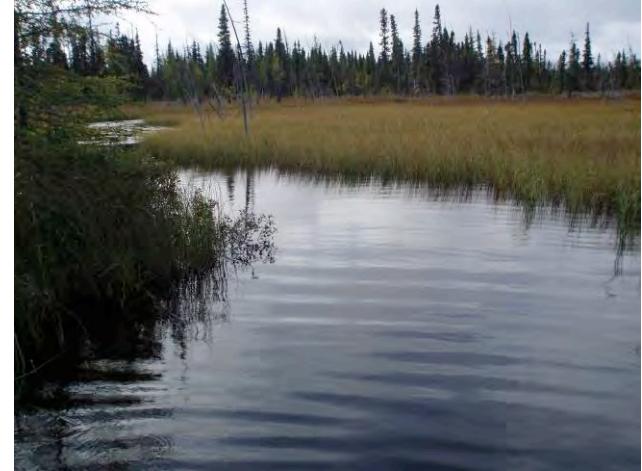
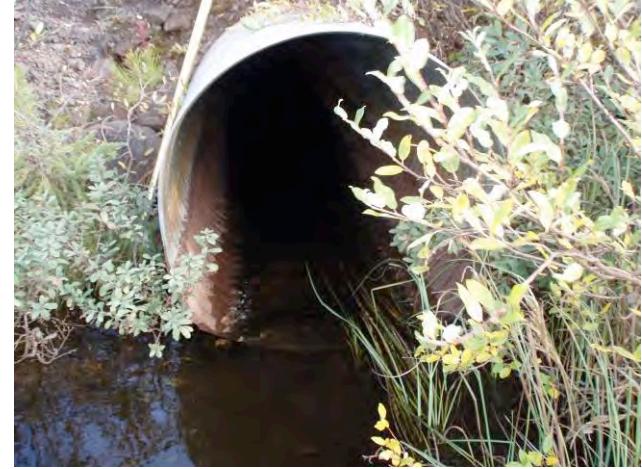
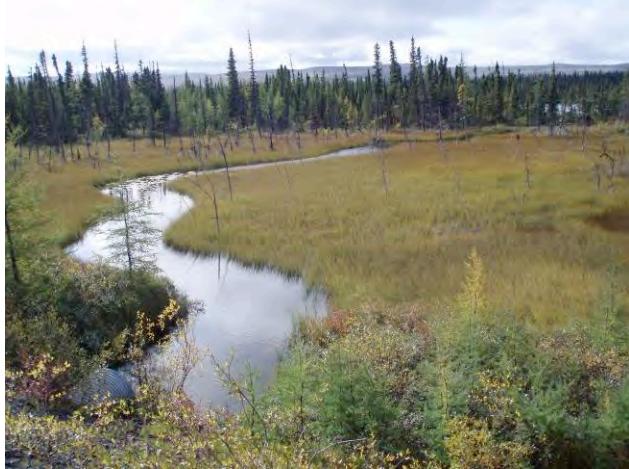
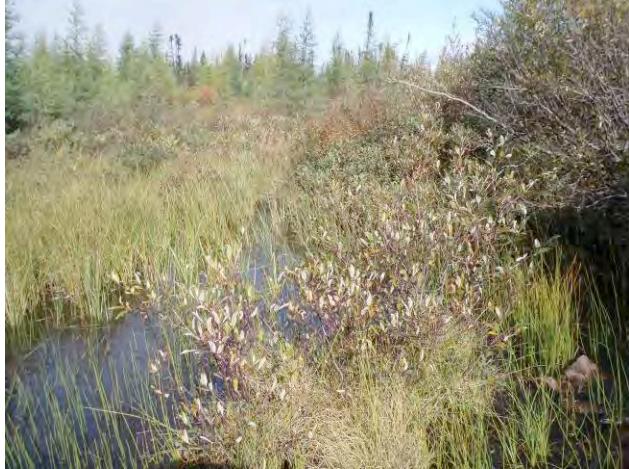
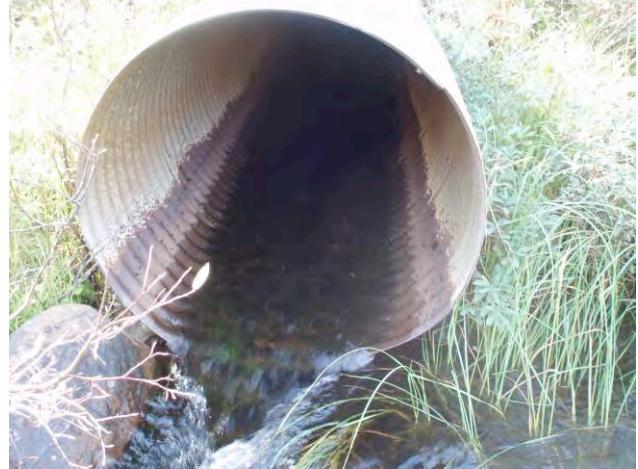
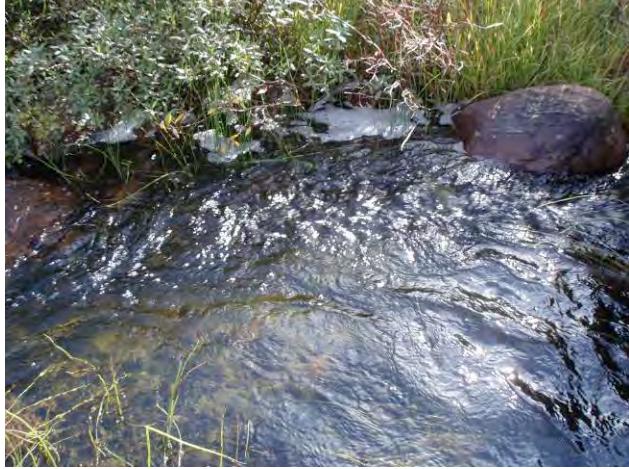
and pebbles) 10%. At this station, the slope of the segment is 2%. The physical and chemical values of the stream are as follows: temperature of 6.4°C, pH of 6.5, conductivity of 8 µmhos/cm and turbidity of 1.00 NTU (photos AR-2: 47-52). The study of the vegetation shows that this segment is characterized by a swamp and that submerged plants occupy an area varying from 10 to 30%. Fish were observed downstream from this segment; consequently, it should be considered a confirmed fish habitat.

AR-2 (view looking upstream)

AR-2 (upstream)

AR-2 (view looking downstream)

AR-2 (view from downstream)

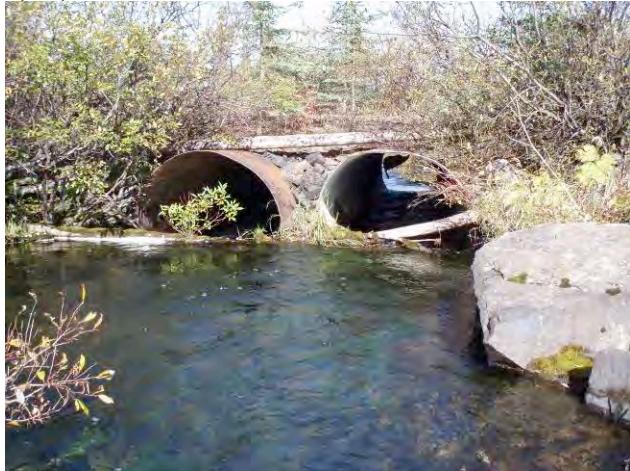
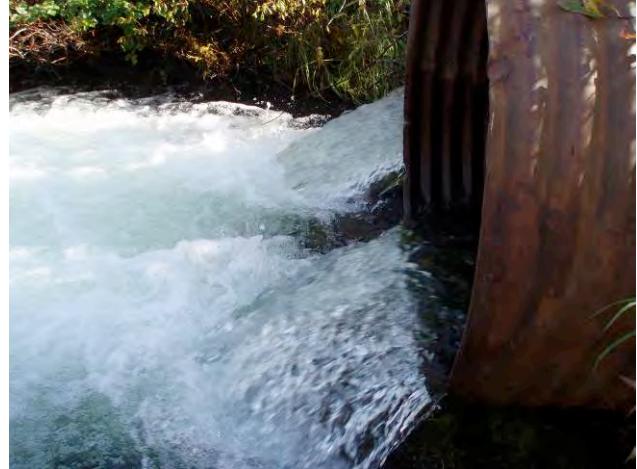
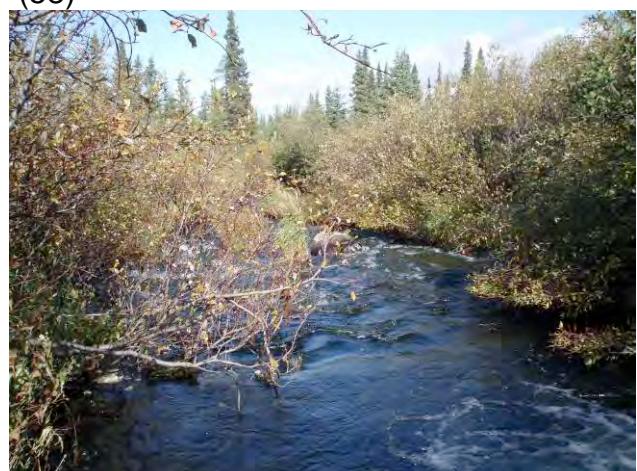
The characterization of this station was carried out in a step-pool section. A waterfall  $0.30 \text{ m}$  high caused by the culverts represents an obstacle for fish (photos AR1 Upstream-3: 56-58). This point is located 200 m upstream from the main access road.

AR-1 Upstream-3 (view looking upstream)

AR-1 Upstream-3 (view looking downstream)
