Coastal Monitoring in Newfoundland and Labrador

Coastal Monitoring Program

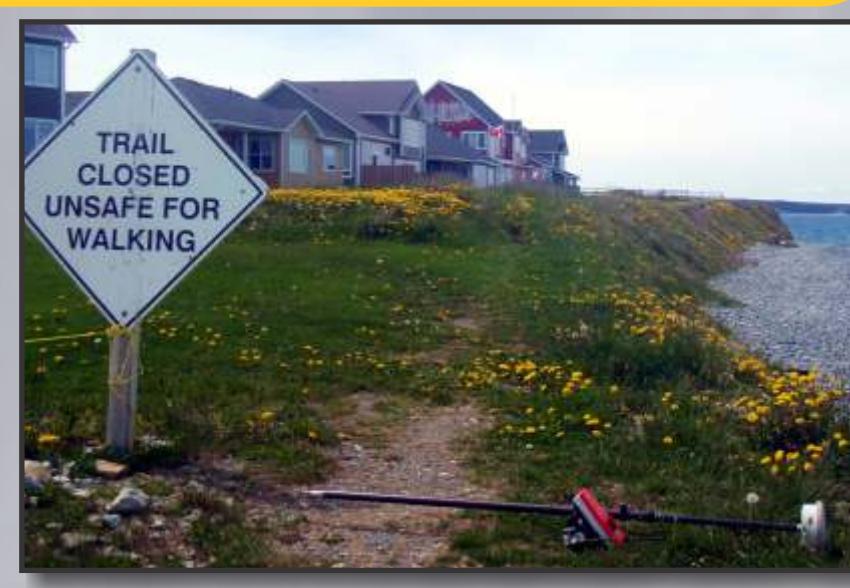
Coastal erosion is occurring in CBS, resulting in the closure of this trail.

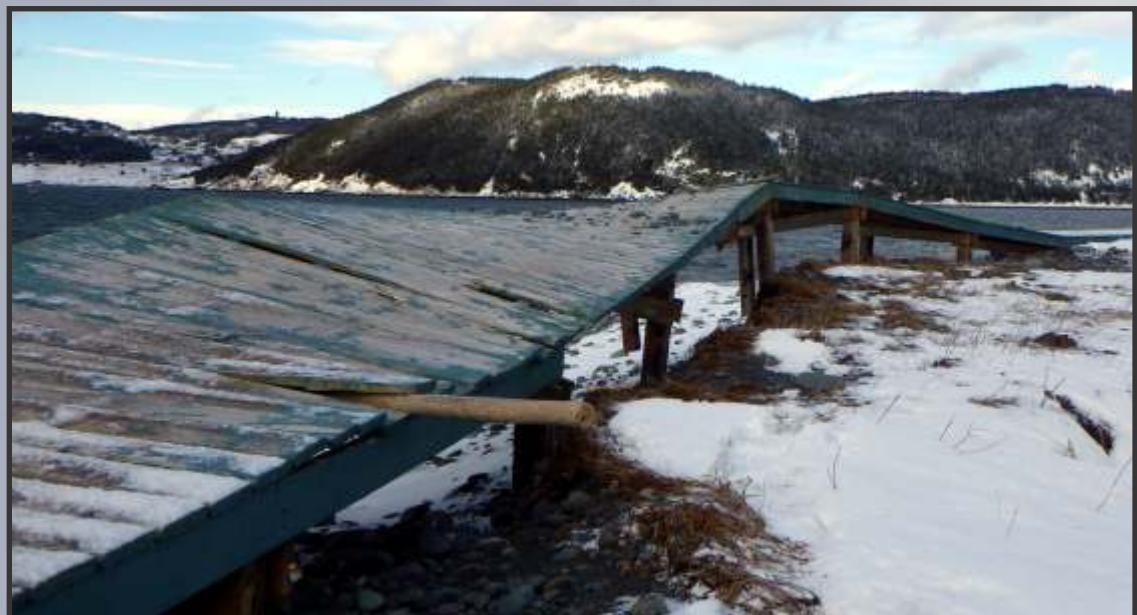
The beach at Placentia, on the Avalon Peninsula, is a pebble-cobble beach ridge, forming an arc 1.2 km long, and the area can be affected by southwesterly storms. In the fall of 2013 a storm surge occurred close to a high tide. The storm surge resulted in extensive damage to the board walk which ran along the beach, causing significant sediment to be moved, and for the back of the beach to migrate landwards, potentially up to 1.6m.

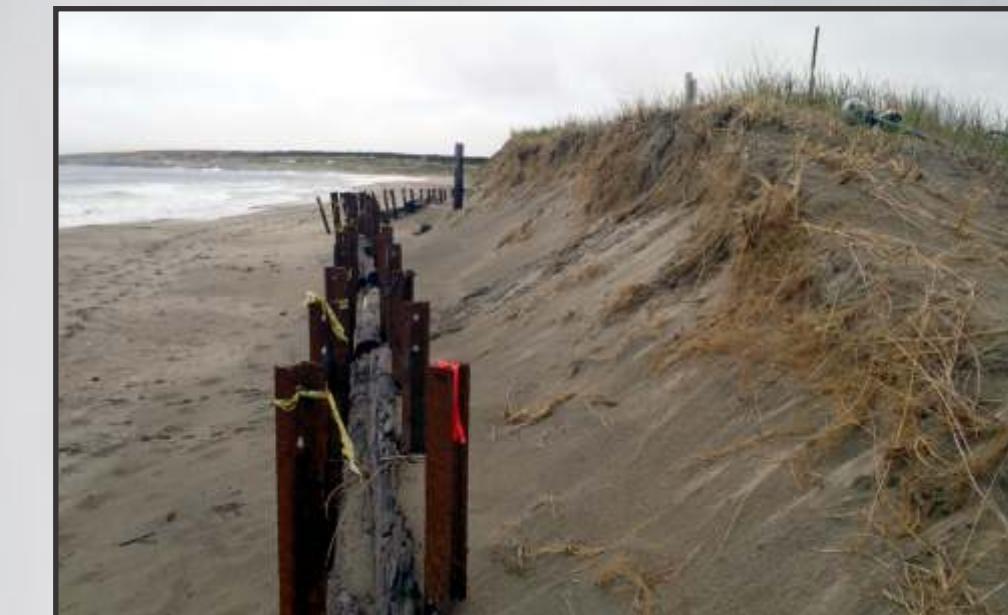
The sandy coastline at JT Cheeseman Provincial Park in southwestern Newfoundland is experiencing rapid erosion. Between 2013 and 2014, a section of the foredune eroded at an average rate of **9.22 metres** a year, exposing an old railway bed.

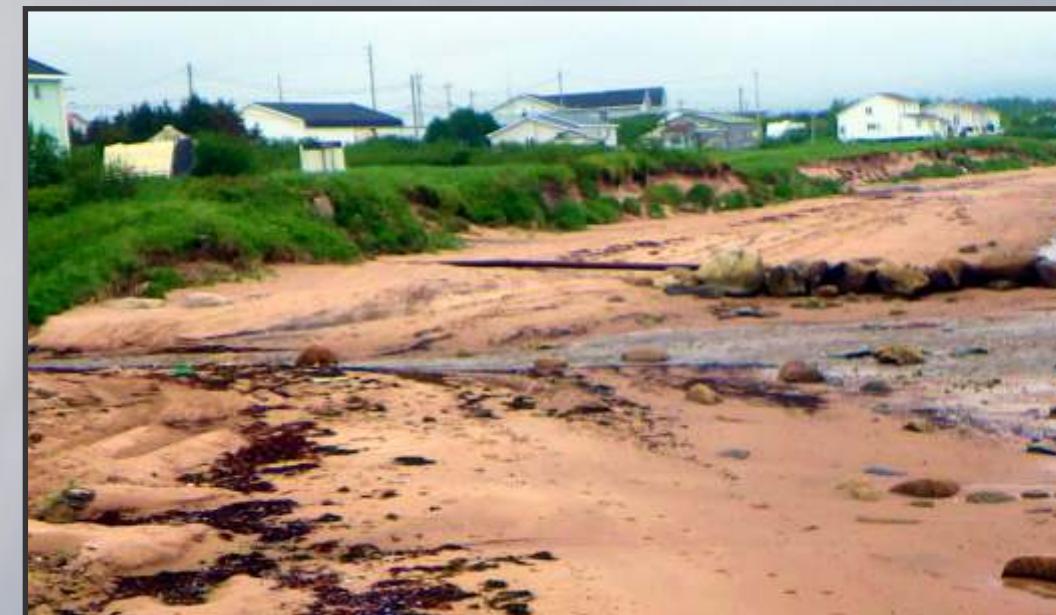
The Forteau monitoring site, in southern Labrador, is a sandy beach. Since 2012, portions of the sandy banks are experiencing erosion at an average rate of **57 cm/a**, with erosion rates of up to **119 cm/a**. Erosion is visible, as suggested by the overhanging turf mats and slumps.

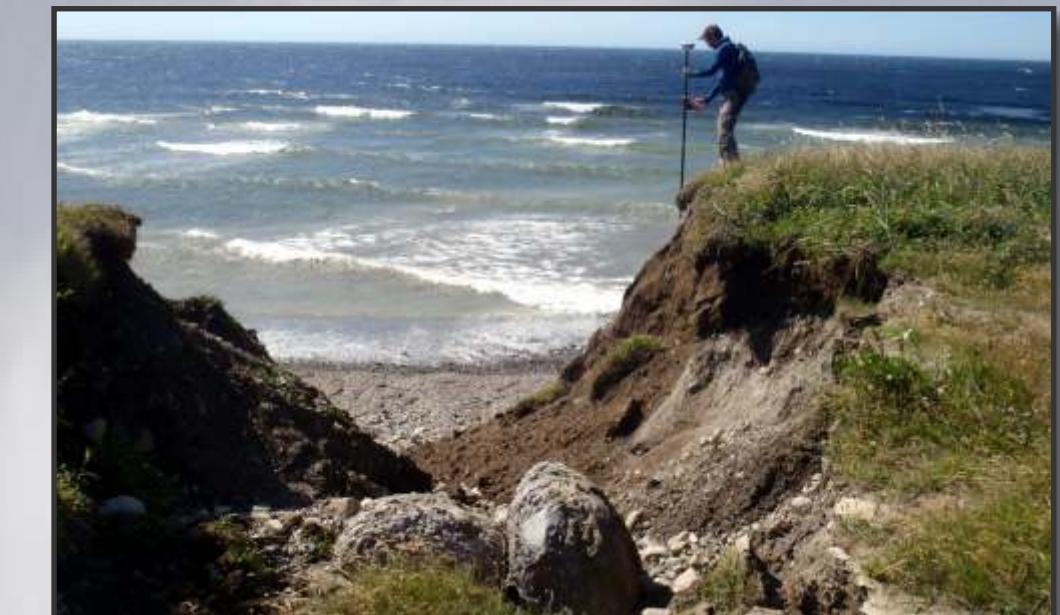
The unconsolidated bluffs at Parsons Pond, on the west coast of Newfoundland, are eroding, likely from surface and ground water creating gullies in the permeable sandy-silty cliffs. Between 2013 and 2014, the bluff experienced erosion at an average rate of **70 cm/a**, with a maximum rate of over **3 m/a**.

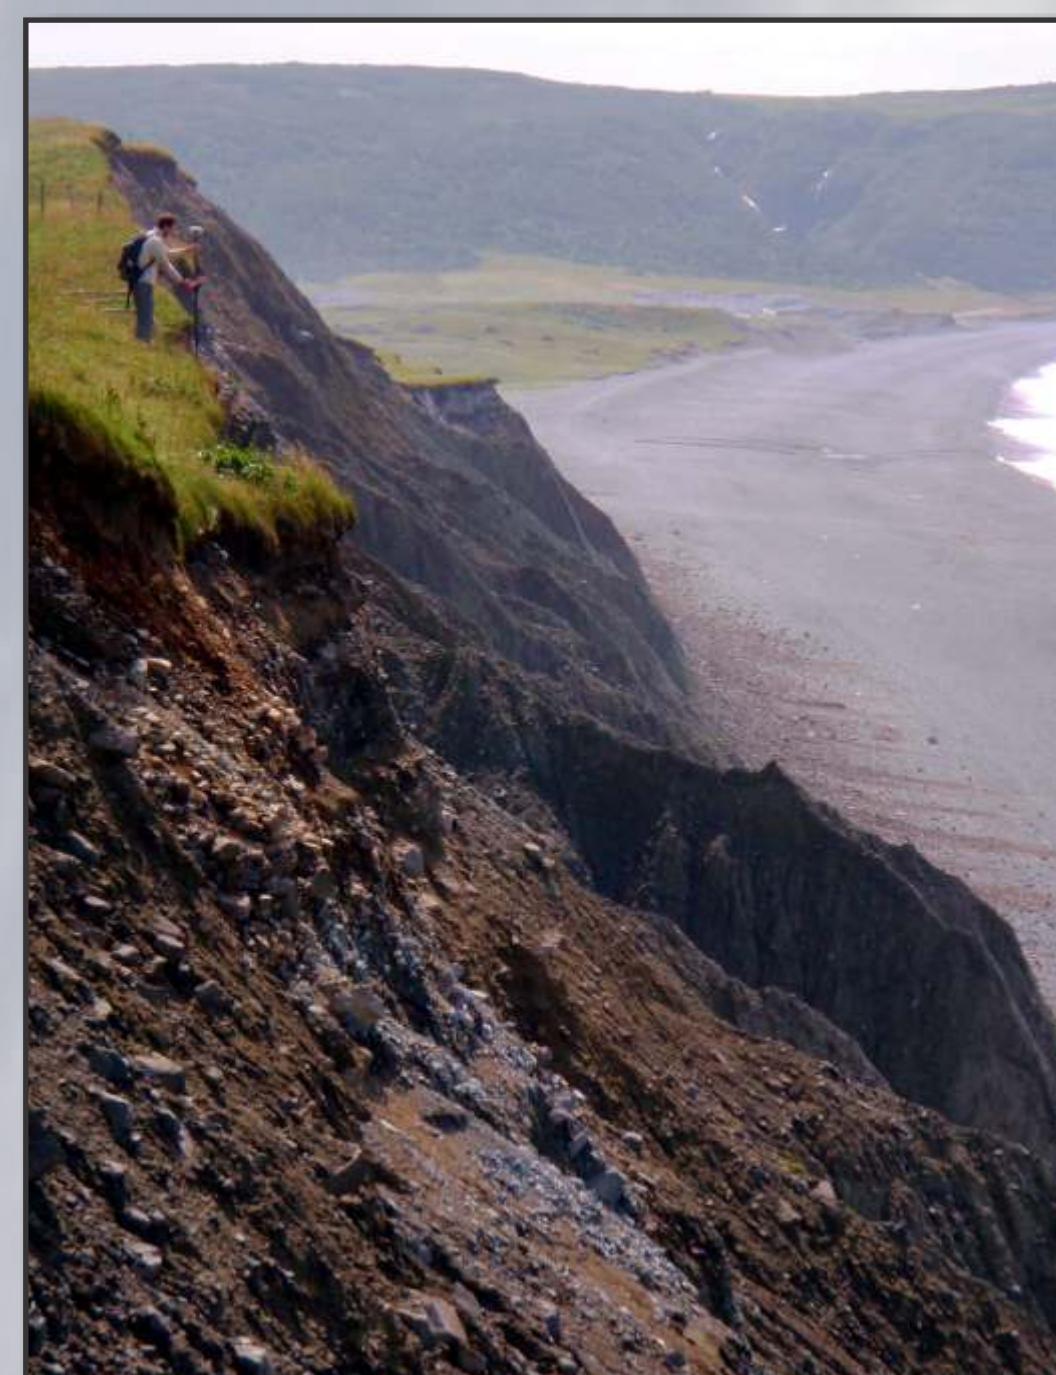
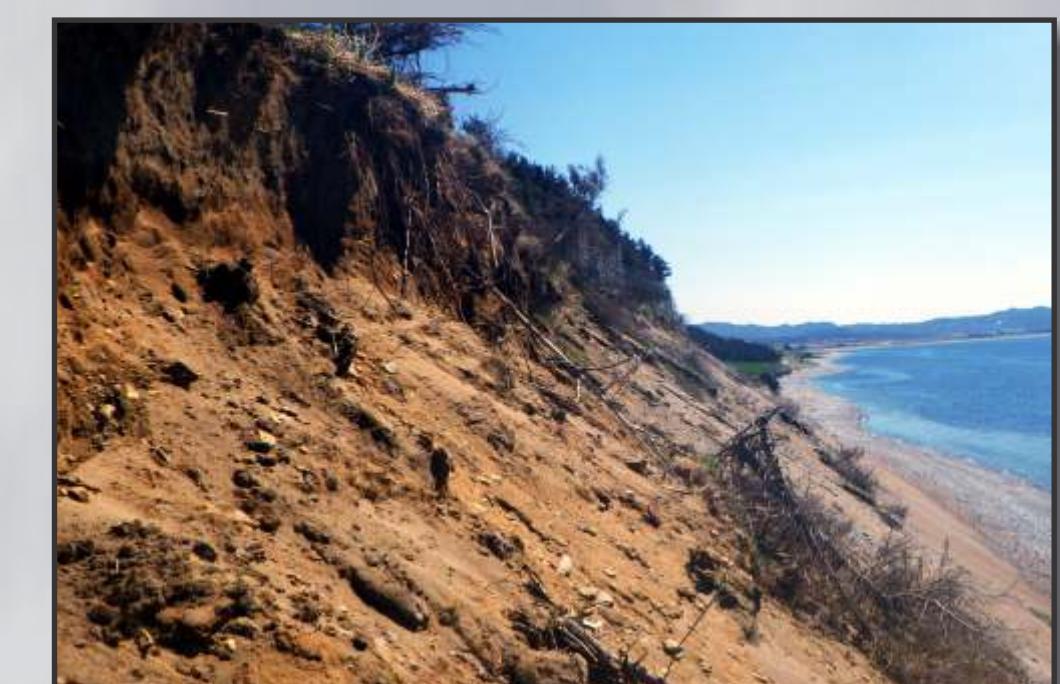
The bluffs near Bayview Heights Road in Kippens, western Newfoundland, are unconsolidated and composed of sand, gravel and silty-clay. The cliffs are 19-25 m above sea level and partly vegetated with grass. Between 1993 and 2013, the cliff top experienced erosion at an average of **9 cm/a**, with rates up to **21 cm/a**.

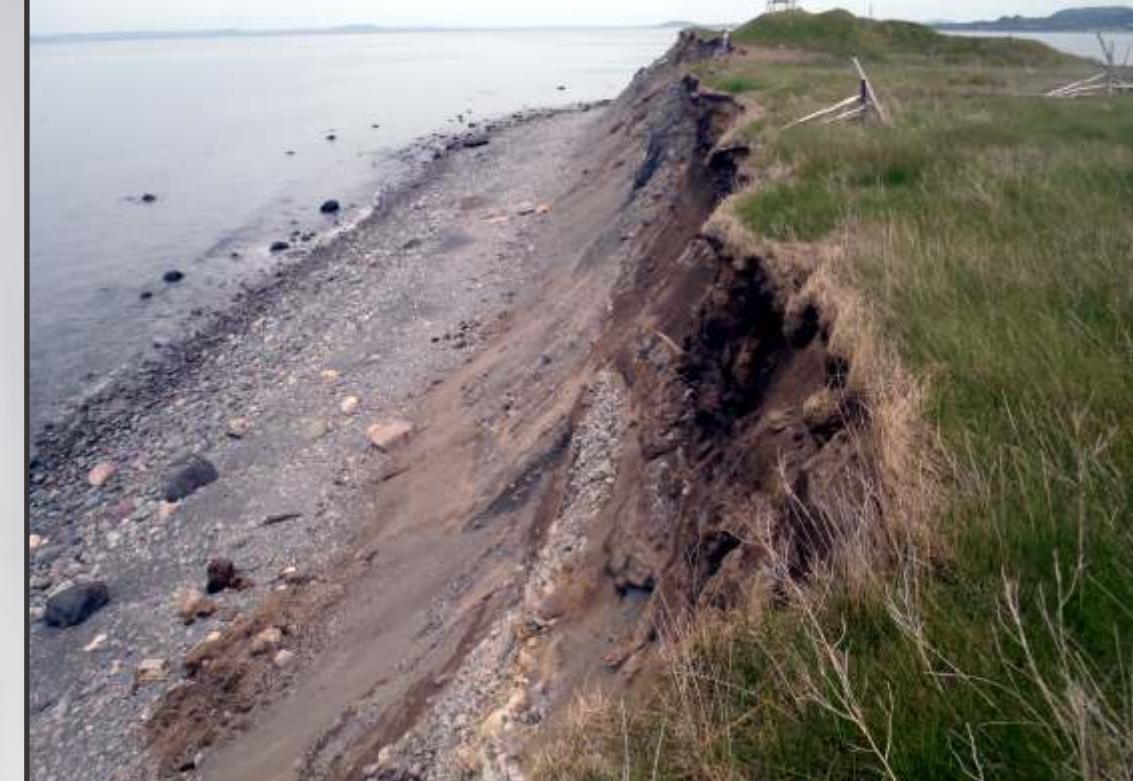
Point Verde in Placentia Bay is a gravel and sand peninsula with a 15 to 20 m high cliff, fronted by a 20 to 30 m wide beach consisting of rounded boulders, cobbles and pebbles. Erosion is visible on the cliff, as seen by the overhanging grass at the top of the cliff, and gullies on the cliff face. Between 1993 and 2014, the entire peninsula eroded at an average rate of **44.42 cm/a**, ranging from **66 cm/a** to **16 cm/a**.
