**MEMORANDUM OF AGREEMENT
FOR
WATER QUANTITY SURVEYS**

**REPORT FOR FISCAL YEAR
2023-2024**

ATLANTIC REGION INFRASTRUCTURE REPORT 2023-24

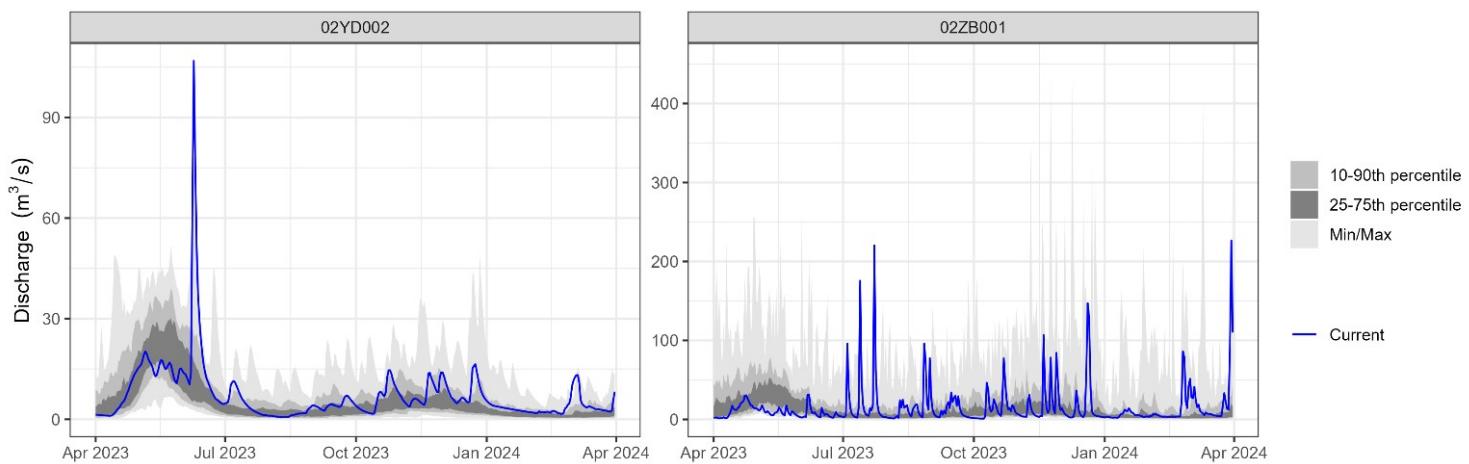
Figure 2.1

- Flow Station 02YD002, Northeast River at Roddickton: Above average wet conditions early summer reflected at a gauge on the Great Northern Peninsula, illustrating the resulting high-flow event
- Flow Station 02ZB001, Isle Aux Morts River Below Highway Bridge: Conditions in southwest Newfoundland, with high flow events in early summer, as well as mid-winter melt in December 2023.

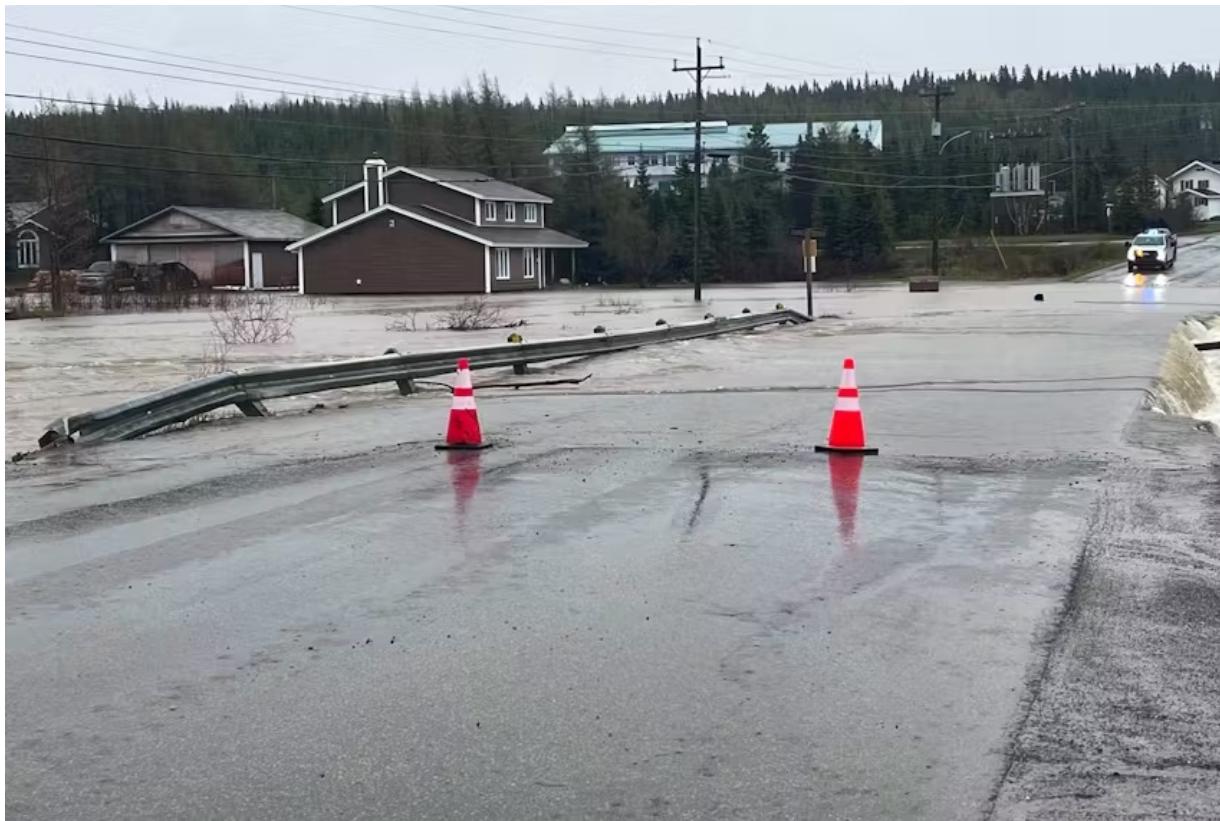
Figure 2.2 Road washout on the Northern Peninsula – Roddickton on June 10th, 2023.
(Photo Credit: Government of Newfoundland and Labrador Staff)

Newfoundland and Labrador followed a similar hydrologic pattern seen across the Atlantic Provinces. This consisted of a very dry spring followed by well above average wet conditions in June, which resulted in one significant high-flow event (see Figures 2.1 and 2.2). A wet fall also contributed to a significant high-flow event on December 22, 2023, that affected Central Newfoundland (see Figures 2.3 and 2.4).

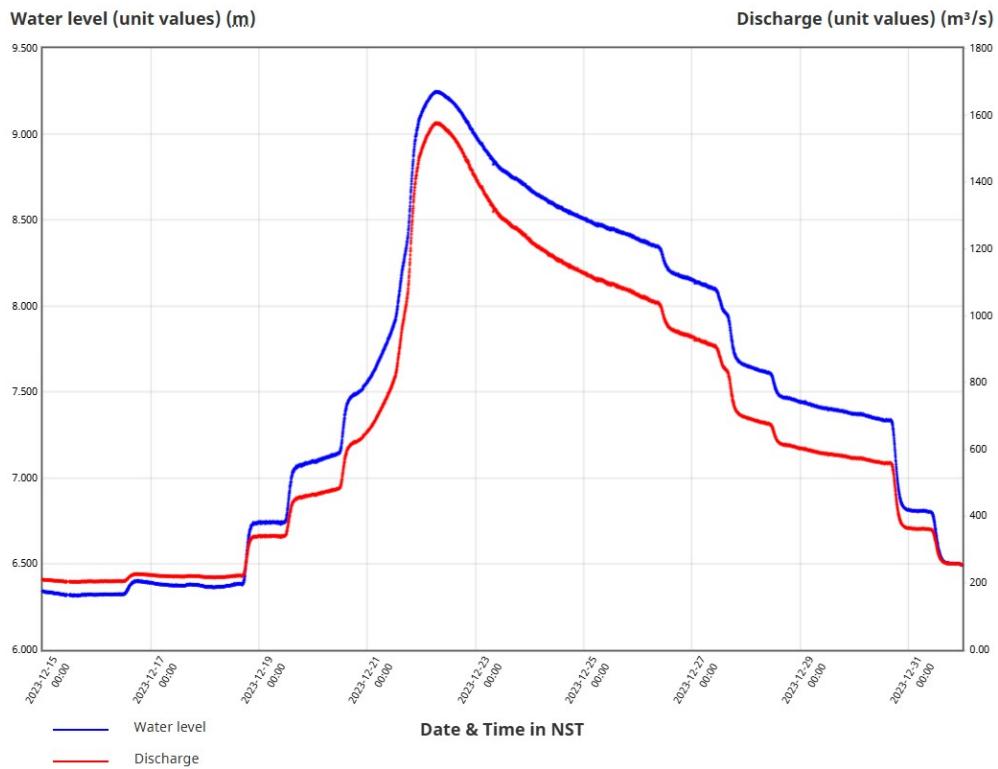
Figure 2.3 - Flow Station 02YO011 Exploits River Below Noel Paul's Brook: High-flow event from December 2023.

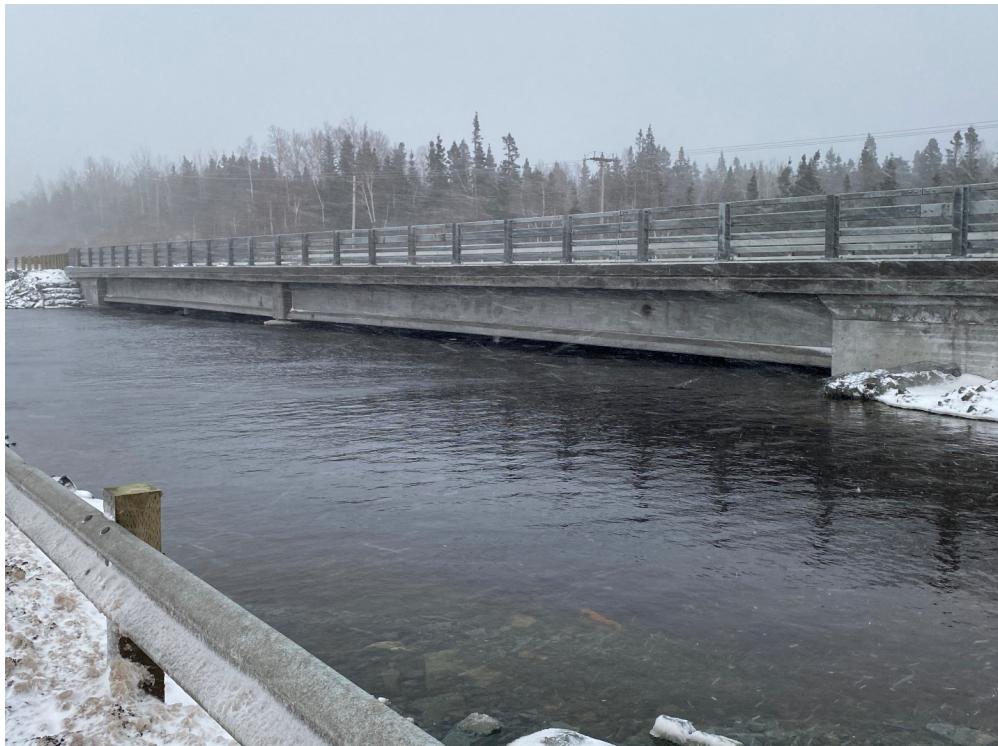
Figure 2.4 - Rushy Pond Brook Bridge in the Exploits River watershed, at capacity on Dec 22, 2023. Photo Credit : Government of Newfoundland and Labrador Staff

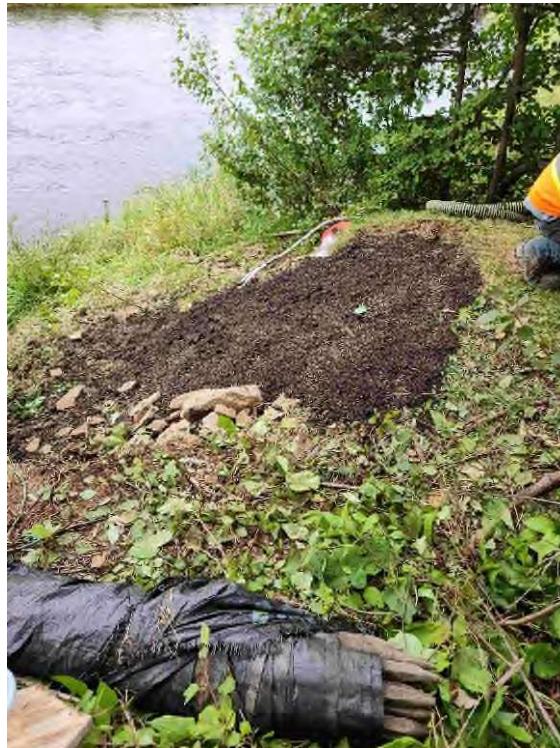
Figure 1. Topsoil overlaid on the decommissioned well at 01BU002 Petitcodiac River near Petitcodiac (photograph taken on September 9th, 2023).

The well was decommissioned in accordance with the New Brunswick Department of Environment and Local Government (NBDELG) Guidelines for Decommissioning (Abandonment) of Water Wells. A Contractor was hired for decommissioning due to their ability to handle

contaminated water and materials independently. The well decommission took place on September 6th, 2023 (Figure 1).

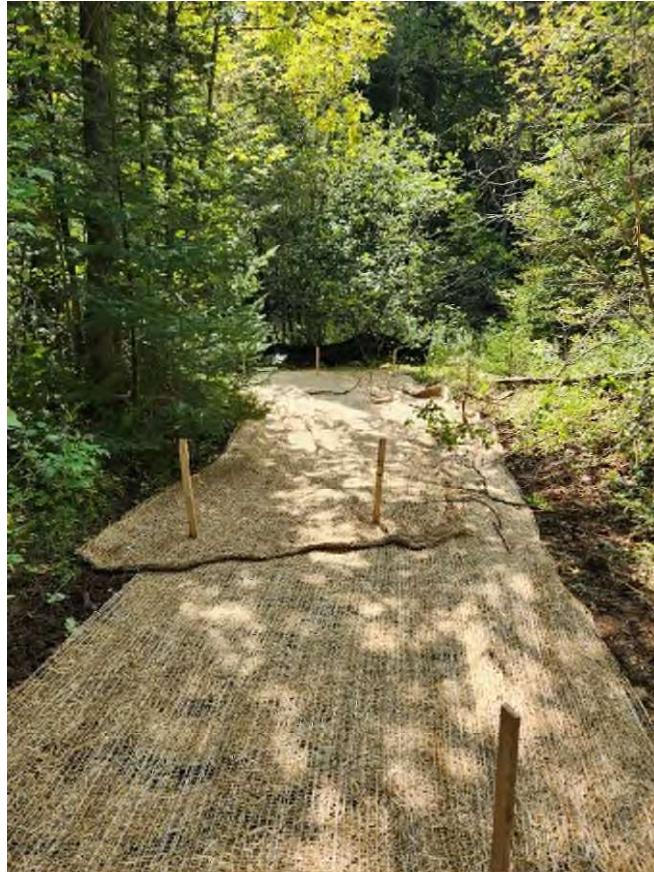
Figure 2. Restoration of the site at 01AP009 Parlee Brook below Arnolds Bridge (photograph taken on September 26th, 2023)

This stilling well had been abandoned since 1992, and therefore decommissioning was a priority. The site was located on private property owned by Randy Donald Arsenault. As a result, the well was decommissioned in accordance with the New Brunswick Department of Environment and Local Government (NBDELG) Guidelines for Decommissioning (Abandonment) of Water Wells. The site was contaminated with lead paint with concentrations of 9,250 mg/kg, and a leachable lead concentration of 0.68 mg/L. These levels required the lead containing paint be disposed of at a sanitary landfill disposal site approved by the NBDELG.

Decommissioning had a deadline of September 30th, 2023, due to strict timeframes on permits administered by the NBDELG. The decommissioning was performed by a local Contractor bundled with the Petitcodiac well for cost saving efficiencies. The well was decommissioned on September 25th, 2023. Photographs of the decommissioning are included in Figures 2 – 5.

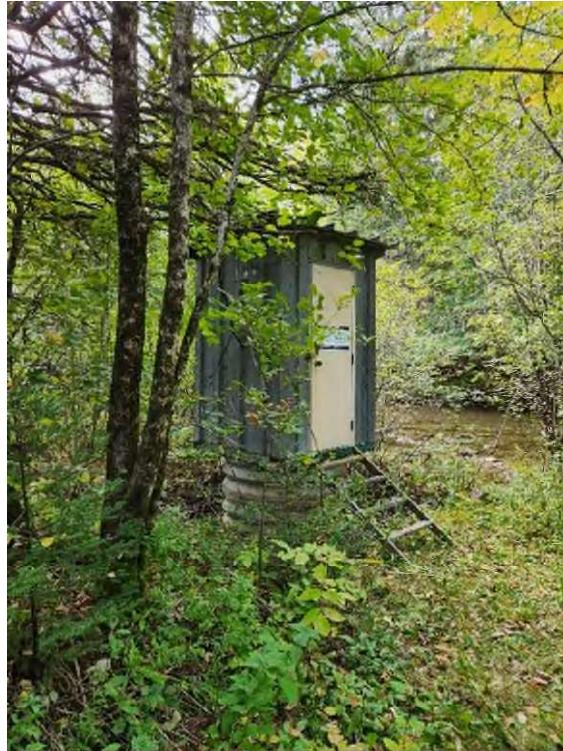
Figure 3. The unused shelter located at 01AP009 Parlee Brook Below Arnolds Bridge (photograph taken on September 25th, 2023).

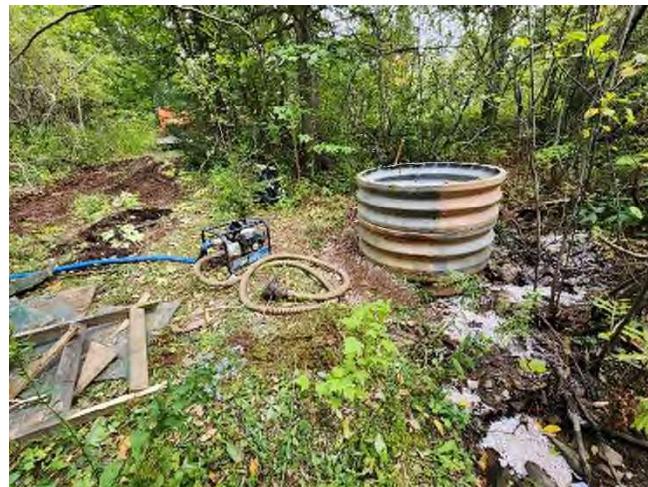
Figure 4. The deconstruction of the shelter located at 01AP009 Parlee Brook Below Arnolds Bridge (photograph taken on September 25th, 2023).

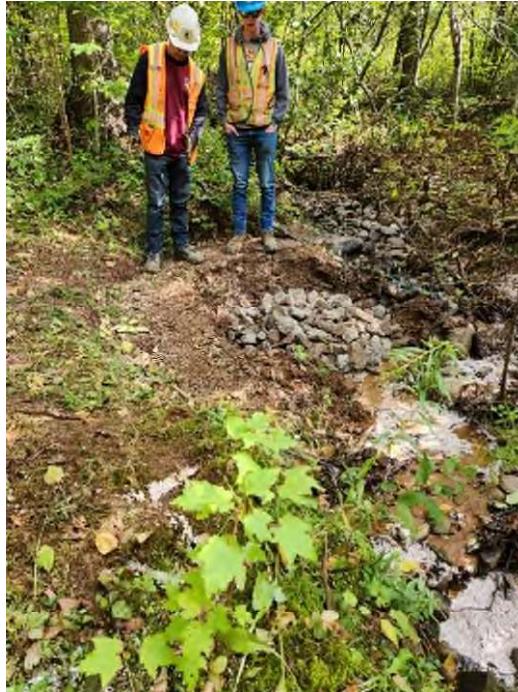
Figure 5. The result of the decommissioning at 01AP009 Parlee Brook Below Arnolds Bridge (photograph taken on September 26th, 2023).

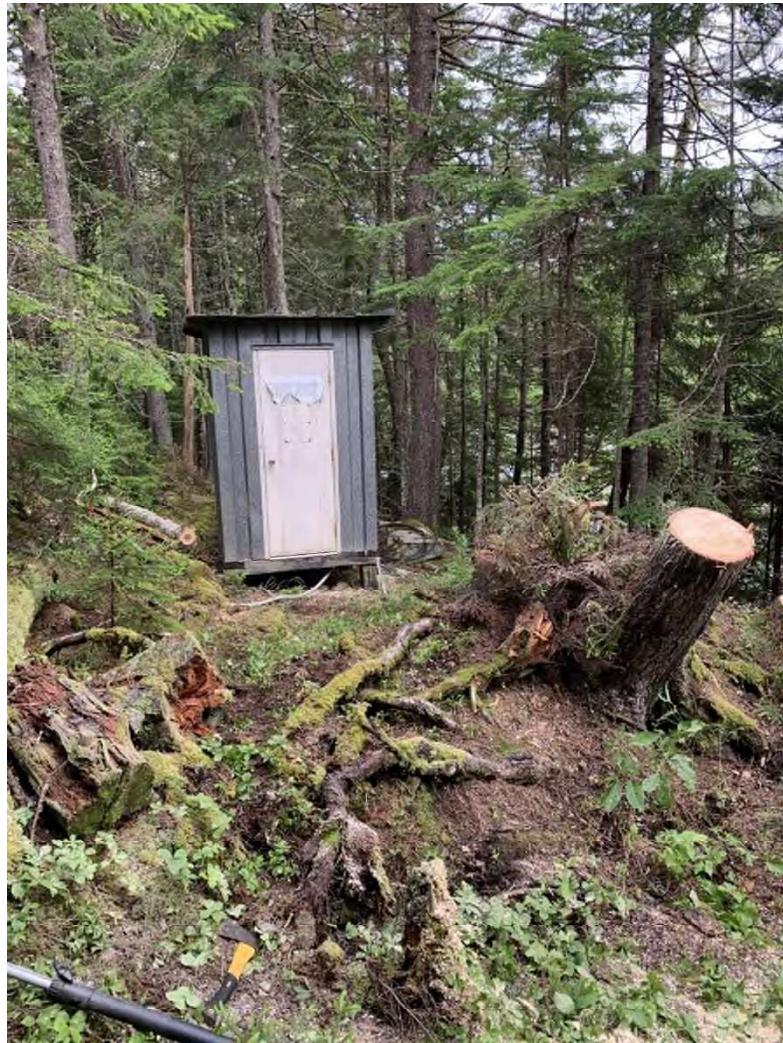
Figure 6. View of wooden walk-in shelter at 01BV006 Point Wolfe at Fundy National Park (Photograph taken in June 2023).

This site consists of an inactive corrugated steel stilling well, a small walk-in shelter and a cableway which have reached the end of their design lives and require decommissioning and replacement (Figures 6 & 7). The cableway, which had an affixed solar panel, required emergency decommissioning due to a fallen tree (Figure 8). The tree was removed by the Fundy National Park of Canada in June 2023 (Figure 9). The station's life cycle maintenance is planned for the 2025-26 fiscal year. Through Public Services and Procurement Canada (PSPC), environmental consultants were hired to complete an environmental site assessment (ESA) report in fiscal year 2021/22 which confirmed soil samples exceeding CCME criteria for lead (Pb), mercury (Hg), and polycyclic aromatic hydrocarbons (PAHs), as well as petroleum hydrocarbons (PHCs) in the stilling well exceeded applicable regulatory criteria. Further investigation is required prior to remediation and decommissioning. A Project Description has been submitted to Parks Canada including the soil and water contamination impacts which is in the reviewing process.

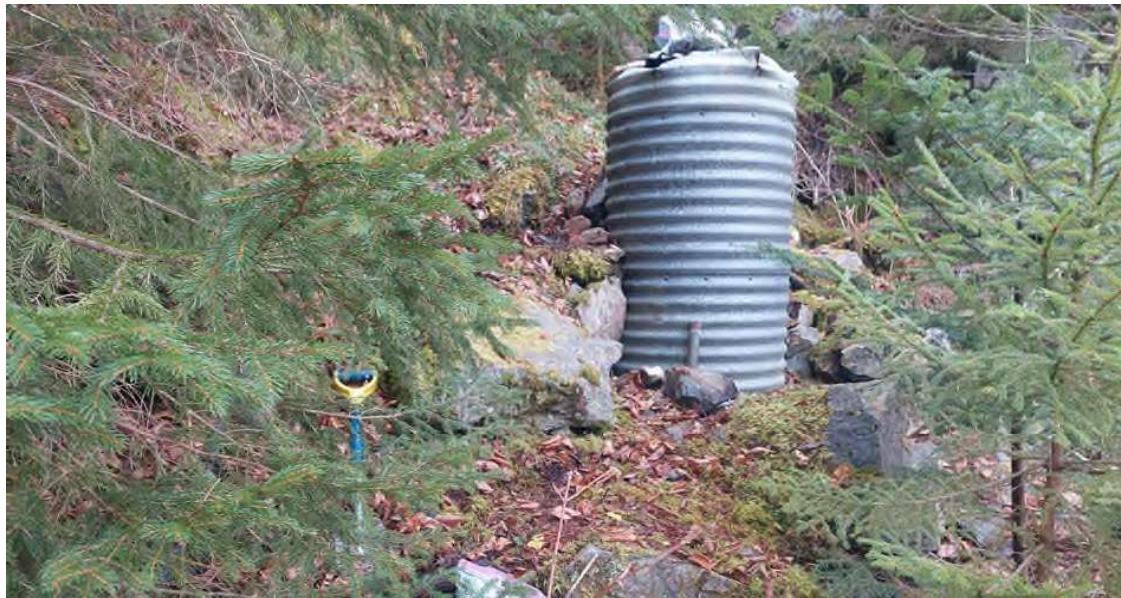
Figure 7. Stilling well and surrounding groundcover at 01BV006 Point Wolfe at Fundy National Park (Photograph taken mid November 2021).

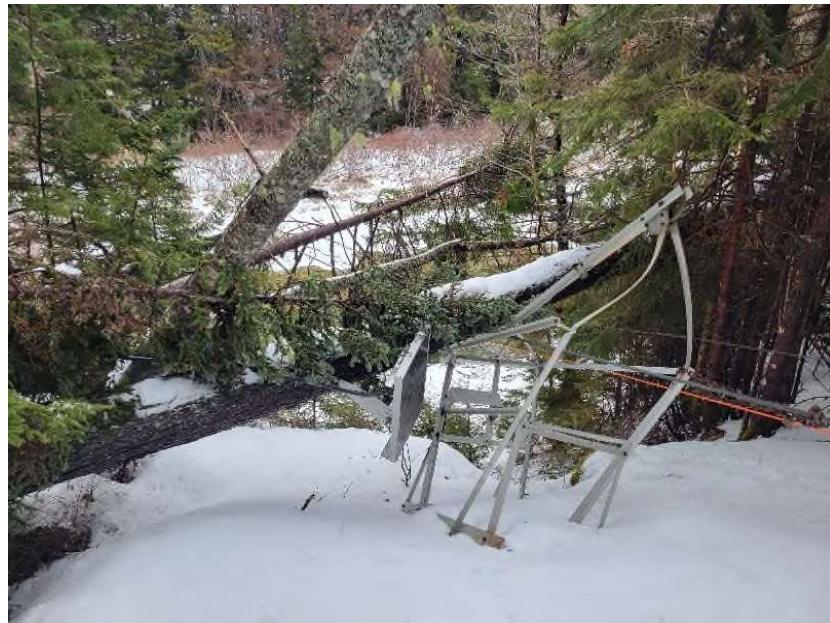
Figure 8. View of cableway with fallen tree overtop at 01BV006 Point Wolfe at Fundy National Park (Photograph taken in March 2023).

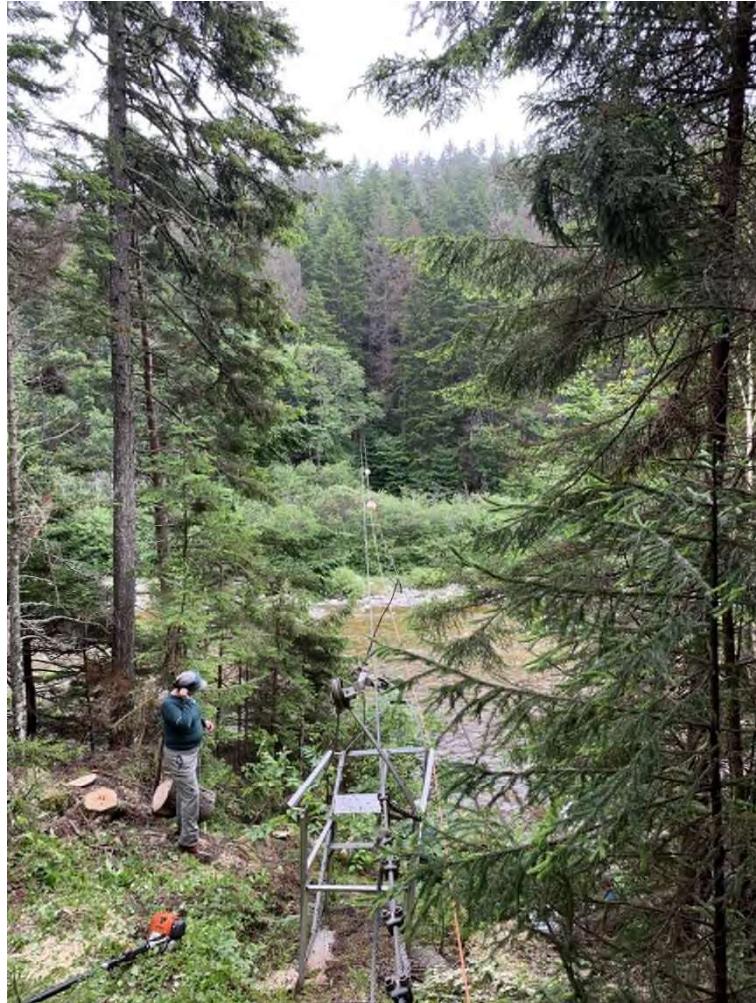
*Figure 9. View of cableway post tree removal at 01BV006 Point Wolfe at Fundy National Park
(Photograph taken in June 2023)*

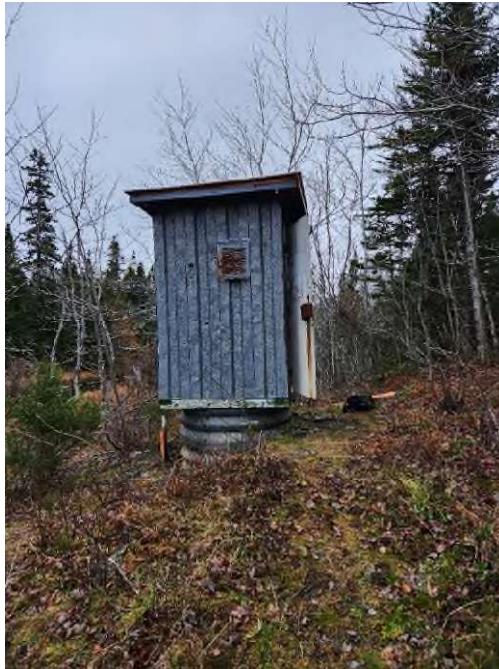
Figure 10. Old station that was decommissioned at 01FJ002 MacAskill's Brook Near Birch Grove (photograph was taken on November 20th, 2023).

This station had an inactive stilling well in poor condition in need of lifecycle replacement. PSPC was used to retain the services of an environmental consultant to conduct the ESA work. The ESA report was completed on March 27, 2023. The results of the report indicated that the site was not contaminated; however, the well water required special handling and disposal at the time of decommissioning. On October 21st, 2023, a Contractor decommissioned the existing shelter shelter, filled the inactive stilling well, restored the site, and installed a concrete pad for the new

station. The old shelter is shown in Figure 10. The new station was installed in December of 2023; it is shown in Figure 11.

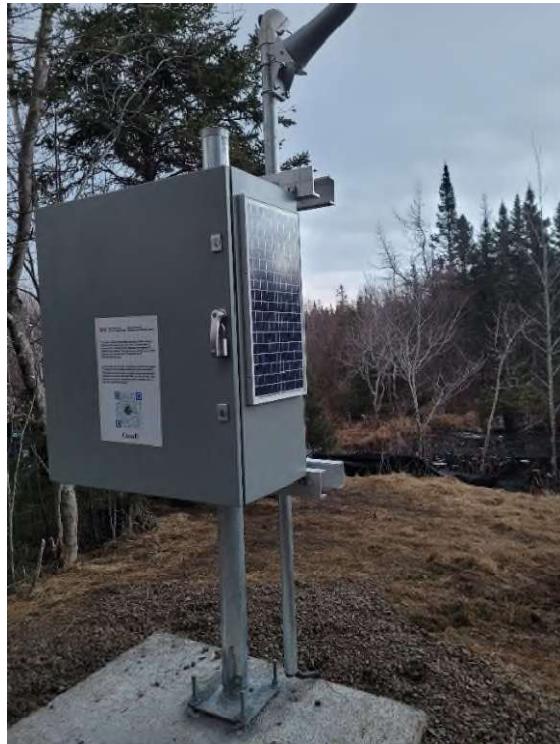
Figure 11. New shelter installed at 01FJ002 MacAskill's Brook Near Birch Grove (photograph was taken on December 13th, 2023).

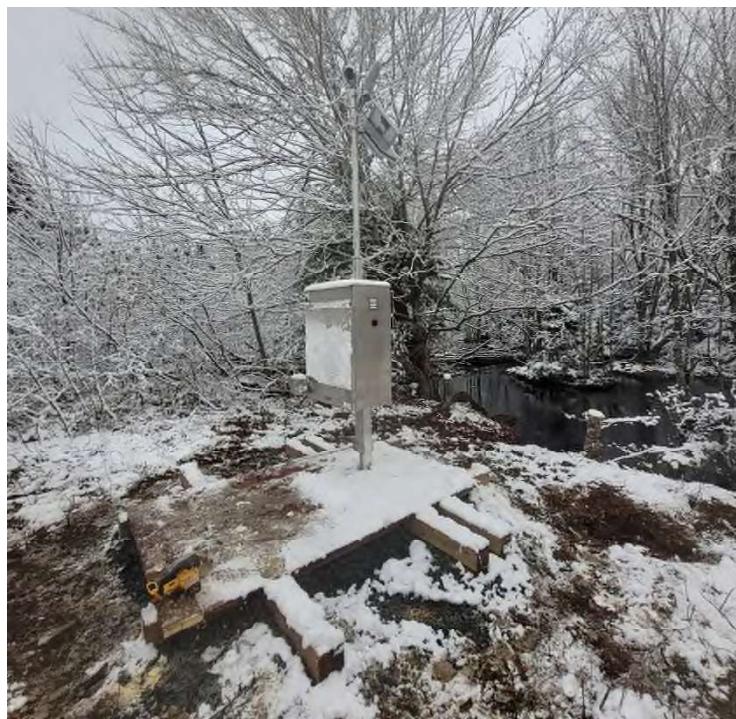
Figure 12. New station installed at Tomahawk Lake outlet (photograph was taken on November 1st, 2023).

Tomahawk Lake was one of the sites of interest for installation of a new hydrometric station by Halifax Water. It was constructed on property owned by Halifax Water and required no additional land leases or permissions. A tilting mast for a look-in equipment box was installed on site in November 2023. Initially, a concrete pad was proposed for the site, but a temporary wooden cribbing foundation was constructed instead, seen below in Figure 12, with gravel underset for drainage purposes.

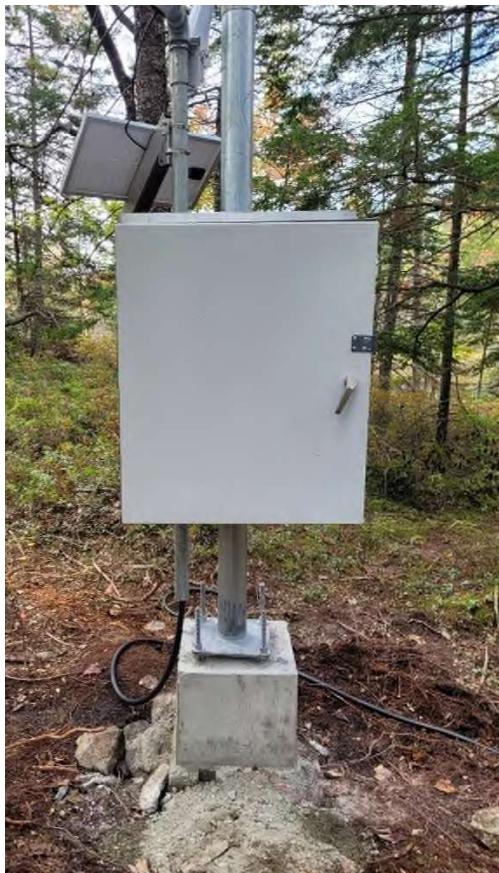
Figure 13. The new look-in style shelter installed at Bennery Lake (photograph taken on October 5th, 2023).

The Bennery Lake location was one of the sites requested by Halifax Water. Site reconnaissance was conducted on February 2nd and August 22nd of 2023. It was constructed on Crown Lands with permission granted via Letter of Authority issued by the Nova Scotia Department of Natural Resources and Renewables on September 5th, 2023. A look-in shelter mounted on a galvanized pipe anchored into bedrock was installed in October 2023, shown below in Figure 13.

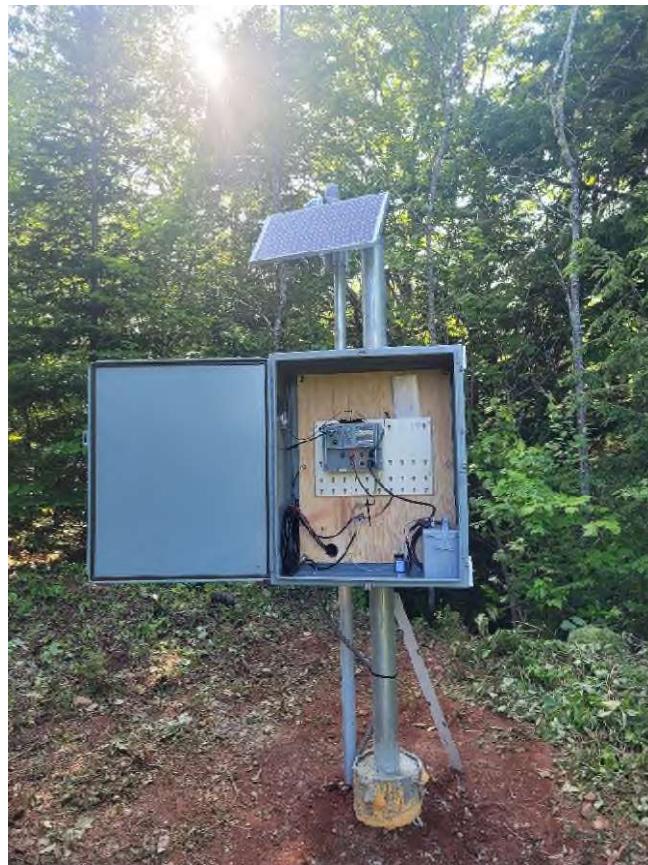
Figure 14. New look-in shelter installed at 01CA003 Carruthers Brook Near Saint Anthony (photograph taken on July 12th, 2023).

Environmental site assessment and remediation were conducted at this site to prepare for the decommissioning of an inactive stilling well, and the construction of a new gauge on site. The decommissioning of the stilling well was completed on January 23rd and 24th, 2024 and a new look-in style gauge was installed on a galvanized steel pipe inset in a sonotube in July of 2023, as seen in Figure 14 below.

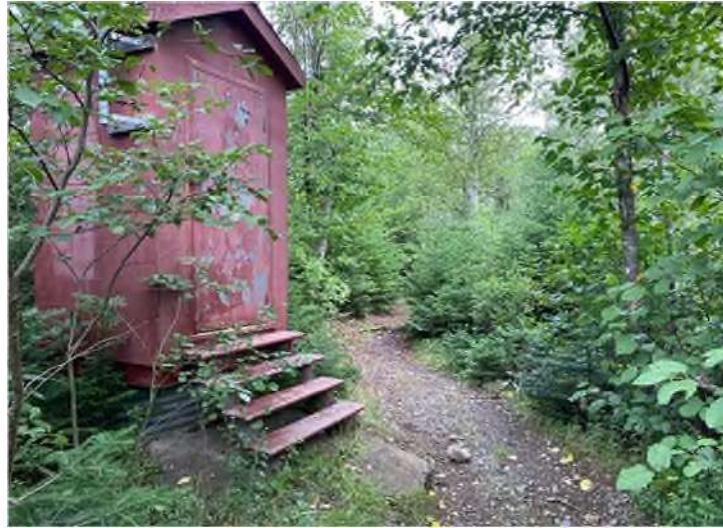
Figure 15. View of former wooden walk-in shelter and stilling well at 02YR003 (Photograph taken September 16, 2022).

Phase II ESA and NCSCS scoring to assess the site which was received on March 30, 2023. The site was scored as NCSCS class 2 and was found to be eligible for FCSAP remediation funding. The report indicated that the soil around the shelter and cableway were contaminated with PAHs and PHCs were found to be present inside the stilling well which required re-sampling. The Consultant completed re-sampling of the stilling well and three monitoring wells in August 2023 which found that the groundwater in the wells was below the discharge guidelines and therefore did not require off-site disposal.

A Contractor was commissioned by PSPC under the supervision of an environmental consultant to complete the decommissioning, installation, and remediation of the station. The decommissioning work was completed between February 21st and 22nd, 2024 and consisted of the removal of the wooden shelter, cutting down and back filling the metal stilling well, and the removal of the creosote-treated timber debris which were disposed of at the Central Newfoundland Waste Management Facility. Remediation of the site was completed on February 22nd, 2024, by the Contractor under the supervision of the environmental consultant. The PAH impacted soil was excavated from the north side of the site and backfilled with clean imported silty sand material (Figures 18 & 19). The new aluminum doghouse look-in style shelter was installed on February 21st and 22nd, 2024, by the Contractor which included a new corrugated metal standpipe at the base of the former stilling well and a new doghouse style look-in shelter with metal stairs/platform (Figure 20). Following the installation, post-remedial groundwater samples of the monitoring wells were collected on March 5th, 2024, by the environmental consultant and reported PAH and PHC concentrations below the applicable guidelines. The monitoring wells were decommissioned on March 21st, 2024. Final reinstatement of the site included placement of gravel along the trailway, and topsoil and seed mix over the decommissioning/remediation areas (Figure 21). The FCSAP site closure report was received on March 31st, 2024. The report finding state that with the remedial excavation and backfilling, no additional assessment or remediation is warranted for the station.

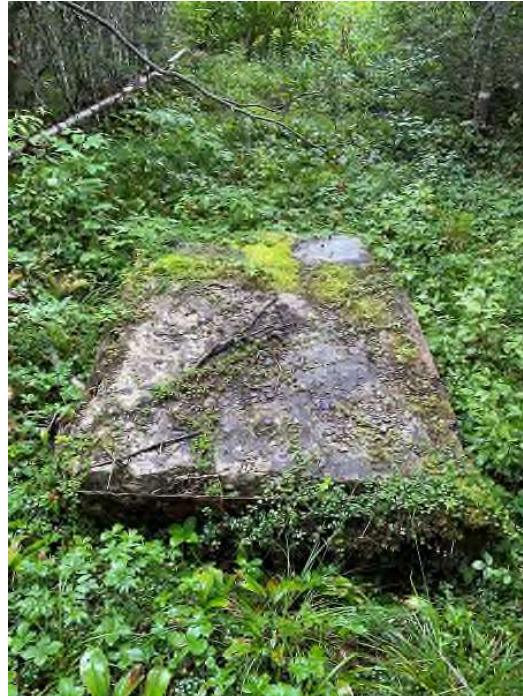
Figure 16. Concrete mass anchor from former cableway at 02YR003 (Photograph taken September 16, 2022).

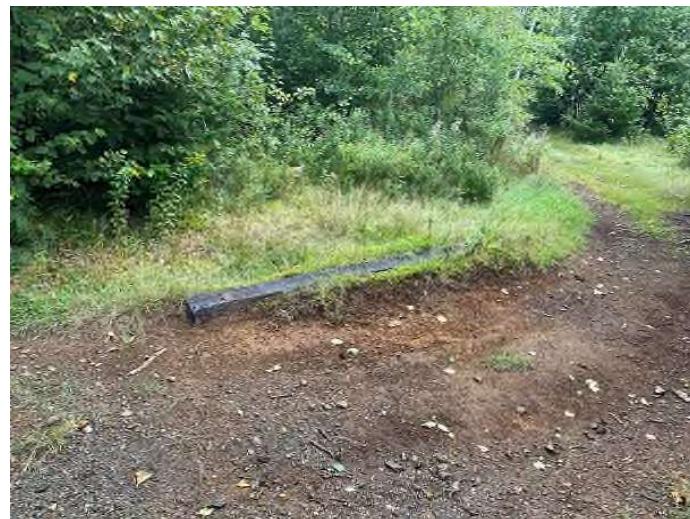
Figure 17. View of creosote timber of the former cableway at 02YR003 (Photograph taken September 16, 2022).

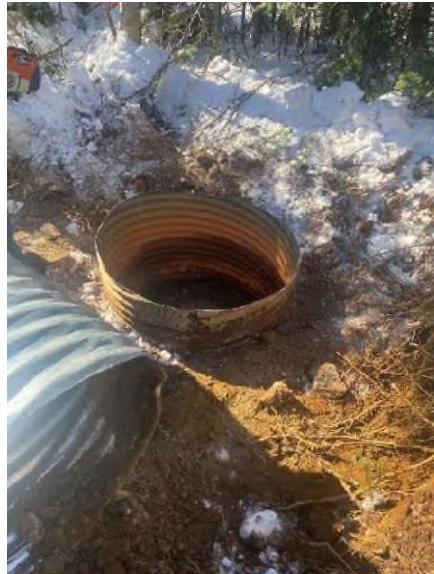
Figure 18. View of the cutdown stilling well during decommissioning at 02YR003 (Photograph taken on February 21, 2024)

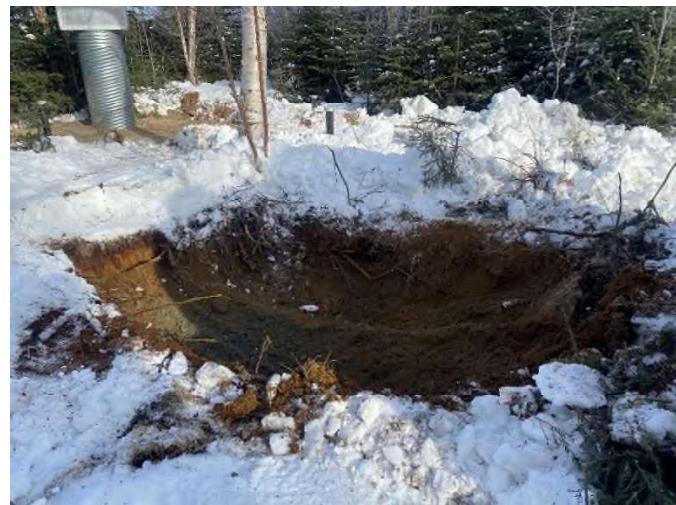
Figure 19. View following the removal of the PAH impacted soil on the northside of the site at 02YR003 (Photograph taken on February 22, 2024)

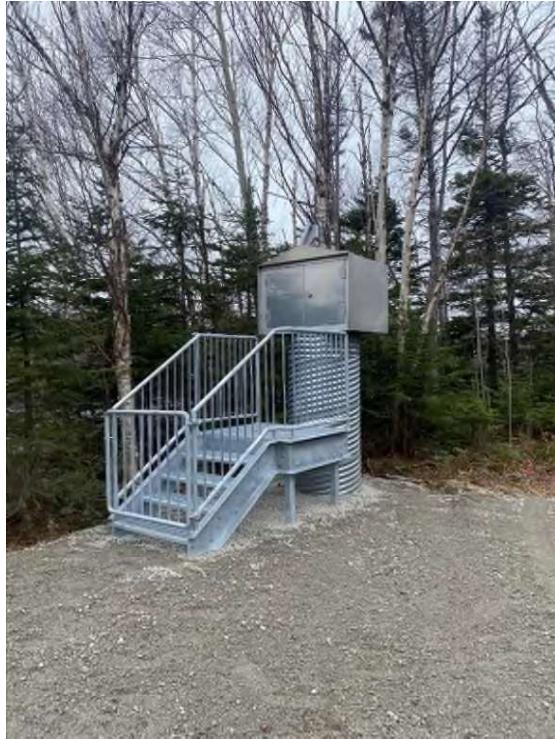
Figure 20. New corrugated metal standpipe and dog-house style look-in shelter with metal stairs/platform at 02YR003.

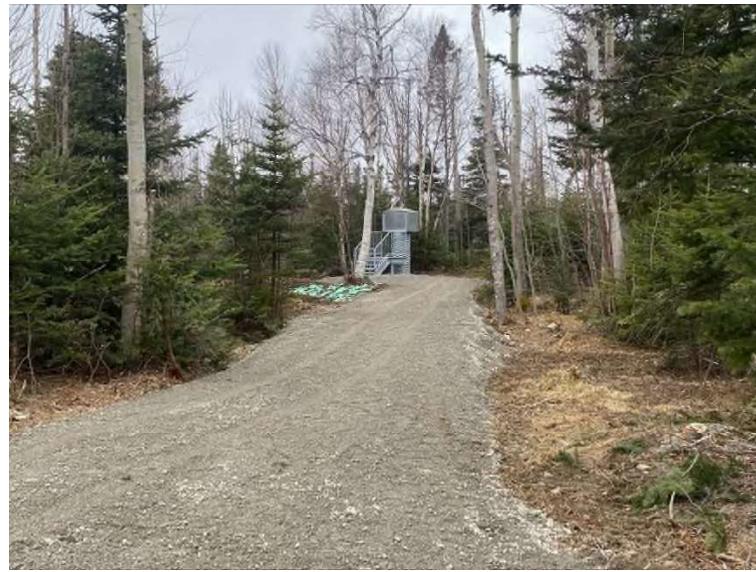
Figure 21. New gravel trailway to the station at 02YR003

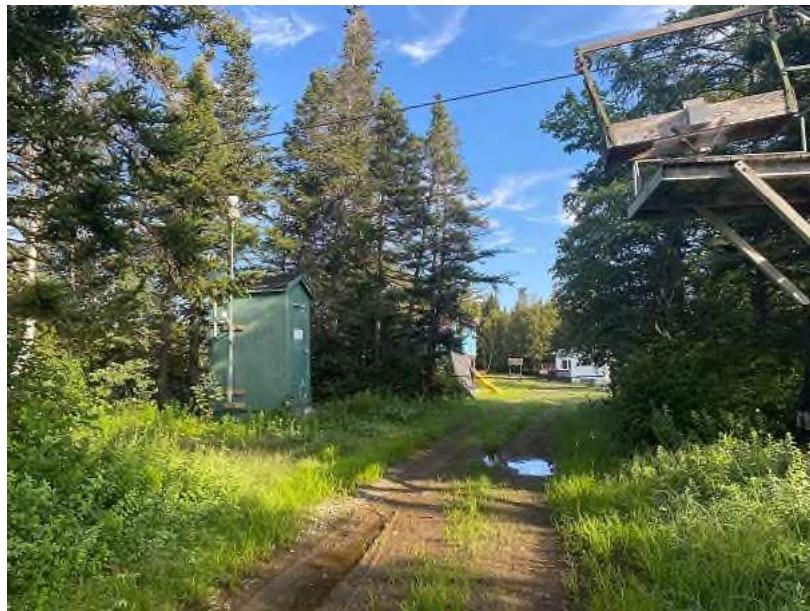
This site consists of a cableway that contained a wooden walk-in shelter with four creosote-treated timbers and A-Frame cableway structures (Figures 22 & 23). PAH staining was identified in the soil along the base of the cableway structure (Figure 24) and paint chipping potentially containing lead and mercury was found on the wooden structure. The station required an ESA for the potential site contamination of the soil, creosote-treated timbers, and paint, therefore, PSPC was used to commission an environmental consultant to complete an ESA of the site. Soil samples were collected on October 11th, 2023, adjacent to the cableway structure and near the shelter for PAHs analysis which were found to be in exceedance of applicable regulatory criteria which required further assessment. Soil samples found no issues with mercury contamination, however samples exceedances for lead contamination were identified. The paint samples from the shelter contained concentrations of lead and mercury below the applicable guidelines as well as the treated wood timbers from the cableway and shelter supports. The site was classified as a Class 2 Site based on the NCSCS Site Classification. Further sampling was identified as required prior to decommissioning and remediation of the site planned in FY 2024-25.

Figure 22. View of cableway structure on the east side with the platform and cable car and creosote-treated A-Frame (October 2023).

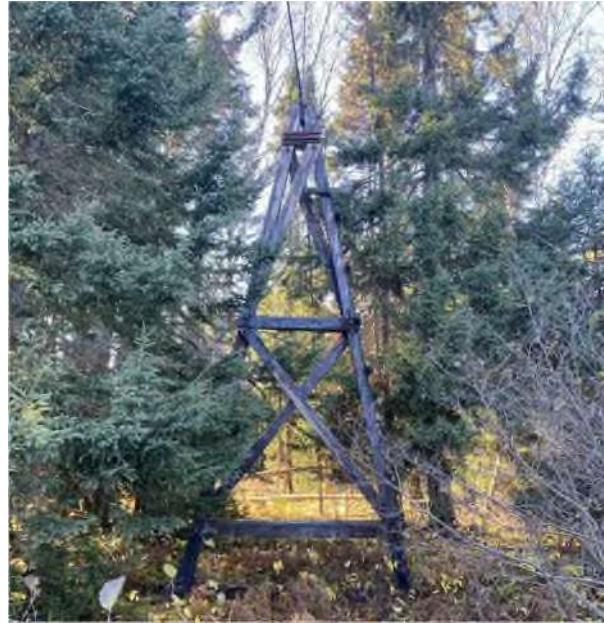
Figure 23. View of A-Frame structure on the west bank side (Photograph taken on October 24, 2023).

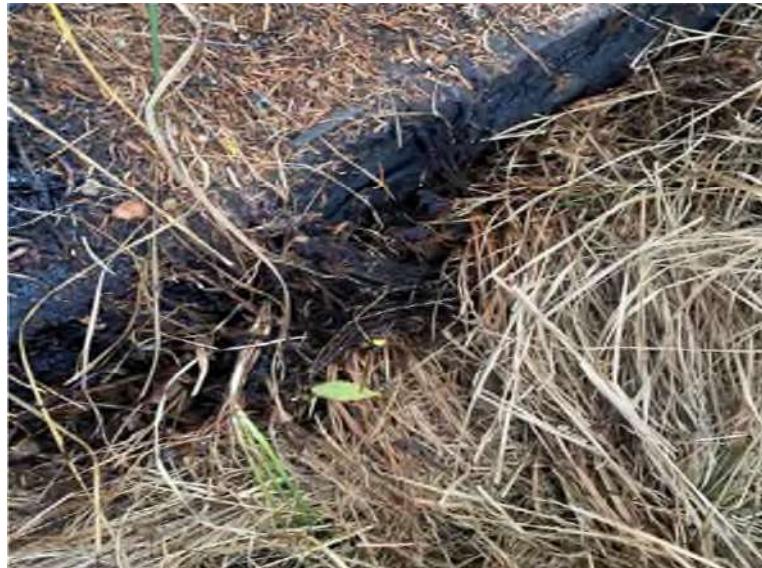
Figure 24. View showing the PAH staining along the base of the cableway structure (Photograph taken on October 11, 2023).
