Annual Weather Station Maintenance Report

2015

Government of Newfoundland & Labrador
Department of Environment and Conservation
Water Resources Management Division

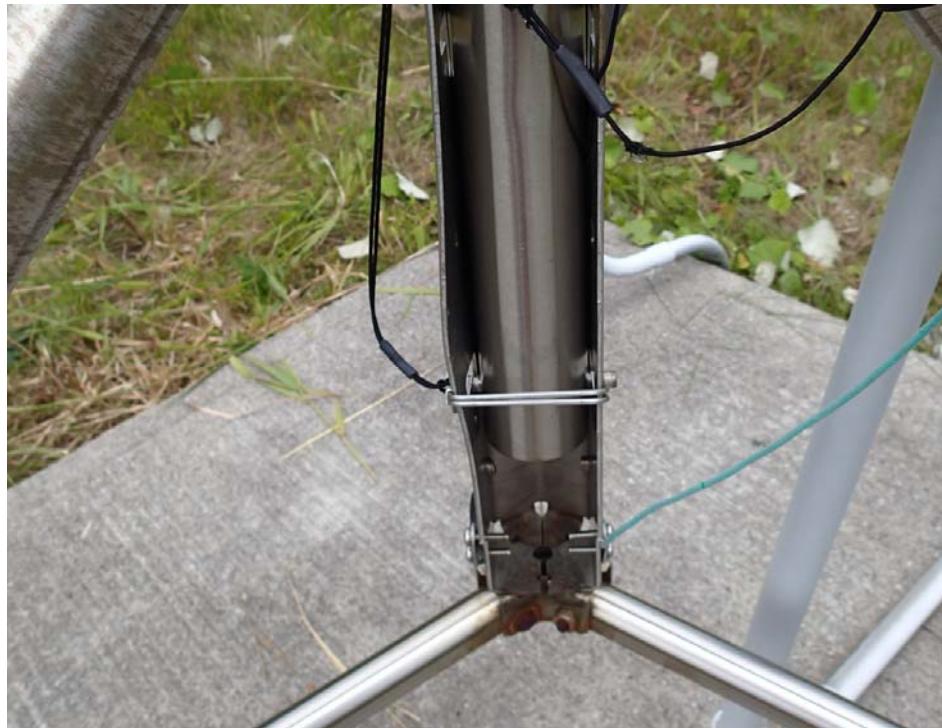
Figure 6: Compromised Tripod Integrity at Humber River At Humber Village Bridge Station

Follow-up tasks required: The tripod was bent due to wind (see Figure 6 below). WRMD Staff were notified to monitor the tripod for further damage.
