Real-Time Water Quality Deployment Report

Marathon Gold Corp
Network

June 5 to July 13, 2023

Government of Newfoundland & Labrador
Department of Environment & Climate Change
Water Resources Management Division

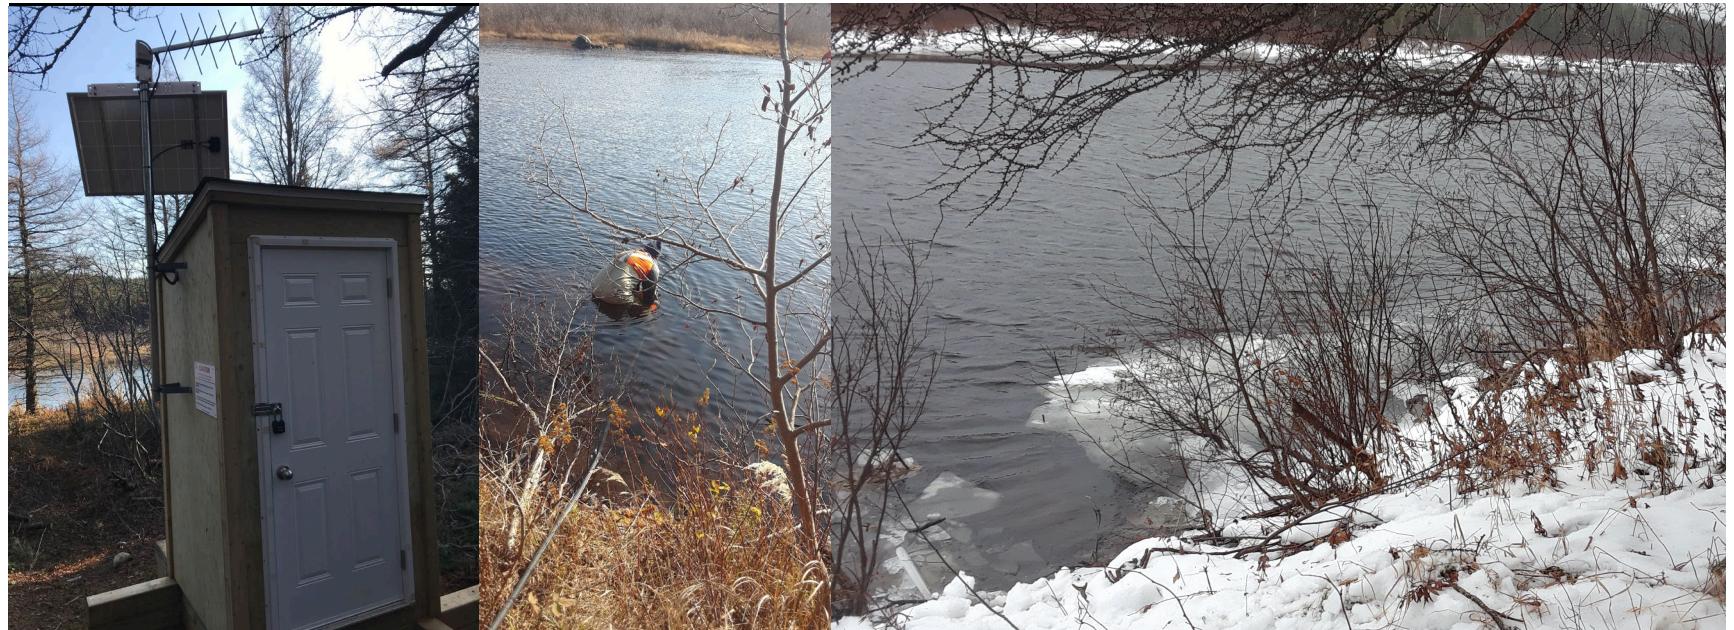
Station Location: Victoria River 6.3km downstream of Victoria dam, below quarry pit. Station setup on western shoreline. Access via ATV trail below quarry pit.

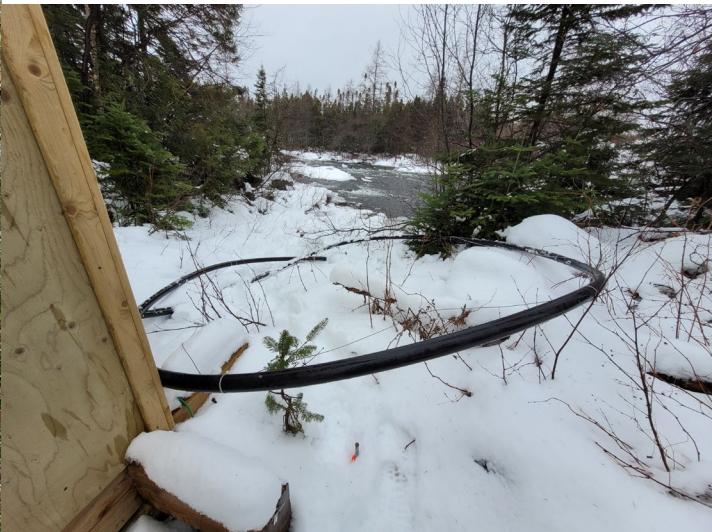
Station Location: Valentine River at access road, 1.9km downstream of Valentine Lake outlet. Station located 15m upstream of access road crossing bridge on southern shoreline.

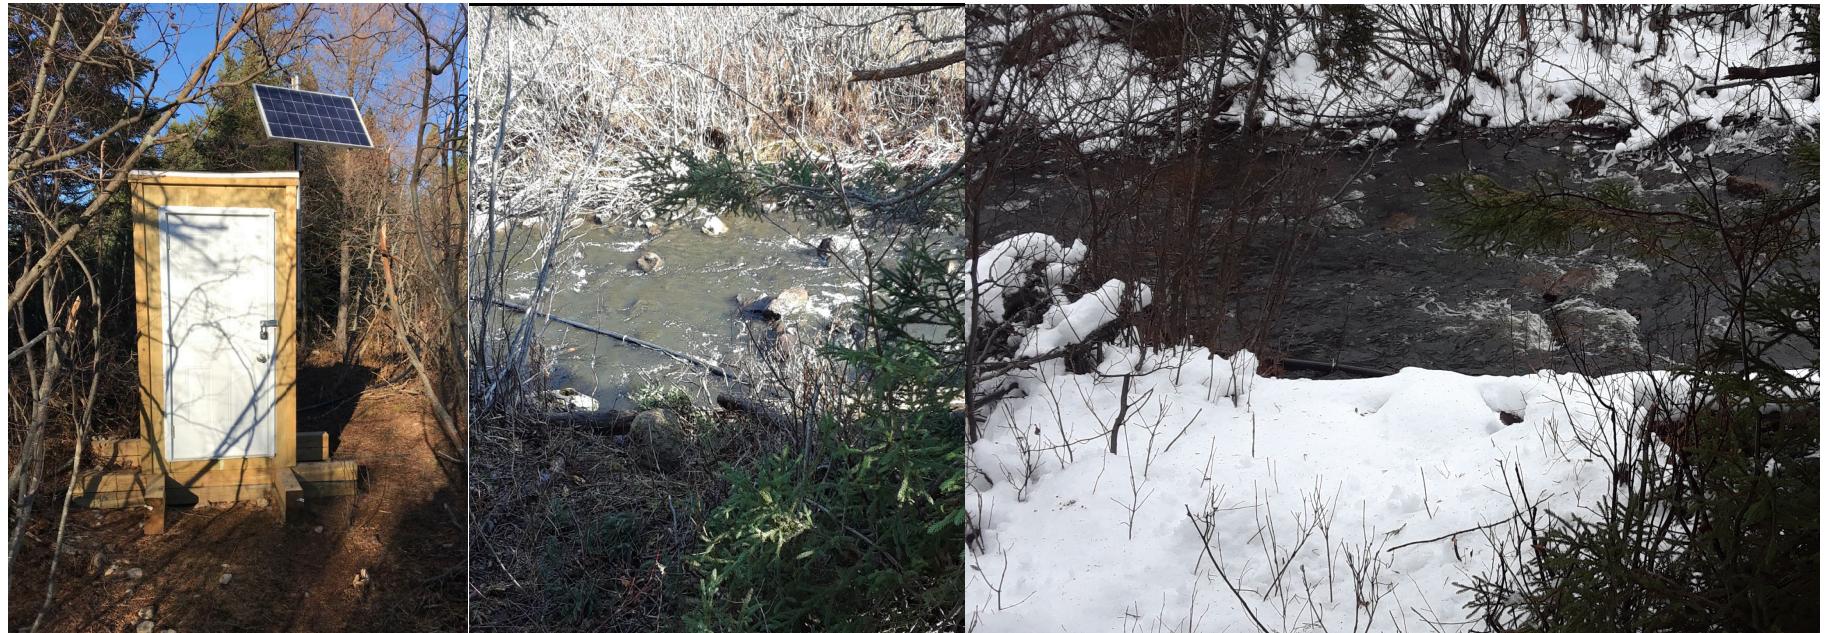
Station Location: Roebucks Brook 30m downstream of access road bridge crossing on western shoreline. Station is 1.6km downstream of Roebucks Lake outlet.
