Real-Time Water Quality Deployment Report

Marathon Gold Corp
Network

July 13 to
September 6, 2023

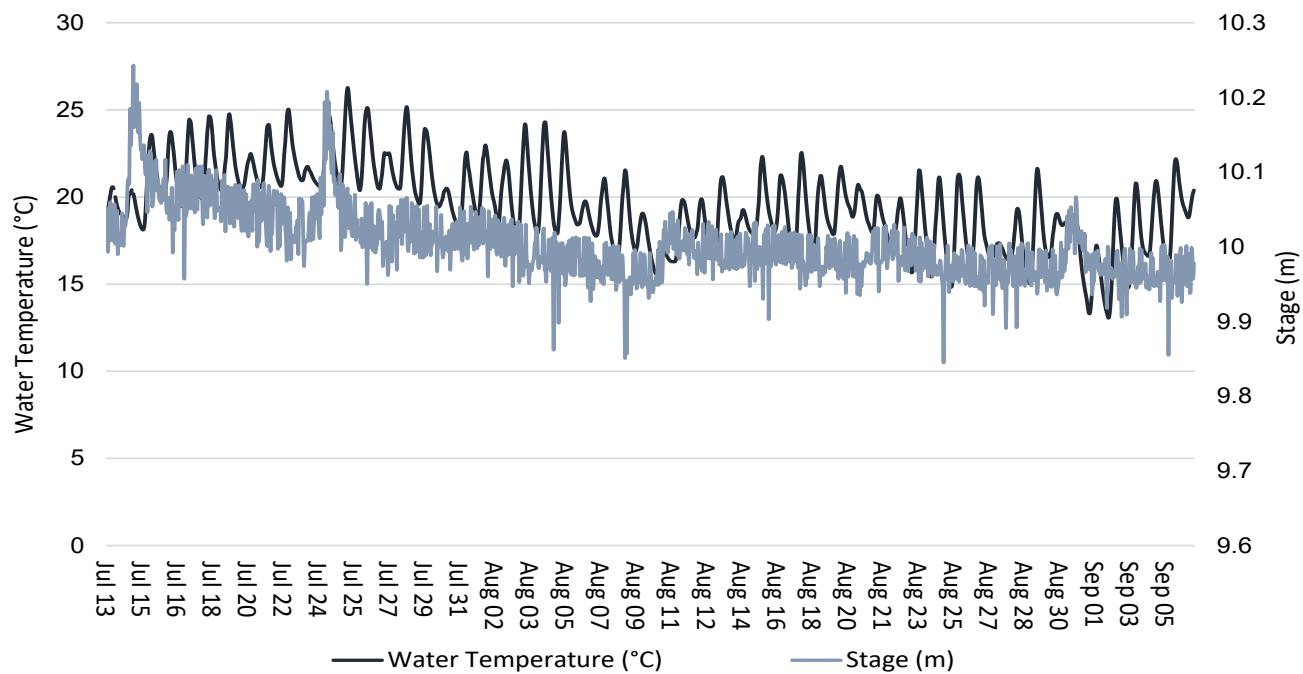
Figure 2: Water Temperature and Stage

- Water temperature ranged from 13.05 to 26.28°C during this deployment period (Figure 2).
- Water temperature showed a decreasing trend throughout deployment, corresponding to ambient air temperatures as the season progressed into late summer.

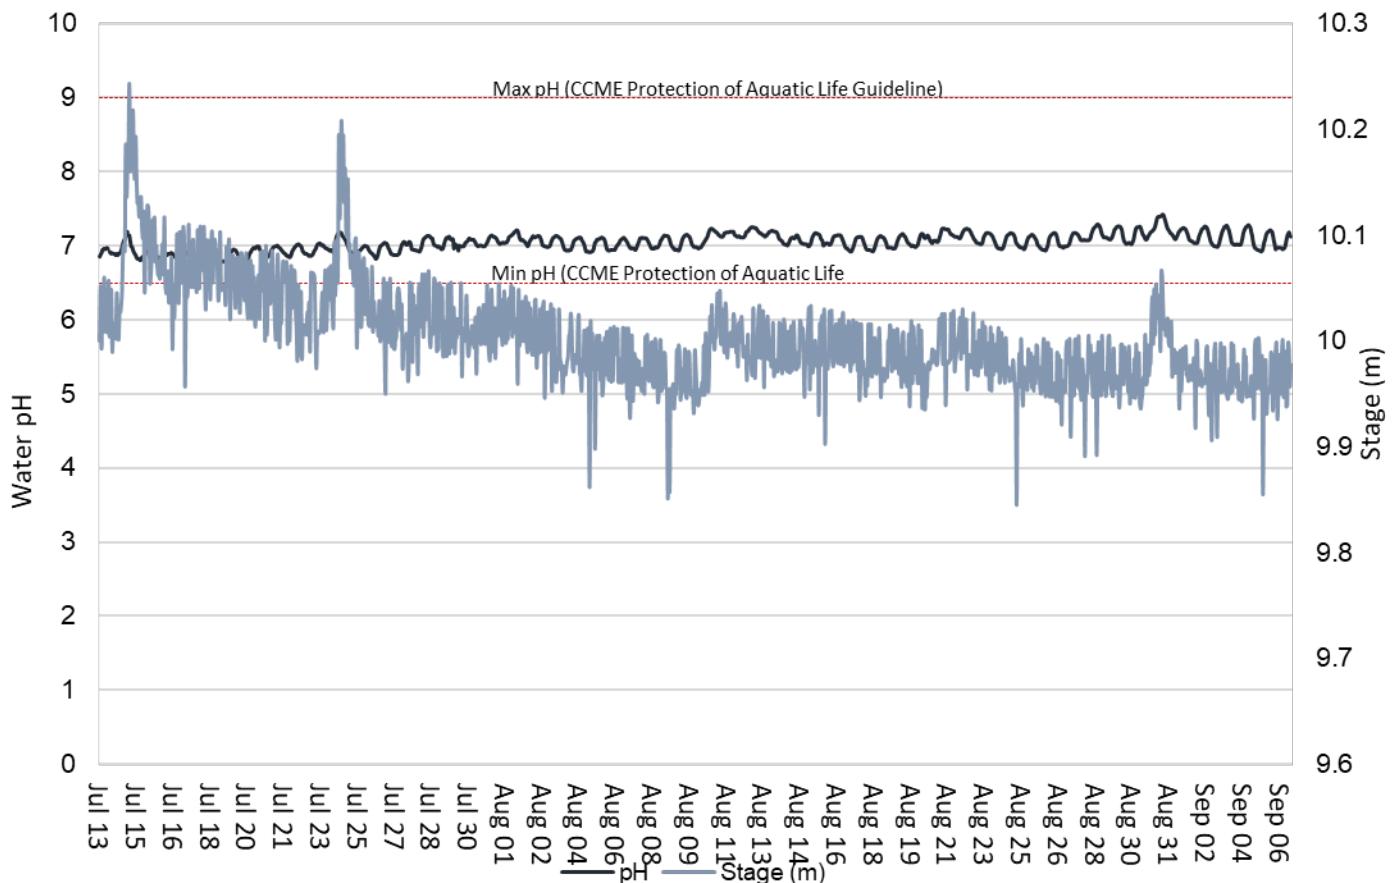
Figure 3: Water pH and Stage

- pH ranged between 6.78 and 7.43 pH units throughout the deployment period, with a median value of 7.05 units (Figure 3).
- All values during the deployment are within the CCME Guidelines for the Protection of Aquatic Life (between 6.5 and 9 pH units). pH fluctuates slightly during the day and night.
- There are occasional small increases in pH associated with increased stage.
- Overall, pH was relatively stable for the deployment.

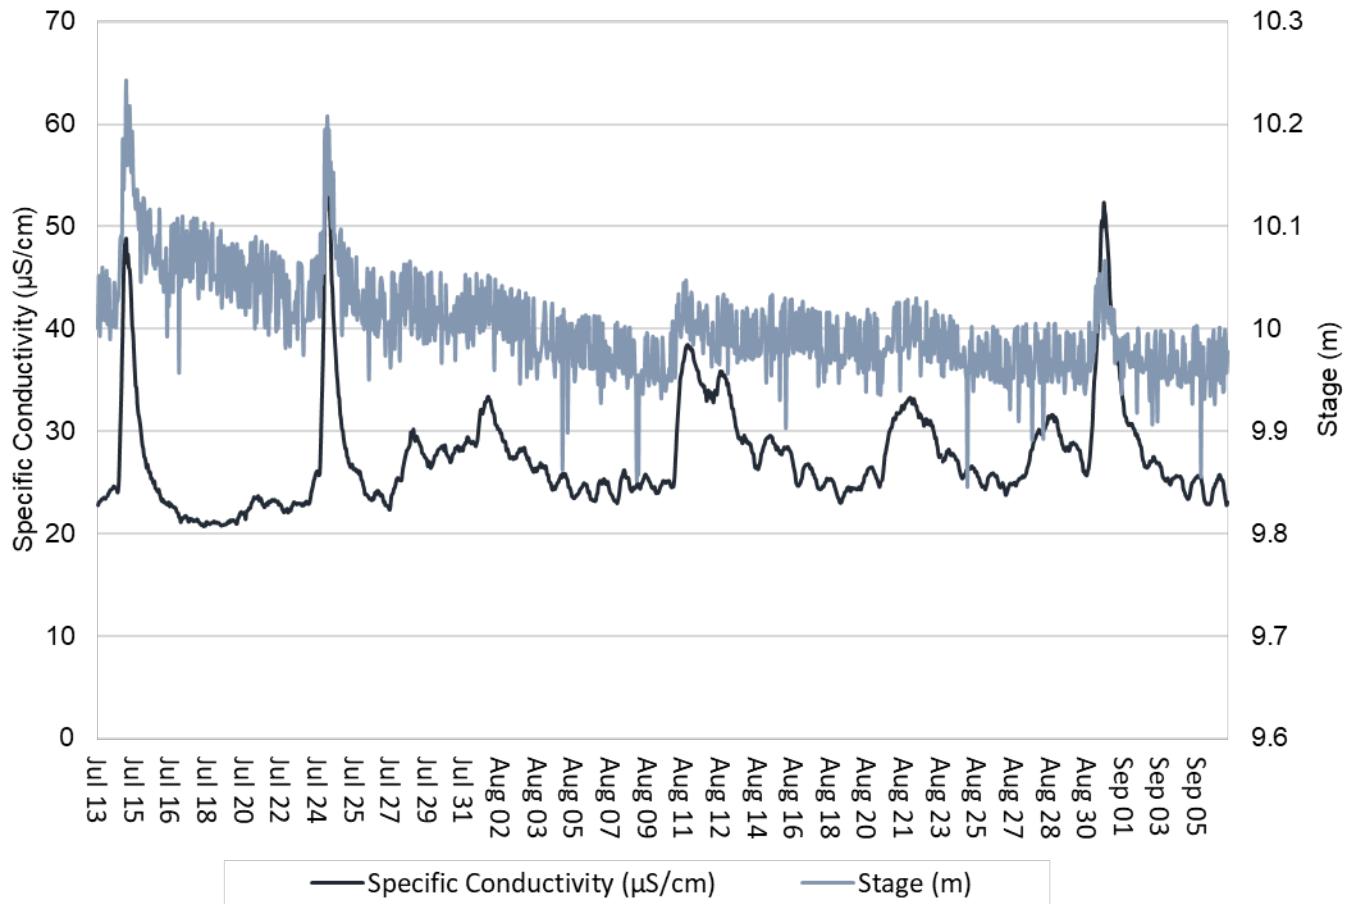
Figure 4: Specific Conductivity of Water and Stage

- Specific conductivity ranged from 20.7 to 59.7 $\mu\text{s}/\text{cm}$ (Figure 4) with a median of 26.1 $\mu\text{s}/\text{cm}$.
- Specific conductivity remained relatively stable over the course of this deployment period, except during periods of high precipitation which caused stage increases and corresponding increases in conductivity for a short time. This indicates the precipitation may cause particulates in the river sediment to re-suspend into the water column, increasing the conductivity for a short period of time before it settles out again.

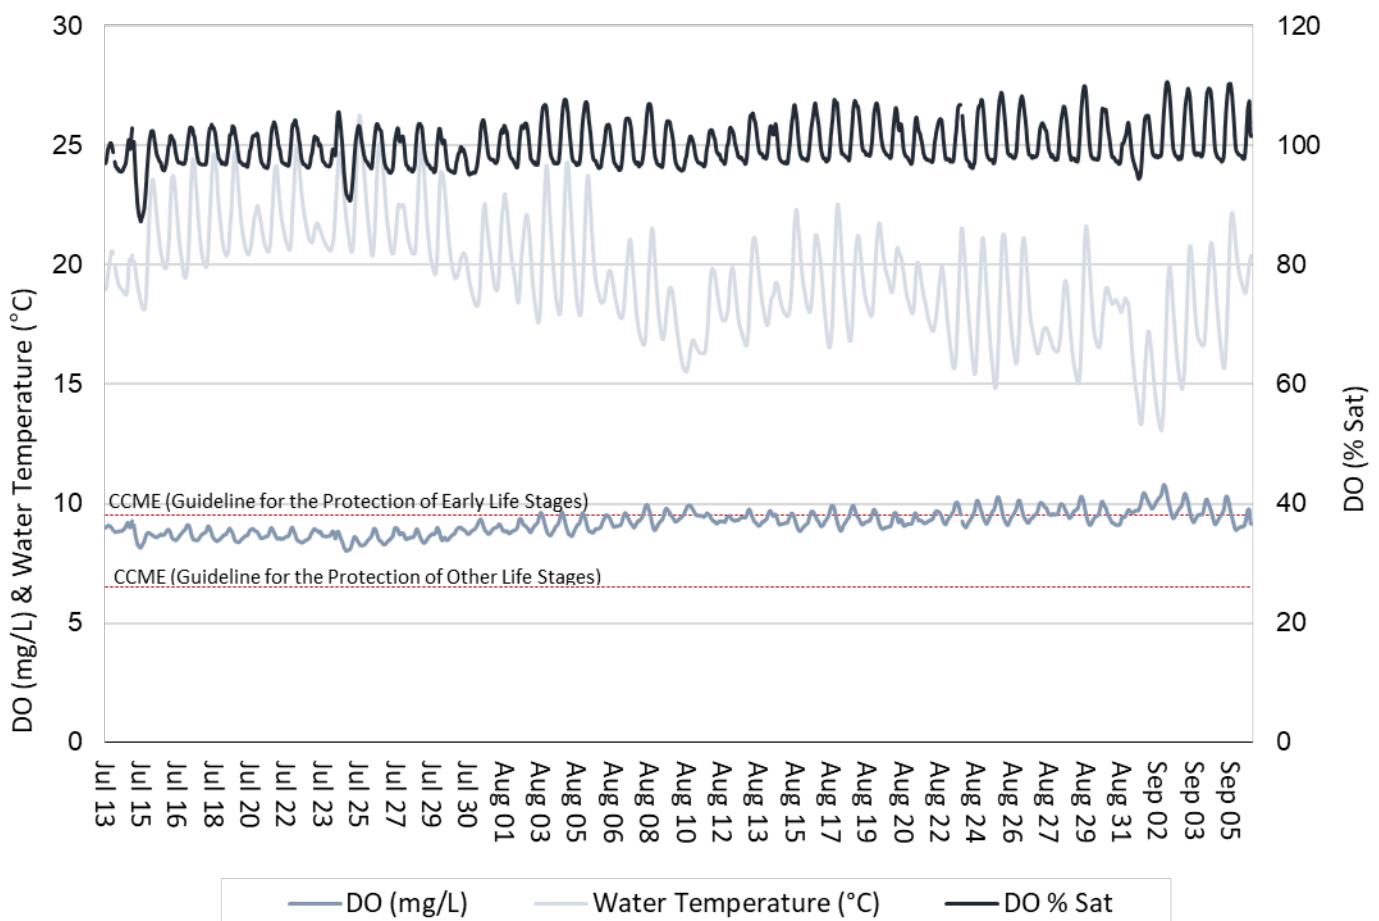
Figure 5: Dissolved Oxygen and Water Temperature

- The saturation of dissolved oxygen ranged from 87.2% to 110.8% and a range of 8.04 to 10.80 mg/l was found for the concentration of dissolved oxygen with a median value of 9.18 mg/l (Figure 5).
- All values were above the minimum CCME Guidelines for the Protection of Other Life Stages but hovered around the Guidelines for Early Life Stage of Cold Water Biota. The guidelines are indicated in red on Figure 5.
- Dissolved oxygen content fluctuates diurnally, displaying the inverse relationship to water temperature. Dissolved oxygen increased steadily during the deployment period as water temperatures cooled into late summer.

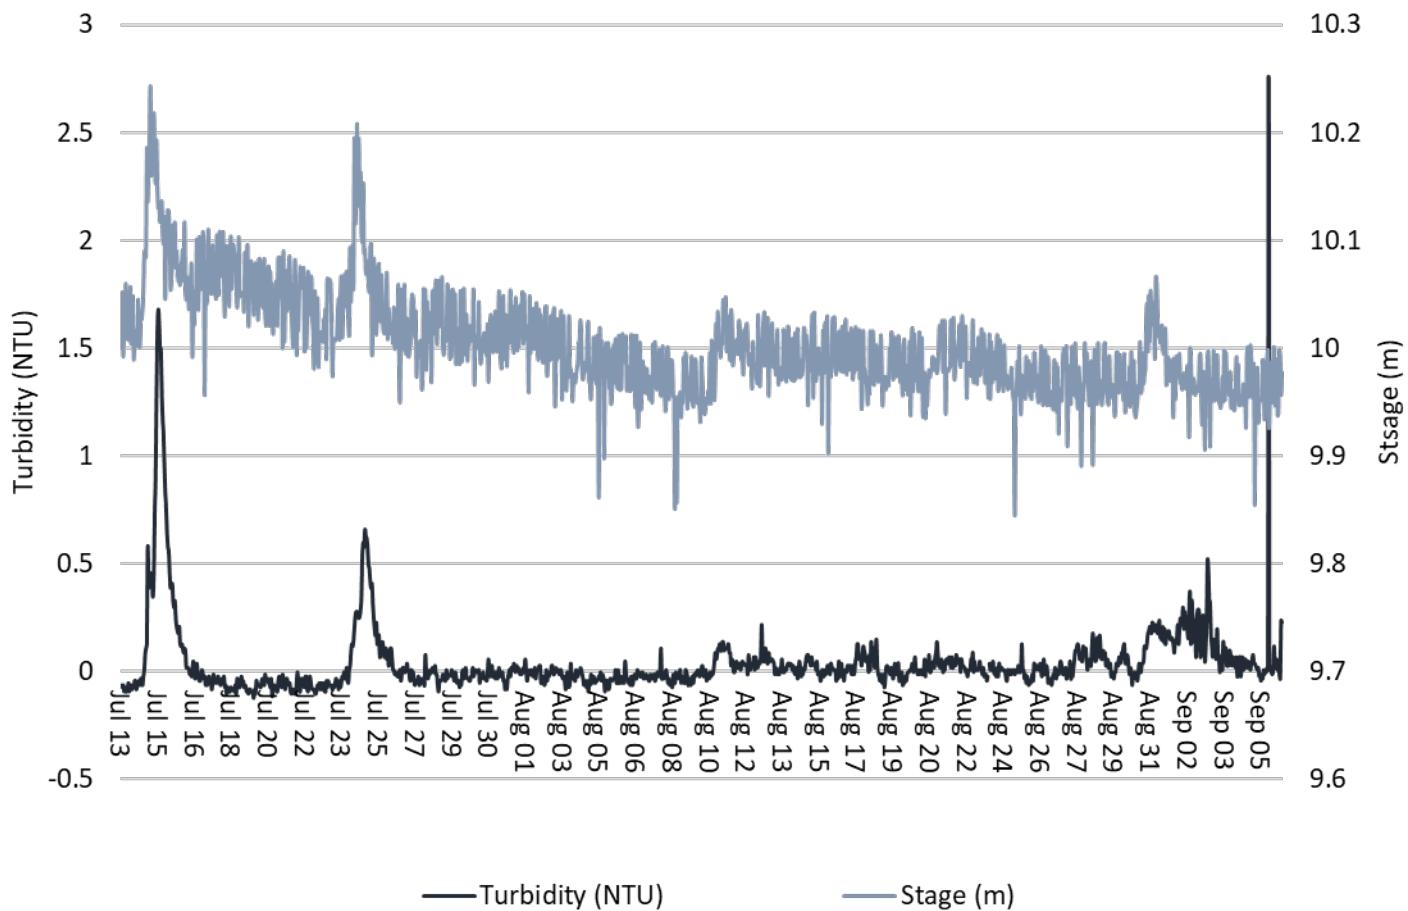
Figure 6: Turbidity and Stage

- Turbidity values range from -0.1 NTU to 2.8 NTU with a median of 0.0, indicating very clear background turbidity.
- Turbidity remained very low throughout deployment with a slight increasing trend. Turbidity increased temporarily during stage events associated with precipitation. (Figure 6). This indicates rainfall associated with stage increases may stir up sediments in the area for a brief period of time before returning to background levels.

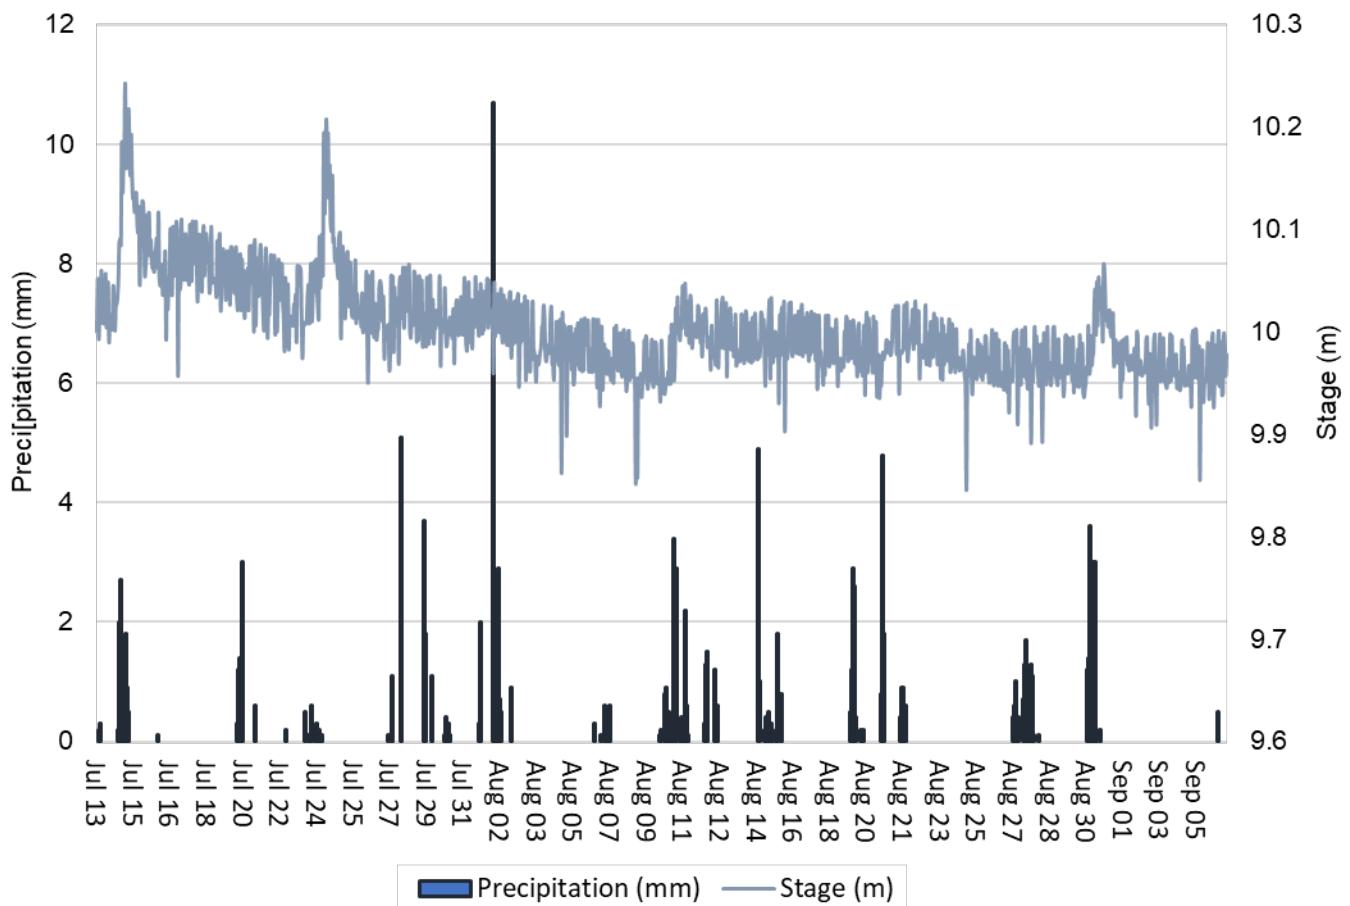
Figure 7: Precipitation and Stage

- Precipitation and stage during the deployment period are graphed below (Figure 7). Stage was decreasing gradually throughout deployment.
- It is notable from the data that smaller precipitation events did not always lead to an increase in stage at this location.

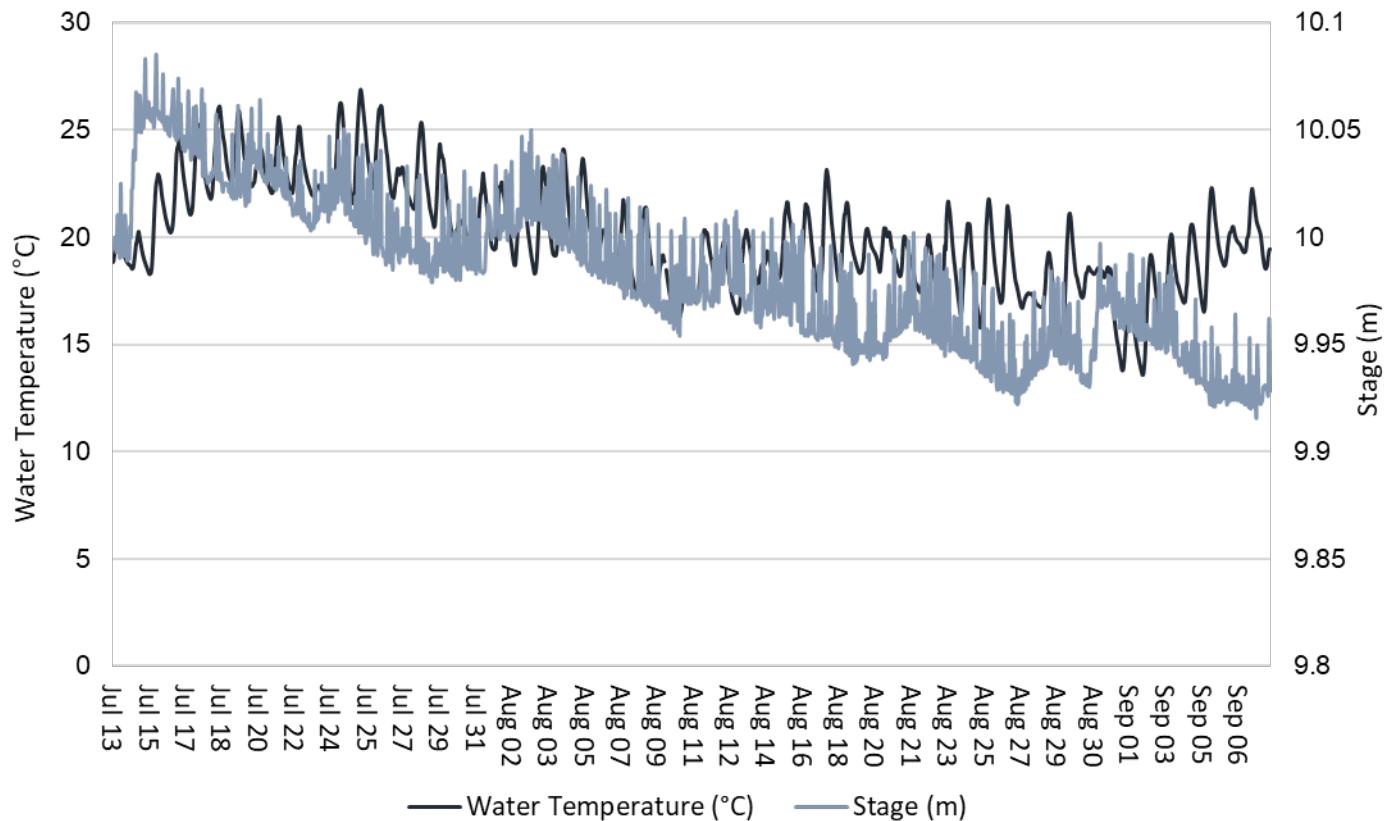
Figure 8: Water Temperature and Stage

- Water temperature ranged from 13.58 to 26.88°C during this deployment period (Figure 8).
- Water temperature showed a decreasing trend throughout deployment, corresponding to ambient air temperatures as the season progressed into late summer (Figure 8).

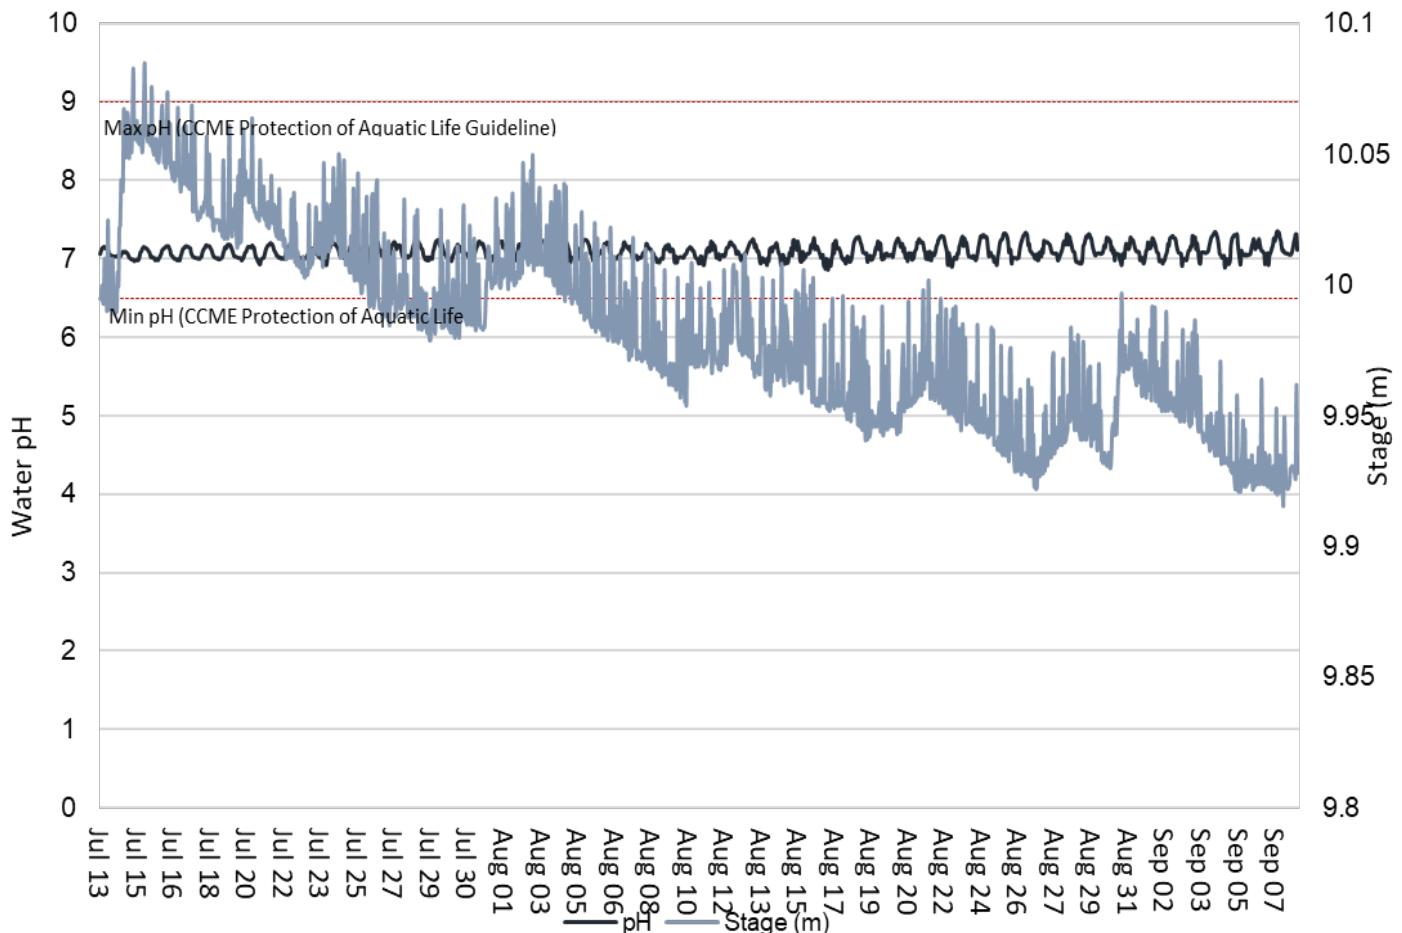
Figure 9: Water pH and Stage

- pH ranged between 6.86 and 7.35 pH units throughout the deployment period, with a median value of 7.08 units (Figure 9).
- All values during the deployment are within the CCME Guidelines for the Protection of Aquatic Life (between 6.5 and 9 pH units). pH fluctuates slightly during the day and night.
- Overall, pH was relatively stable for the deployment, but was influenced by large precipitation events.

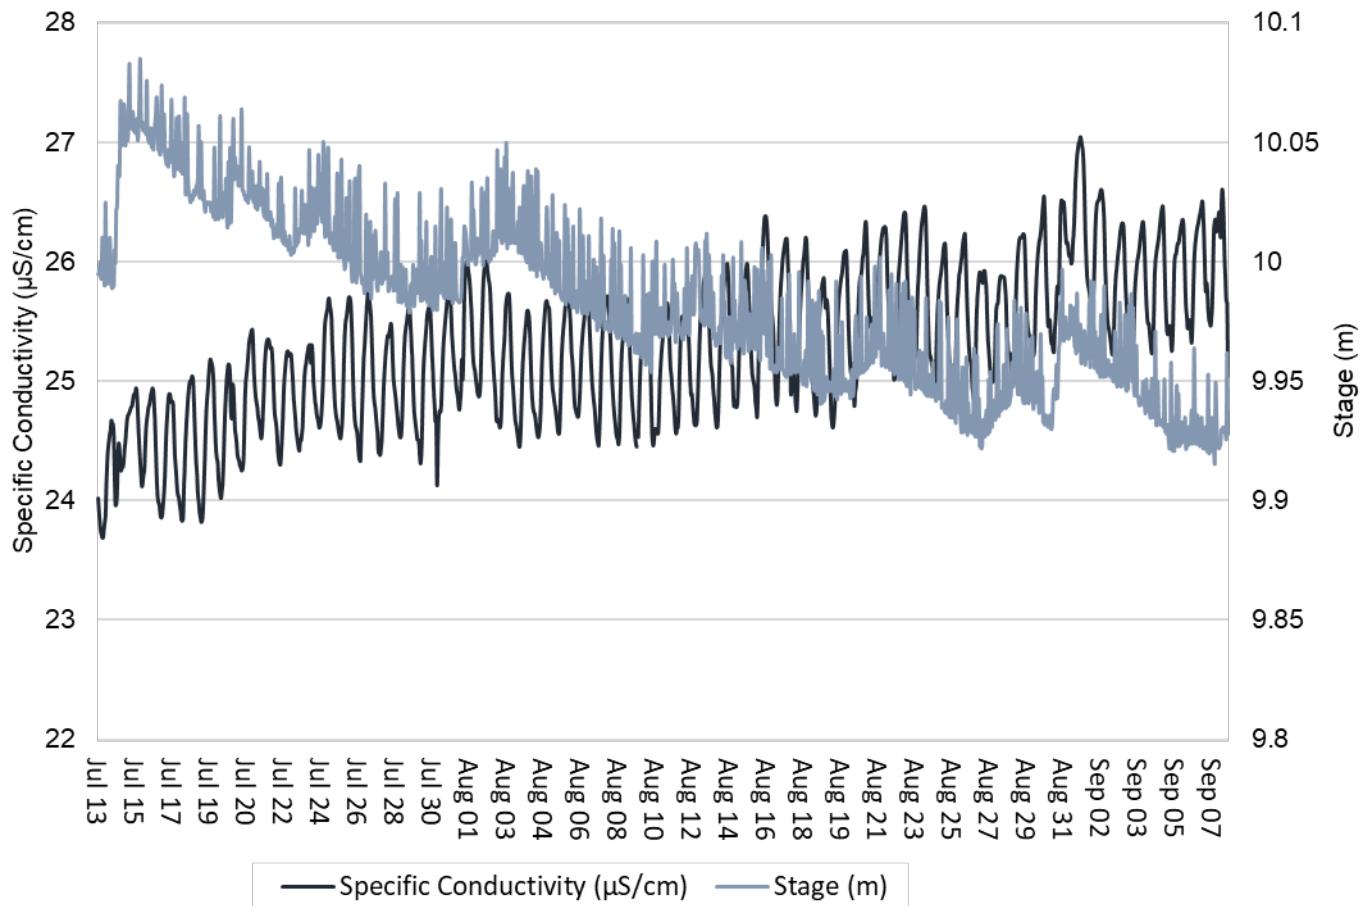
Figure 10: Specific Conductivity of Water and Stage

- Specific conductivity ranged from 23.7 to 27.0 $\mu\text{s}/\text{cm}$ (Figure 10) with a median of 25.3 $\mu\text{s}/\text{cm}$ (Figure 10).
- Specific conductivity is trending upward over the course of this deployment period as stage decreases. This suggests the conductivity increase may be due to solutes in the water column becoming increasingly concentrated as there is less water added to the system from precipitation.

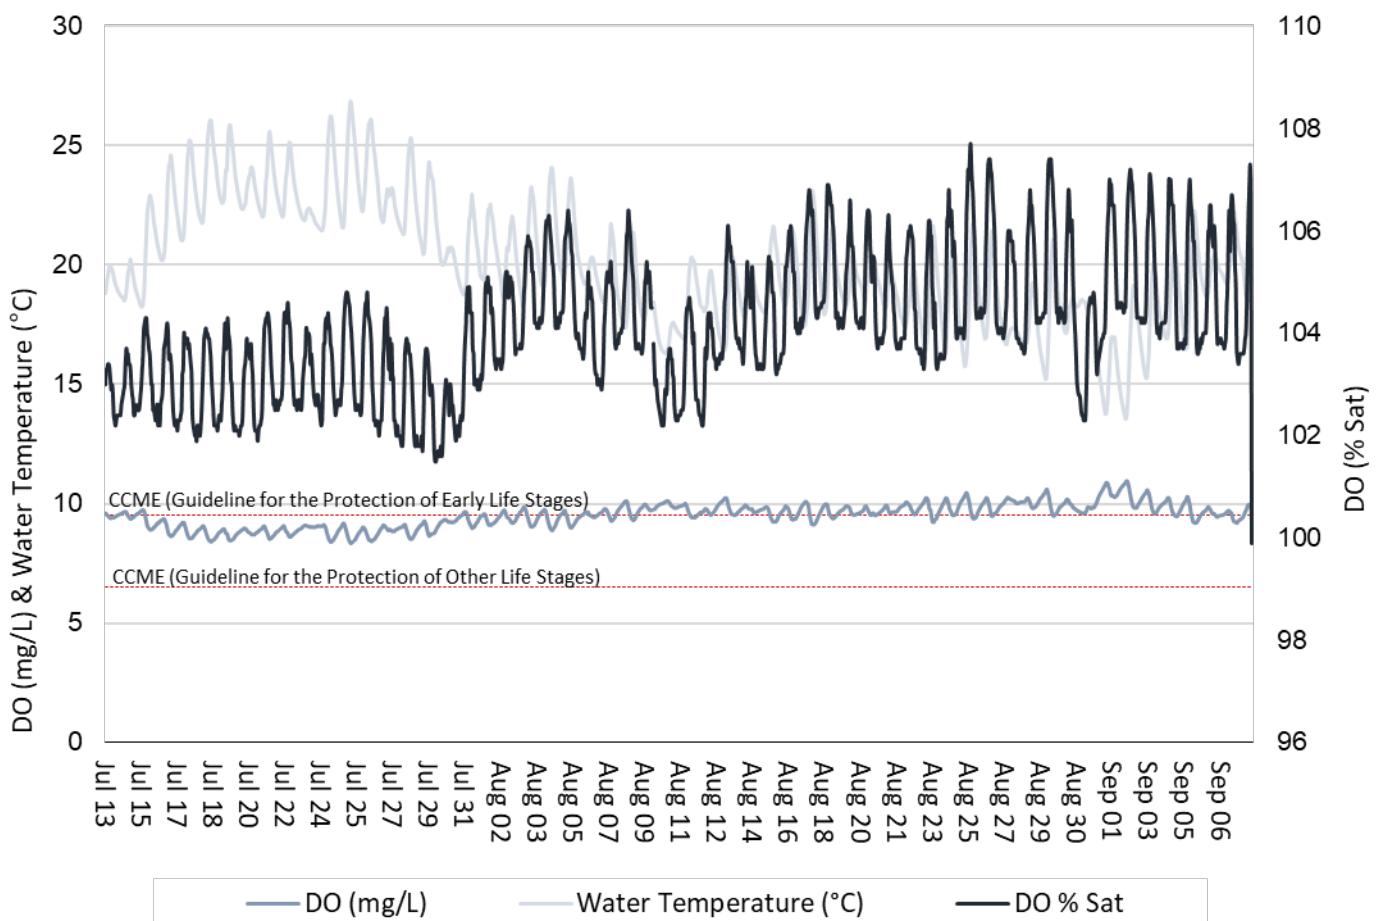
Figure 11: Dissolved Oxygen and Water Temperature

- The saturation of dissolved oxygen ranged from 99.9% to 107.7% and a range of 8.32 to 10.95 mg/l was found for the concentration of dissolved oxygen with a median value of 9.54 mg/l (Figure 11).
- All values were above the minimum CCME Guidelines for the Protection of Other Life Stages while the majority of values were above the Guidelines for Early Life Stages. The guidelines are indicated in red on Figure 11.
- Dissolved oxygen content fluctuates diurnally, displaying the inverse relationship to water temperature. Dissolved oxygen increased steadily during the deployment period as water temperatures cooled into late summer.

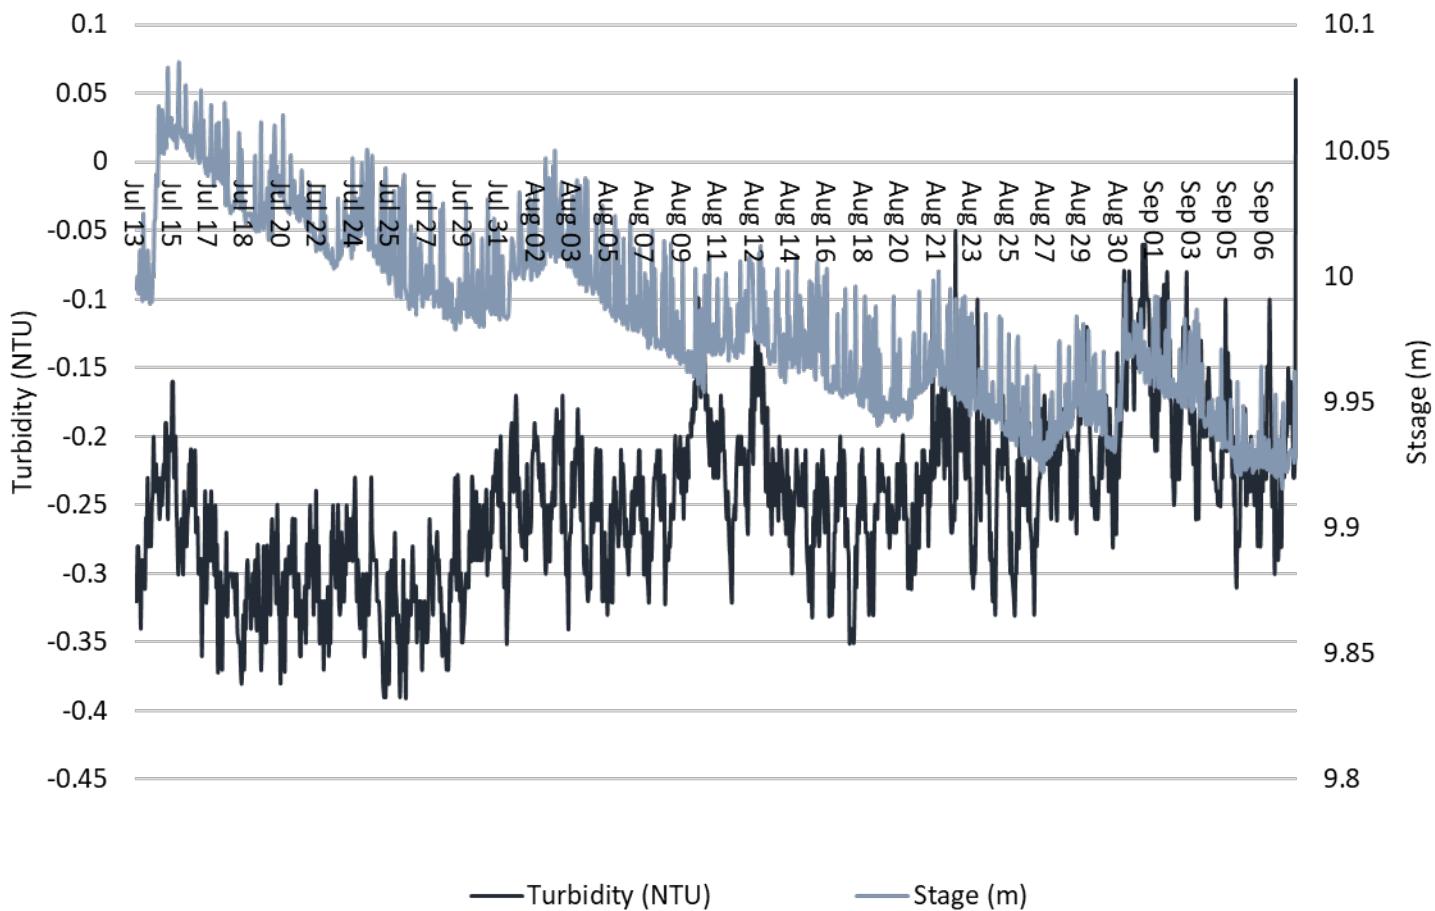
Figure 12: Turbidity and Stage

- Turbidity values range from -0.4 NTU to 0.1 NTU with a median of -0.3, indicating very clear background turbidity.
- Turbidity remained very low throughout deployment with a slight increasing trend. Turbidity increased temporarily during stage events associated with precipitation (Figure 12). This indicates rainfall associated with stage increases may stir up sediments in the area for a brief period of time before returning to background levels.

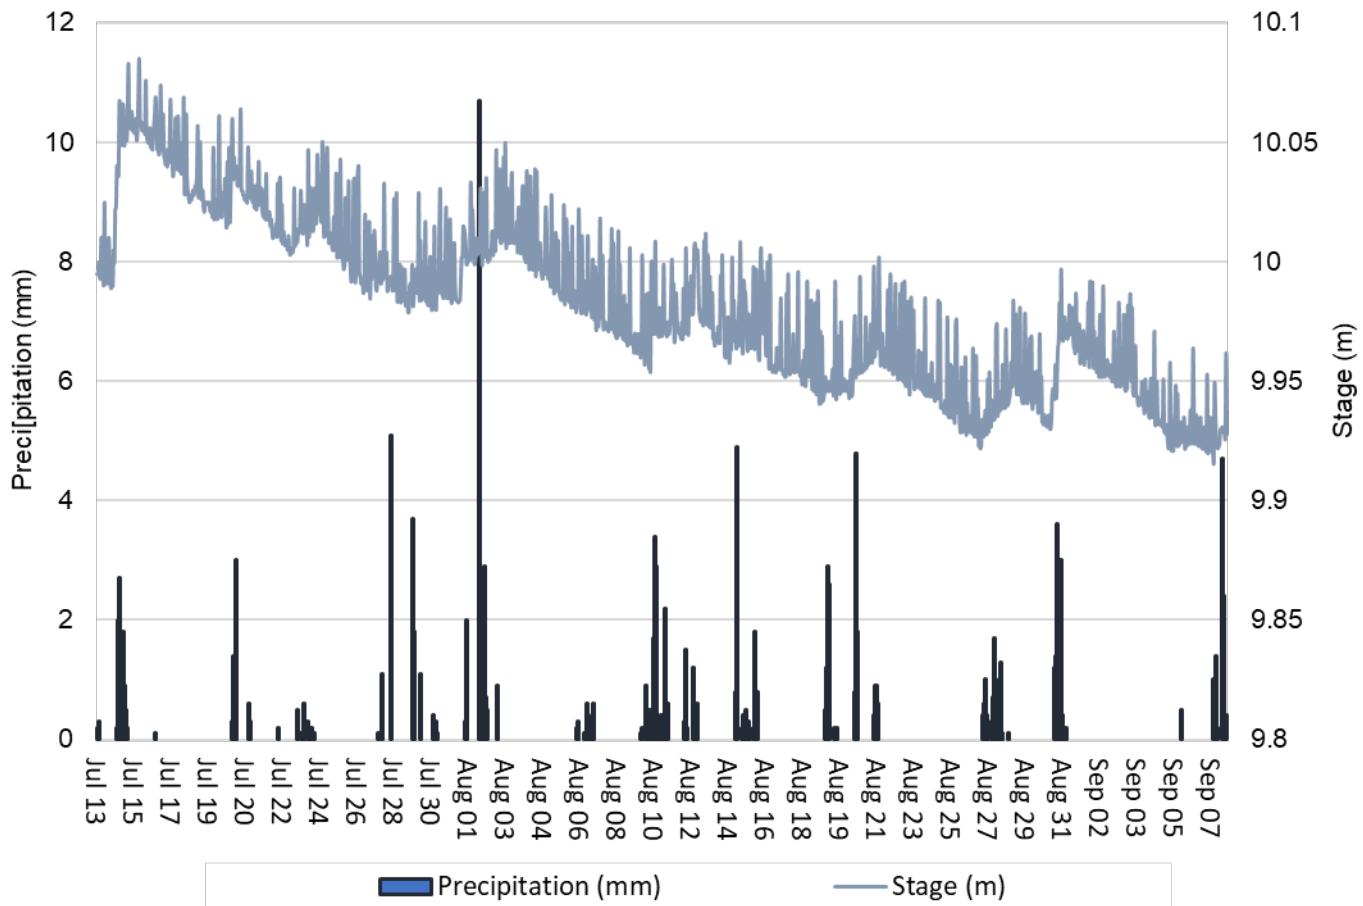
Figure 13: Precipitation and Stage

- Precipitation and stage during the deployment period are graphed below (Figure 13). Stage was decreasing gradually throughout deployment, influenced by several precipitation events.
- It is notable from the data that smaller precipitation events had more of an effect on this river than they did in Victoria River.

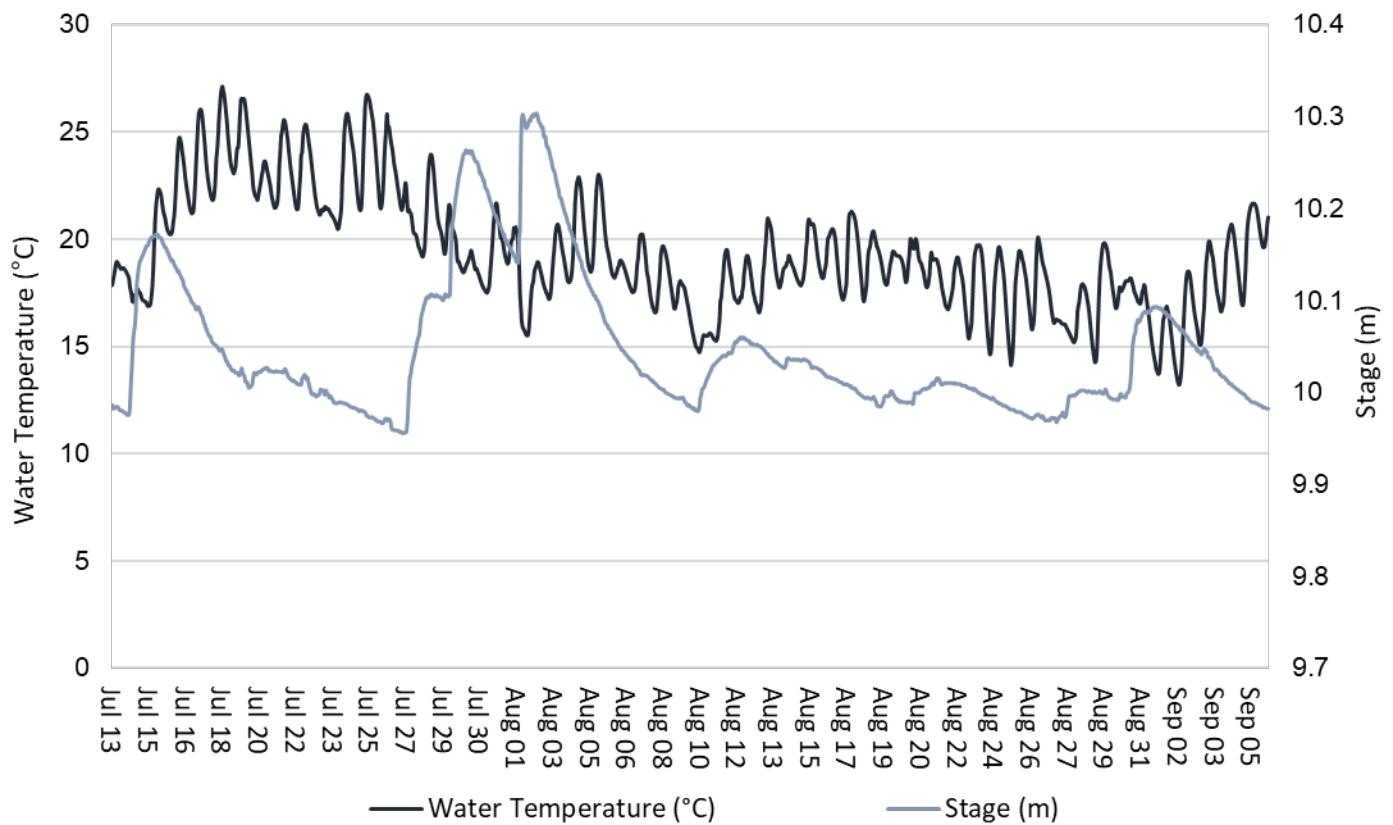
Figure 14: Water Temperature and Stage

- Water temperature ranged from 13.23 to 27.11°C during this deployment period (Figure 14).
- Water temperature showed an overall decreasing trend throughout deployment, corresponding to ambient air temperatures as the season progressed to late summer. This trend was also observed at Victoria and Valentine Rivers.

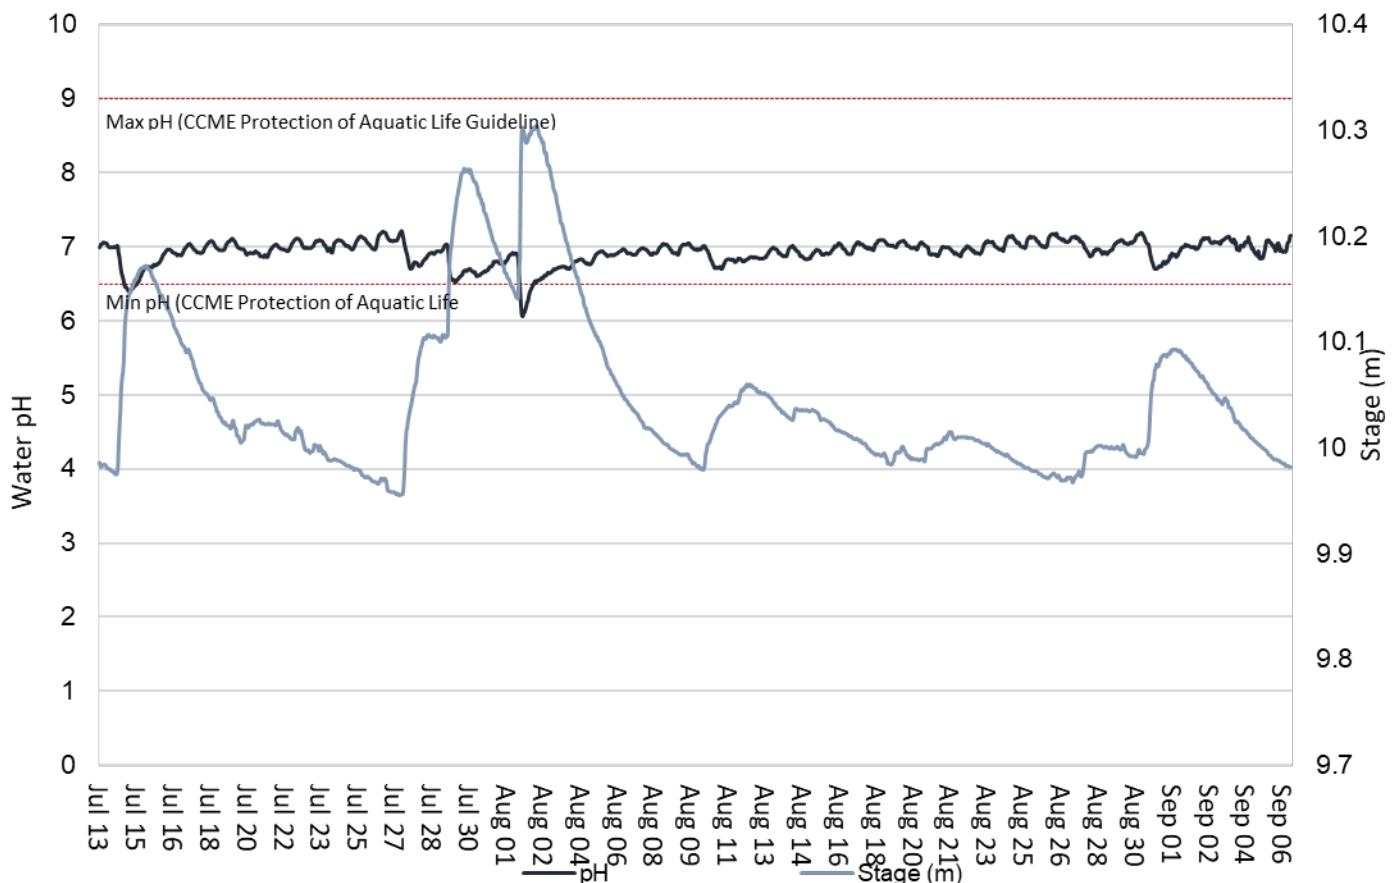
Figure 15: Water pH and Stage

- pH ranged between 6.07 and 7.22 pH units throughout the deployment period, with a median value of 6.97 units (Figure 15).
- The majority of values during the deployment are within the CCME Guidelines for the Protection of Aquatic Life (between 6.5 and 9 pH units). Values drop below the minimum threshold periodically during high stage events. pH fluctuates slightly during the day and night.
- Significant rainfall on July 29th and August 3rd (evident as rises in stage levels) caused a slight dip in pH. This is a common occurrence in freshwater as the slightly acidic rain influences the overall pH of the river for a short period of time.
- Overall, pH was relatively stable for the deployment, but was influenced by large precipitation events.

- All pH values were within the recommended CCME Guidelines for the Protection of Aquatic Life at Victoria and Valentine River. At Roebucks Brook, pH dropped below the minimum guideline briefly during periods of high precipitation.

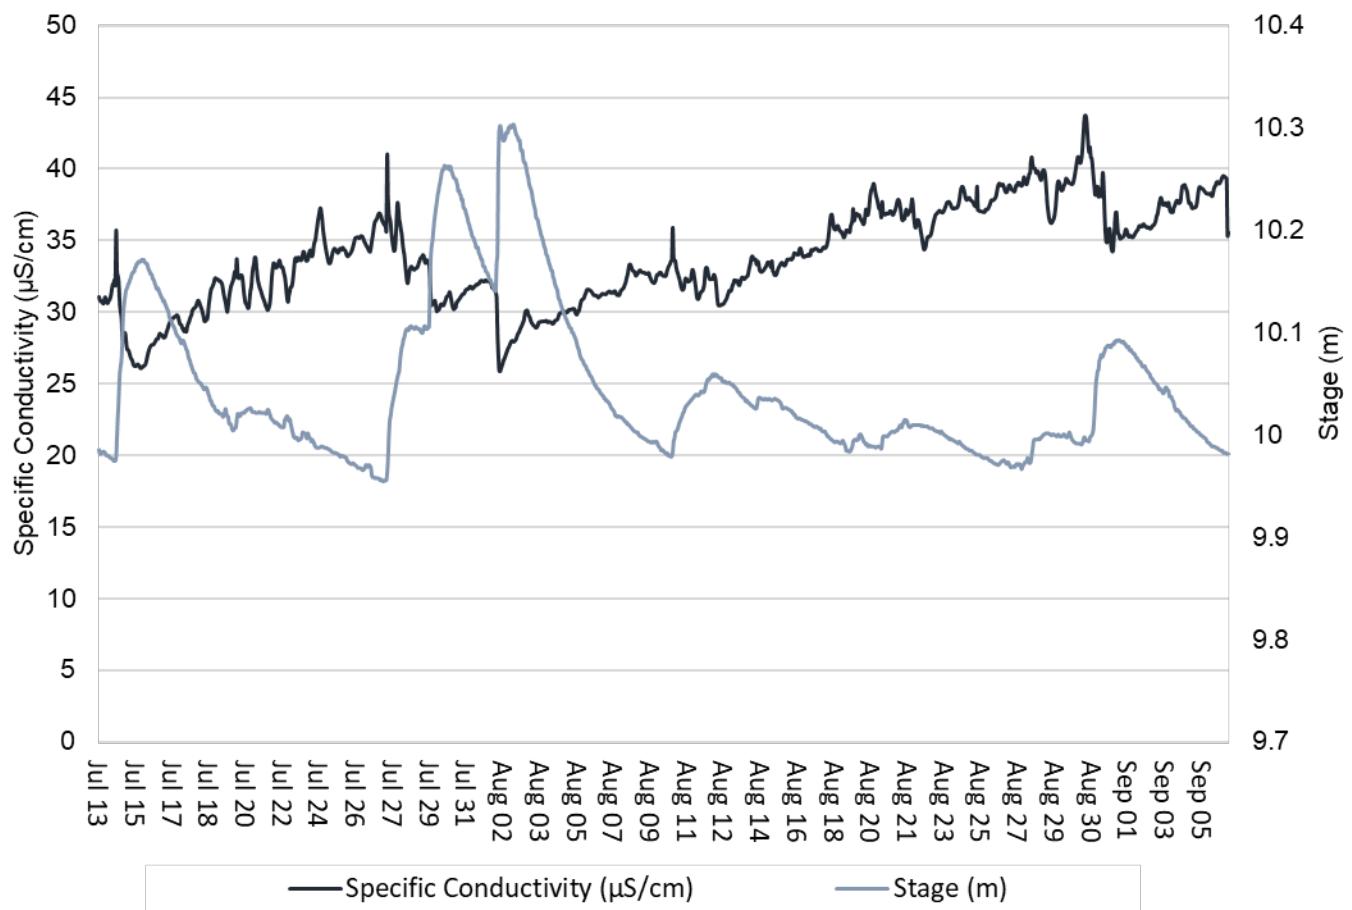
Figure 16: Specific Conductivity of Water and Stage

- Specific conductivity ranged from 25.8 to 43.7 $\mu\text{s}/\text{cm}$ (Figure 16) with a median of 33.6 $\mu\text{s}/\text{cm}$.
- Specific conductivity fluctuated but tended to increase over the course of this deployment period. During periods of high precipitation and corresponding stage increases, conductivity in Roebucks Brook decreased. A similar trend is seen at Valentine River but is different from Victoria River where conductivity generally increases for a short time when stage increases.
- This overall rise in conductivity as stage goes down indicates solutes in the river become concentrated without the addition of water from precipitation events.

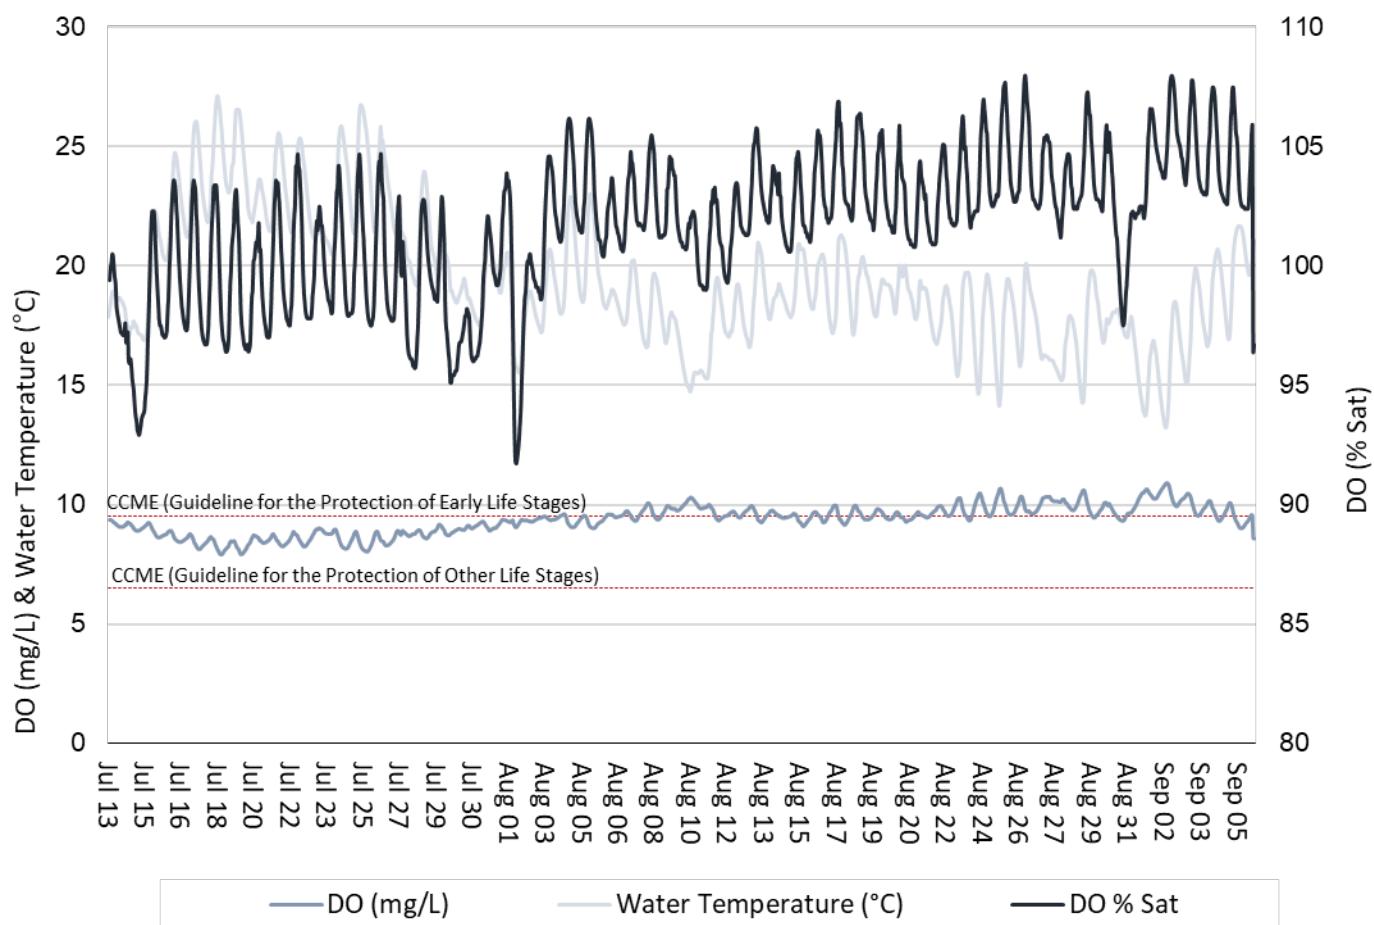
Figure 17: Dissolved Oxygen and Water Temperature

- The saturation of dissolved oxygen ranged from 91.7% to 108.0% and a range of 7.94 to 10.94 mg/l was found for the concentration of dissolved oxygen with a median value of 9.46 mg/l (Figure 17).
- All values were above the minimum CCME Guidelines for the Protection of Other Life Stages while values hovered around the minimum CCME Guideline for the Protection of Early Life Stages. The guidelines are indicated in red on Figure 17.
- Dissolved oxygen content fluctuates diurnally, displaying the inverse relationship to water temperature. Dissolved oxygen tended to increase overall, during the deployment period as water temperatures cooled into late summer.
