Real-Time Water Quality Deployment Report

Marathon Gold Corp
Network

July 13 to
September 6, 2023

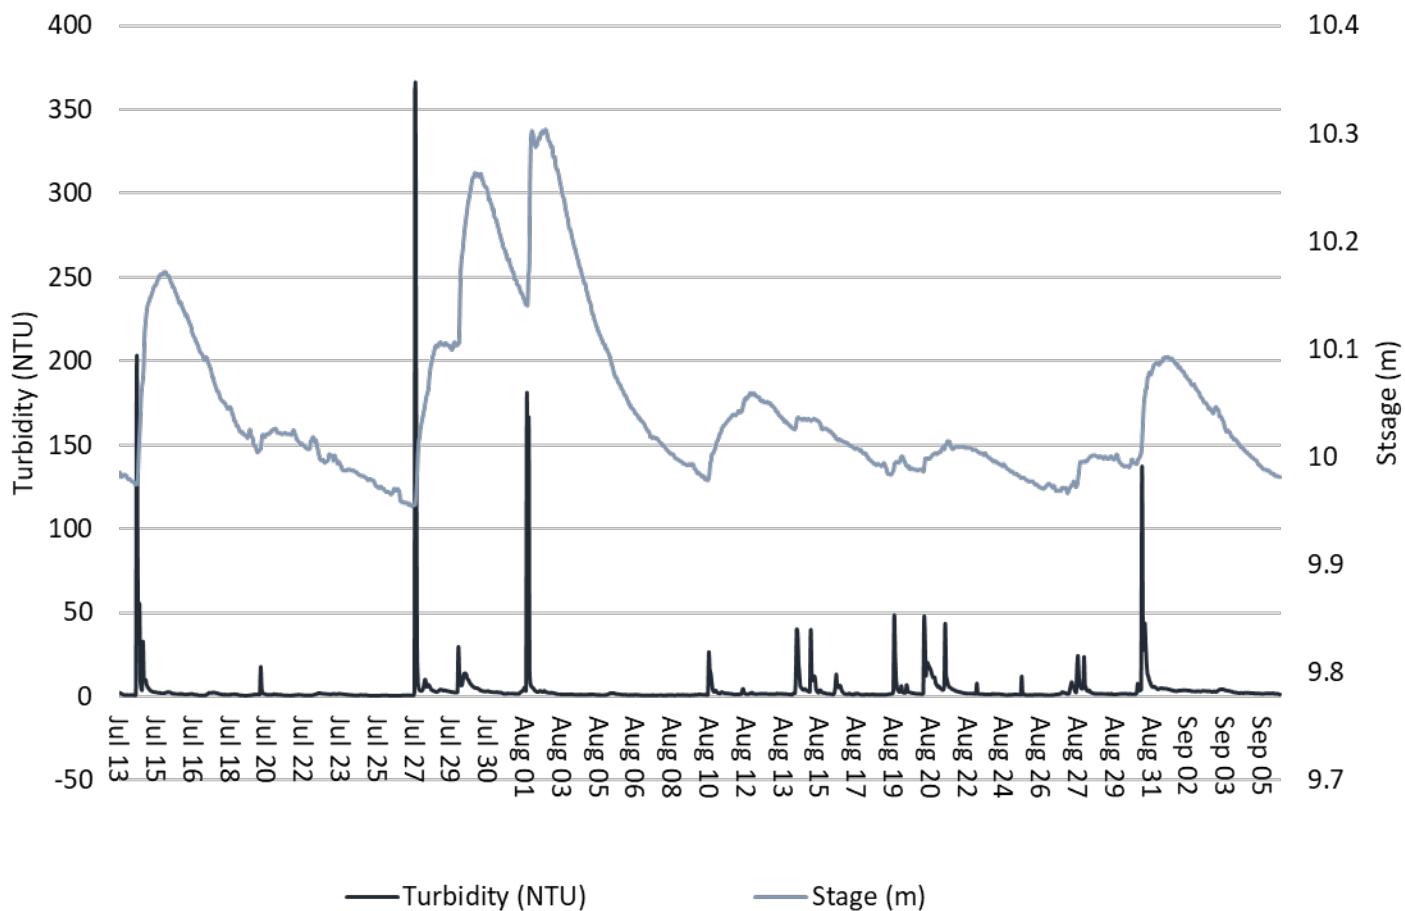
Figure 18: Turbidity and Stage

- Turbidity values range from 0.2 NTU to 362.3 NTU with a median of 1.4, indicating low background turbidity which was higher than Victoria or Valentine Rivers (Figure 18).
- Turbidity remained relatively stable throughout deployment with occasional spikes during stage events associated with precipitation (Figure 18). This indicates rainfall associated with stage increases may stir up sediments in the area for a brief period of time before returning to background levels.

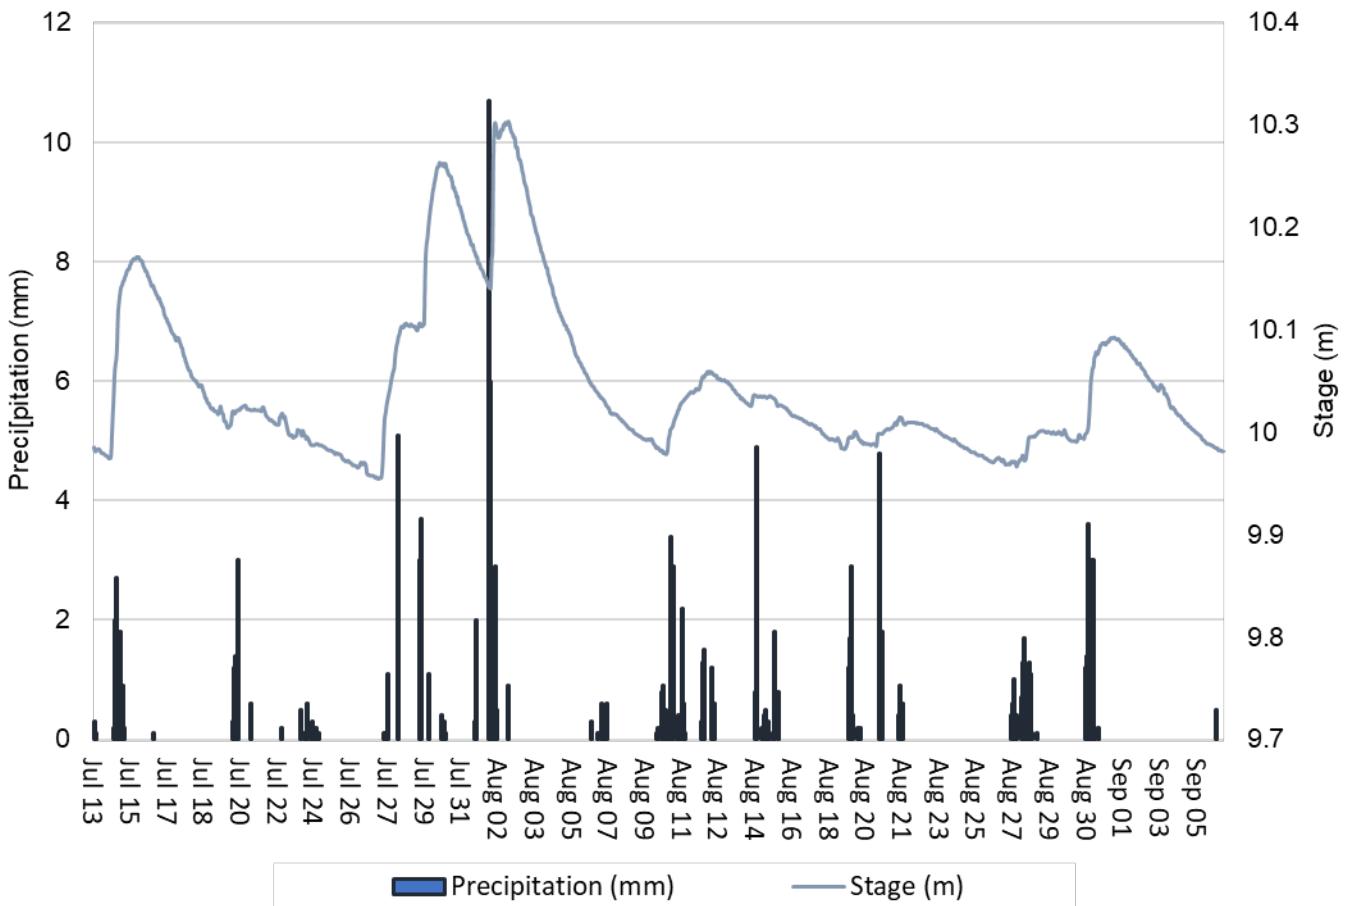
Figure 19: Precipitation and Stage

- Precipitation and stage during the deployment period are graphed below (Figure 19). Stage fluctuated throughout deployment, influenced by several major precipitation events.
- It is notable from the data that smaller precipitation events did not always lead to an increase in stage at this location.

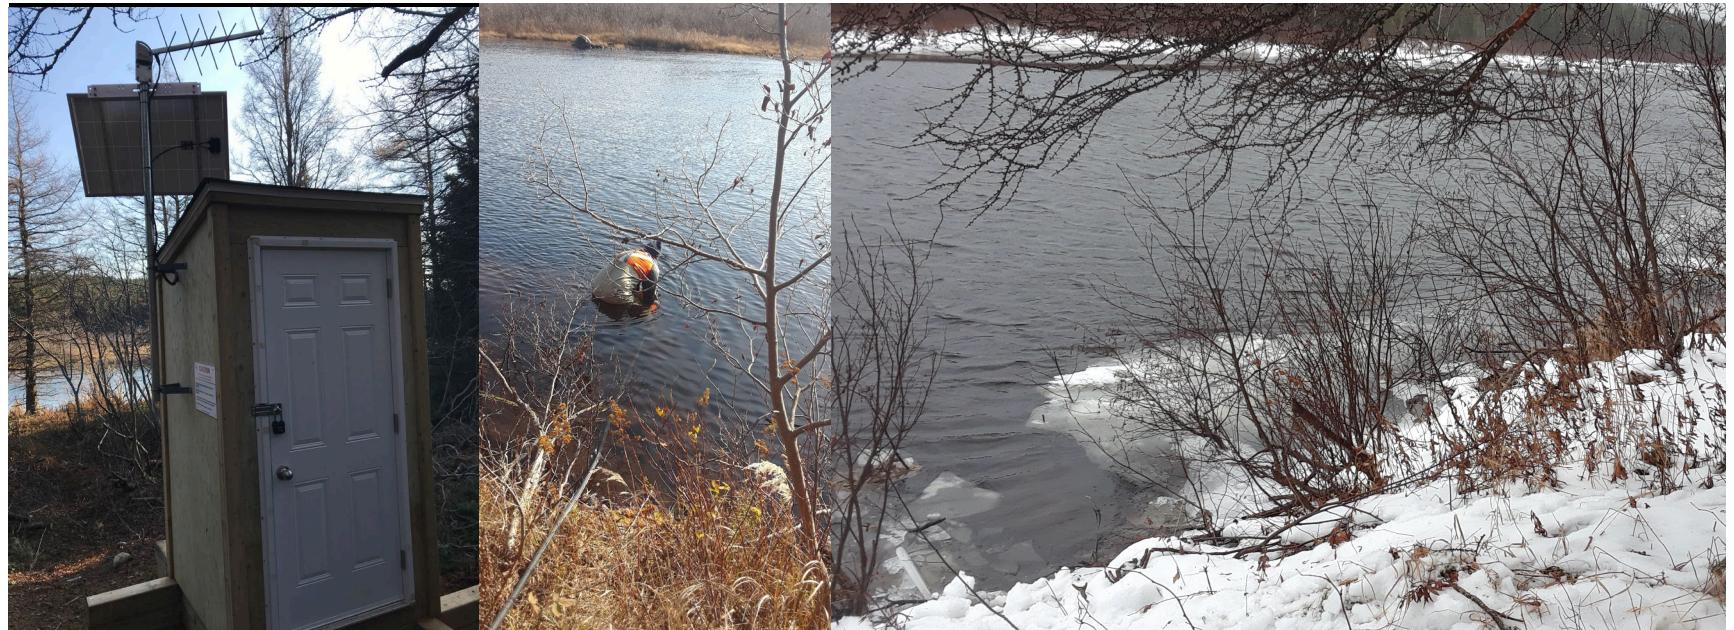
Station Location: Victoria River 6.3km downstream of Victoria dam, below quarry pit. Station setup on western shoreline. Access via ATV trail below quarry pit.

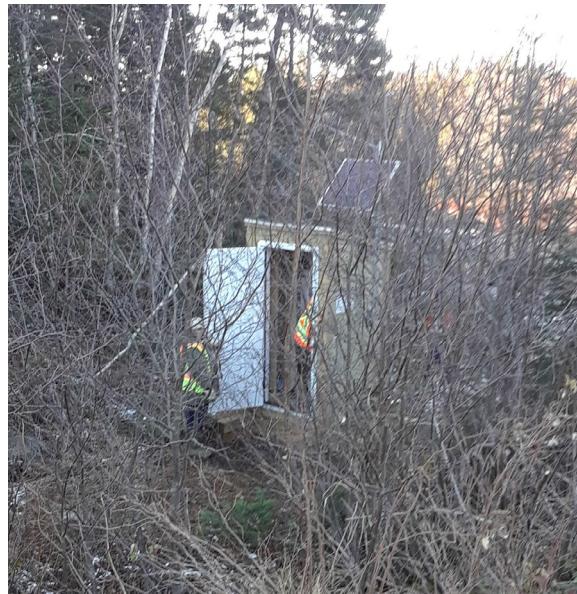
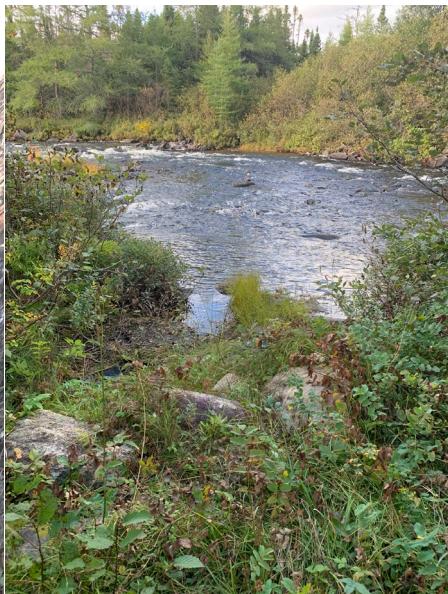
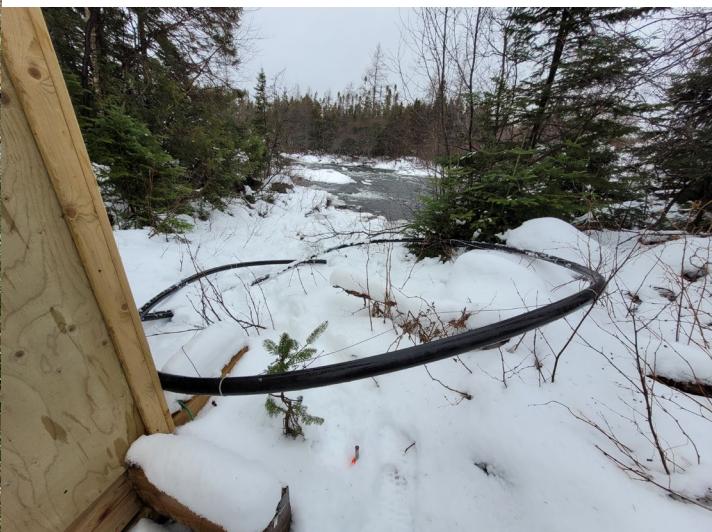
Station Location: Valentine River at access road, 1.9km downstream of Valentine Lake outlet. Station located 15m upstream of access road crossing bridge on southern shoreline.
