Real-Time Water Quality Deployment Report

Marathon Gold Corp
Network

September 6 to November 23, 2023

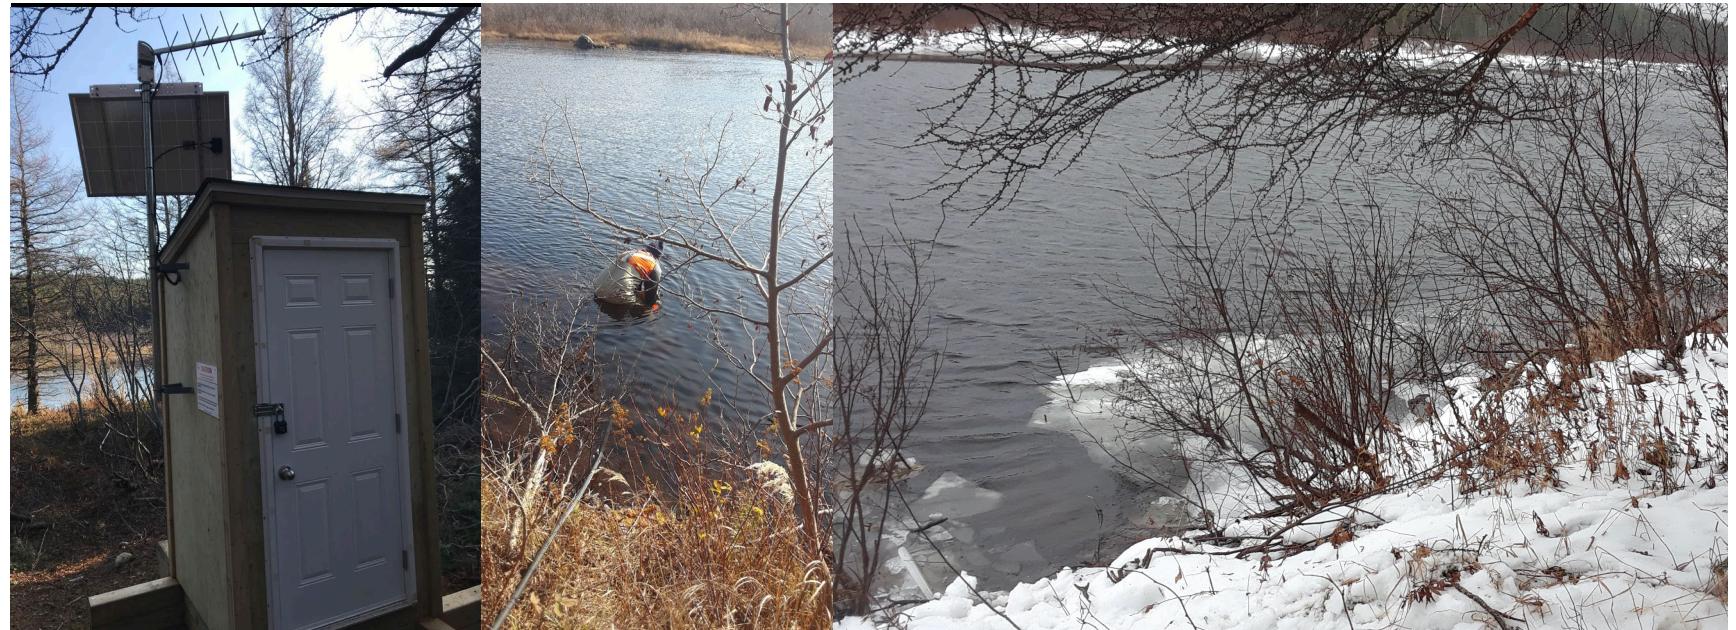
Station Location: Victoria River 6.3km downstream of Victoria dam, below quarry pit. Station setup on western shoreline. Access via ATV trail below quarry pit.

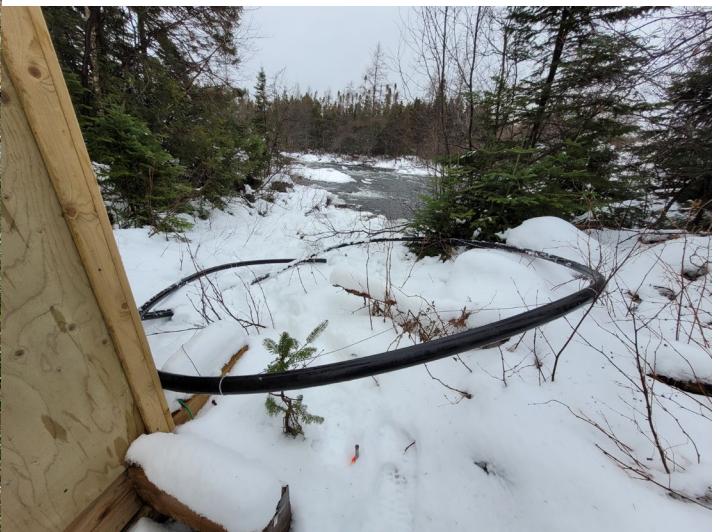
Station Location: Valentine River at access road, 1.9km downstream of Valentine Lake outlet. Station located 15m upstream of access road crossing bridge on southern shoreline.

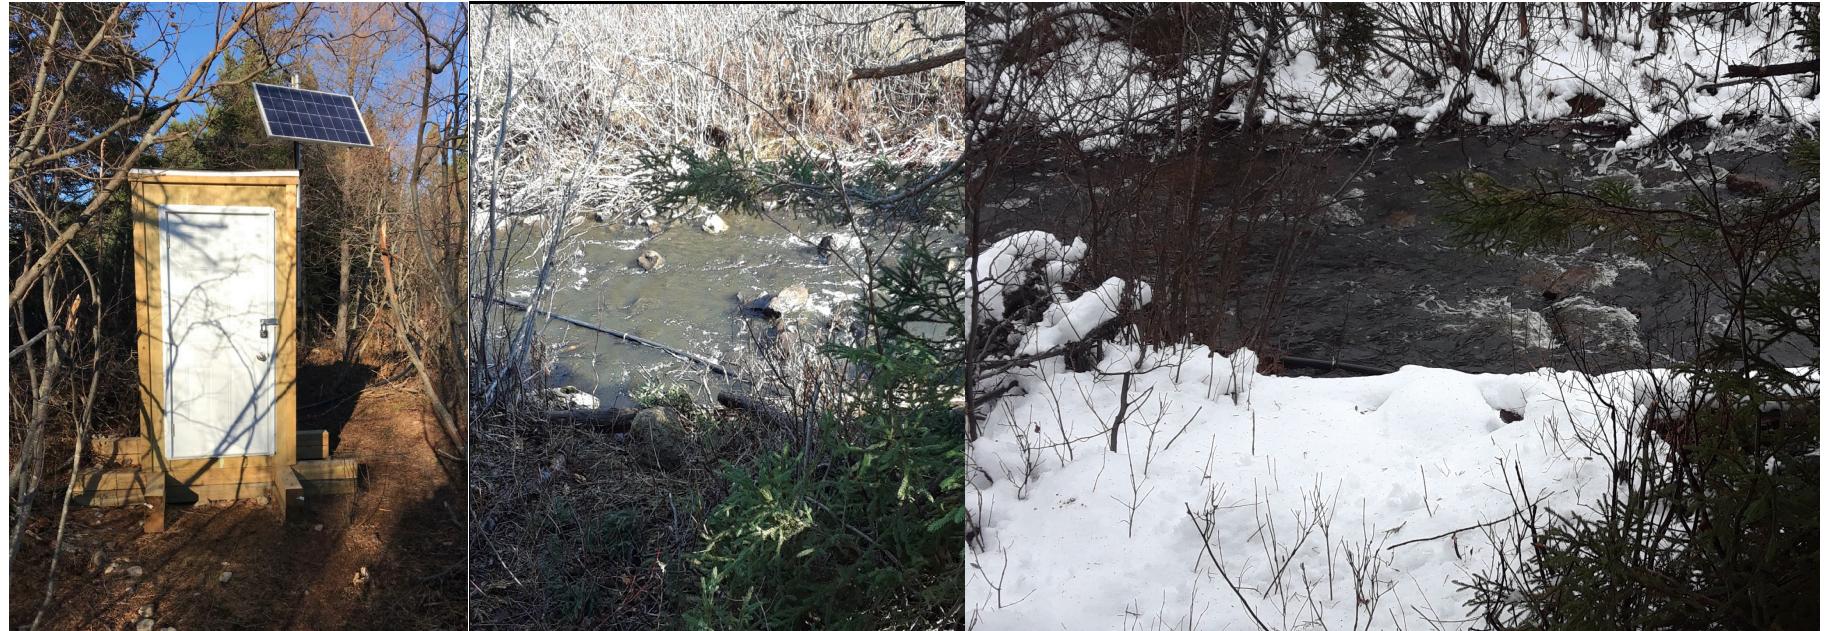
Station Location: Roebucks Brook 30m downstream of access road bridge crossing on western shoreline. Station is 1.6km downstream of Roebucks Lake outlet.
