**SURFACE WATER AND HYDROLOGY
BASELINE REPORT
FOR
PROPOSED WABUSH 3 MINE SITE
LABRADOR CITY
NEWFOUNDLAND AND LABRADOR**

November 2012

TF1243003.2003

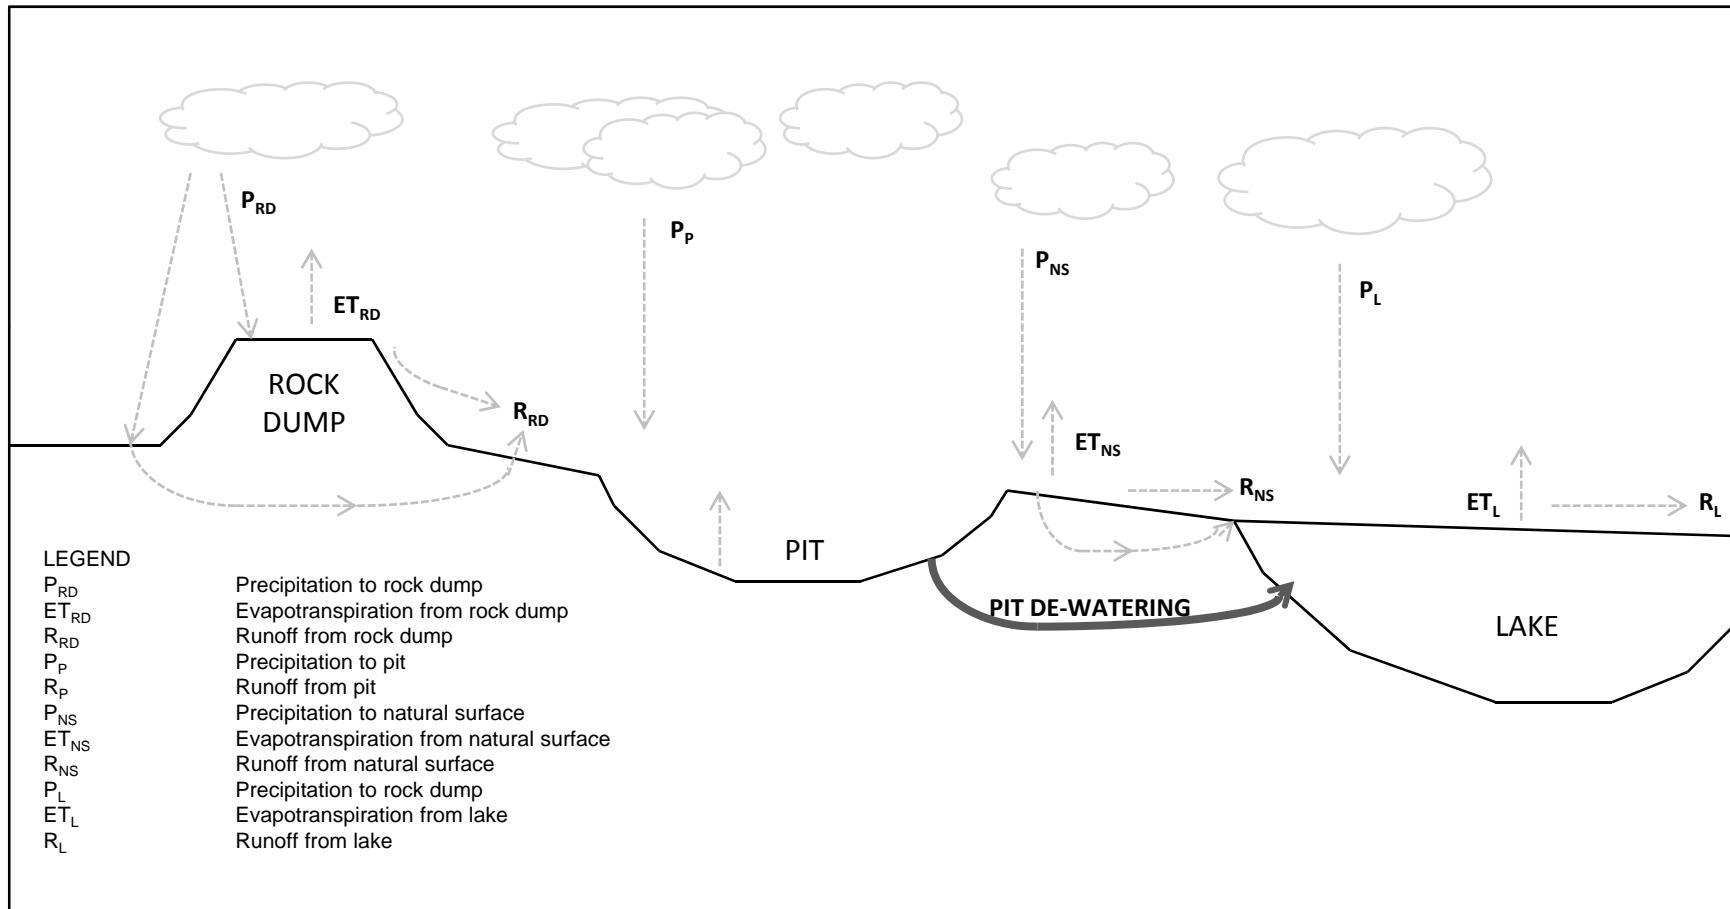
APPENDIX C
SITE WATER BALANCE SCHEMATIC

The model was setup and run using a deterministic Excel-based spreadsheet. The model calculates runoff based on precipitation and evapotranspiration. On a watershed basis, annual changes to groundwater storage due to infiltration (increase in storage) and recharge to lakes and rivers (decrease in storage) were assumed to be negligible (i.e. input to groundwater is balanced by discharge from groundwater). Monthly values were predicted for a mean precipitation year for two conditions:
