HOLYROOD MARINE BASE PHASE IIA

Environmental Registration Document

Fisheries and Marine Institute - Memorial University of Newfoundland

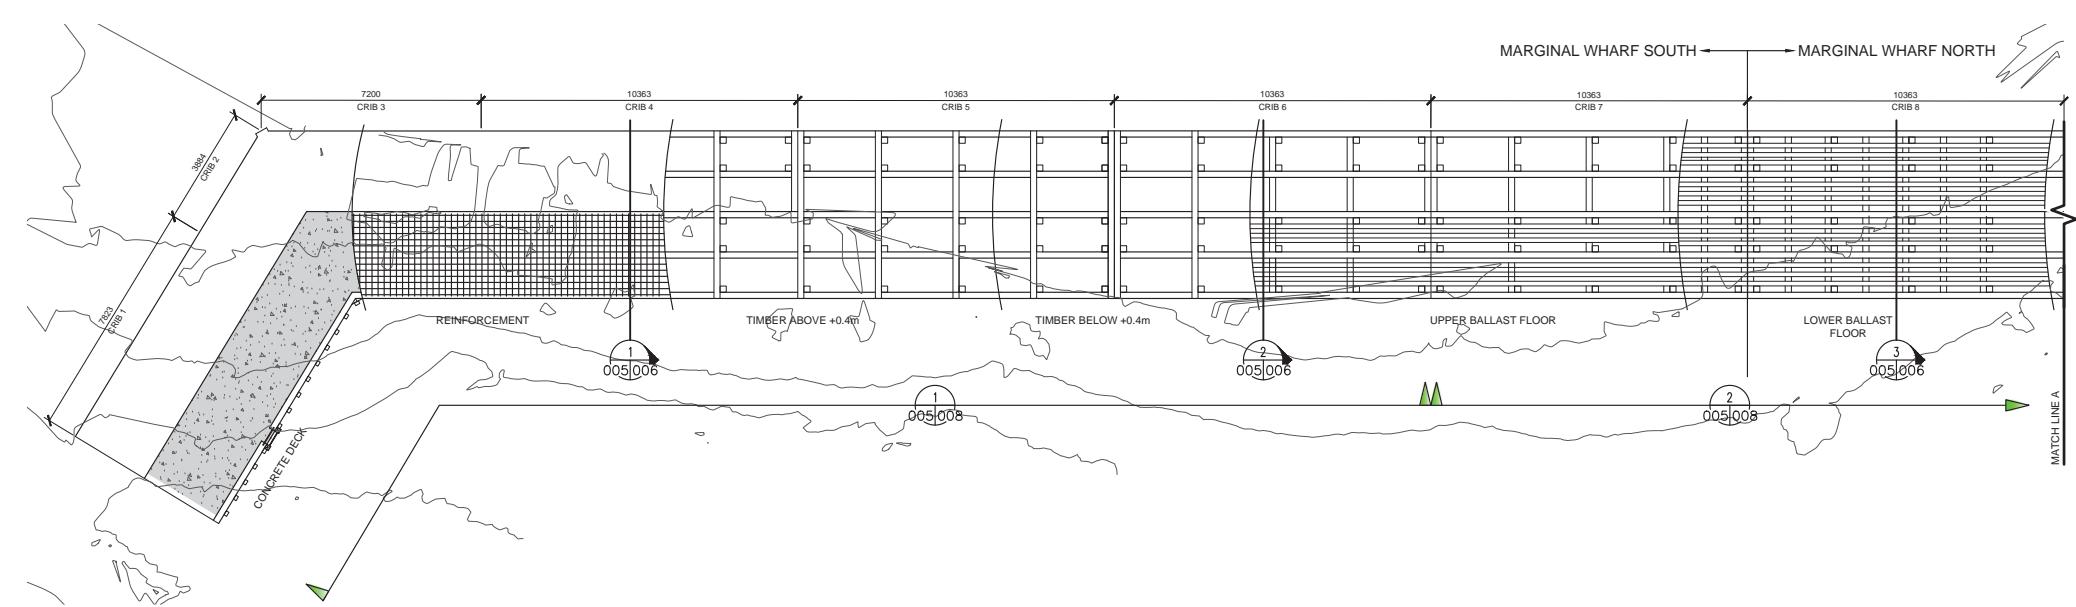
MARGINAL WHARF PLAN VIEW

NOTES: DIMENSIONS FOR S-SHAPED REBAR AS REQUIRED TO SPLICER HORIZONTAL REINFORCEMENT OF RETAINING WALL

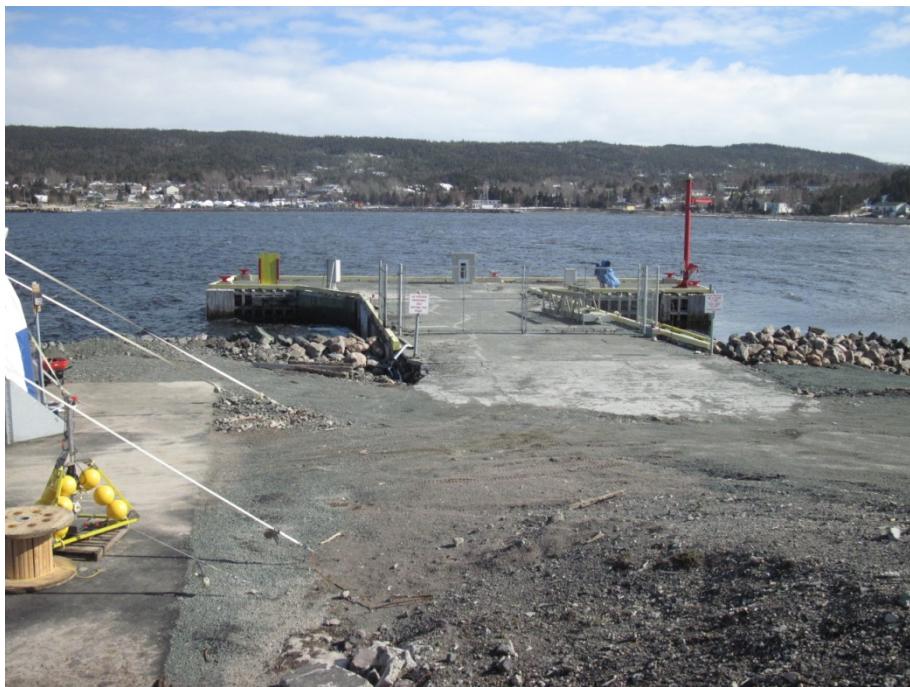
Photo 3: T-shaped wharf located within the subject property (facing east).

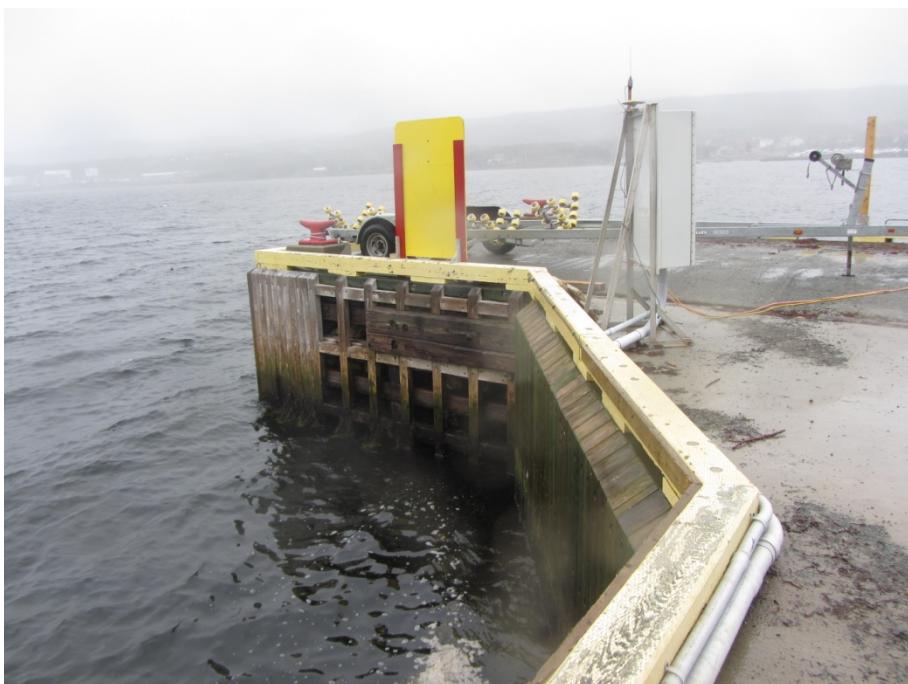
Photo 8: Detail of T-shaped wharf.

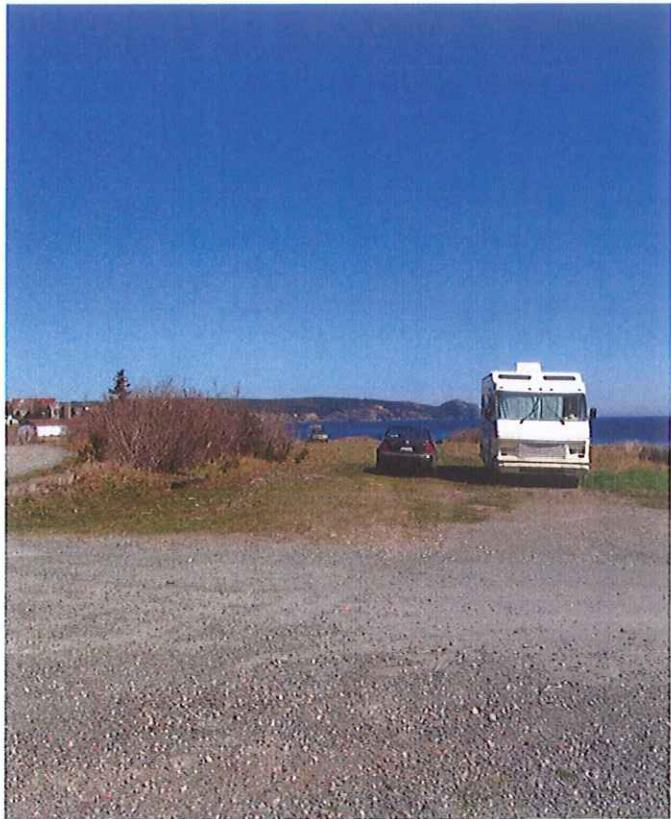
Photo#1: Looking north across subject property.
CNR was located near bushes at left.

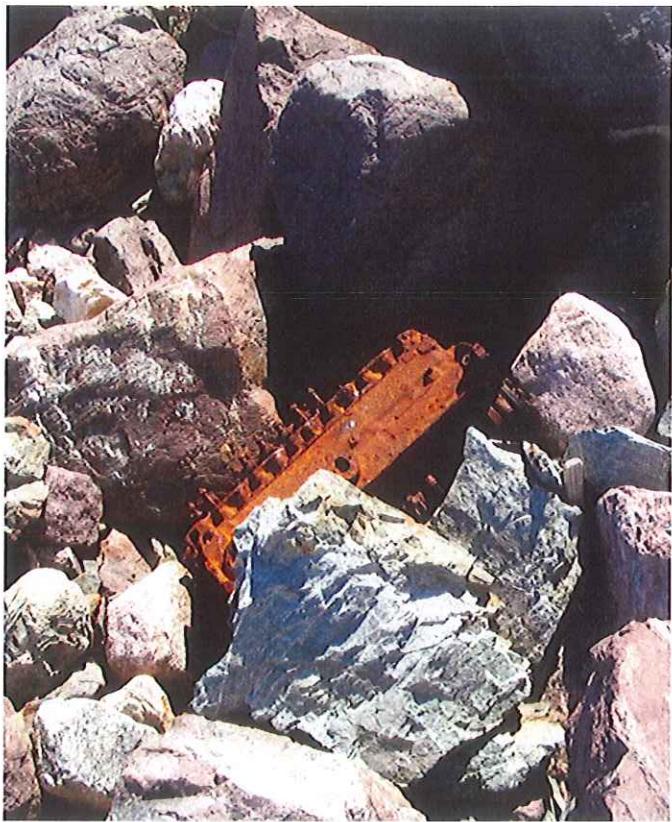
Photo#5: Discarded engine block on slope-north edge of subject property.

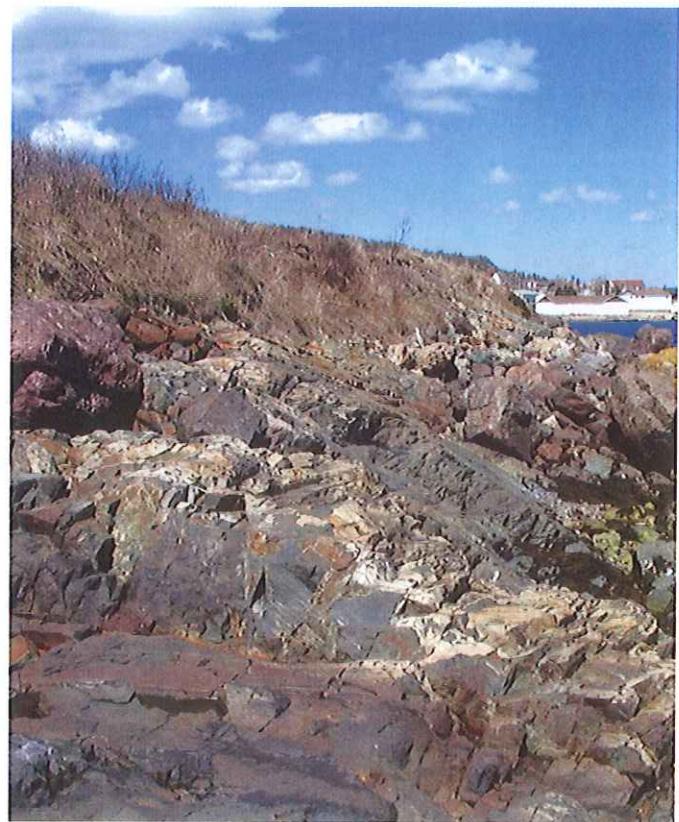
Photo#6: Bedrock outcropping along shoreline east side of subject property.

Bedrock was observed outcropping along the eastern edge of site shoreline. Based on a field examination of these exposures, bedrock consists of a grey to green, interbedded siltstone and fine

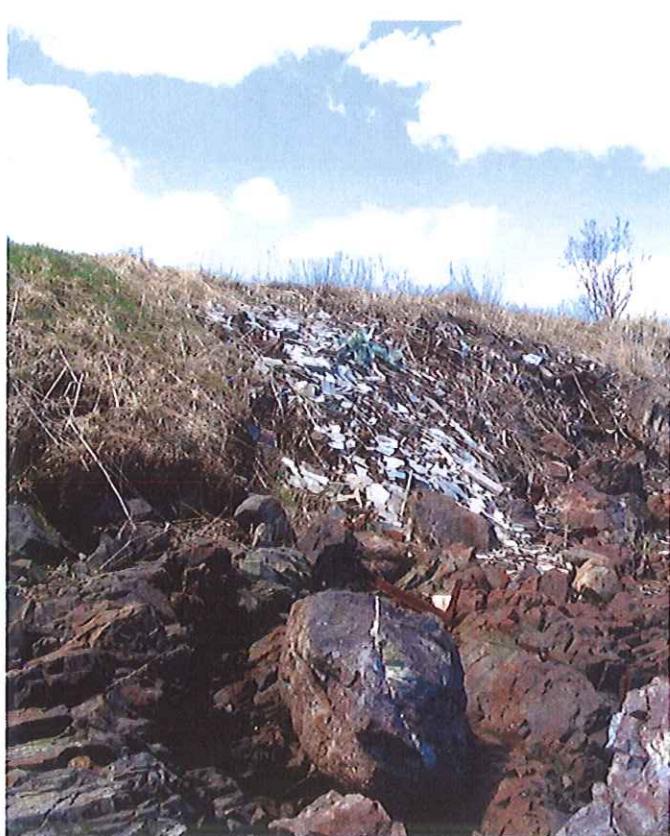
Photo#7: Garbage/debris along east edge of site (near south end).

Some suspected ACMs (non-friable siding) were observed as part of some surface debris near the southeast edge of the subject property (along shoreline embankment).

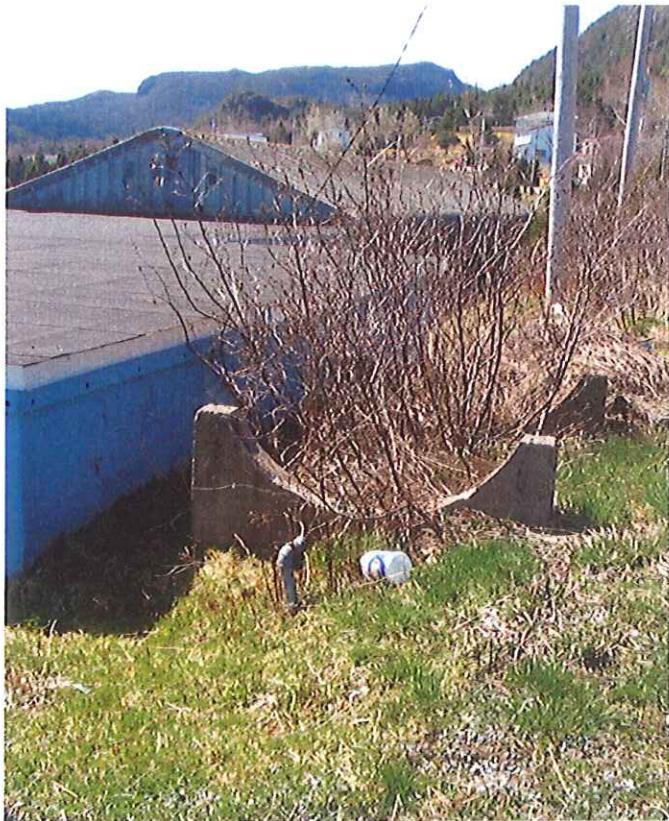
Photo#9: Former above ground fuel oil tank on west side of fish plant (south of subject property).

The subject property is bounded to the south by an associated easement, and by the *Seaxx Fish Plant* and Federal wharf. A tank cradle, formerly supporting an above ground furnace oil tank (confirmed by neighbour), was observed adjacent to this easement beside the fish plant south structure.

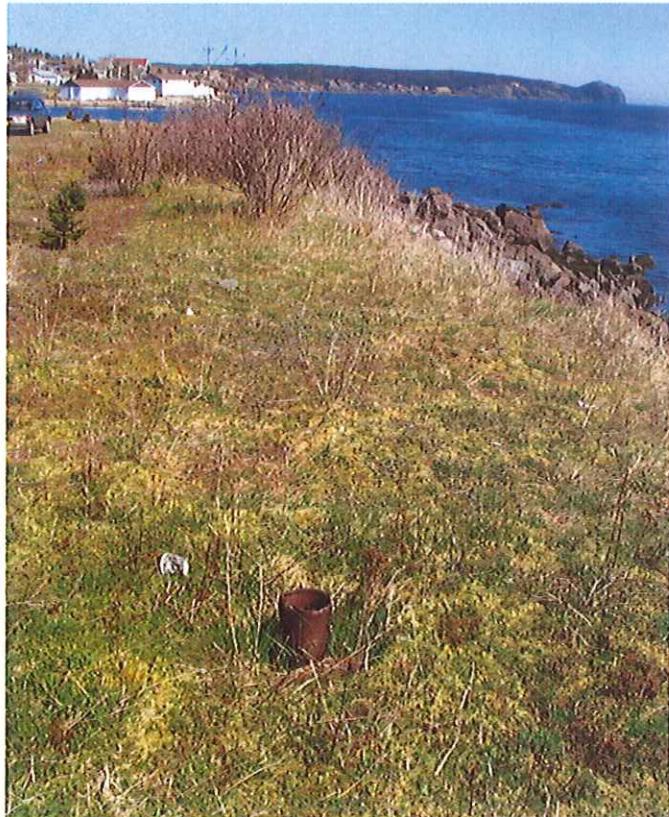
Photo#15: Suspected abandoned well at south end of subject property.

A suspected abandoned 150 mm diameter drilled well was noted at the south edge of the property.

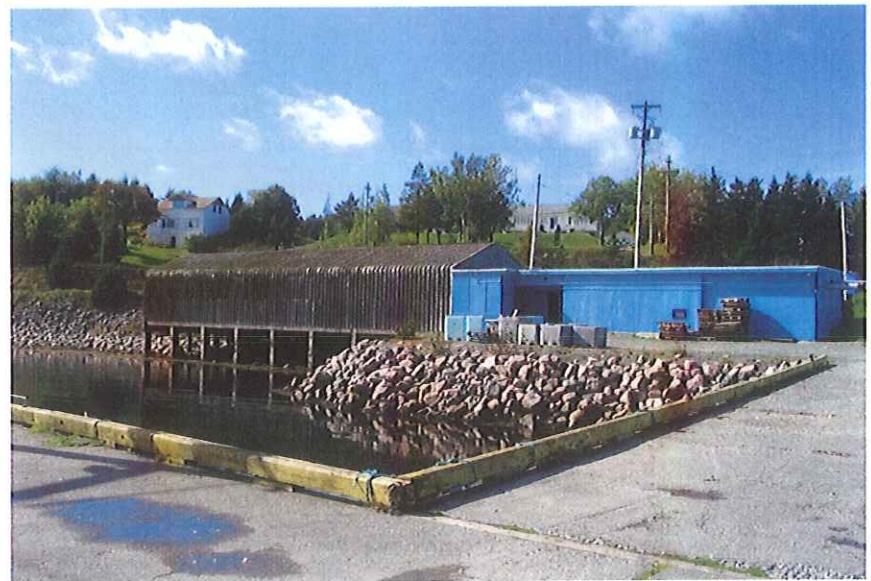
Photo#7: Waste oil storage on east side of Main Plant.

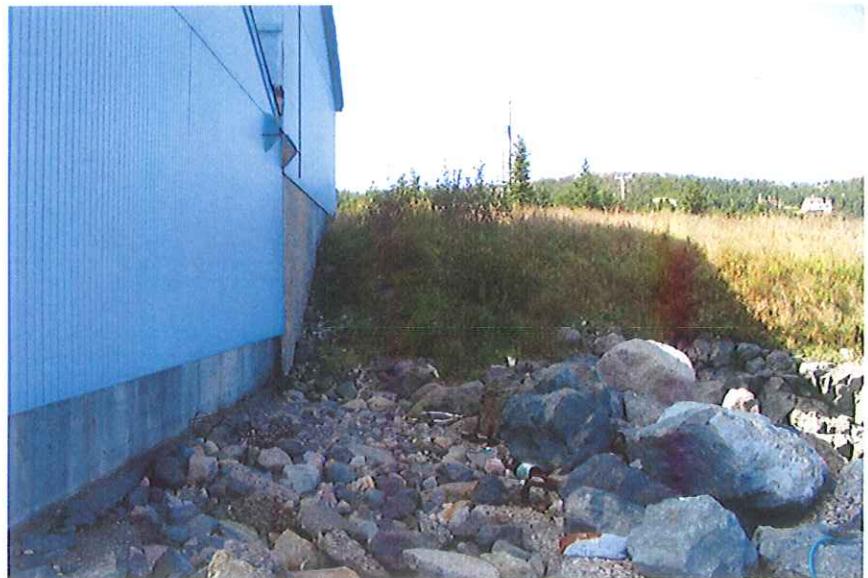
Photo#10: Suspected ACM debris along north side of Main Plant.

ACMs are highly suspect as exterior shingle-type cladding over approximately 30 percent of the main plant building. ACMs are highly suspect as a rigid, corrugated sheeting on the roof and siding of approximately 50 percent of the cold storage structure. ACM debris associated with broken ACM shingles was noted on the ground along the north side of the main plant building. Corrugated ACM sheeting from the cold storage building was seen to be extensively damaged with numerous holes. ACMs may be present within other building materials such as vinyl floor tiles, ceiling tile, joint compound/plaster, and mechanical insulation.

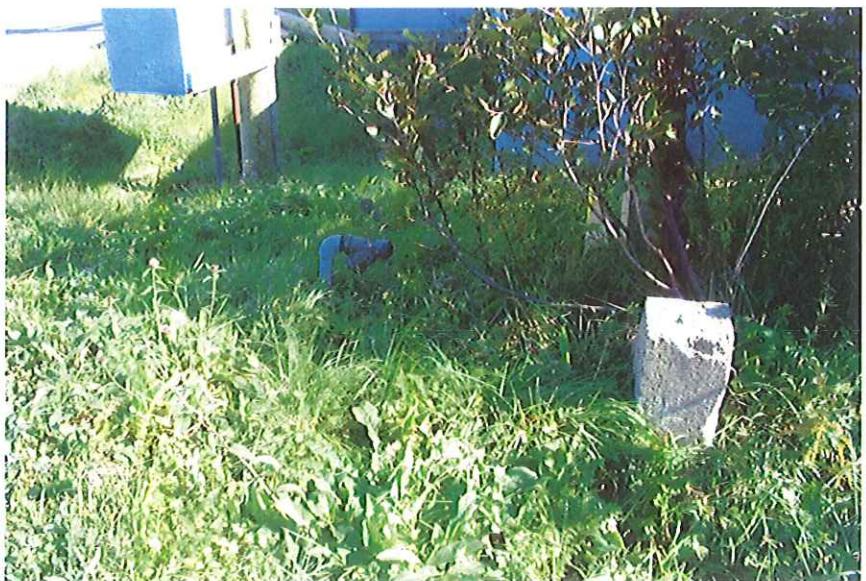
Photo#12: Tank cradle and u/g line at northwest corner of Cold Storage Building.

Several pressure vessels/tanks, all associated with the ammonia refrigeration system, were present in the engine room. A concrete tank cradle was observed near the northwest corner of the southern building. This cradle appears to be large enough to support a storage tank capacity in the range of 15 000 to 20 000 litres. The tank itself was reported removed in the 1970s-1980s and was formerly used to store diesel that supplied on-site power generators (used to power refrigeration system until 1970s).

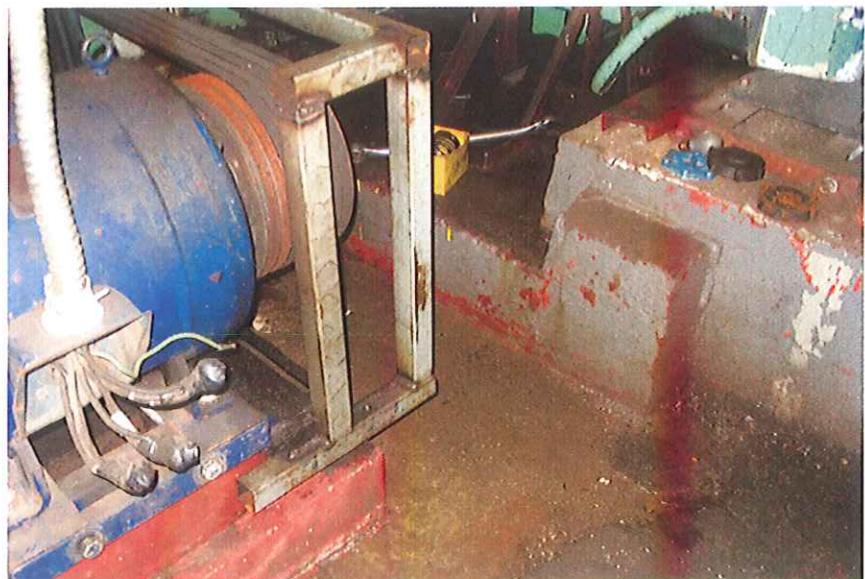
Photo#16: Waste oil storage in compressor/engine room.

Some oil staining and free oil from recent spillage was noted on the compressor room floor (concrete).

Findings	Evaluation of Findings
Actual	
1. Waste compressor oils were noted spilled on the engine/compressor room floor.	1. These oils should be cleaned up. There is some potential for impacts beneath the floor of the plant.

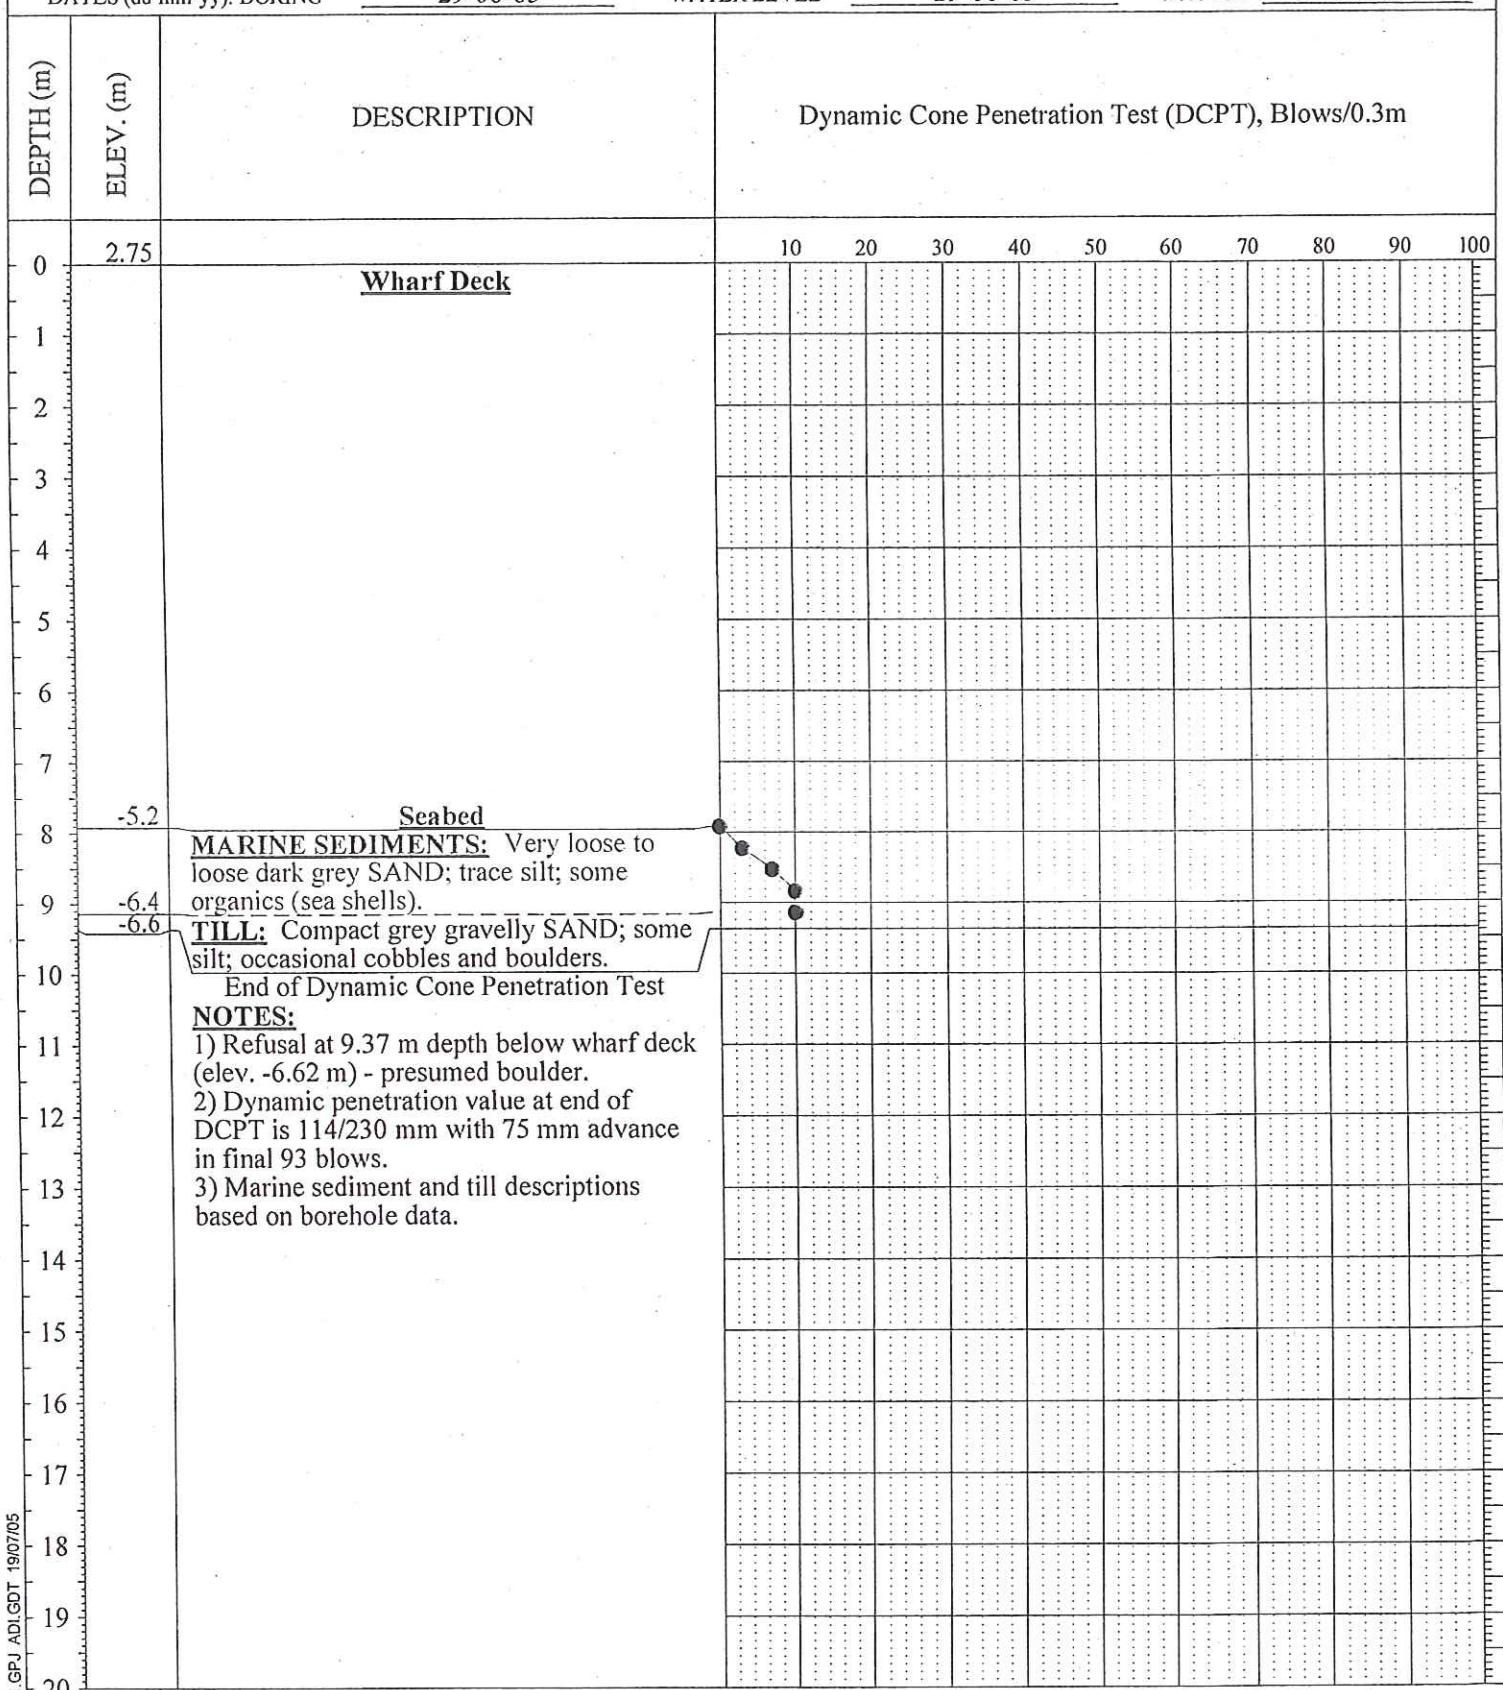
DYNAMIC CONE PENETRATION TEST RECORD

D.C.P.T. No. DCPT 1

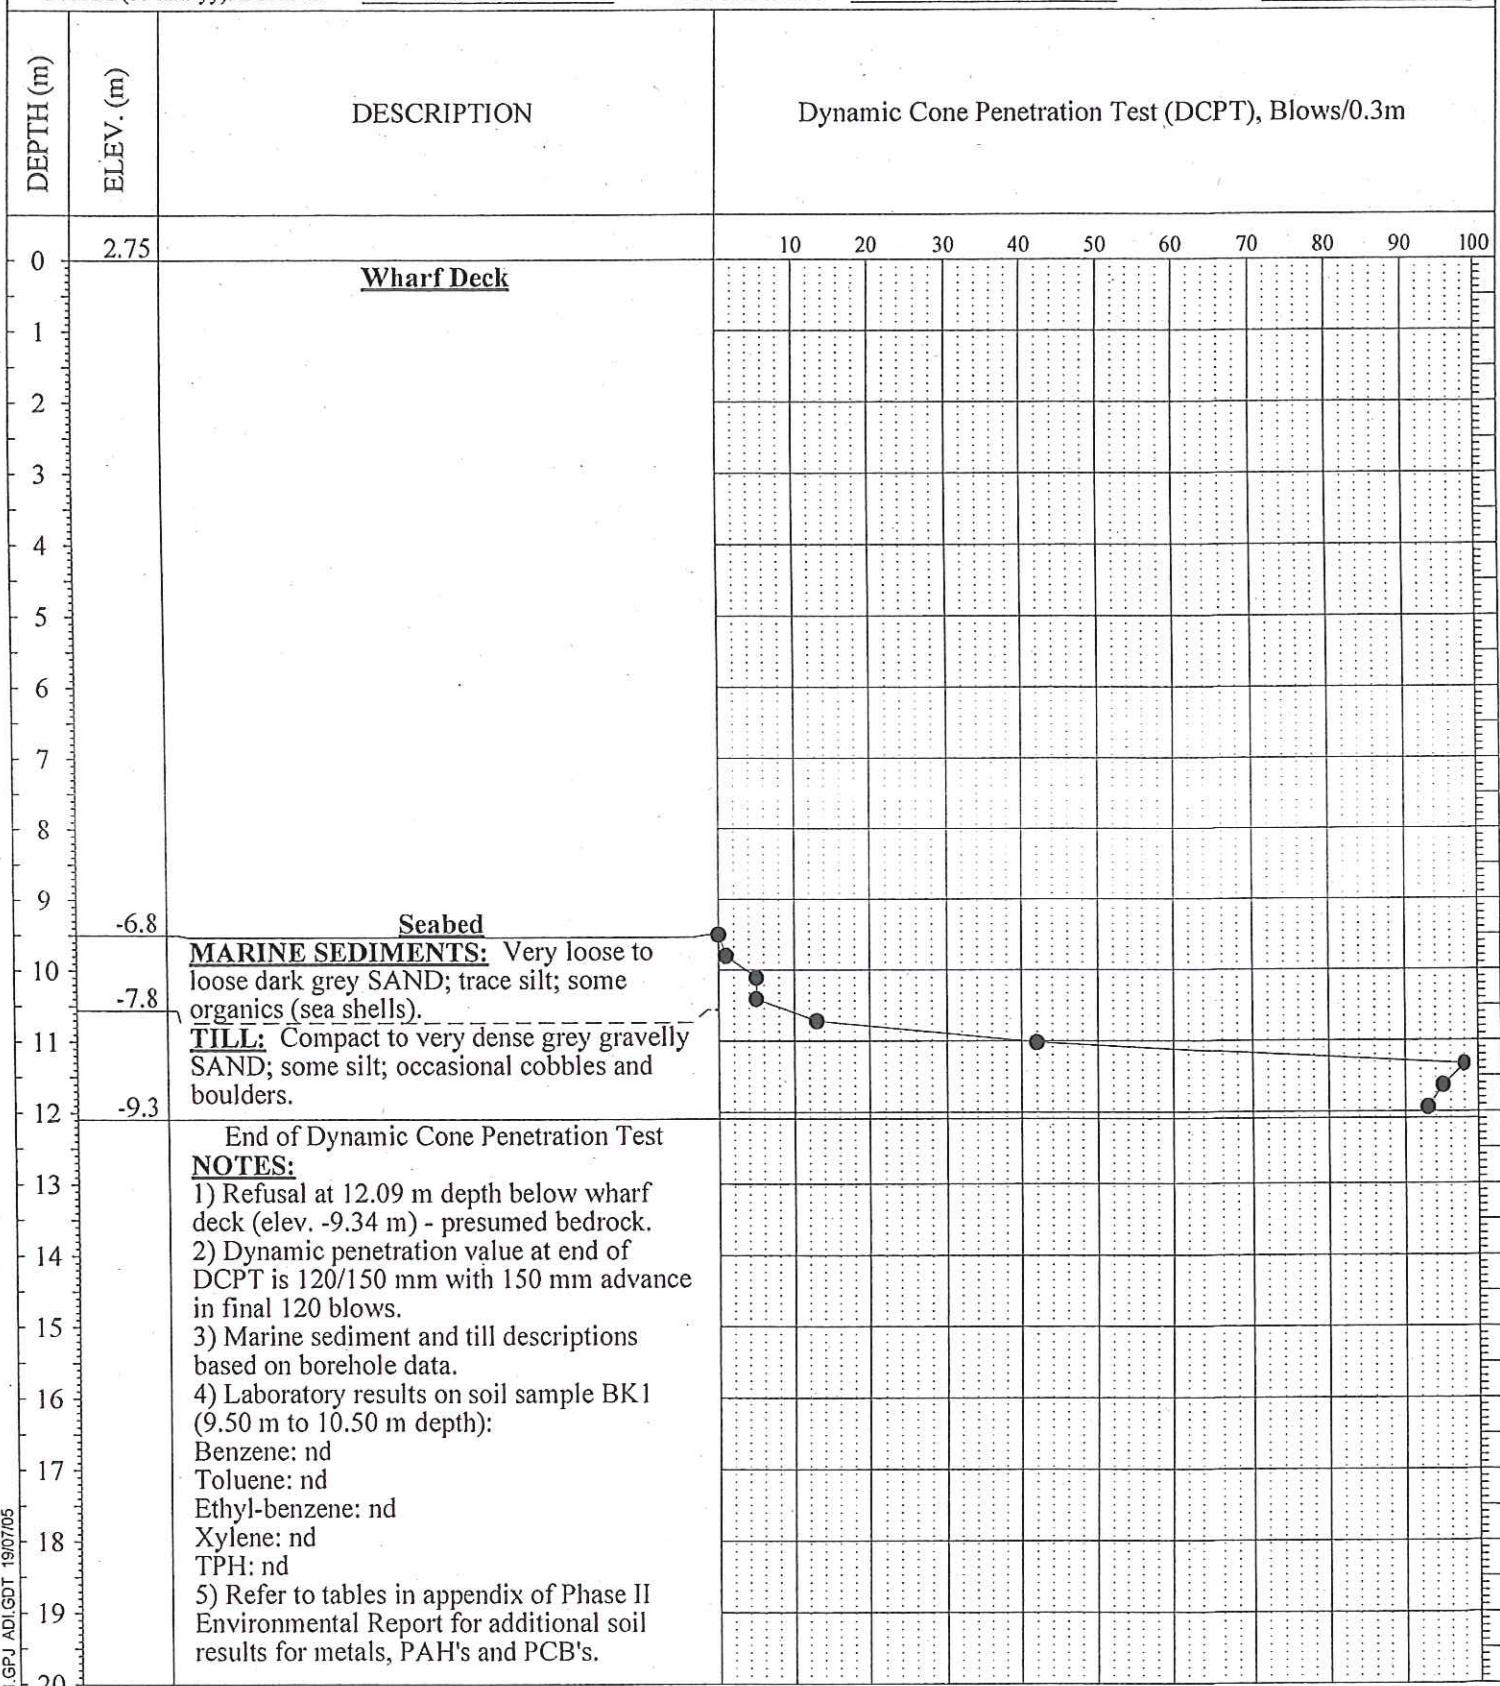
DYNAMIC CONE PENETRATION TEST RECORD

PROJECT No. 26-4553-004.1
 D.C.P.T. No. DCPT 4
 DATUM Geodetic

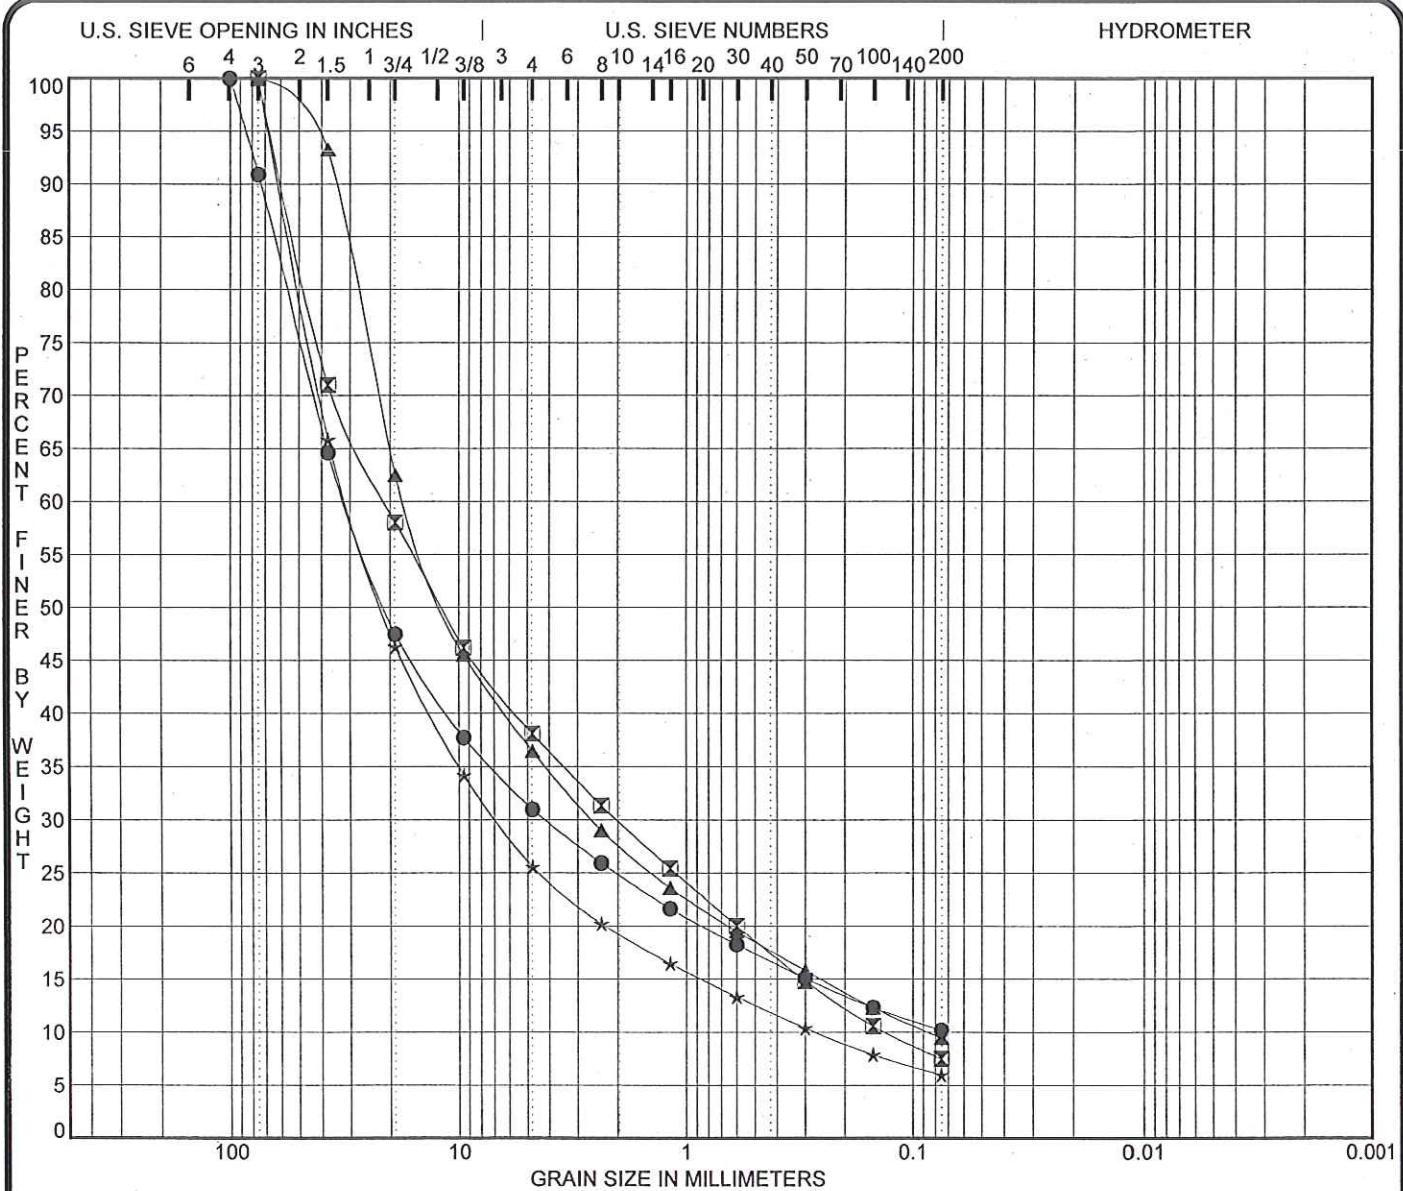
GRADATION CURVES

COBBLES	GRAVEL		SAND			SILT OR CLAY					
	coarse	fine	coarse	medium	fine						
● TP 1 1.3	FILL: Sandy GRAVEL, some silt (GP-GM)					5.9				7.71	438.3
✖ TP 2 1.3	FILL: Sandy GRAVEL, trace silt (GW-GM)					14.2				1.45	158.9
▲ TP 3 1.3	FILL: Sandy GRAVEL, trace silt (GP-GM)					11.2				4.54	199.6
★ TP 4 2.3	FILL: GRAVEL, some silt, trace silt (GP-GM)					6.0				5.57	113.2
Location Depth (m)	Classification (USCS)					MC%	LL	PL	PI	Cc	Cu
● TP 1 1.3	FILL: Sandy GRAVEL, some silt (GP-GM)					5.9				7.71	438.3
✖ TP 2 1.3	FILL: Sandy GRAVEL, trace silt (GW-GM)					14.2				1.45	158.9
▲ TP 3 1.3	FILL: Sandy GRAVEL, trace silt (GP-GM)					11.2				4.54	199.6
★ TP 4 2.3	FILL: GRAVEL, some silt, trace silt (GP-GM)					6.0				5.57	113.2
Location Depth (m)	D100	D60	D30	D10	%Gravel	%Sand	%Silt	%Clay			
● TP 1 1.3	100.00	31.22	4.141		59.9	20.8	10.2				
✖ TP 2 1.3	75.00	21.08	2.014	0.1327	61.9	30.6	7.5				
▲ TP 3 1.3	75.00	17.17	2.591	0.0860	63.5	27.0	9.4

★ TP 4 2.3	75.00	30.60	6.785	0.2703	74.4	19.6	6.0
