RISK MANAGEMENT PLAN FOR PUBLIC AREAS

BUCHANS, NEWFOUNDLAND AND LABRADOR

**Prepared by:
Conestoga-Rovers
& Associates**

**JUNE 2011
REF. NO. 070854 (4)**

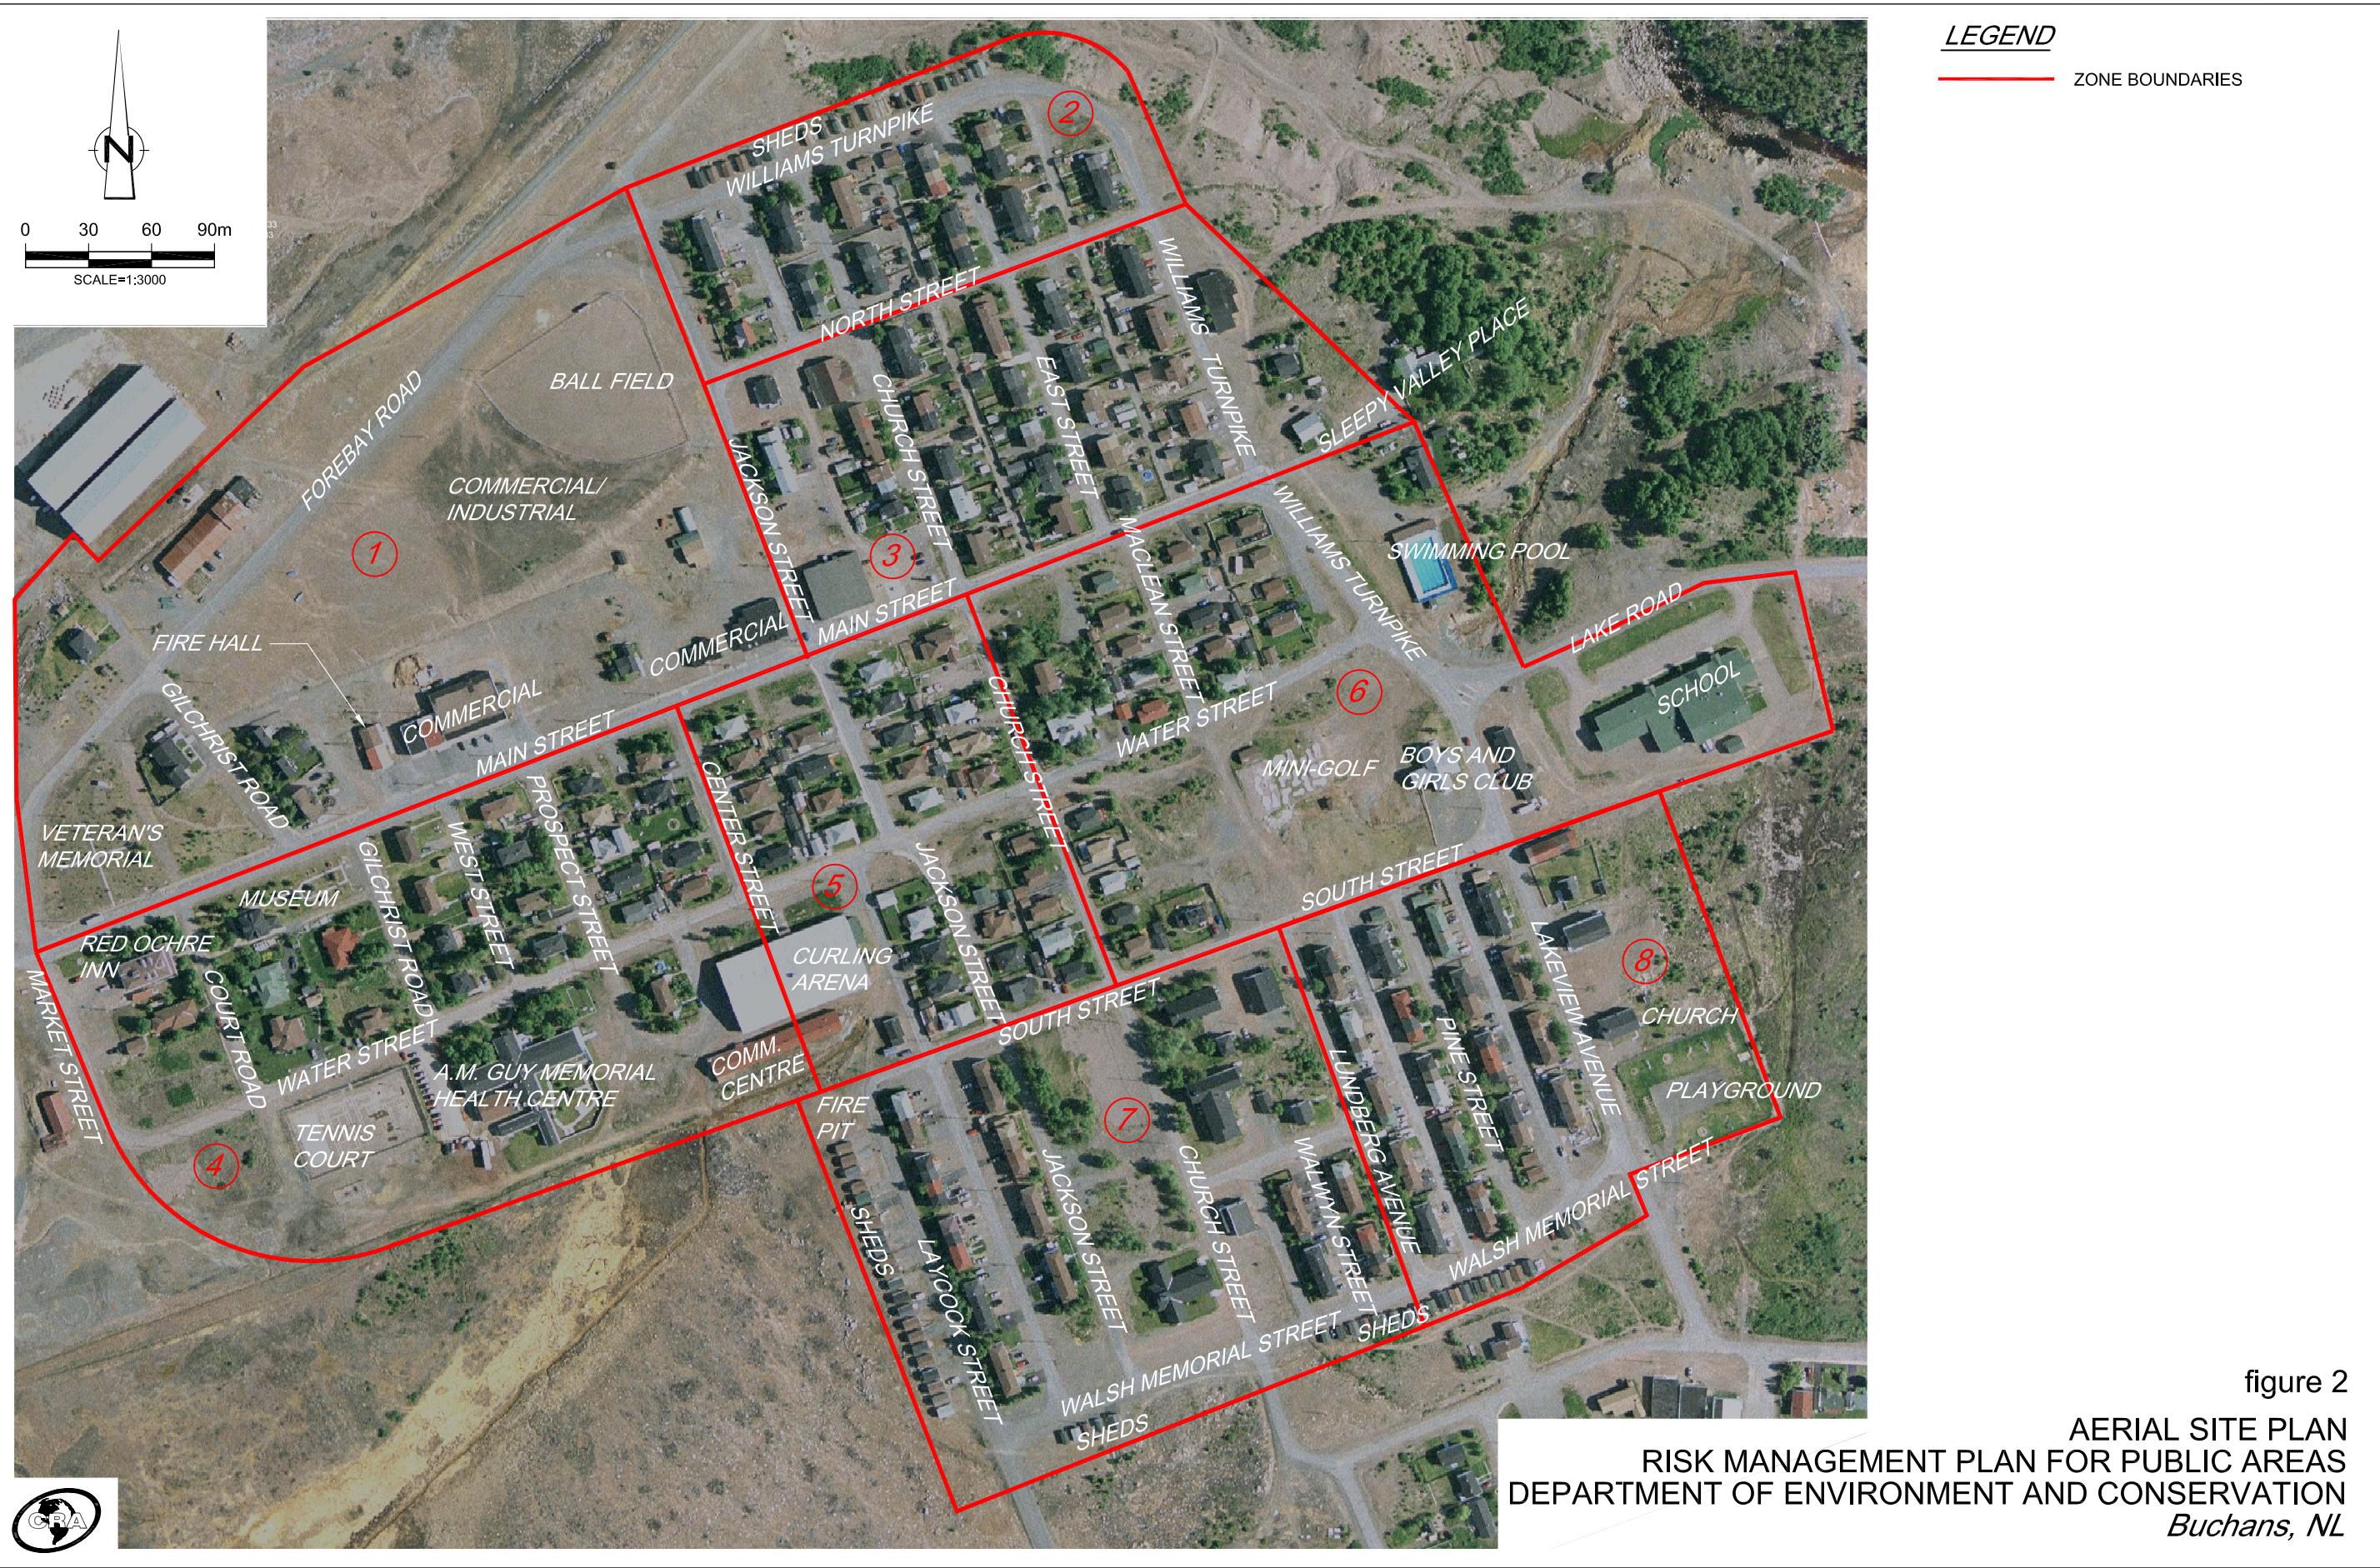
figure 2

CRA investigated 8 zones in the northern area of Town as shown on Figure 2. CRA combined the analytical data for samples collected from the CRA 2009 Phase II Environmental Site Assessment (ESA), 2010 HHRA, and 2010 RMP.

AERIAL SITE PLAN RISK MANAGEMENT PLAN FOR PUBLIC AREAS DEPARTMENT OF ENVIRONMENT AND CONSERVATION *Buchans, NL*

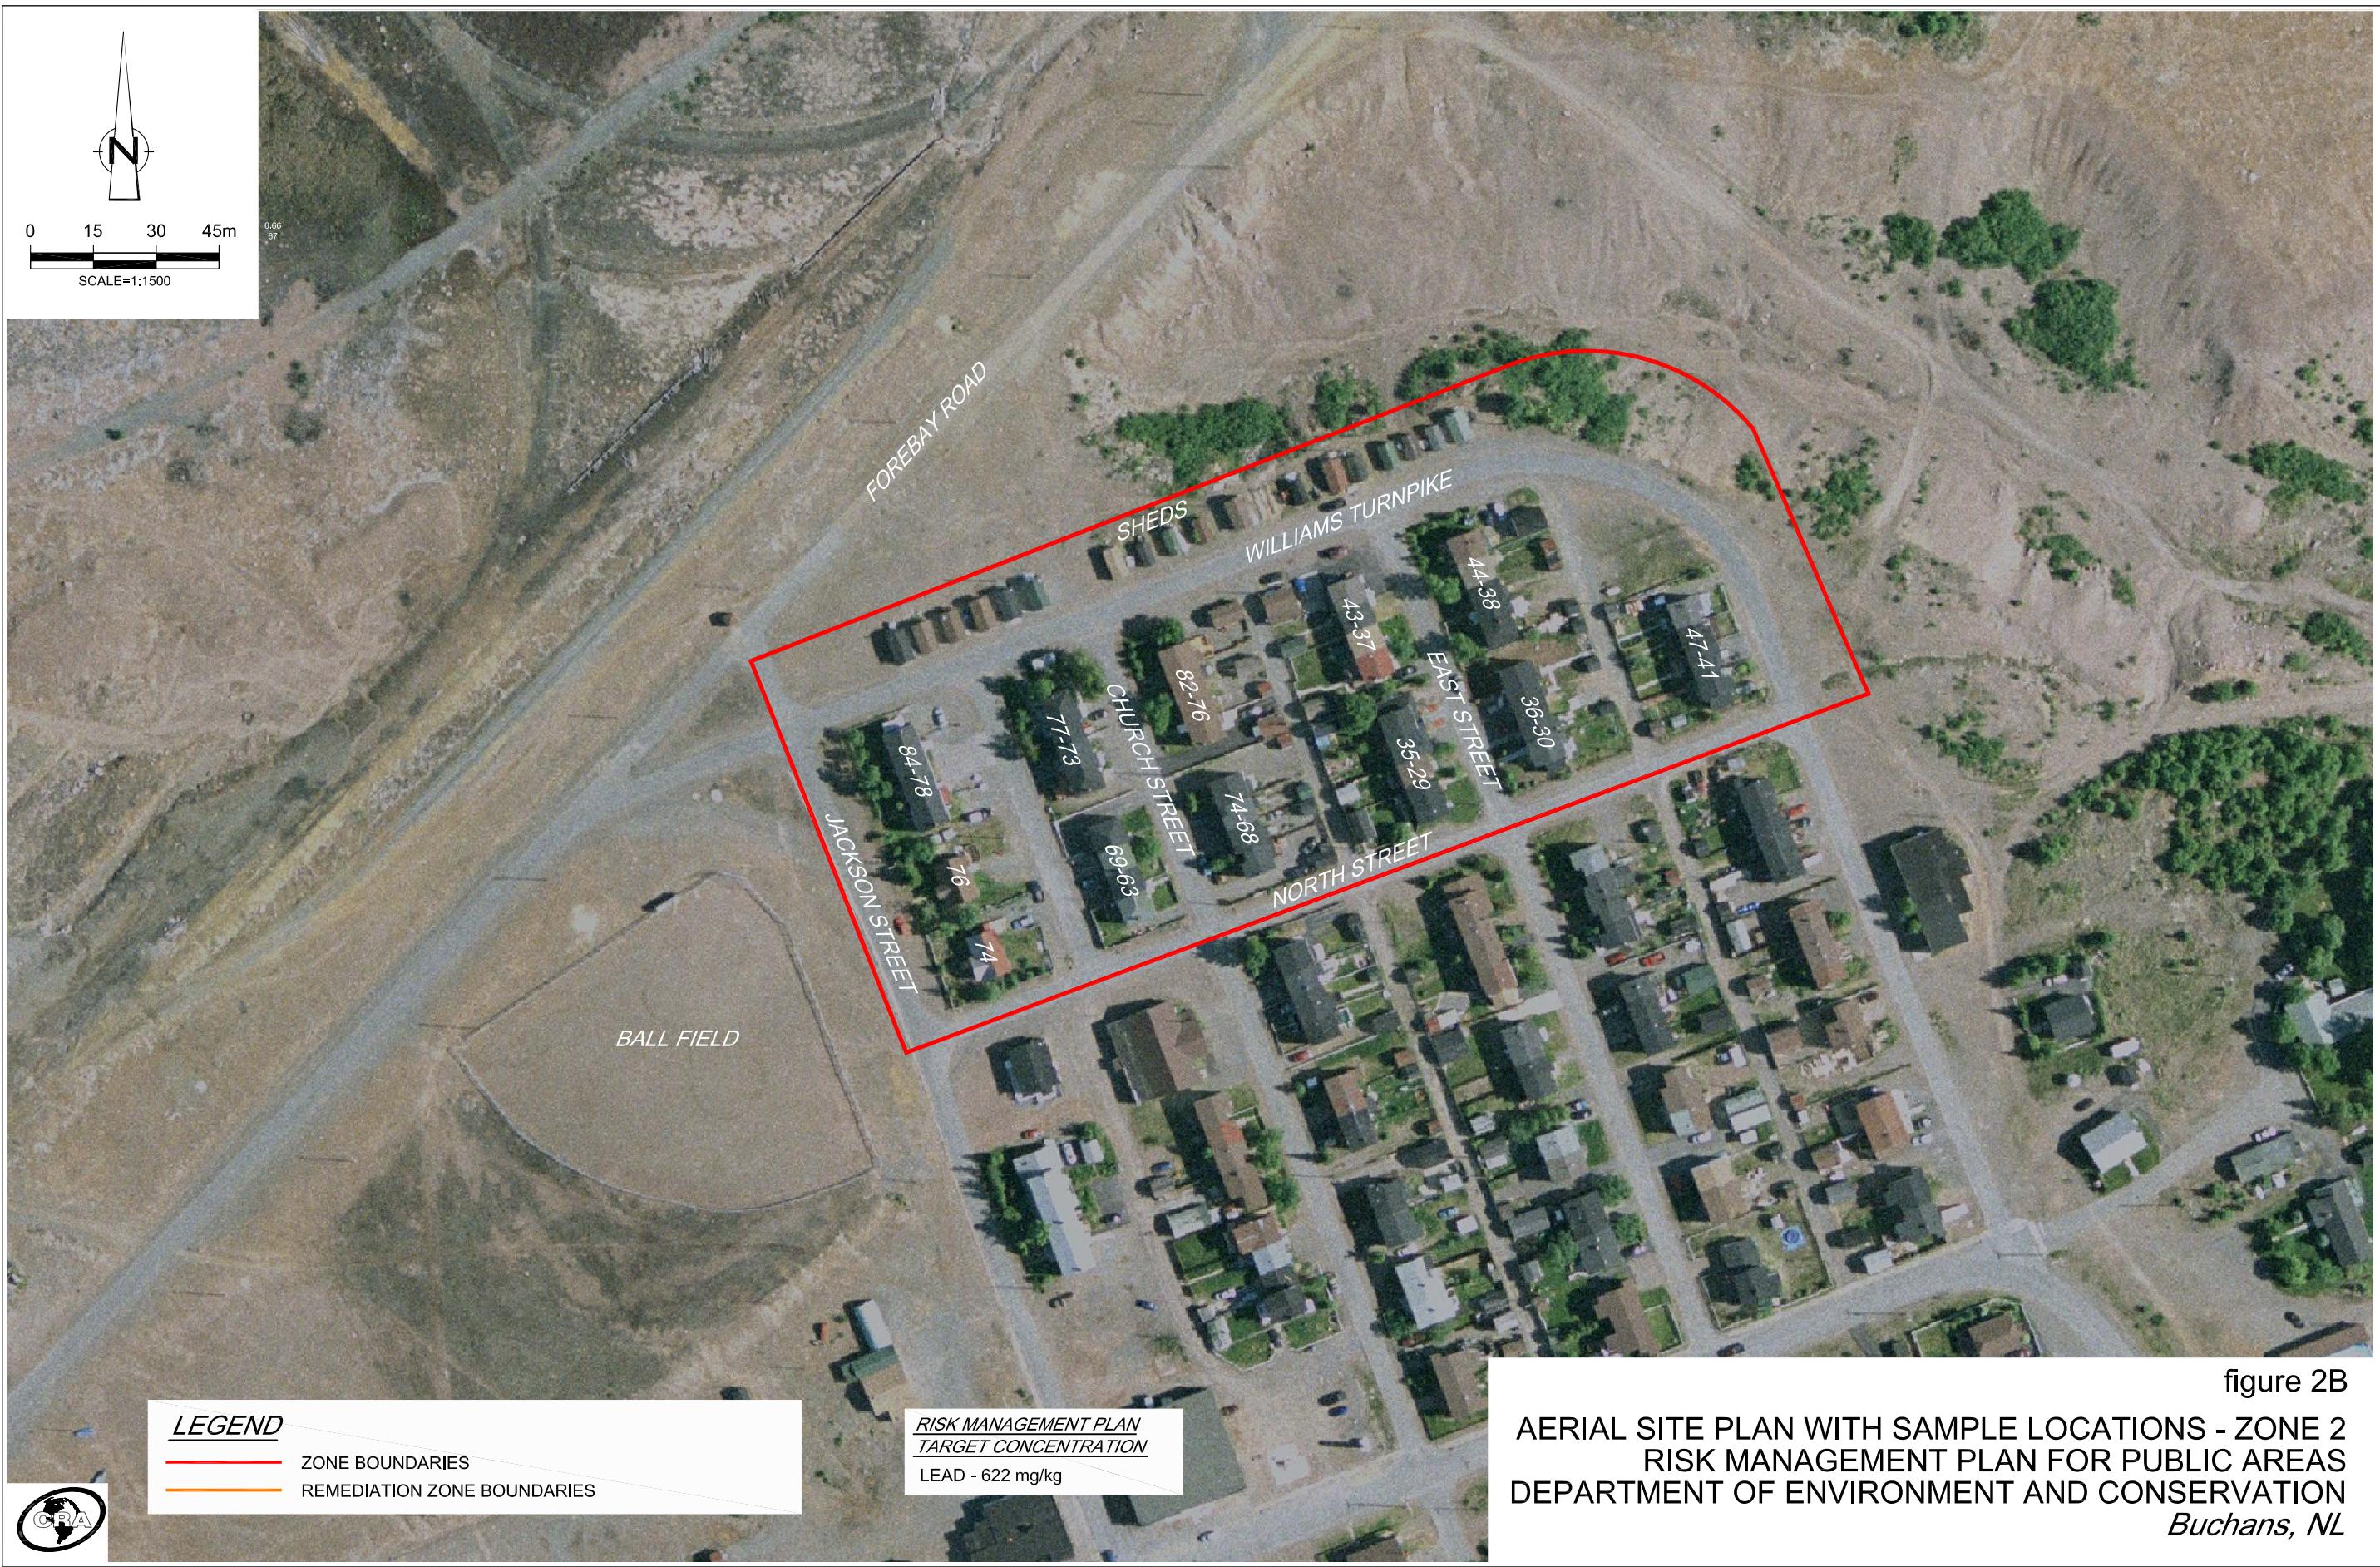
Zone 2 is bounded to the east and north by William's Turnpike, to the west by Jackson Street, and to the south by North Street along with sections of East Street and Church Street contained within the above noted boundaries. Public Areas were not identified in Zone 2 as shown on Figure 2B.

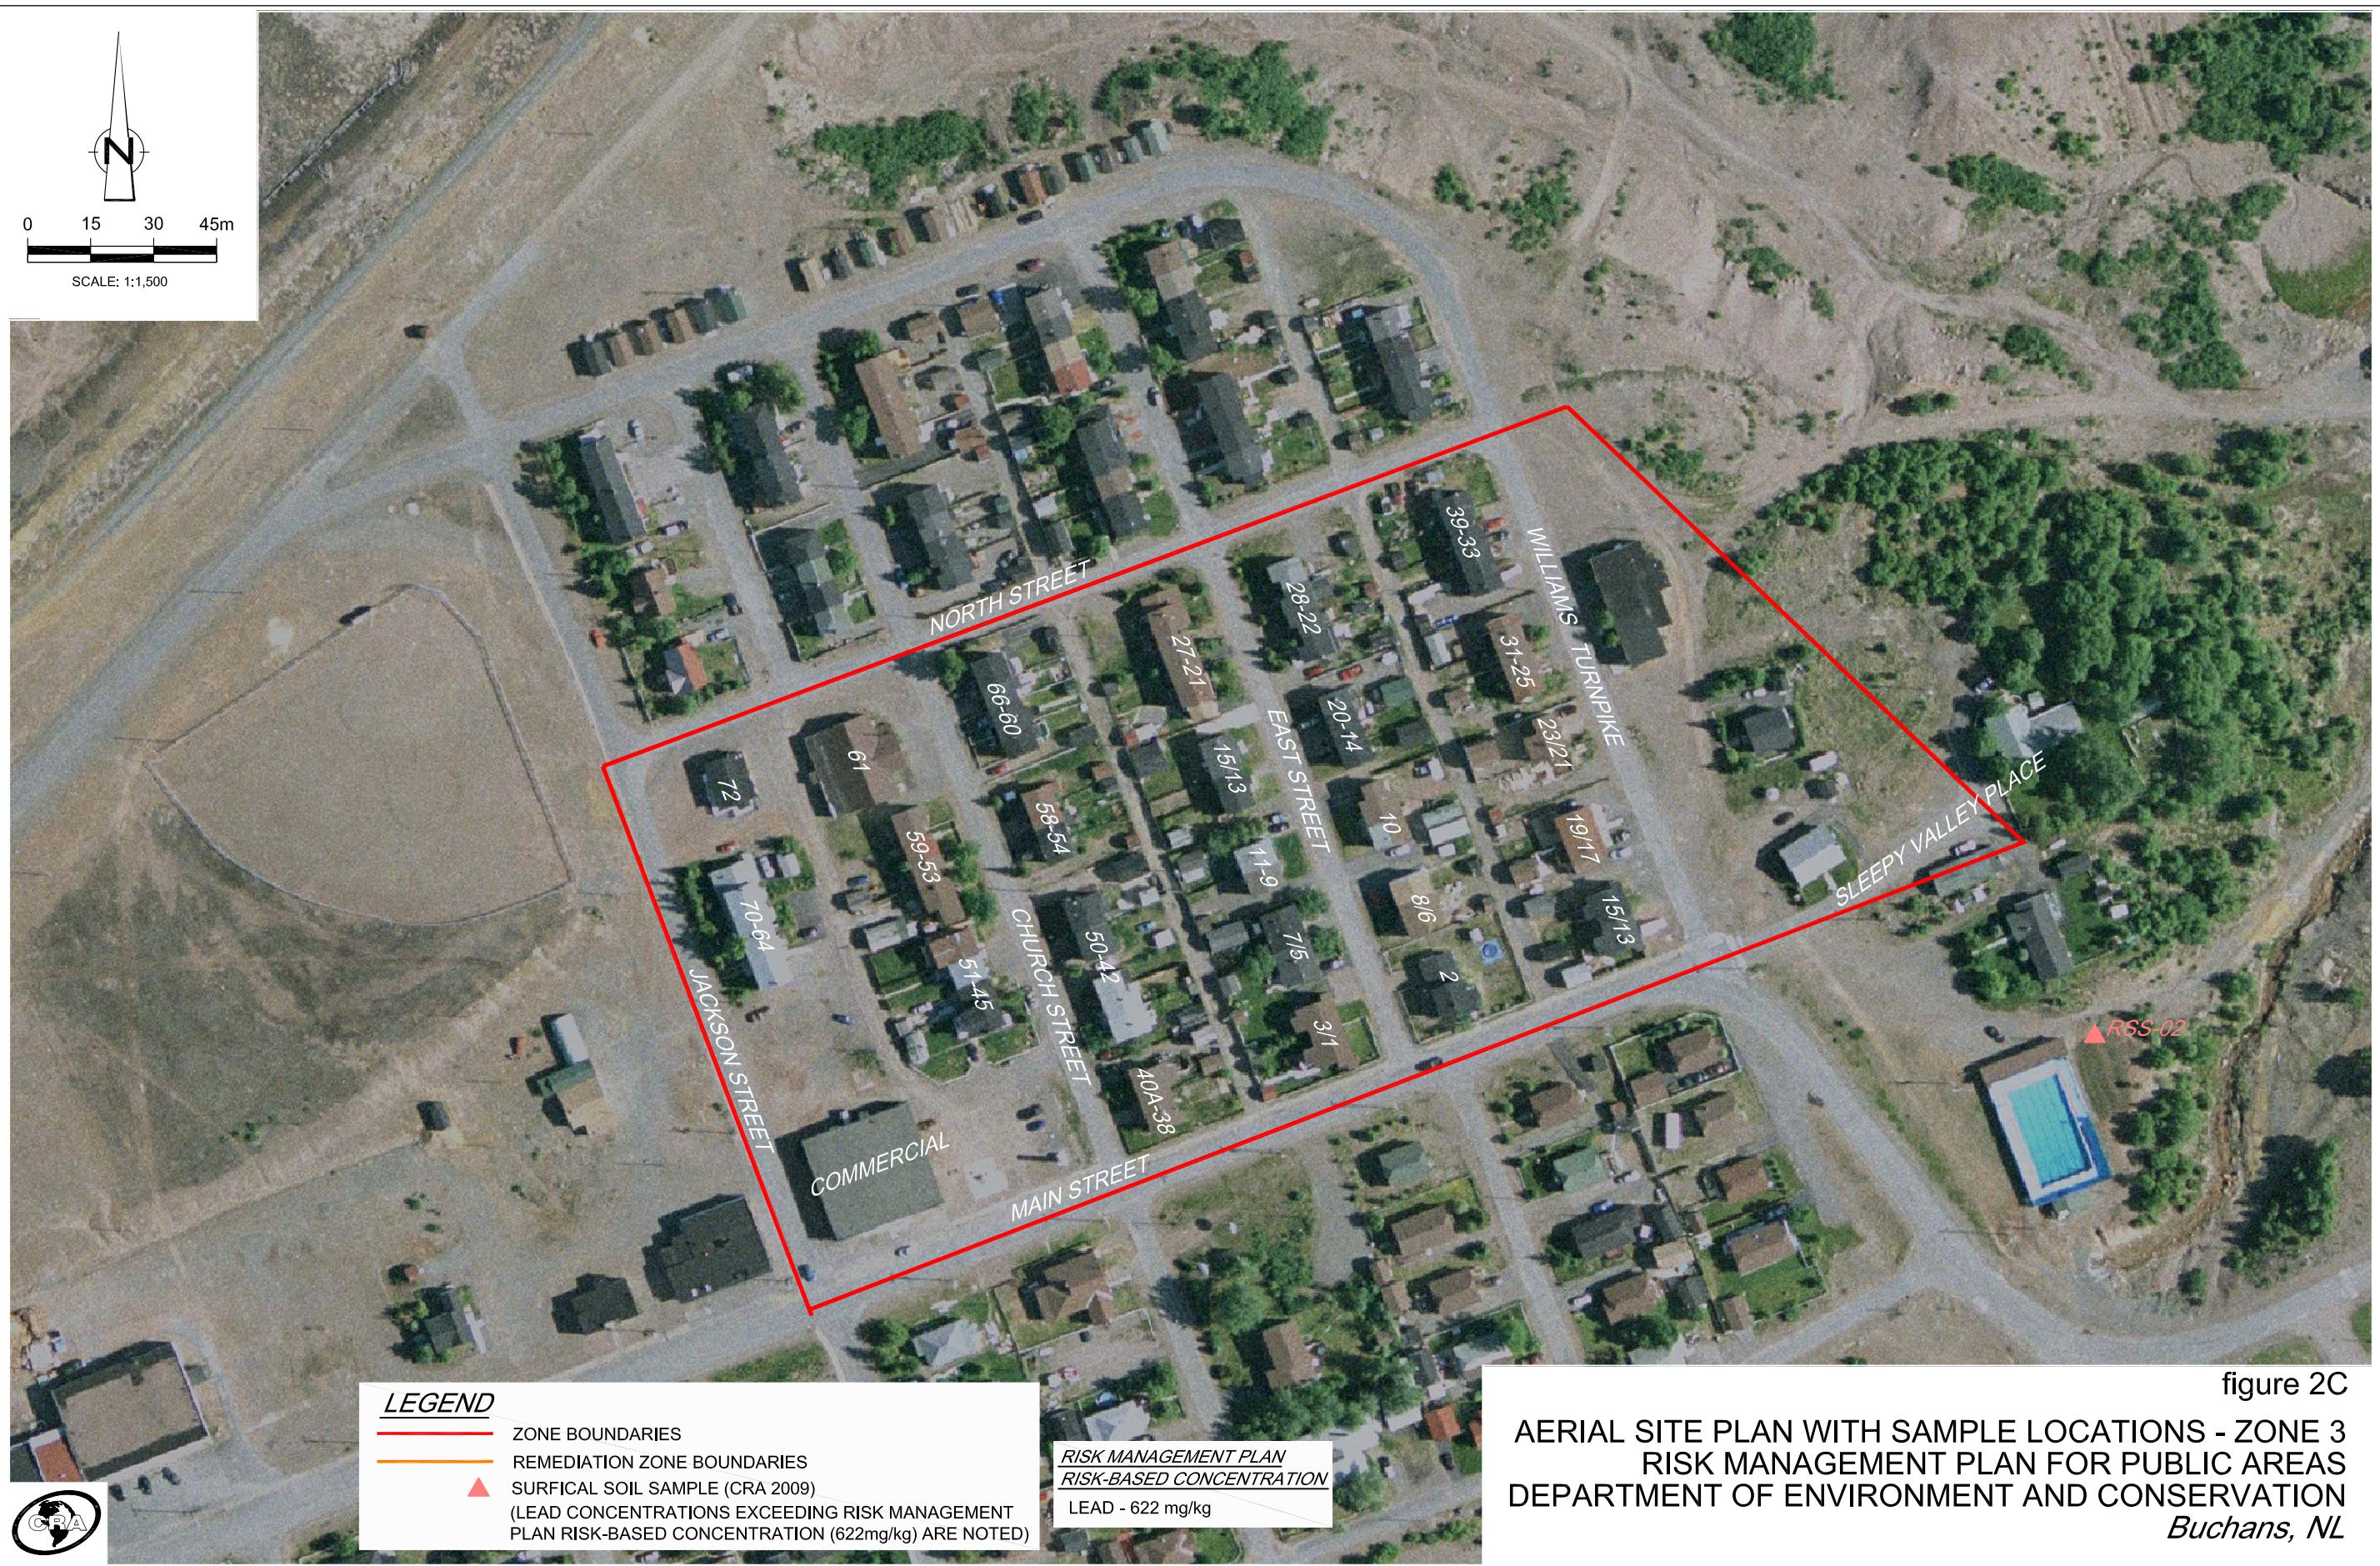
Zone 3 is bounded to the north by North Street, to the west by Jackson Street, to the south by Main Street, and to the east by William's Turnpike along with sections of East and Church Streets contained within above noted boundaries; this Zone also includes Sleepy Valley Place. Public Areas were not identified in Zone 3 as shown on Figure 2C.

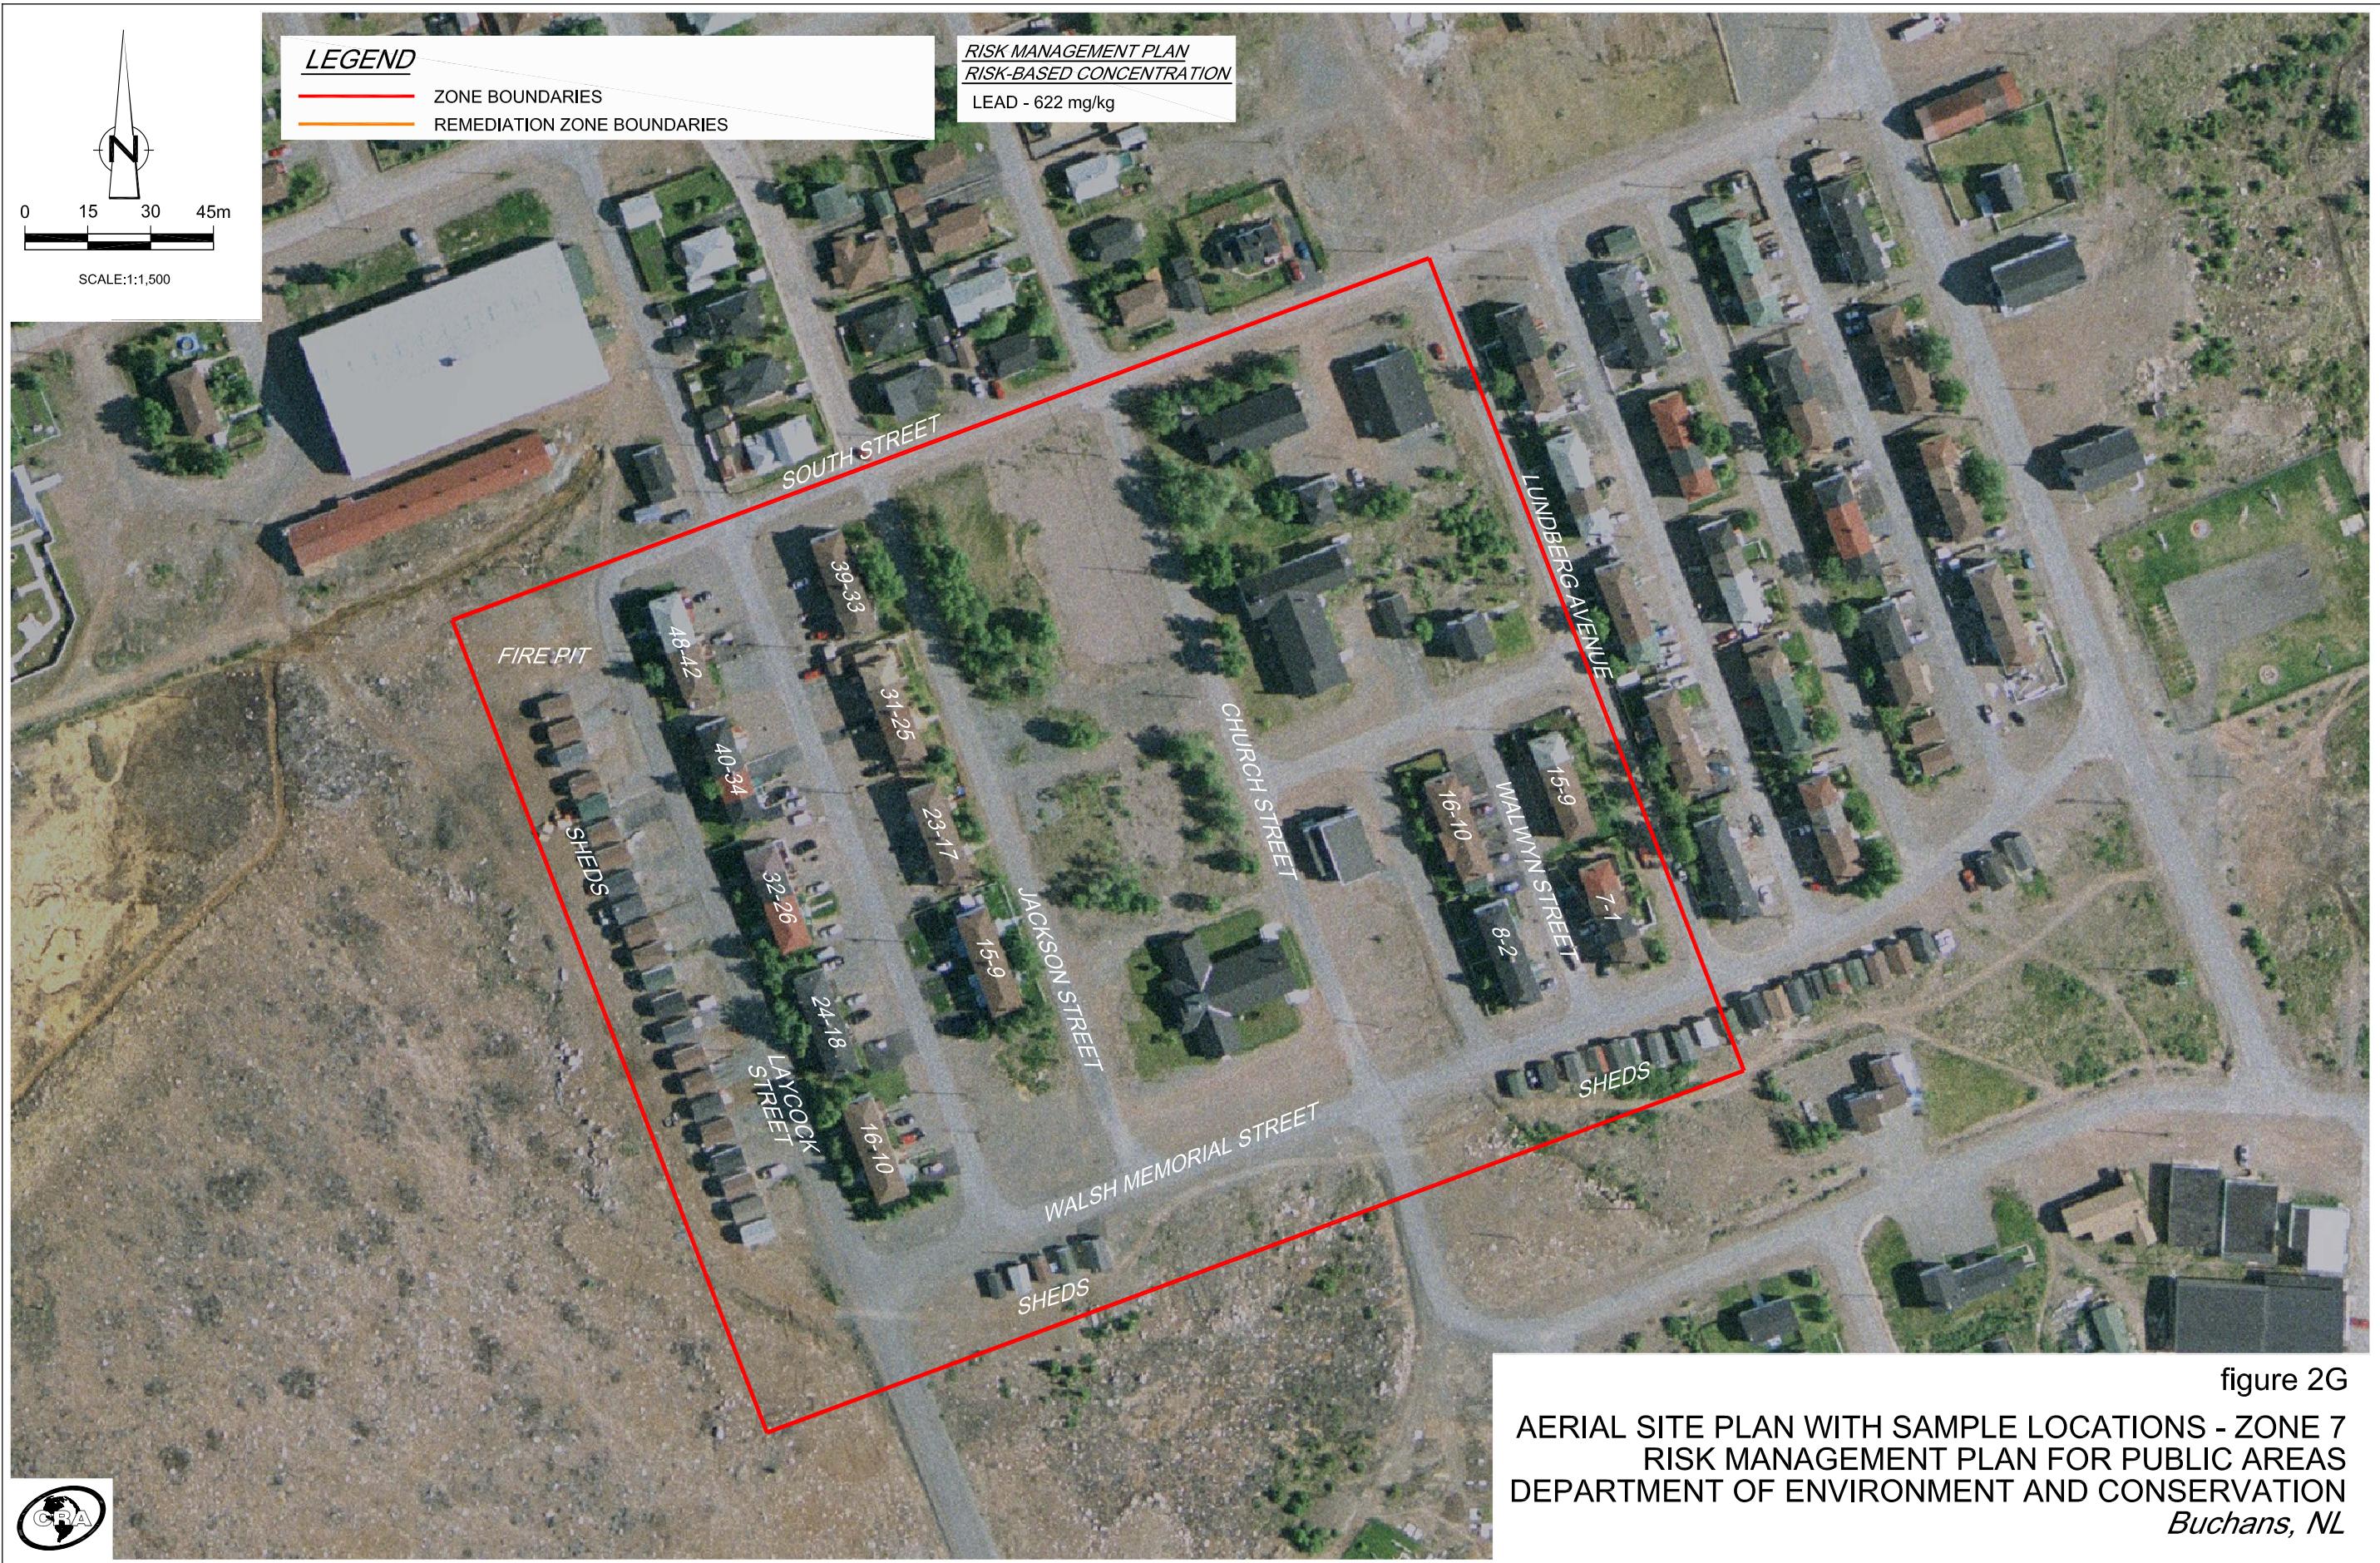
figure 2G
AERIAL SITE PLAN WITH SAMPLE LOCATIONS - ZONE 7
RISK MANAGEMENT PLAN FOR PUBLIC AREAS
DEPARTMENT OF ENVIRONMENT AND CONSERVATION
Buchans, NL

Zone 7 is bounded to the north by South Street, to the west by sheds on Laycock Street, to the south by sheds on Walsh Memorial Street, and to the east by Lundberg Avenue along with sections of Walwyn Street, Church Street, and Jackson Street contained within the above noted boundaries. Public Areas were not identified in Zone 7 as shown on Figure 2G.

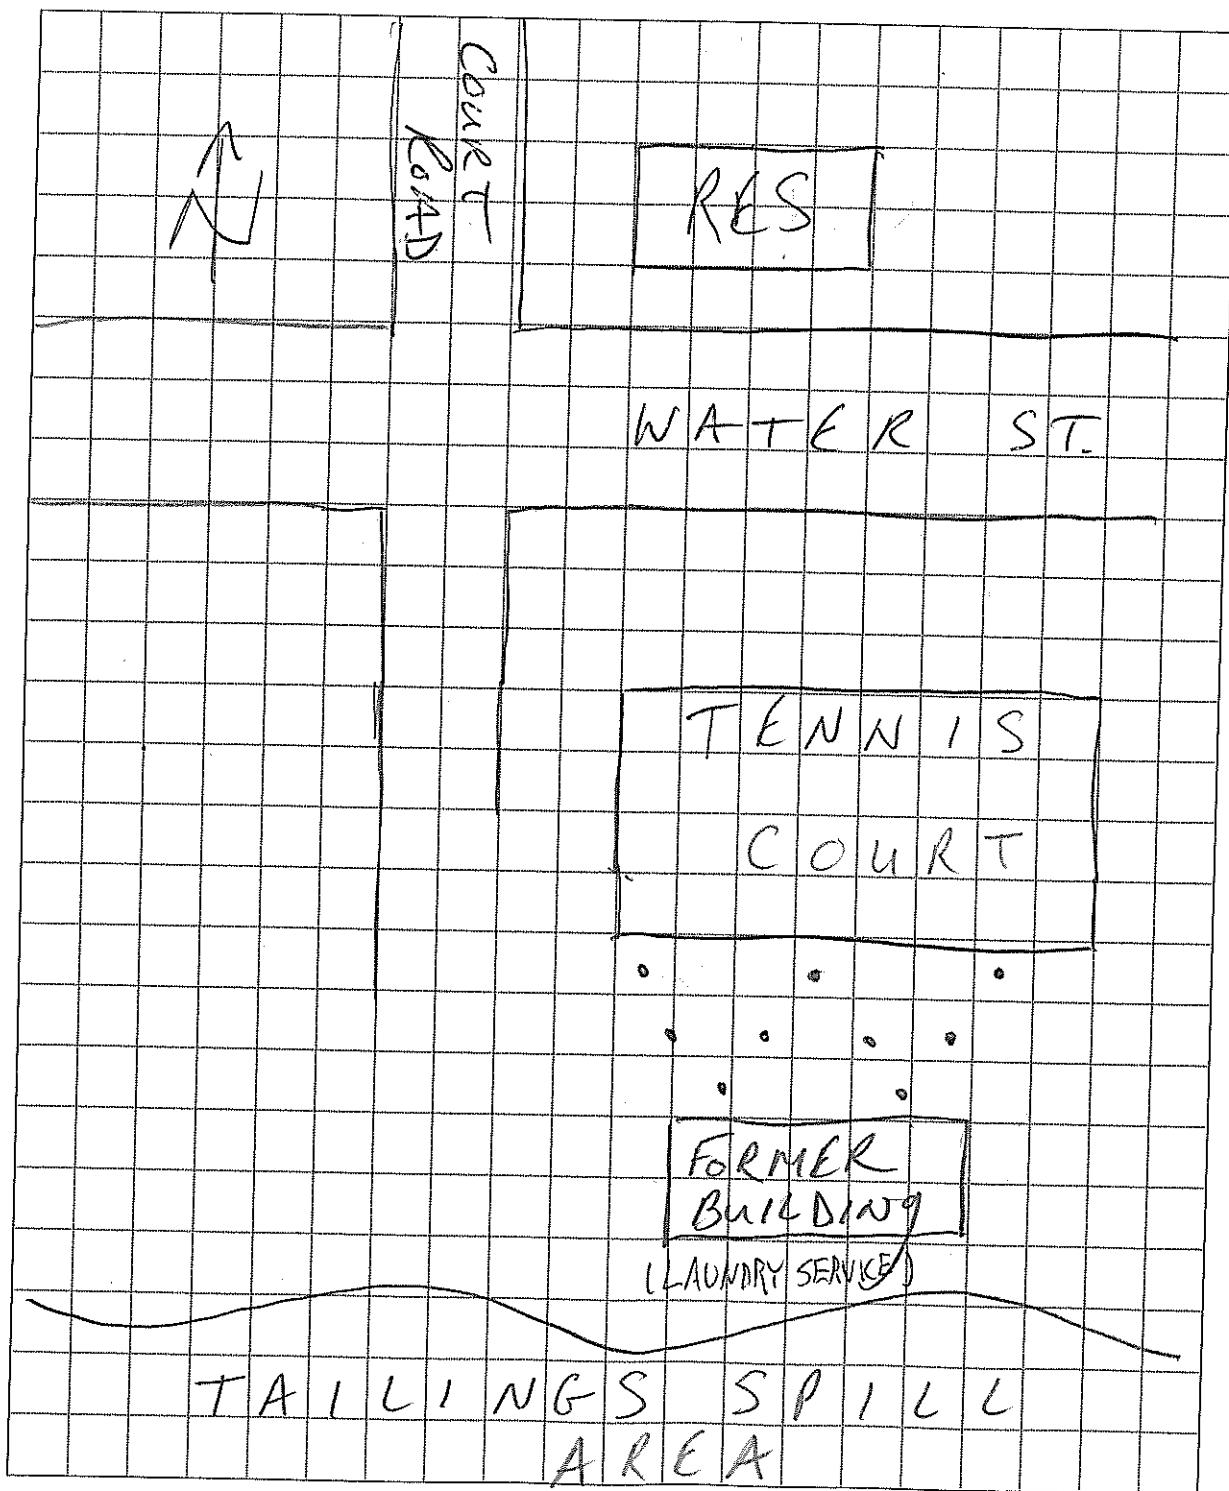
SITE PLAN (Show scale or rough measurements)

Observations	Sample Intervals
	0-5cm
Any vegetation present?	<u>No</u>
Vegetation/grass cover removed for sampling?	<u>No</u>
Staining/odours present?	<u>No</u>
Visual appearance and texture of soil	<u>Crushed stone cover with sandy silt + gravel @ sample depth. Possible tailings in fill. Dark brown to black in colour.</u>
Approximate depth range of all sub-sample collected

Observations	Sample Intervals
	0-5cm
Any vegetation present?	<u>No</u>
Vegetation/grass cover removed for sampling?	<u>No</u>
Staining/odours present?	<u>Yellow-Orange surface staining</u>
Visual appearance and texture of soil	<u>Compact gravel fill with sand. Orange staining @ sample depth. Metallic particulate @ 1 sample loc.</u>
Approximate depth range of all sub-sample collected	<u>25-30 cm</u>

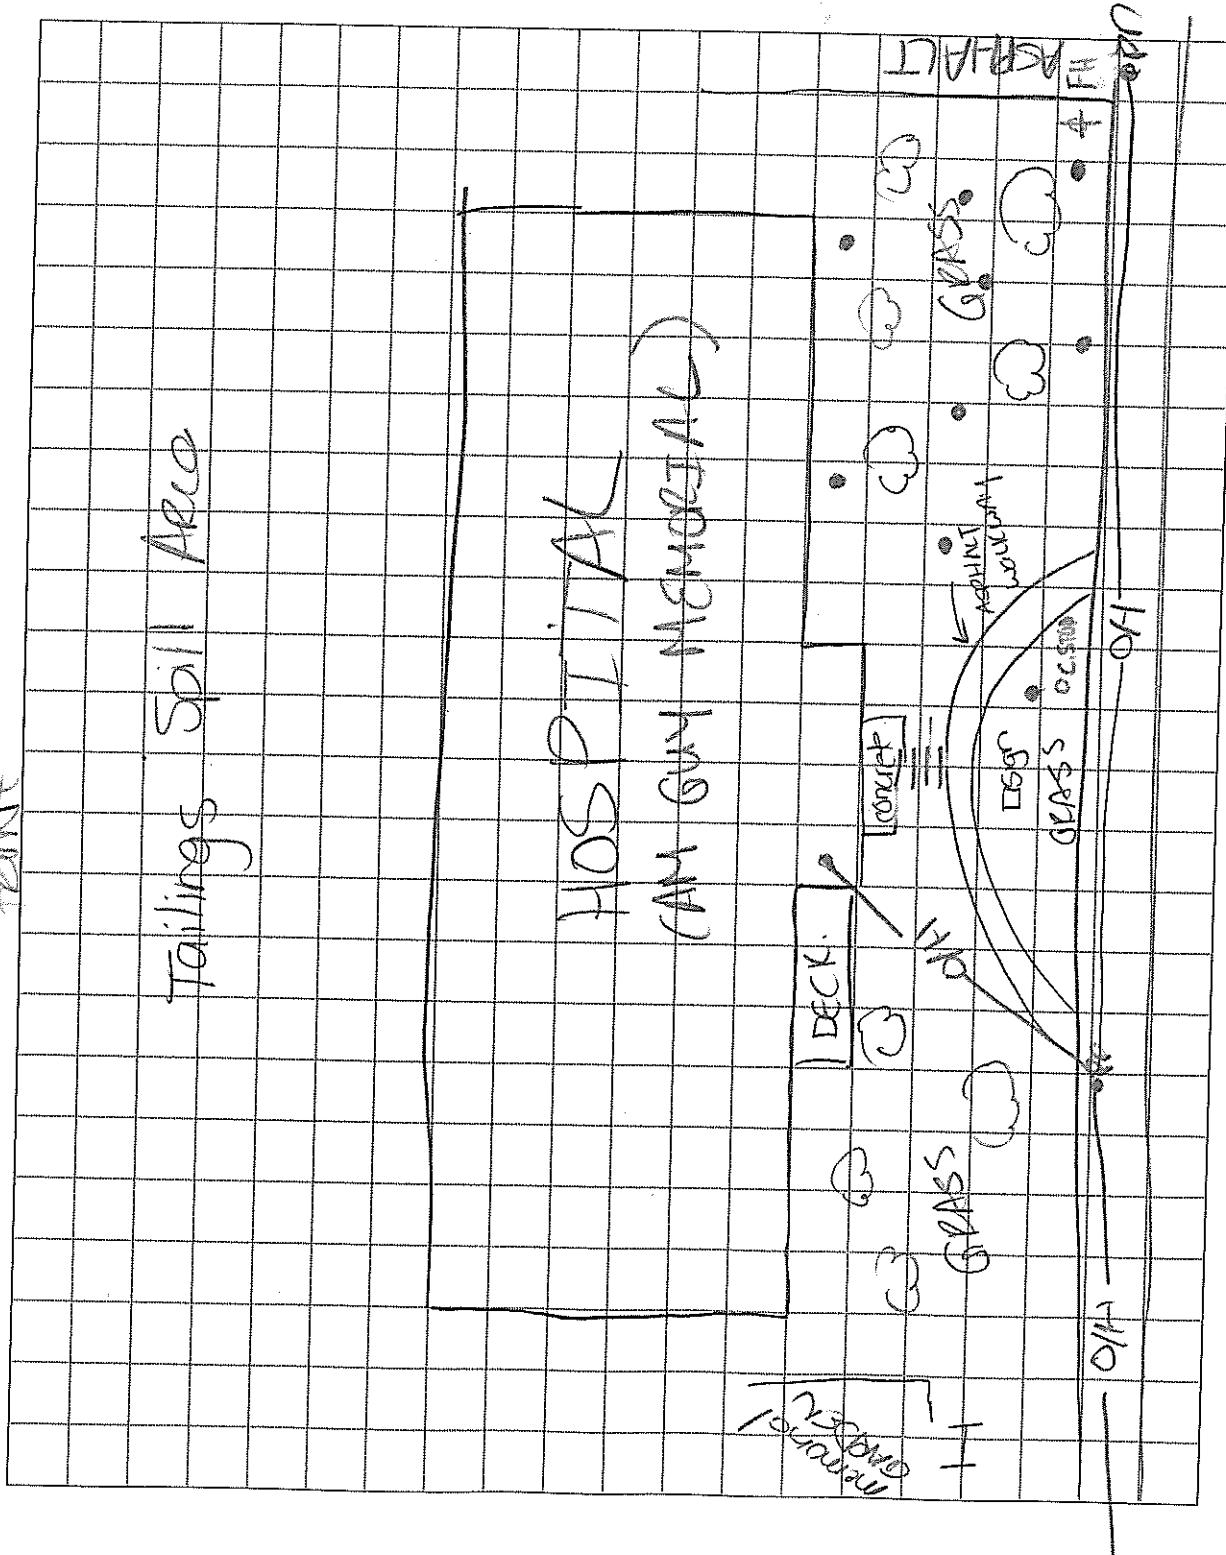
SITE PLAN (Show scale or rough measurements)

Note: numerous
trees in
surrounding

Observations	Sample Intervals
	0-5cm
Any vegetation present?	<u>Yes - Grass + Trees</u>
Vegetation/grass cover removed for sampling?	<u>Yes</u>
Staining/odours present?	<u>No</u>
Visual appearance and texture of soil	<u>Silty sand w/ topsoil, moist</u>
Approximate depth range of all sub-sample collected	<u>0 - 10cm</u>
