**Implementation of the
Remedial Action Plan –
Year 6, Former U.S. Military
Site, Hopedale, NL**

Final Report

File No. 121413099

July 26, 2017

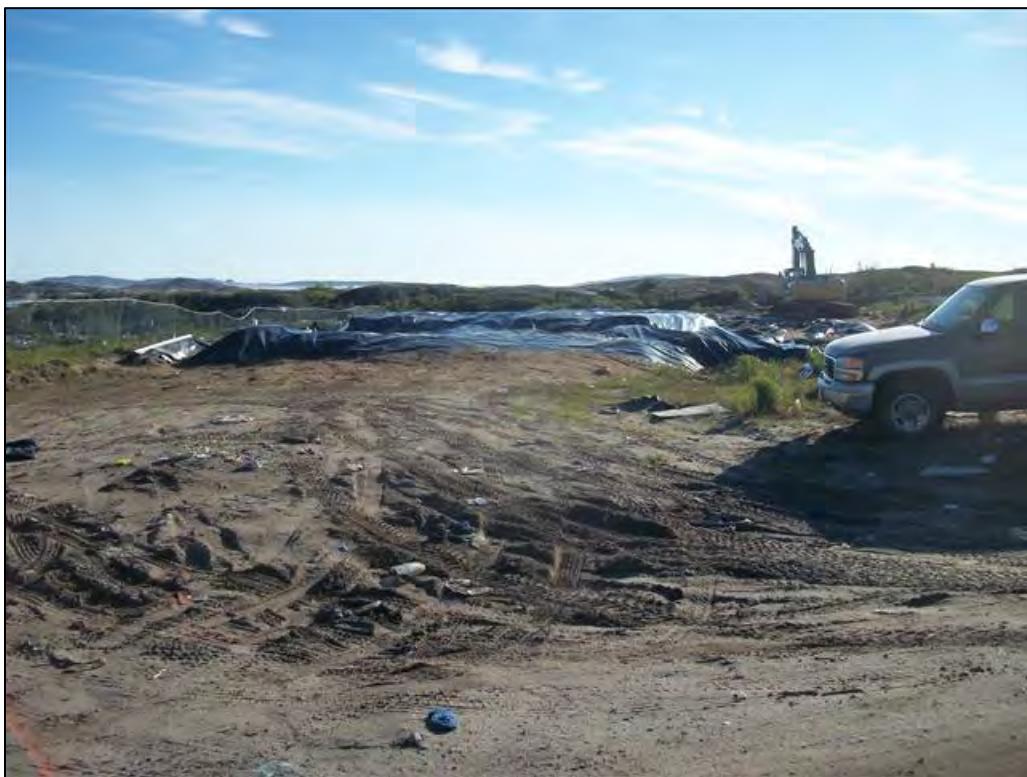
Photo 1 Biopile in Year 6 prior to soil sampling, July 7, 2016.

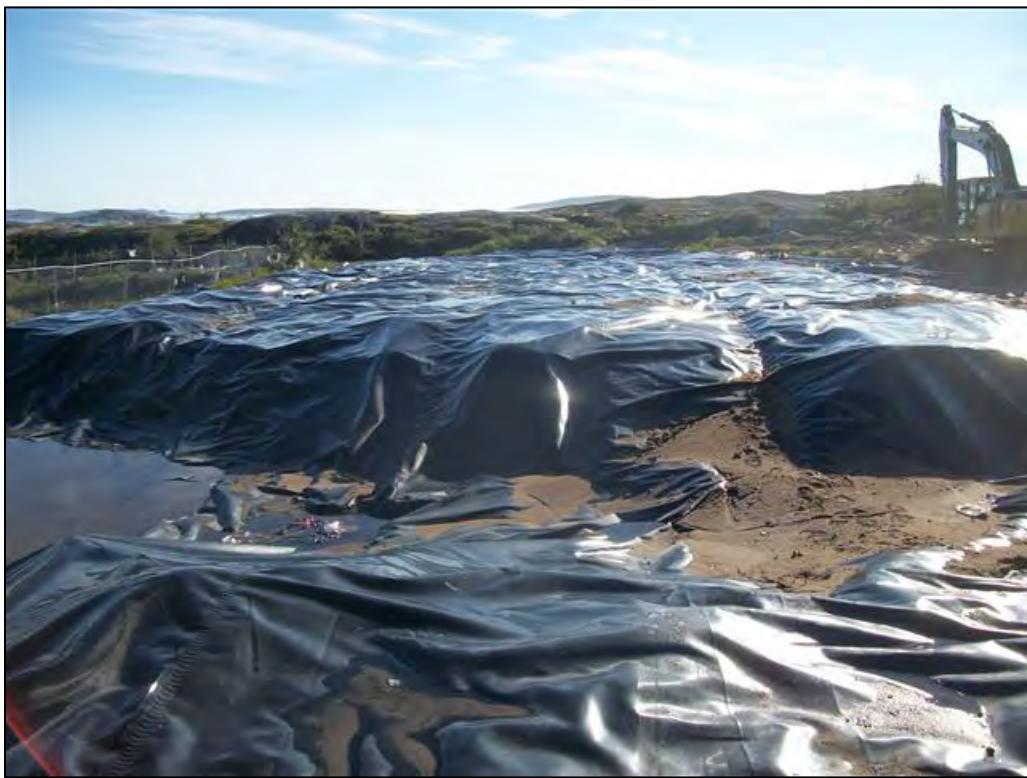
Photo 2 Biopile in Year 6 prior to soil sampling, July 7, 2016.

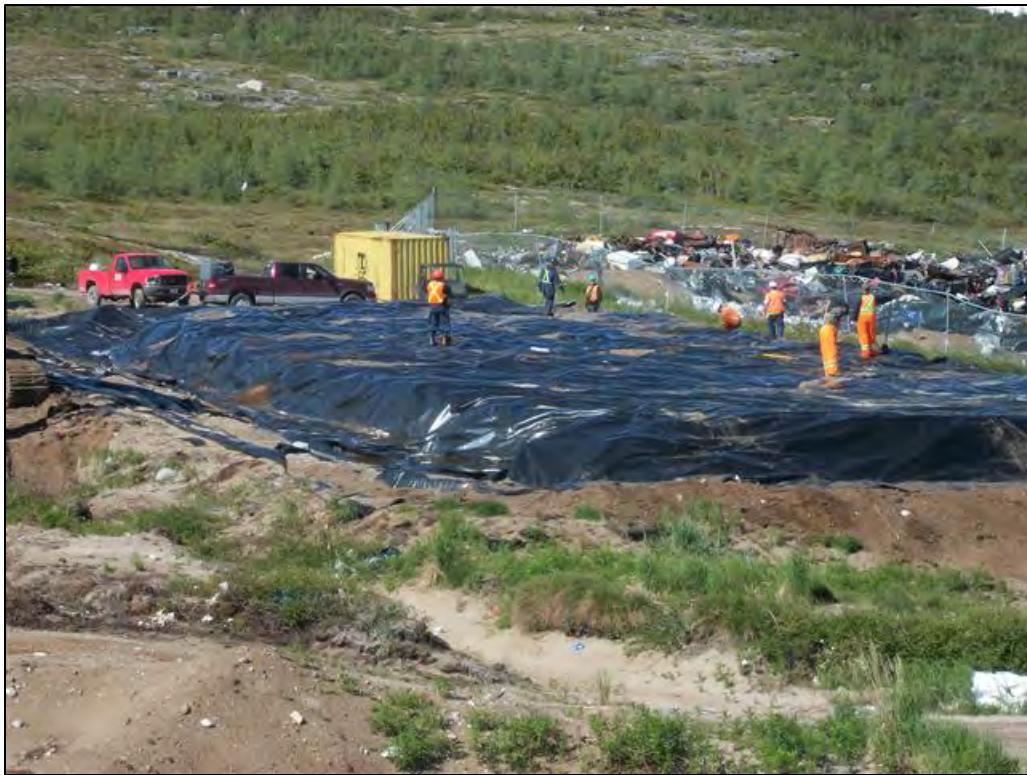
Photo 3 Biopile in Year 6 prior to soil sampling, July 7, 2016.

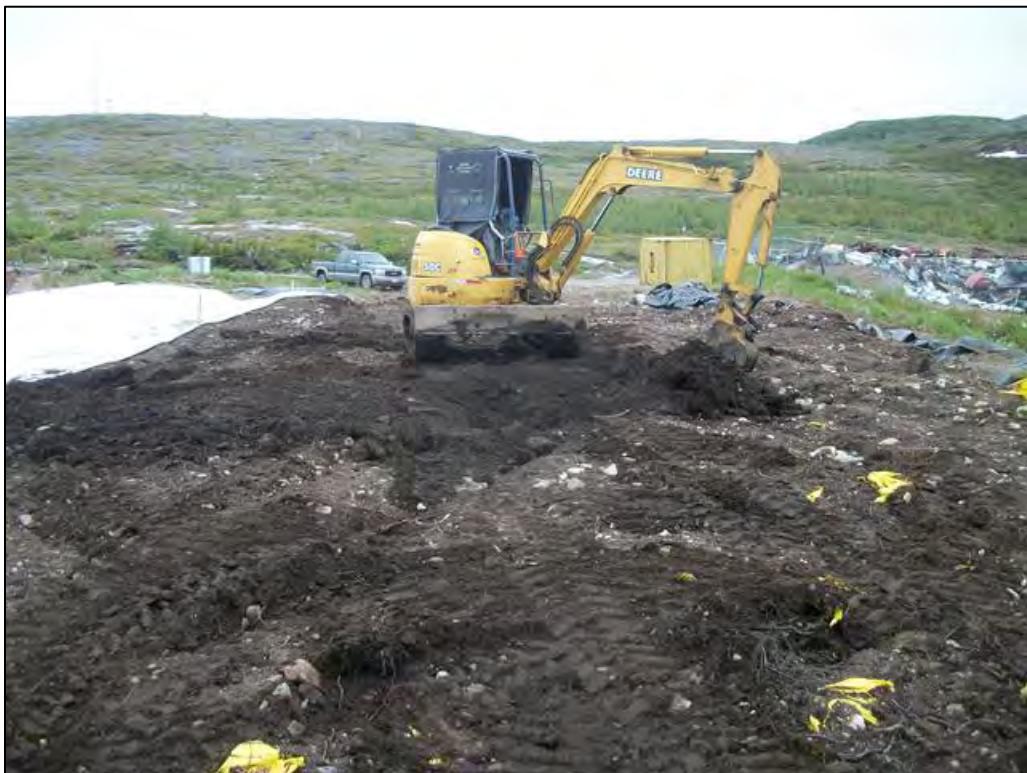
Photo 4 Placing test pits at the biopile, July 10, 2016.

On July 10, 2016, confirmatory soil sampling was carried out at the biopile to confirm that concentrations of TPH in soil were below the landfill acceptance criteria of 1,000 mg/kg. The HDPE cover was removed and test pits were excavated with the aid of a track-mounted excavator supplied and operated by Budgell's. Stantec personnel recorded details of subsurface conditions encountered during excavation and collected confirmatory soil samples.

Soil sampling was carried out following composite soil sampling protocols outlined in NLDMAE's standard Certificate of Approval (COA) for soil treatment facilities. Soil samples were collected from 13 test pits by bulk sample methods over continuous 0.5 m intervals, to a maximum depth of 2.0 m. The test pits were not extended to the bottom of the biopile (approximately 2.5 m deep) in order to prevent damage to the bottom liner. To obtain average petroleum hydrocarbon concentrations within each horizon of the biopile, soil samples from the same depths were combined to form composite samples following the confirmatory sampling protocol provided in NLDMAE's standard COA for soil treatment facilities. Two (2) composite samples from the 0.0 m to 0.5 m horizon (16-BP-COMP-A1 and 16-BP-COMP-A2), two (2) composite samples from the 0.5 m to 1.0 m horizon (16-BP-COMP-B1 and 16-BP-COMP-B2), two (2) composite samples from the 1.0 m to 1.5 m horizon (16-BP-COMP-C1 and 16-BP-COMP-C2) and two (2) composite samples from the 1.5 m to 2.0 m horizon (16-BP-COMP-D1 and 16-BP-COMP-D2) were submitted to Maxxam Analytics in St. John's, NL for analysis of petroleum hydrocarbons. The test pit locations are shown on Drawing No. 121413099-800-EE-11 in Appendix A. Photos taken of the biopile are provided in Appendix B.

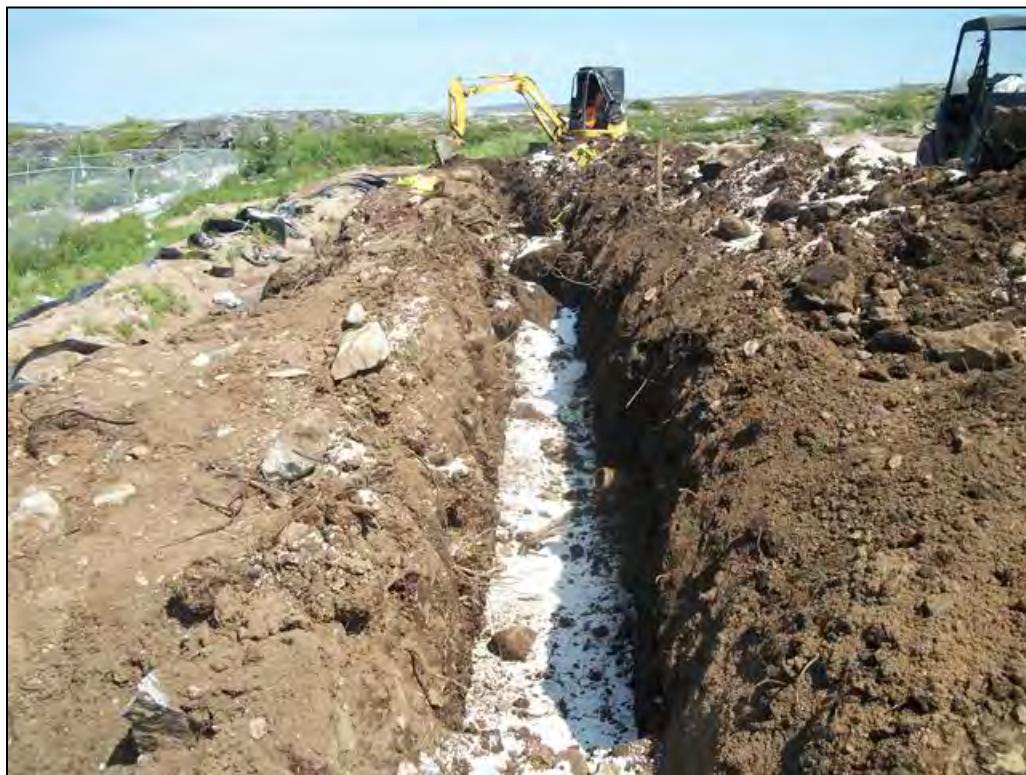
Photo 5 Application of amendments to the nutrients, July 17, 2016.

along the length of the biopile to facilitate the application of nutrients. Each trench measured approximately 1.0 m wide by 1.5 m deep. Excavated soil was temporarily stockpiled in a windrow (i.e., a build-up of material stored along the edge of the newly excavated area) adjacent to the trench from which it was excavated. Caution was taken not to damage the underlying liner during the advancement of each trench. The following nutrients were added evenly to each trench and windrow of excavated soil:

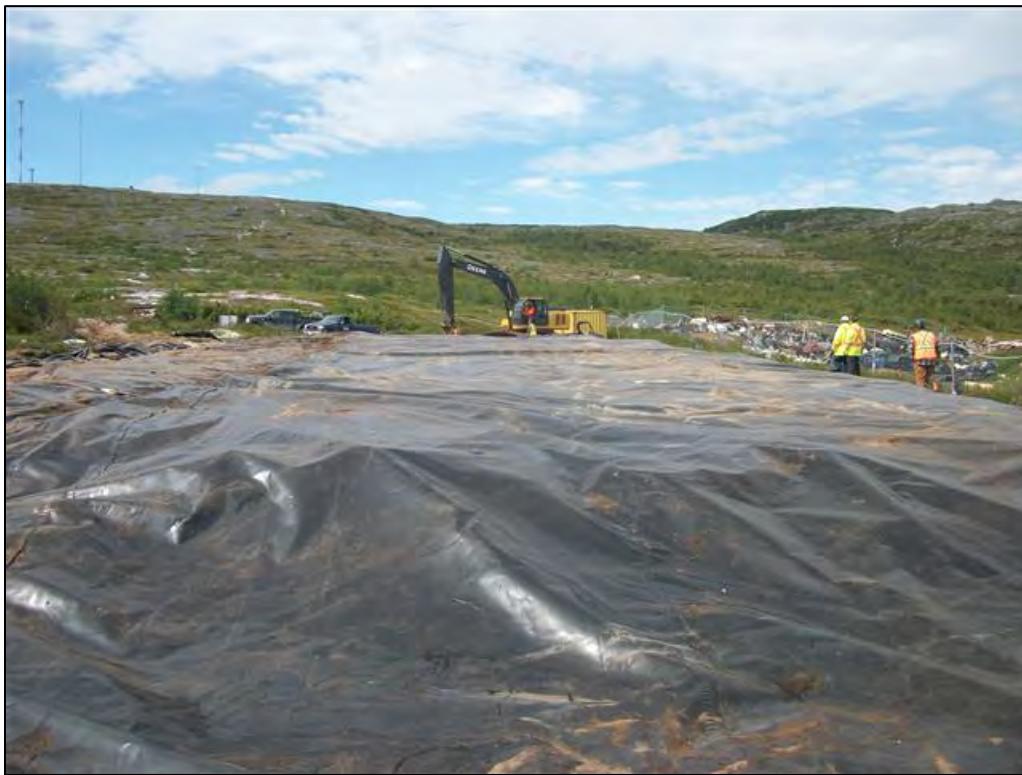
Photo 6 Securing the cover on the biopile, August 2, 2016.

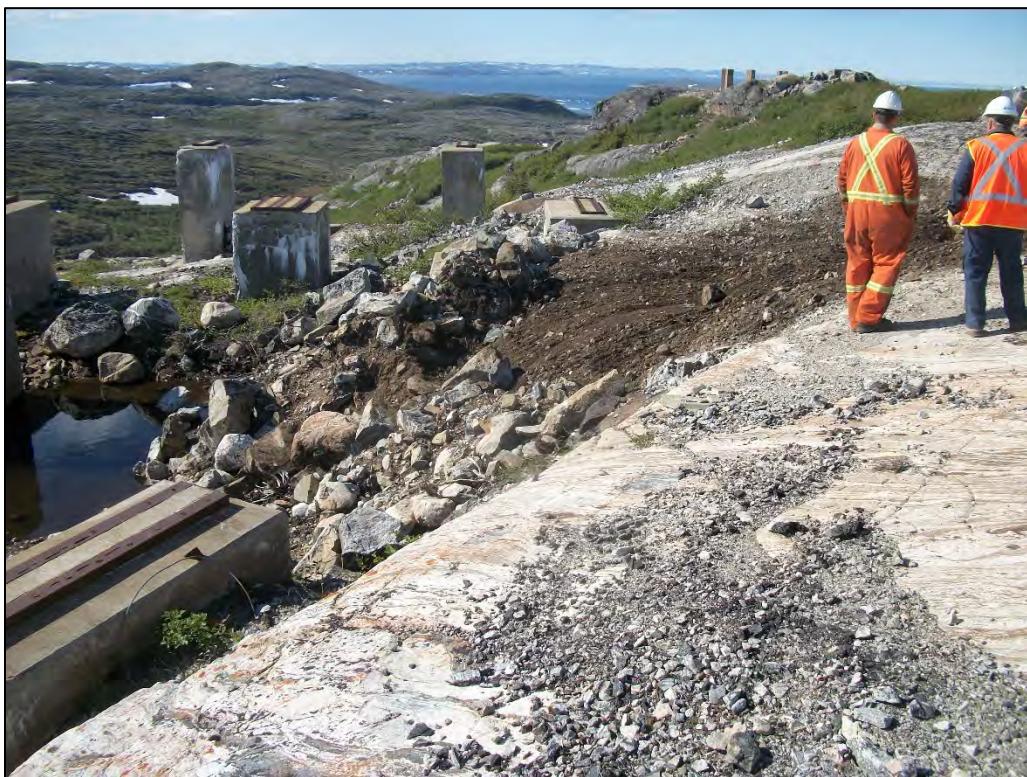
Photo 7 Prior to soil removal at Main Base-Area 1 Northwest, July 7, 2016.

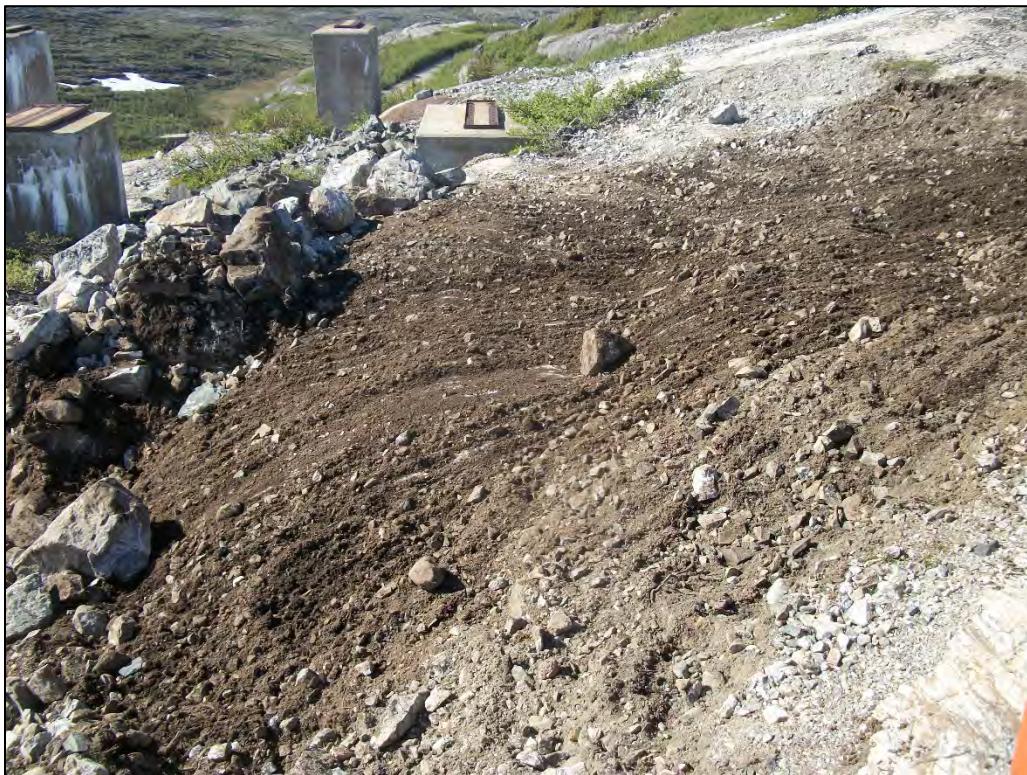
Photo 8 Prior to soil removal at Main Base-Area 1 Northwest, July 7, 2016.

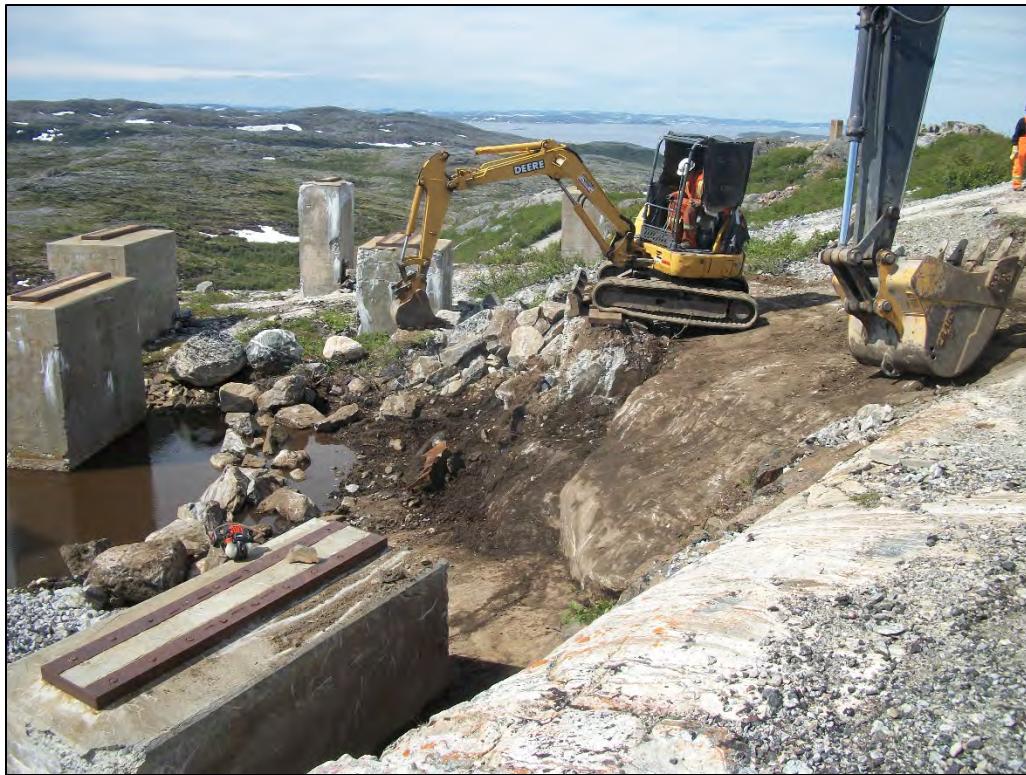
Photo 9 Soil removal at Main Base-Area 1 Northwest, July 8, 2016.

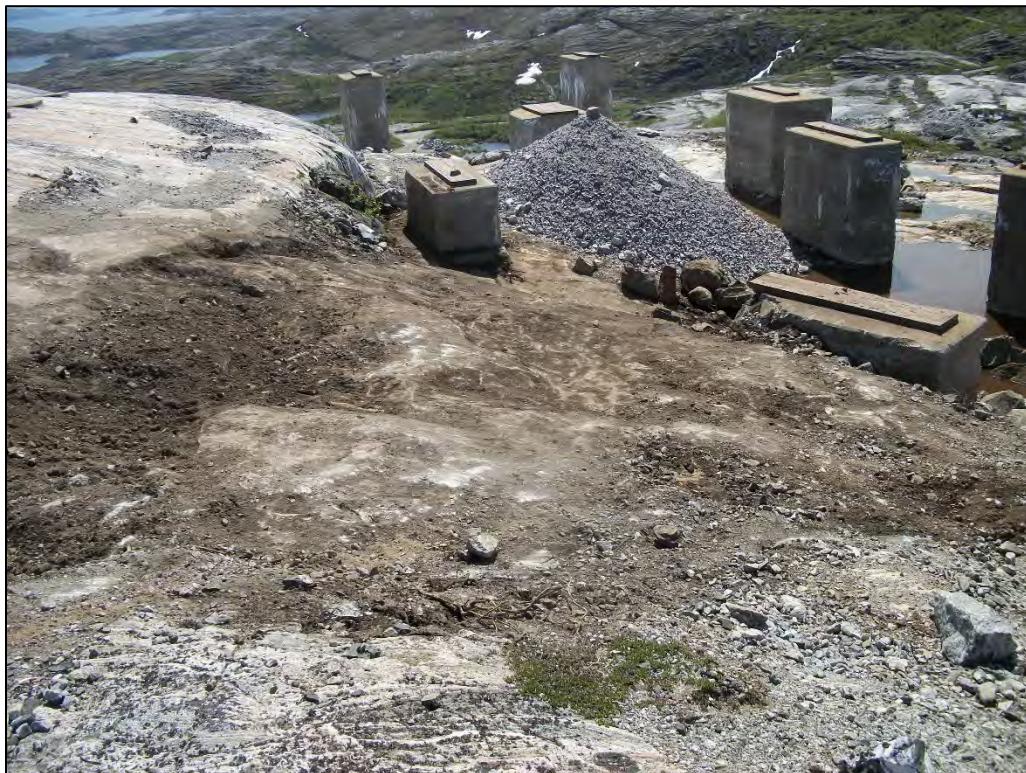
Photo 10 After soil removal at Main Base-Area 1 Northwest, July 9, 2016.

The Main Base-Area 1 remedial excavation was partially backfilled and levelled following soil removal using clean backfill. Main Base Area 4 was also backfilled. Backfill consisted of clean 100 mm minus sized material obtained from a local rock pit. The remainder of the remedial areas will be backfilled once remediation is completed during subsequent years of the Implementation of the RAP. Topsoil will also be replaced in selected areas of the Site during subsequent years of the Implementation of the RAP.

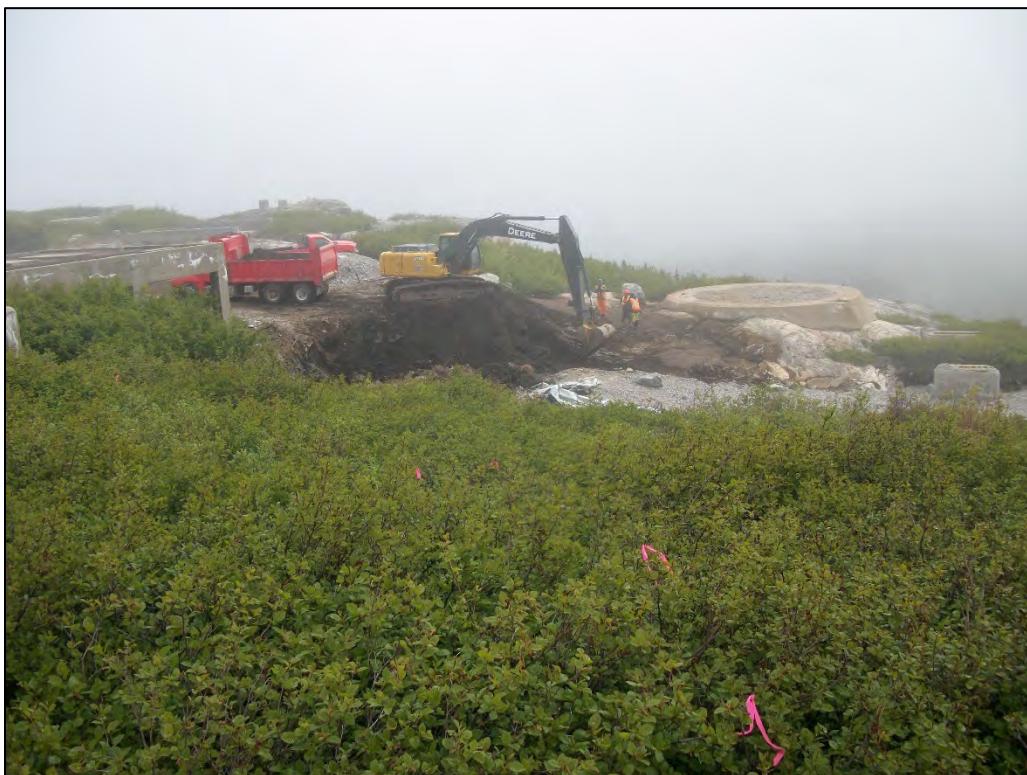
Photo 11 Prior to soil removal at Main Base-Area 1 Centre, July 12, 2016.

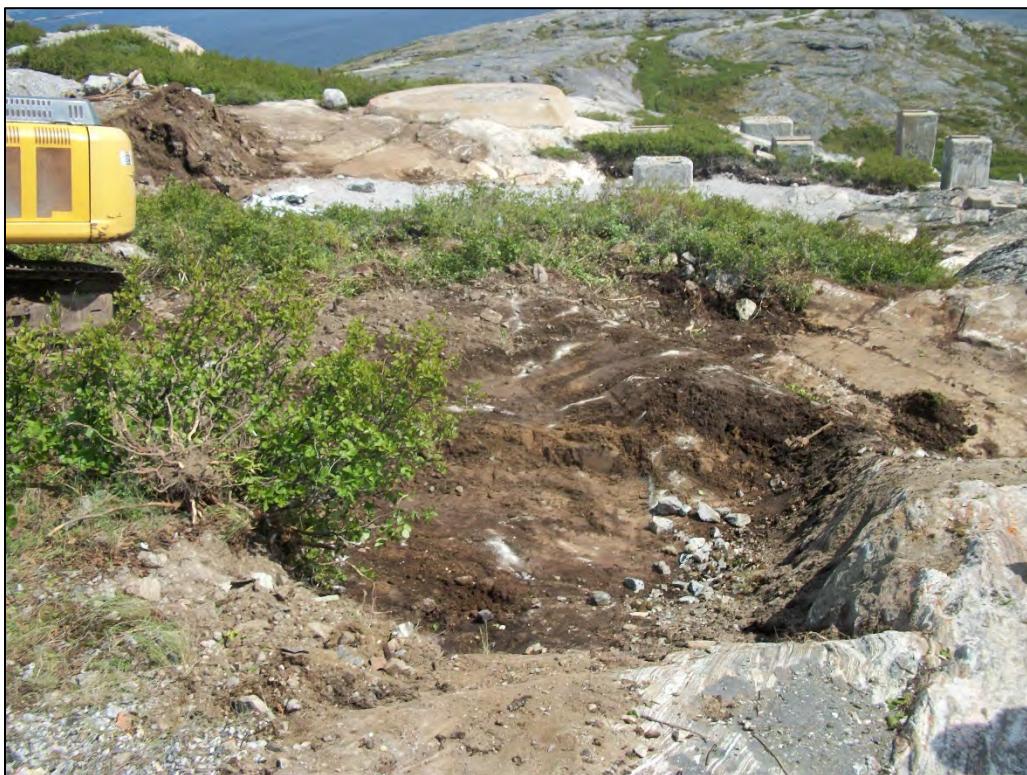
Photo 12 Soil removal at Main Base-Area 1 Centre, July 13, 2016.

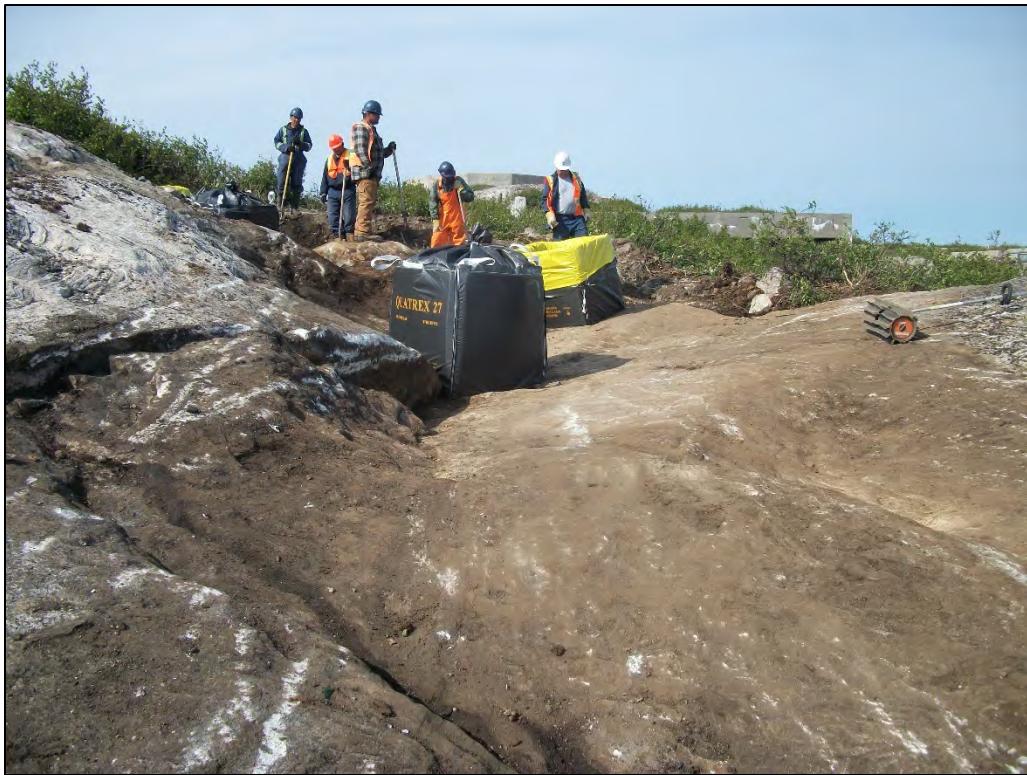
Photo13 After soil removal at Main Base-Area 1 Centre, July 13, 2016.

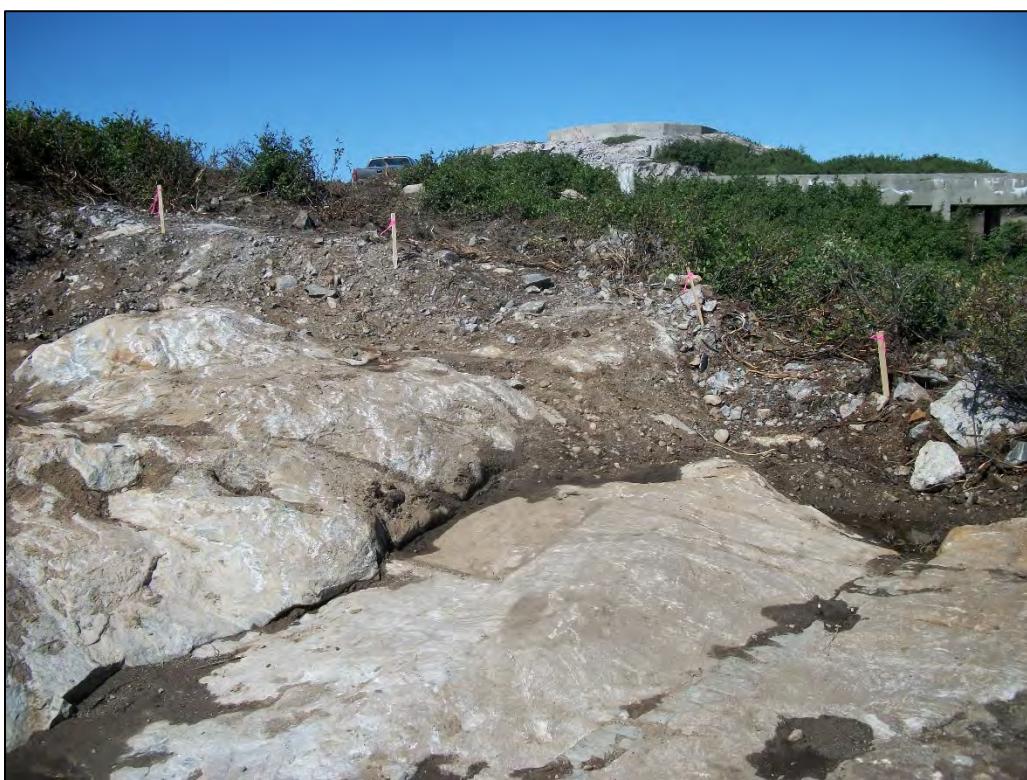
Photo 14 After soil removal at Main Base-Area 1 Centre, July 21, 2016.

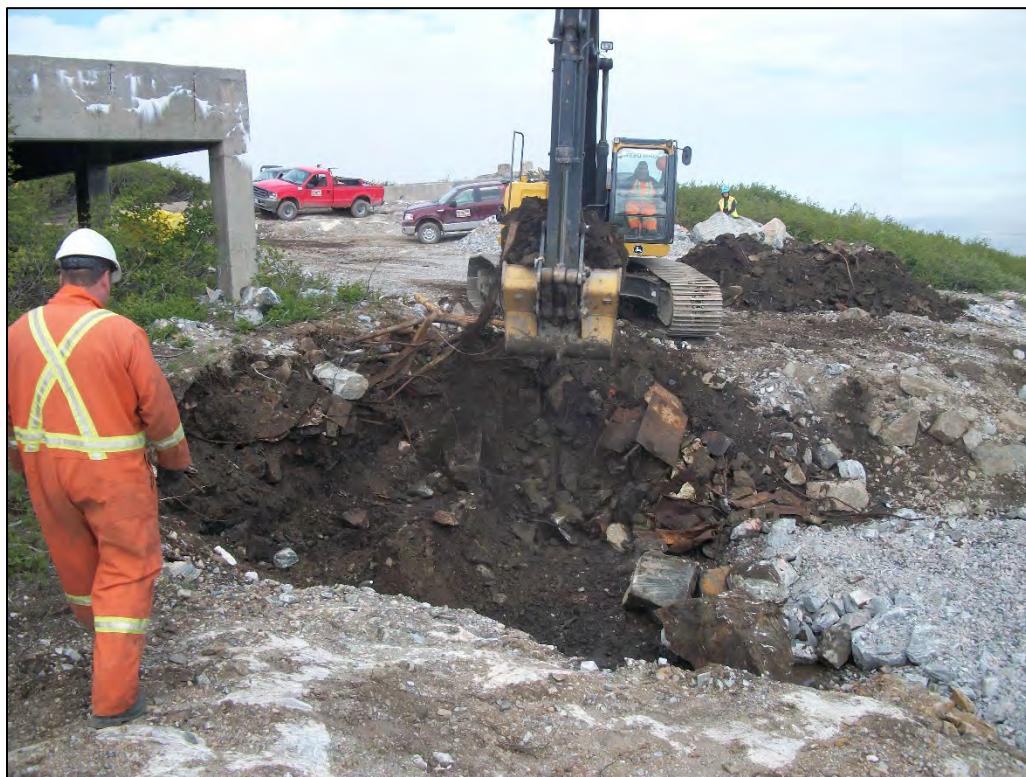
Photo 15 Soil removal at Main Base-Area 1 Northeast, July 9, 2016.

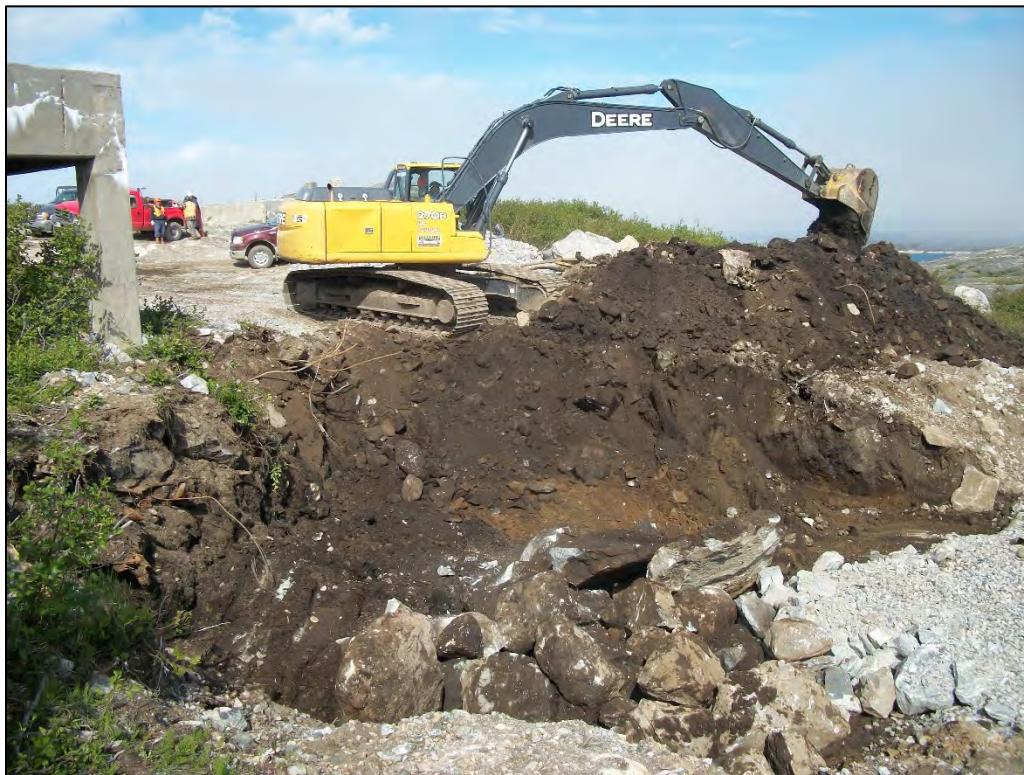
Photo 16 Soil removal at Main Base-Area 1 Northeast, July 9, 2016.

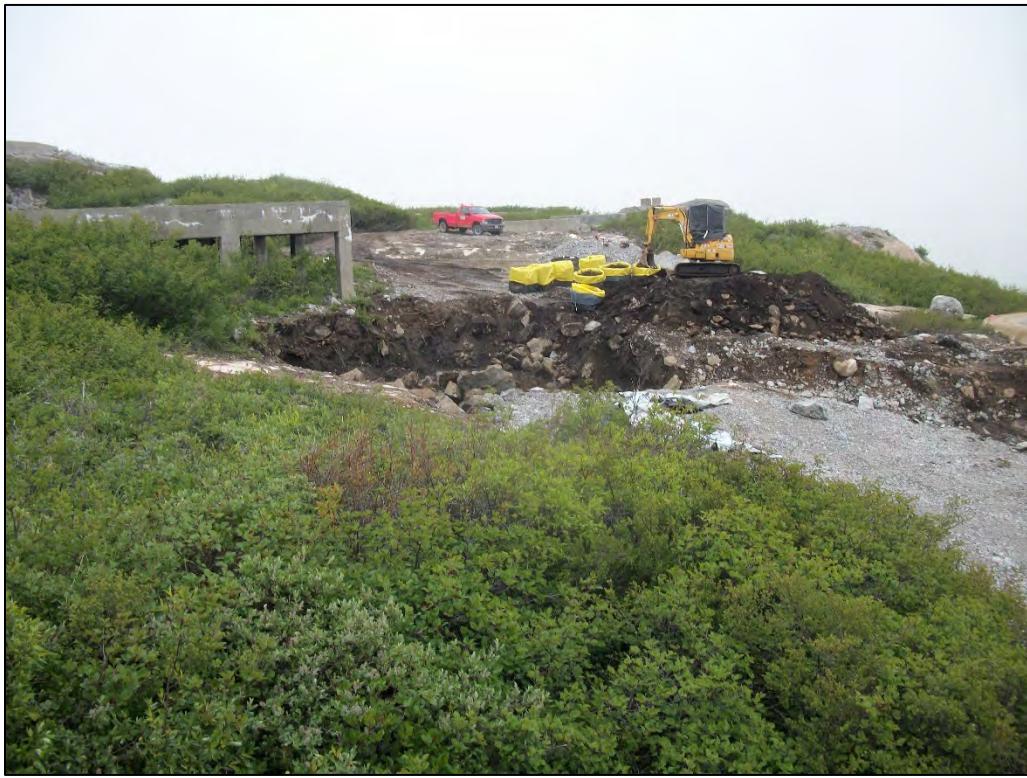
Photo 17 Soil removal at Main Base-Area 1 Northeast, July 10, 2016.

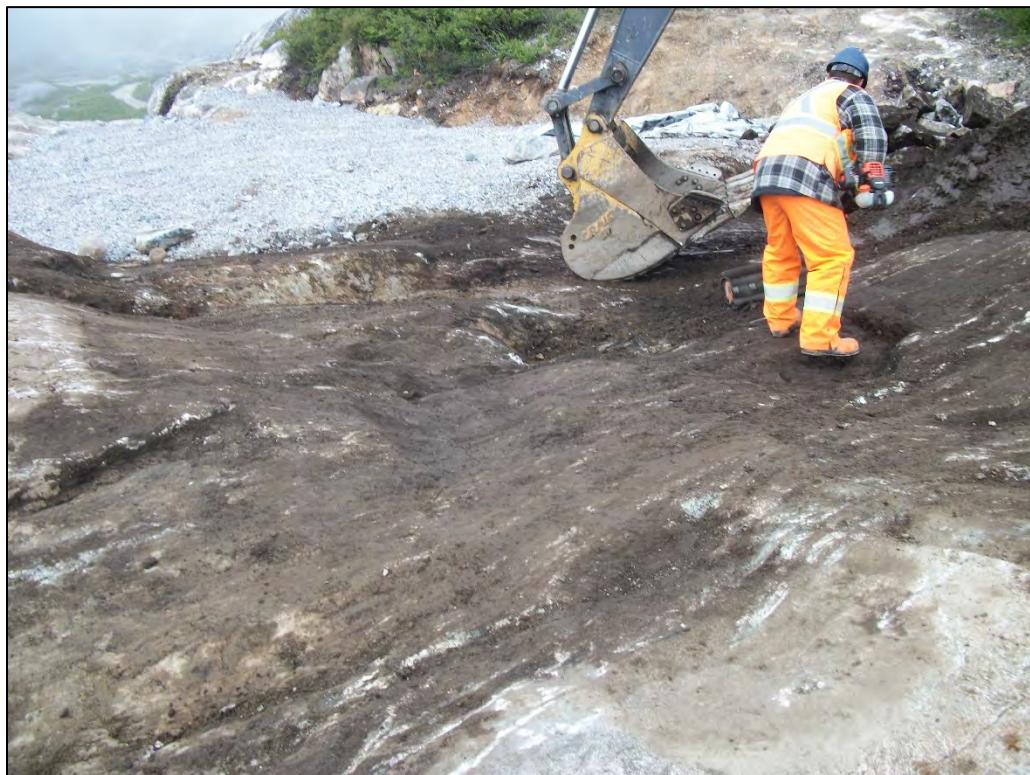
Photo 18 Soil removal at Main Base-Area 1 Northeast, July 12, 2016.

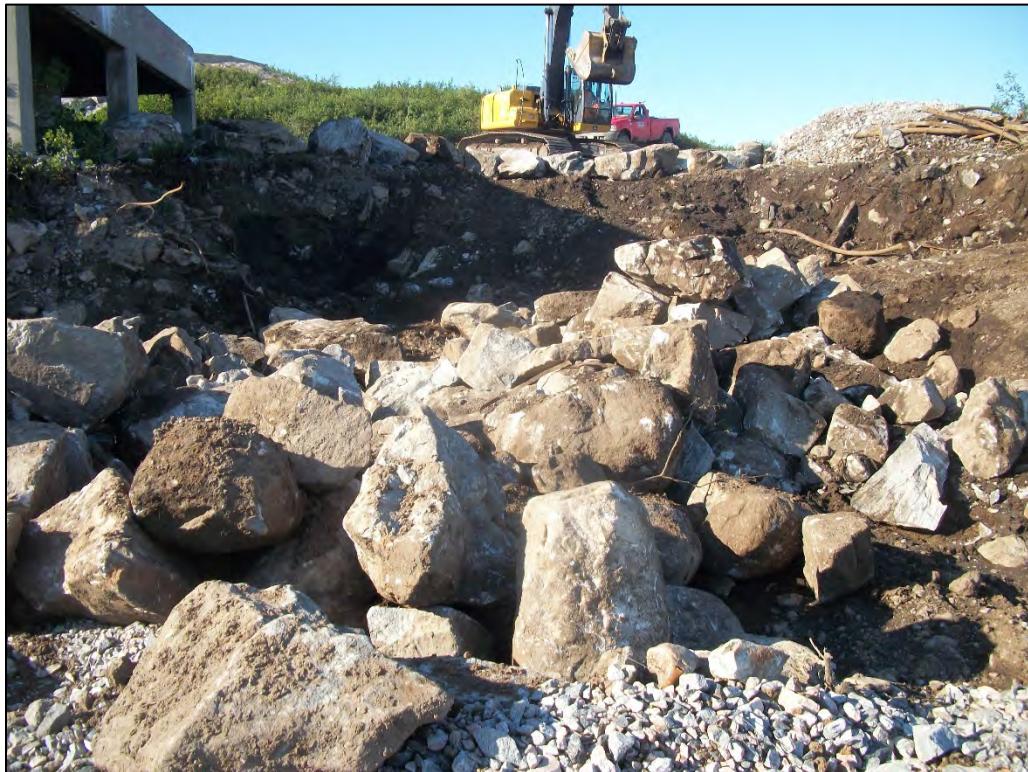
Photo 19 After soil removal at Main Base-Area 1 Northeast, July 21, 2016.

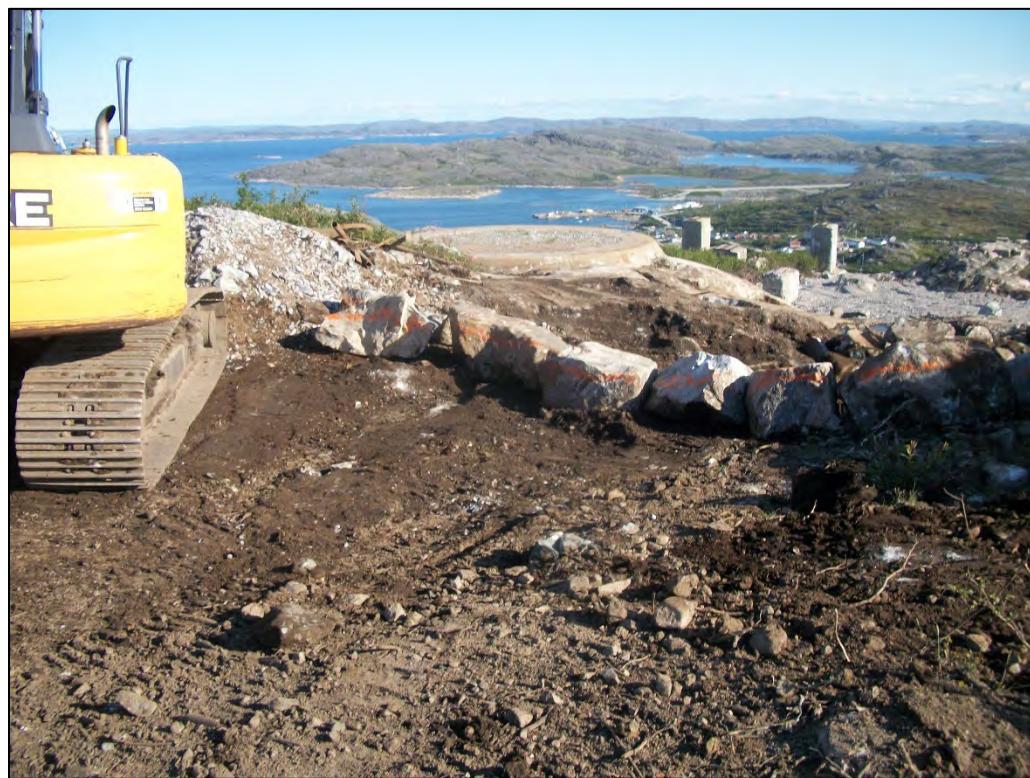
Photo 20 After soil removal at Main Base-Area 1 Northeast and remedial excavation boundary blocked by boulders, July 21, 2016.

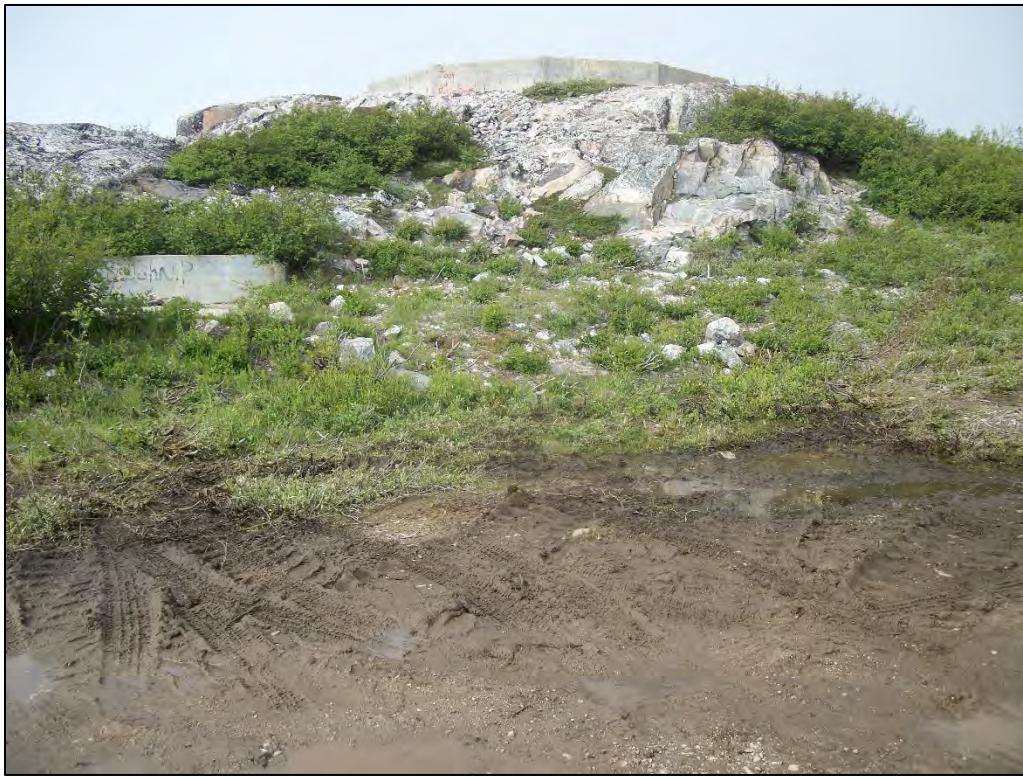
Photo 21 Prior to soil removal at Main Base-Area 4, July 10, 2016.

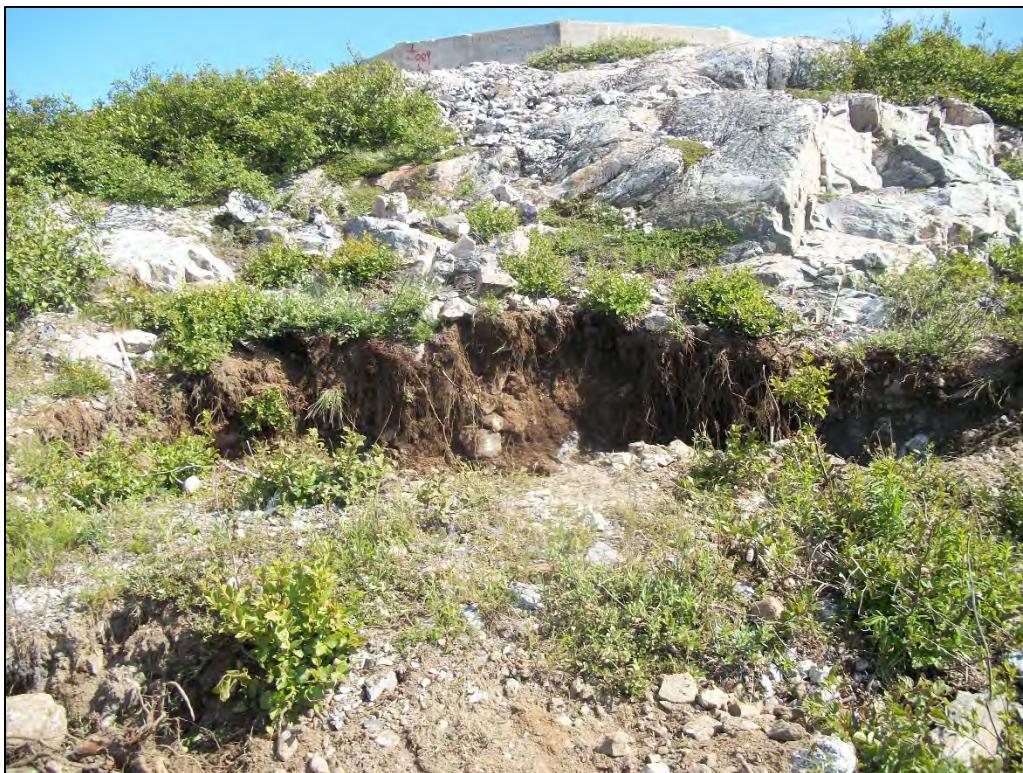
Photo 22 After soil removal at Main Base-Area 4, July 13, 2016.

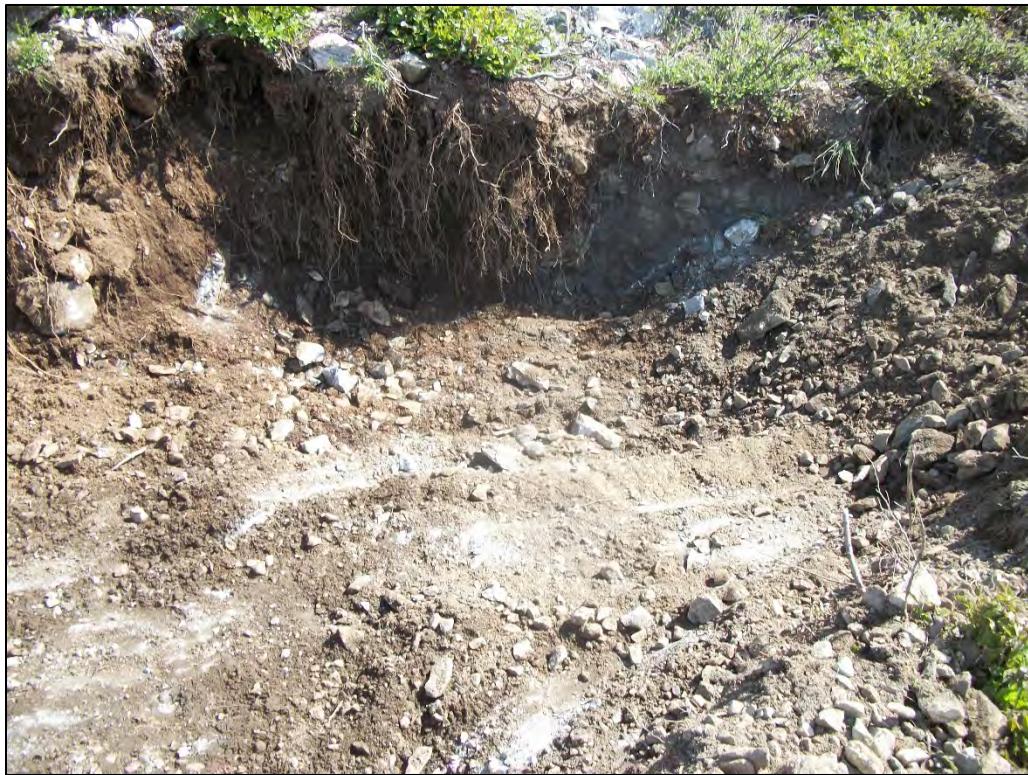
Photo 23 After soil removal at Main Base-Area 4, July 13, 2016.

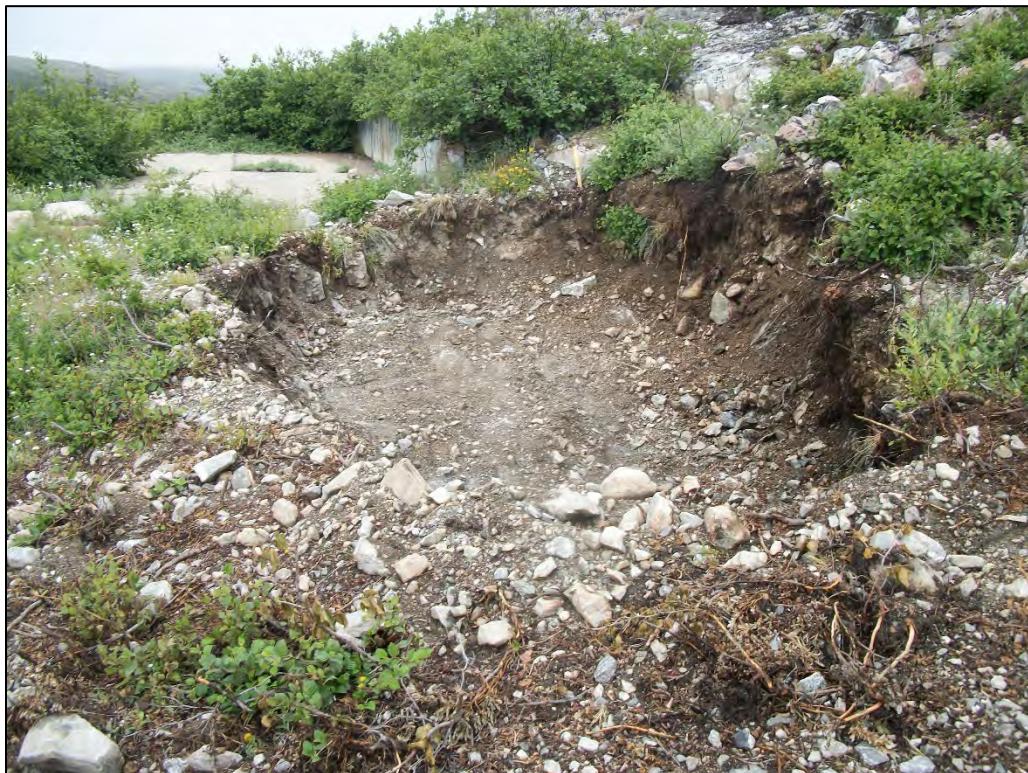
Photo 24 After soil removal at Main Base-Area 4, July 13, 2016.

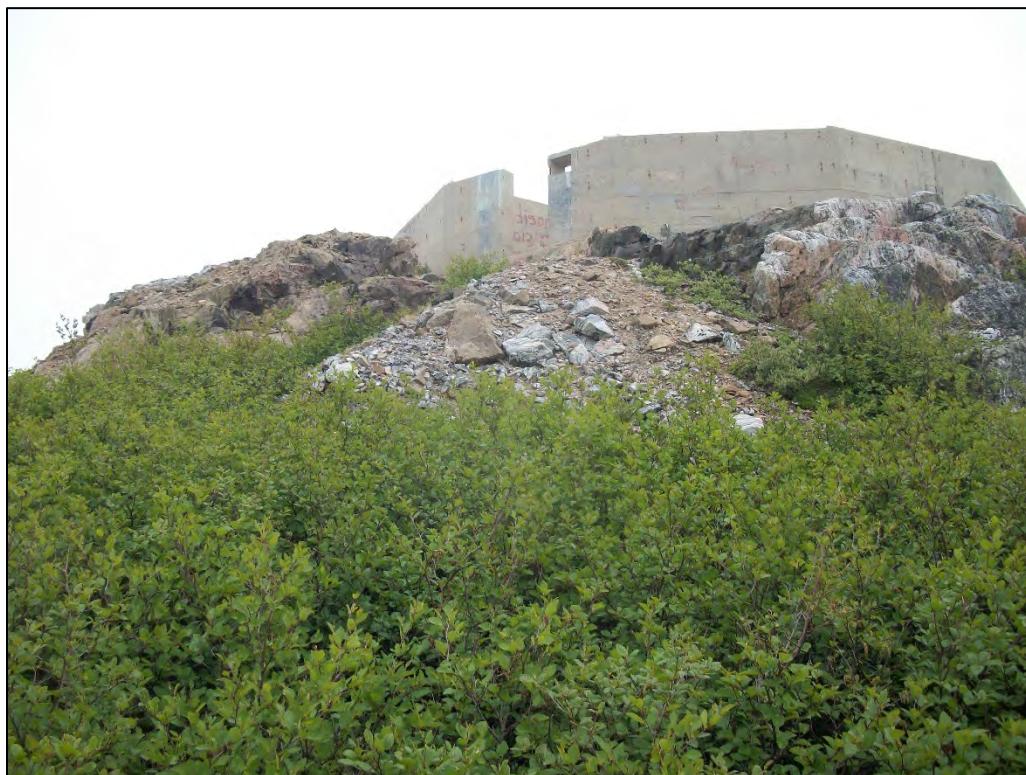
Photo 25 View of Main Base-Area 5, July 12, 2016.

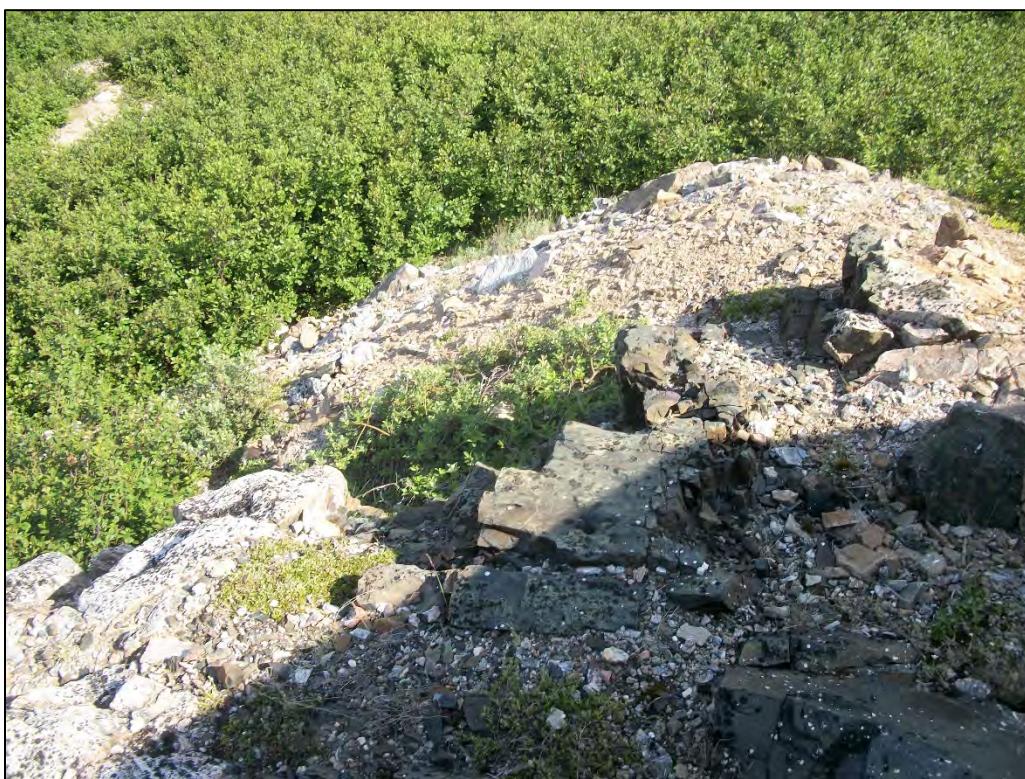
Photo 26 View of Main Base-Area 5, July 12, 2016.

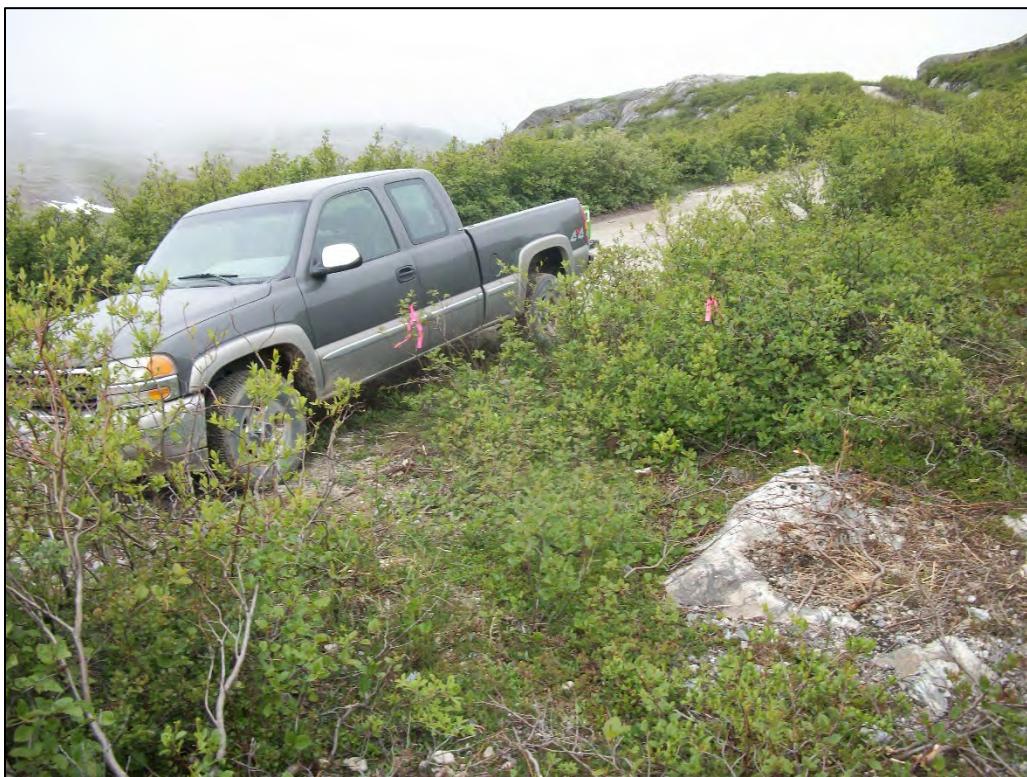
Photo 27 Prior to soil removal at Main Base-Area 4, July 12, 2016.
