**Implementation of the
Remedial Action Plan –
Year 6, Former U.S. Military
Site, Hopedale, NL**

Final Report

File No. 121413099

July 26, 2017

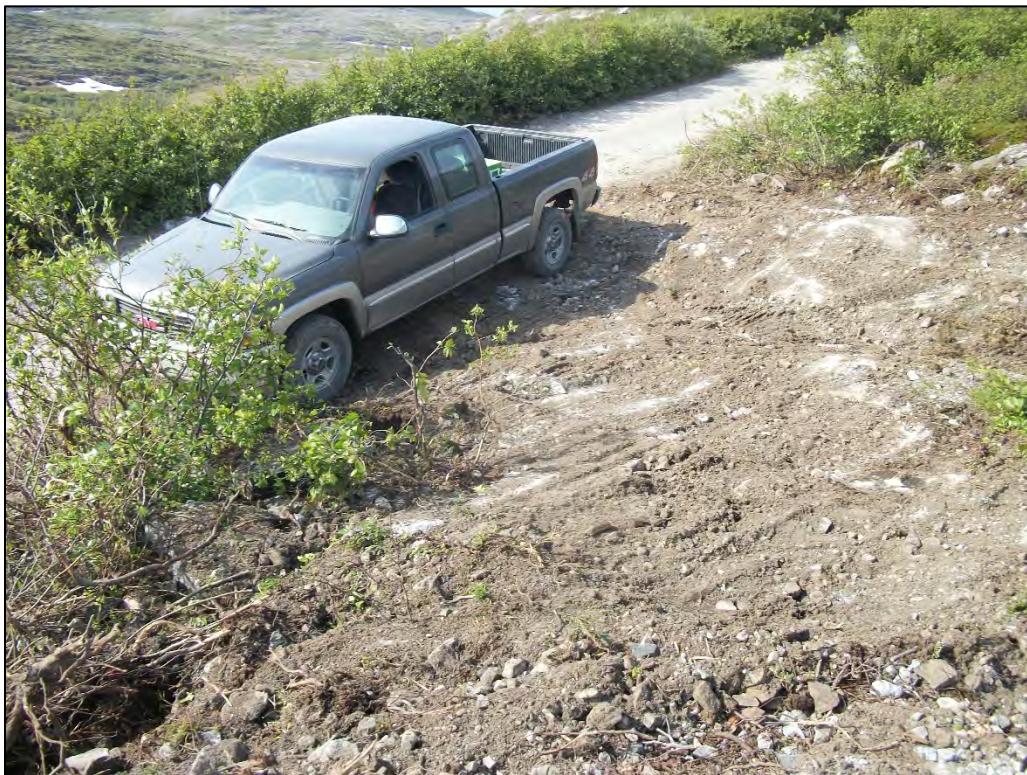
Photo 28 After soil removal at Main Base-Area 4, July 13, 2016.

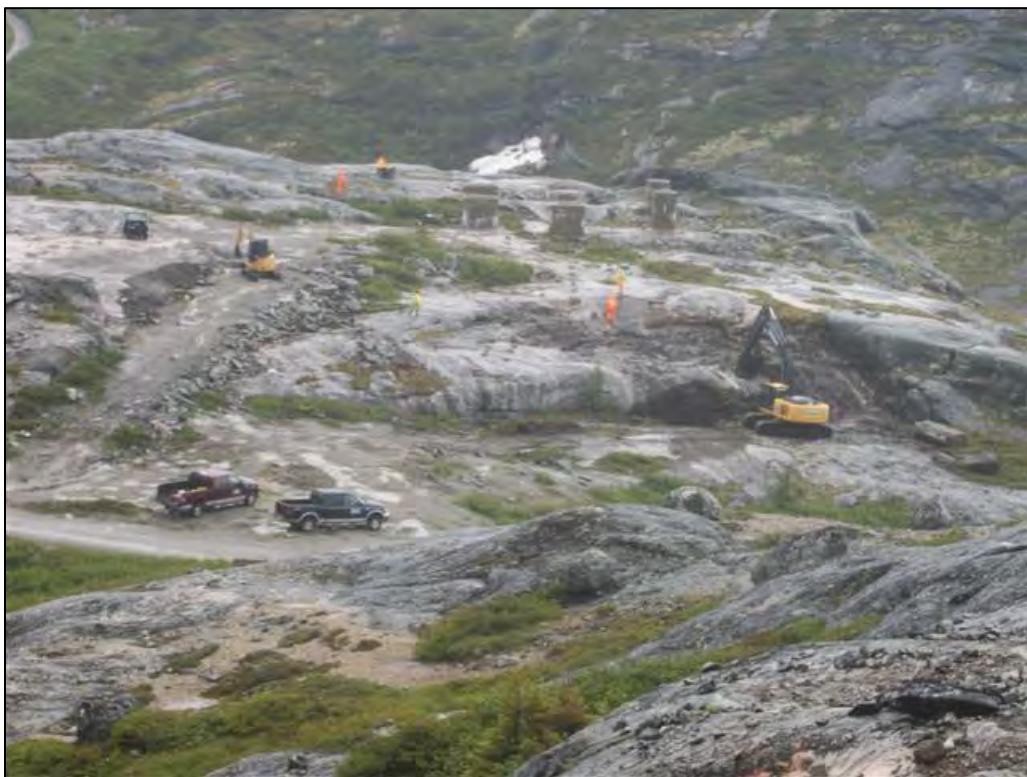
Photo 29 Soil removal at Old Base, July 14, 2016.

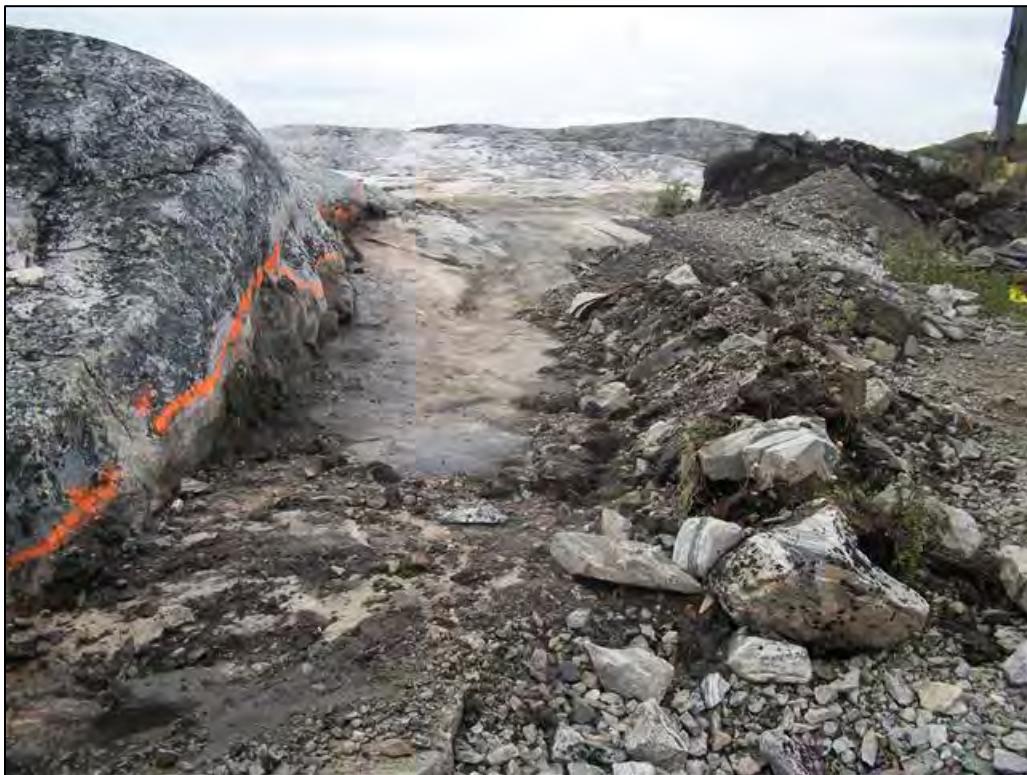
Photo 30 Soil removal at Old Base, July 14, 2016.

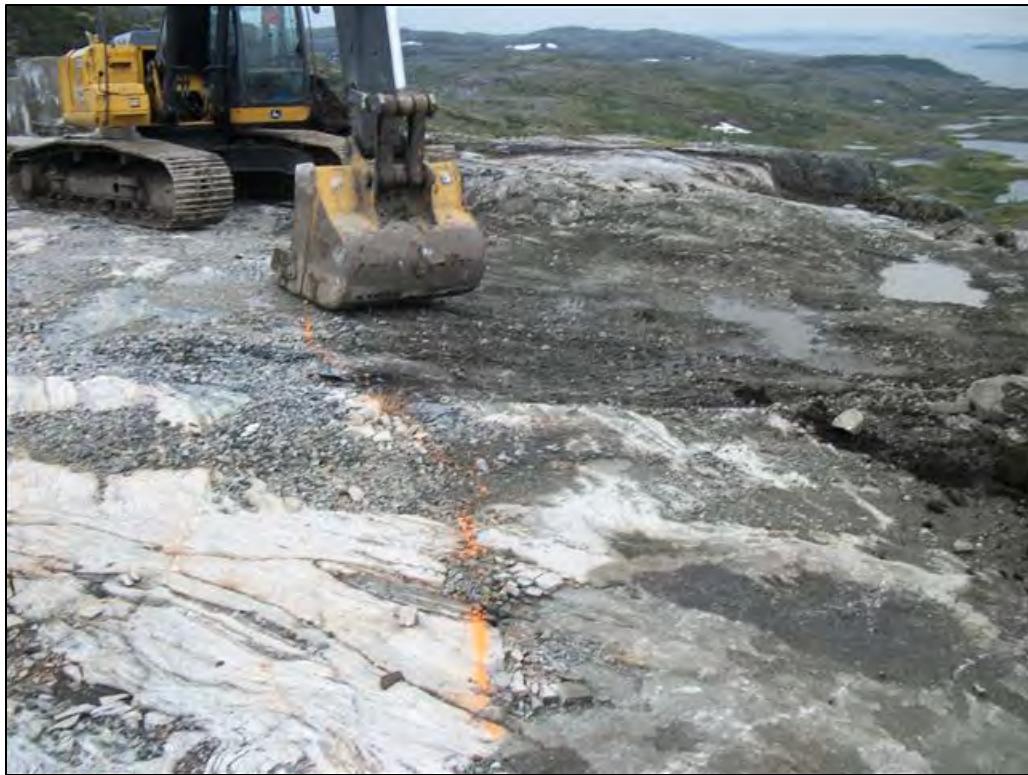
Photo 31 Soil removal at Old Base, July 14, 2016

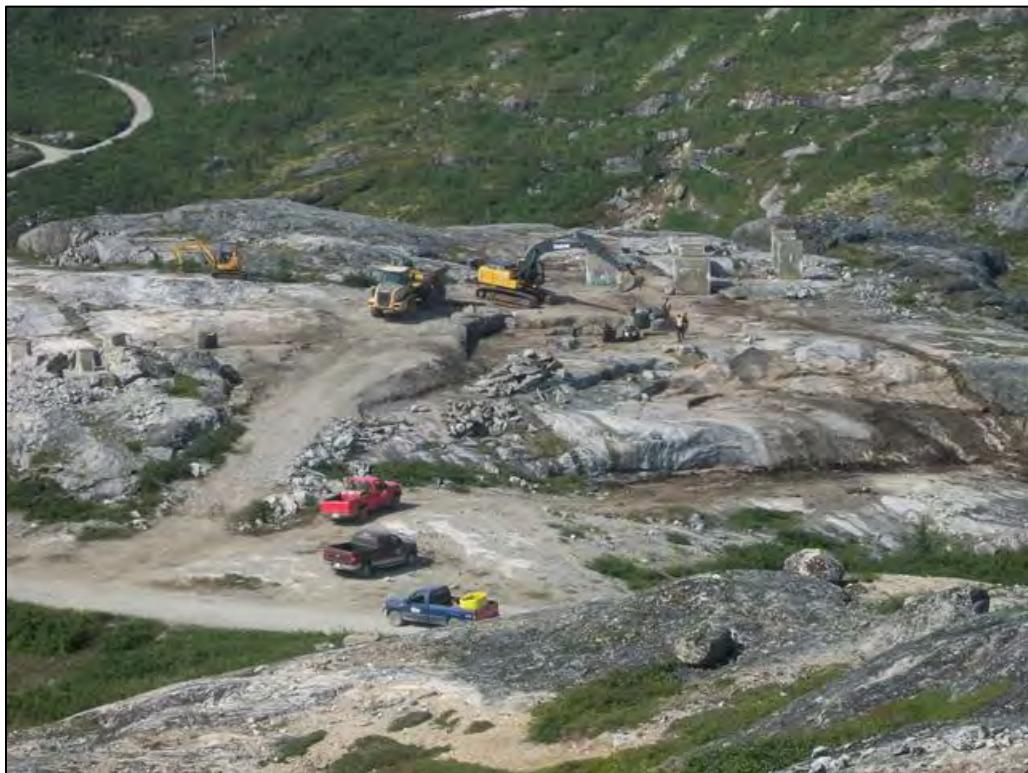
Photo 32 After soil removal at Old Base, July 19, 2016

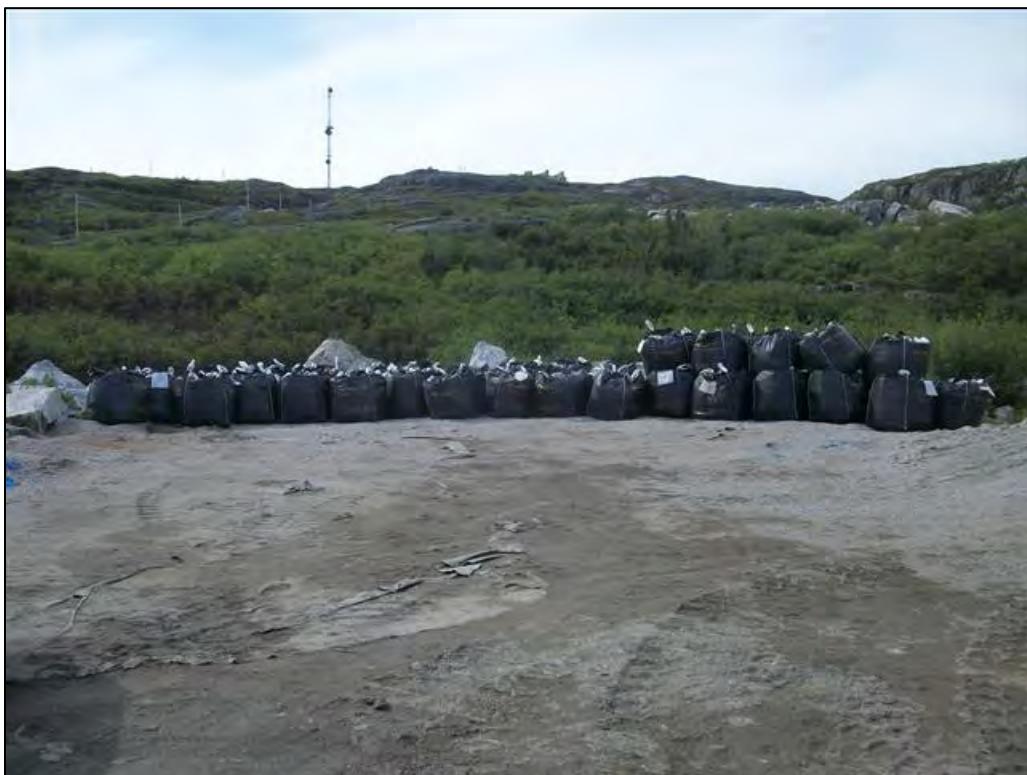
Photo 33 Stockpiled bags of impacted soil at Pit No. 1, July 8, 2016.

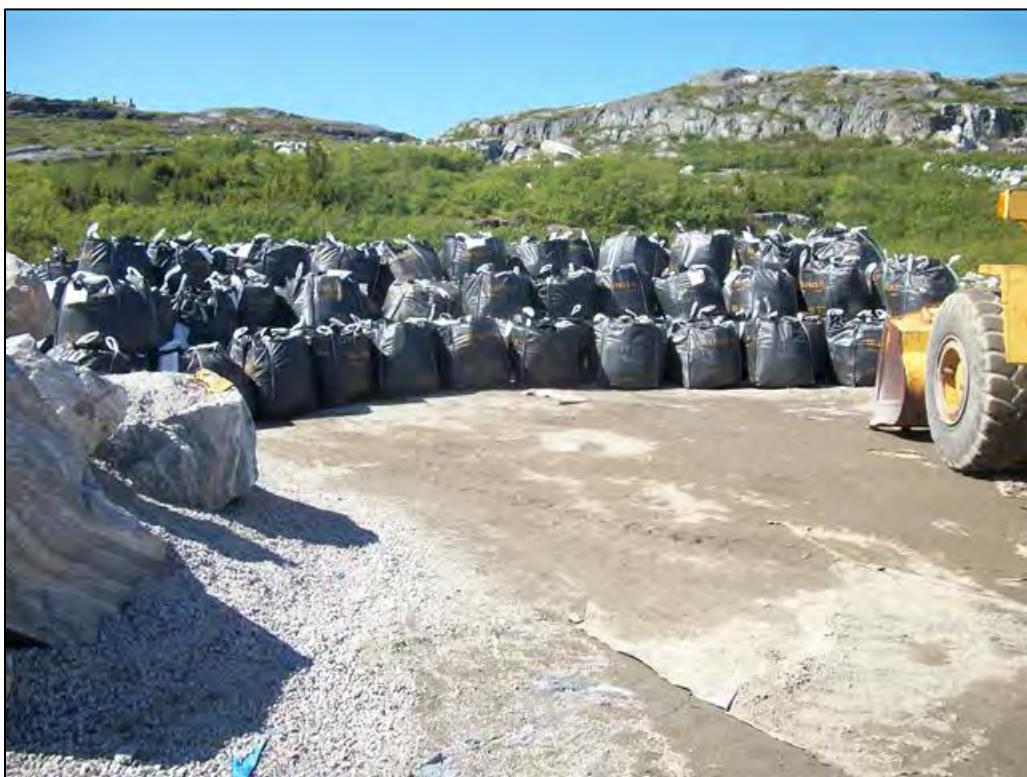
Photo 34 Stockpiled bags of impacted soil at Pit No. 1, July 11, 2016.

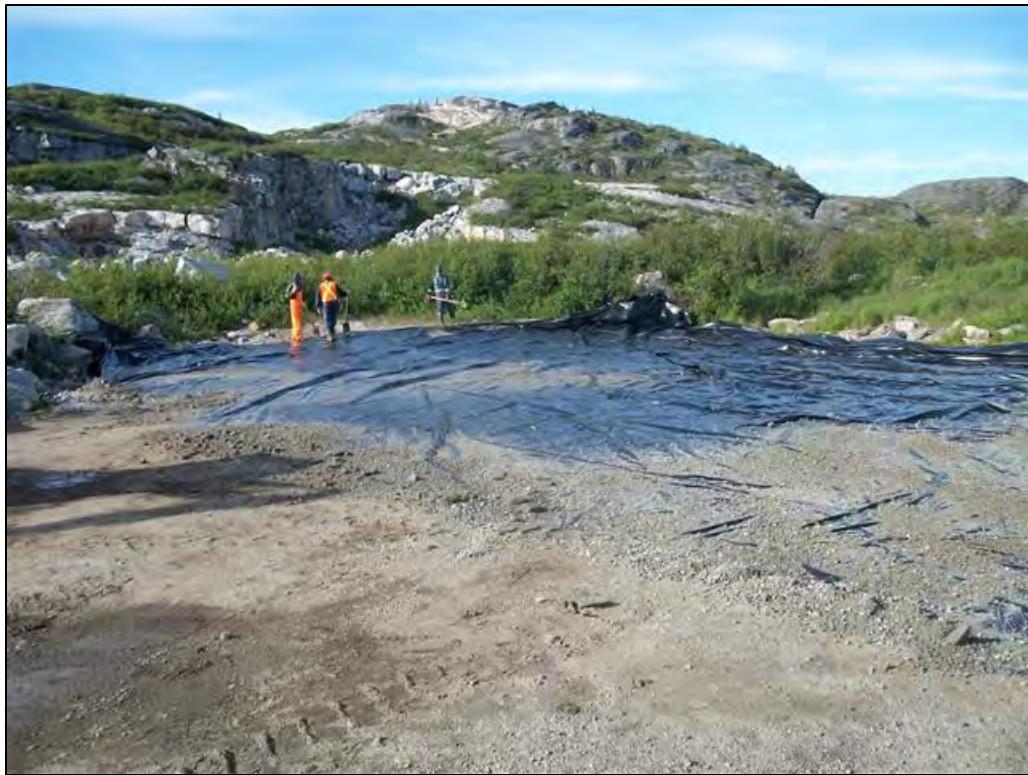
Photo 35 Pit No. 1, installing liner at staging area, July 11, 2016.

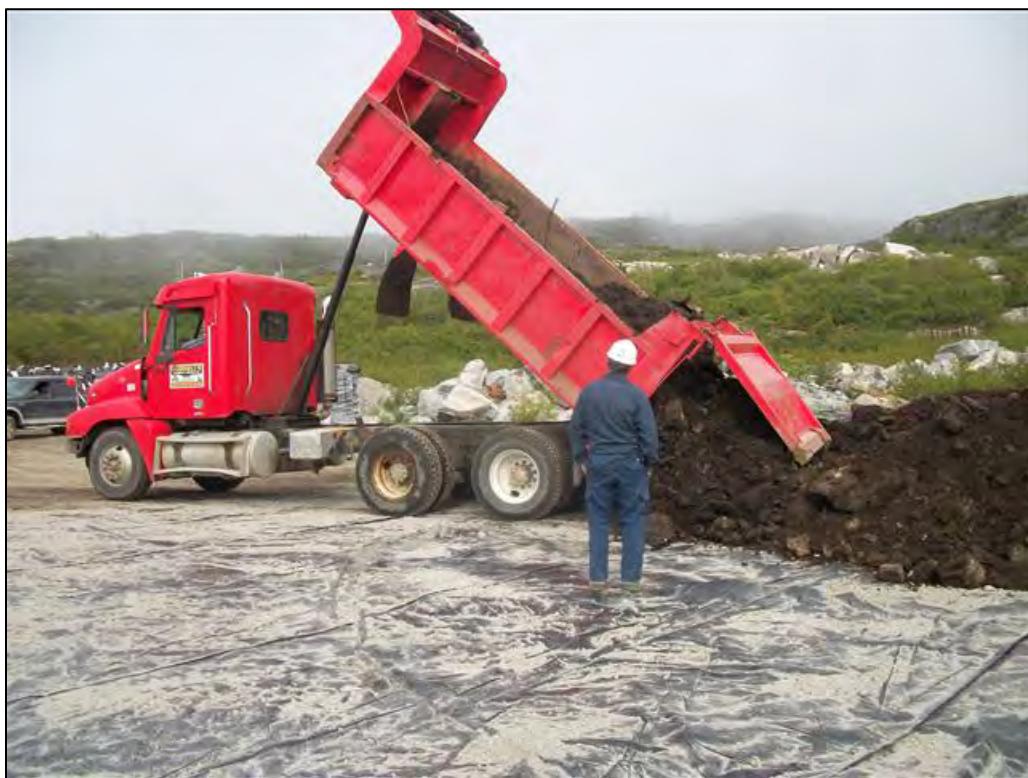
Photo 36 Pit No. 1, impacted soil being placed at staging area, July 22, 2016.

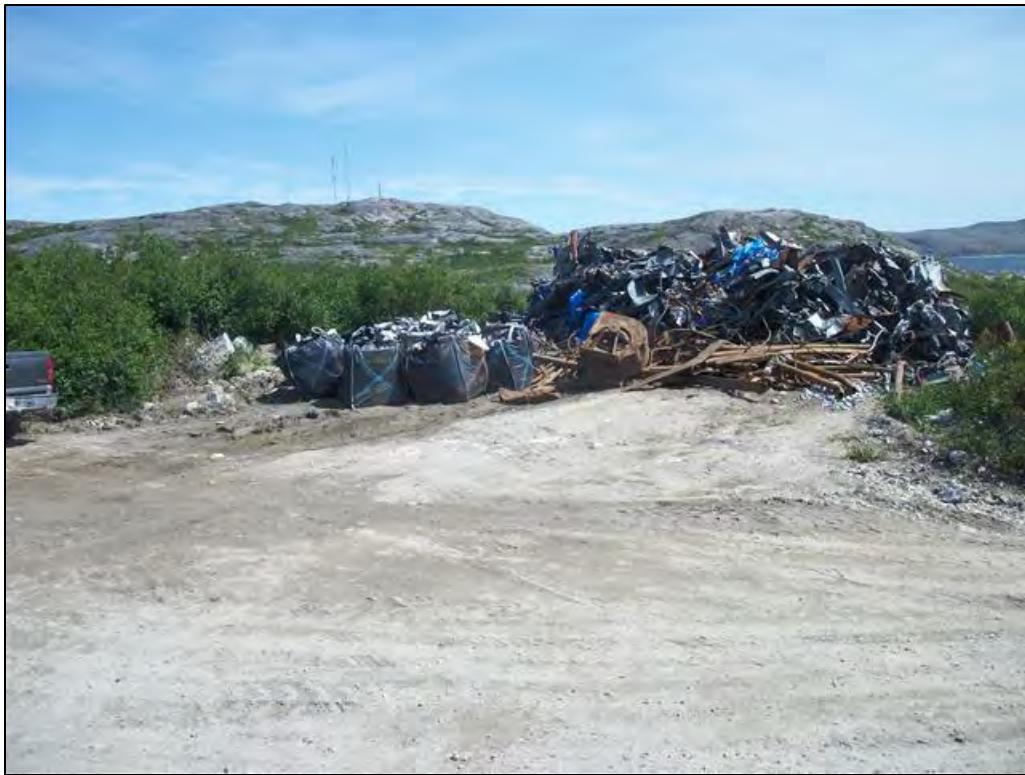
Photo 37 Pit No. 1, stored metal debris, July 22, 2016.

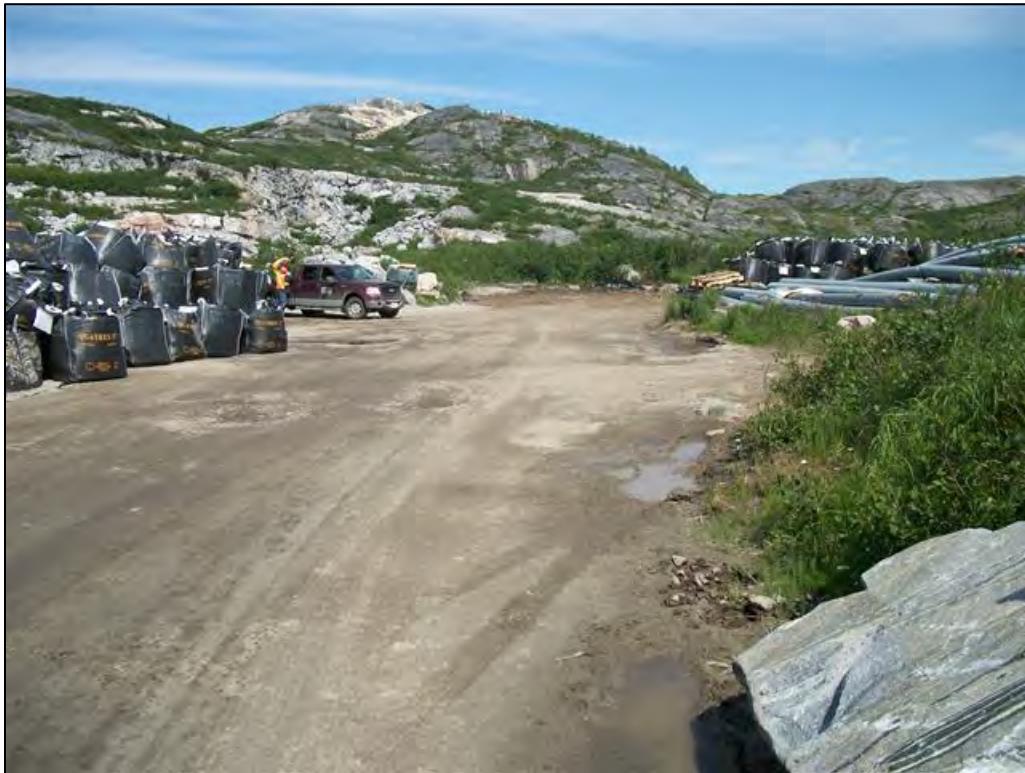
Photo 38 Pit No. 1, storage of impacted soil bags, July 22, 2016.

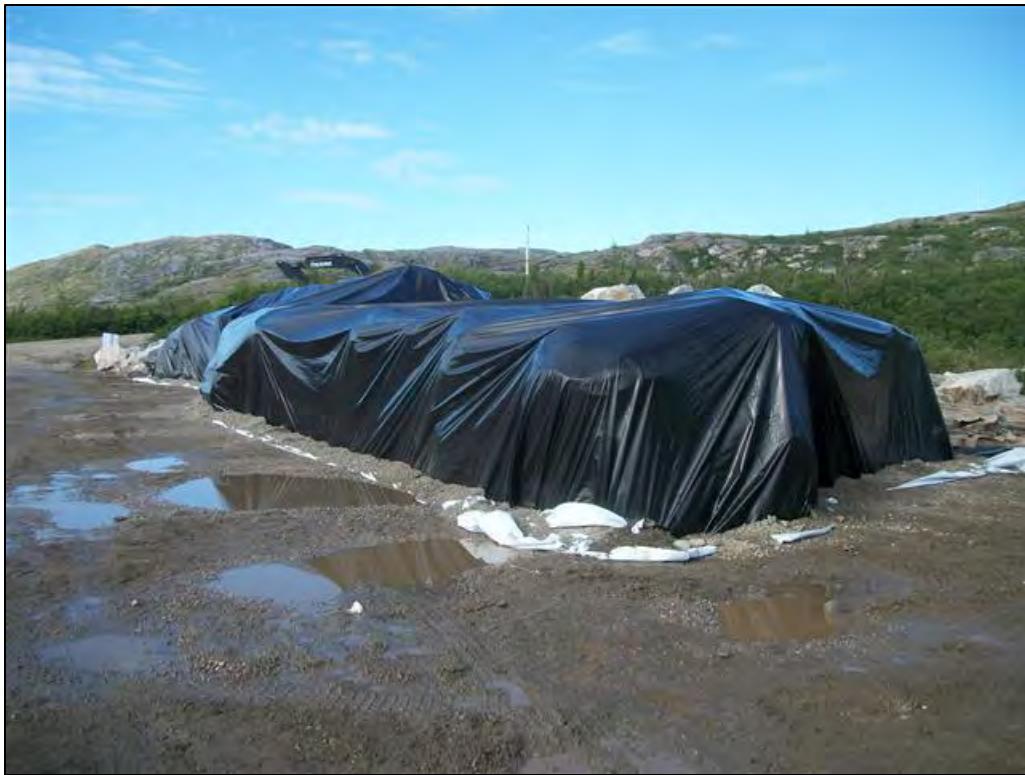
Photo 39 Storage of soil bags containing PCB-impacted soil for second shipment at Pit No. 1, August 3, 2016.

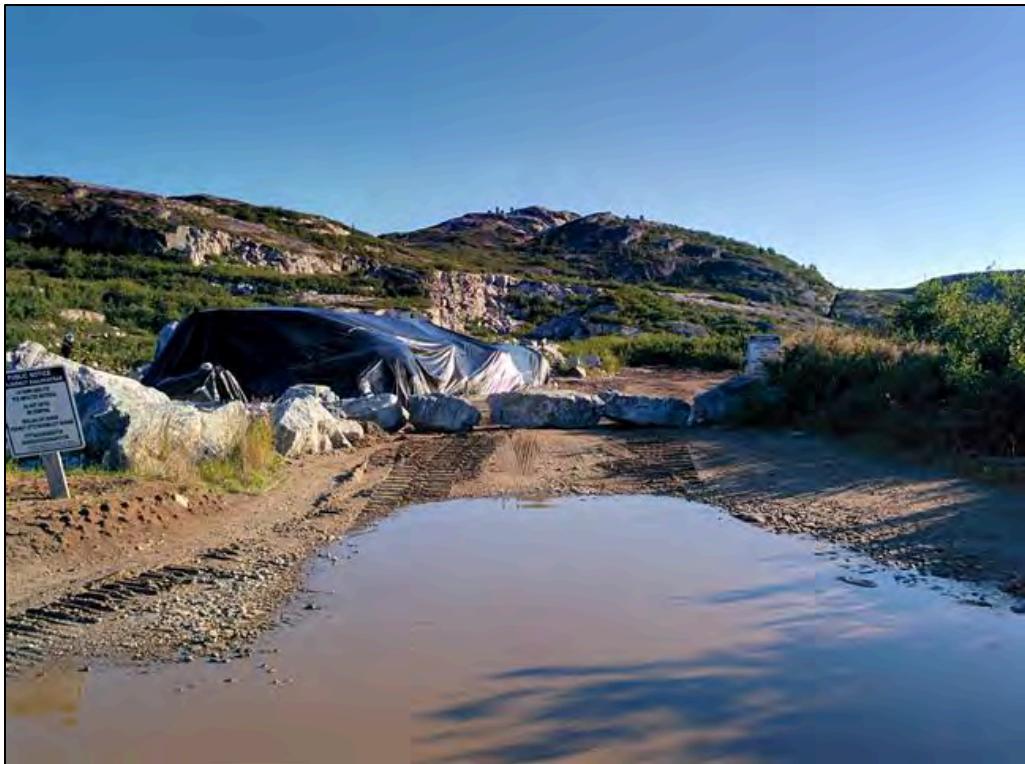
Photo 40 Pit No. 1 access blocked by boulders, August 4, 2016.

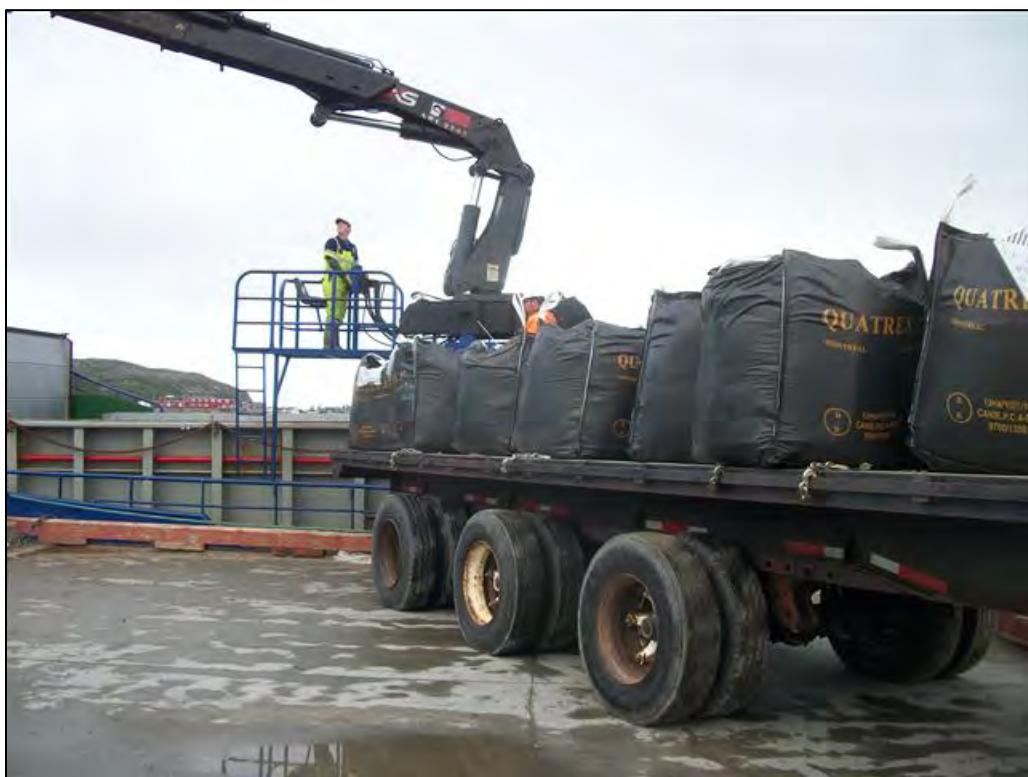
Photo 41 Loading of impacted soil bags from a flat bed truck, July 30, 2016.

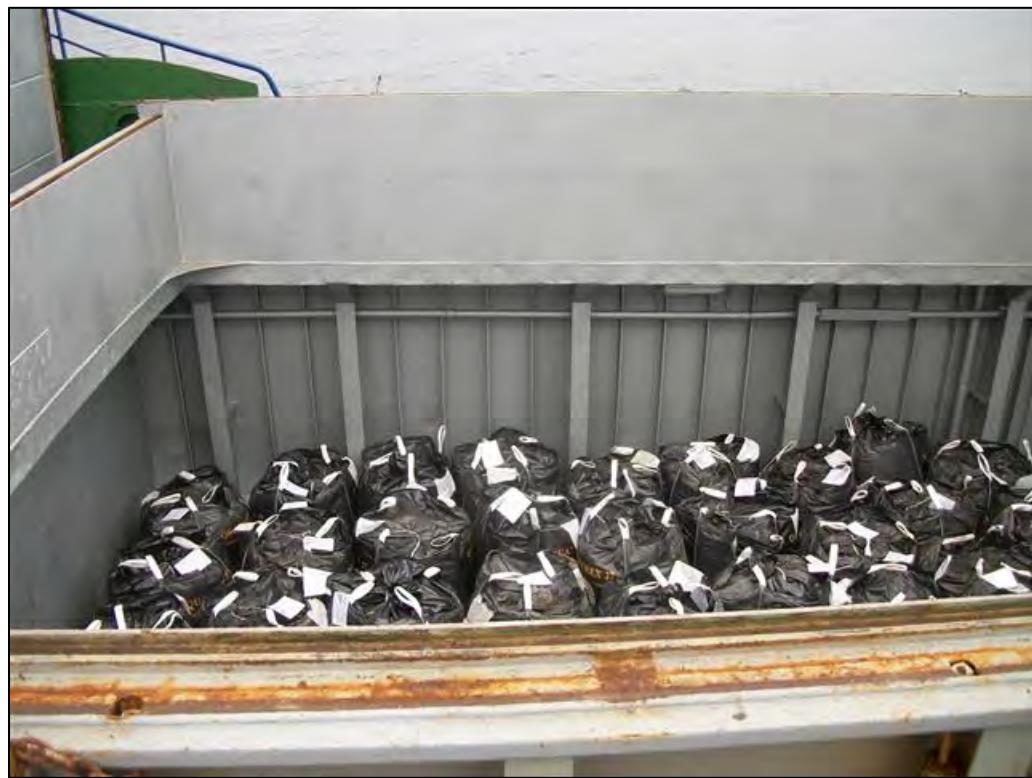
Photo 41 PCB-impacted soil bags in Long Island's cargo hold at the American Dock, July 31, 2016.

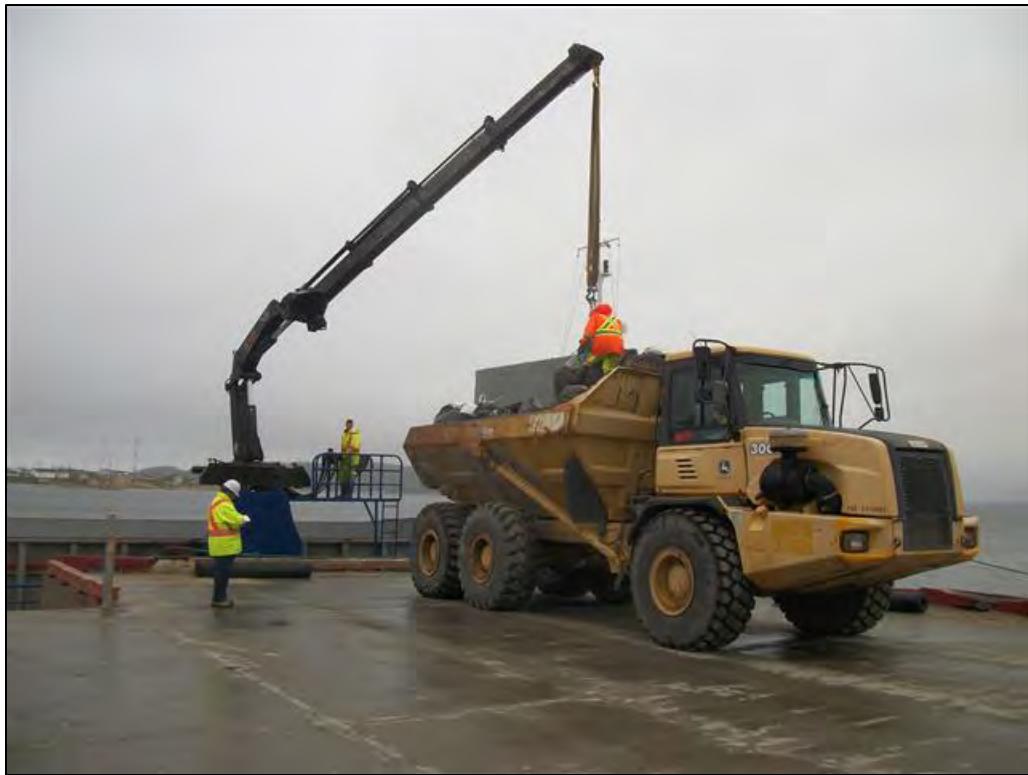
Photo 43 Loading soil bags, July 31, 2016.

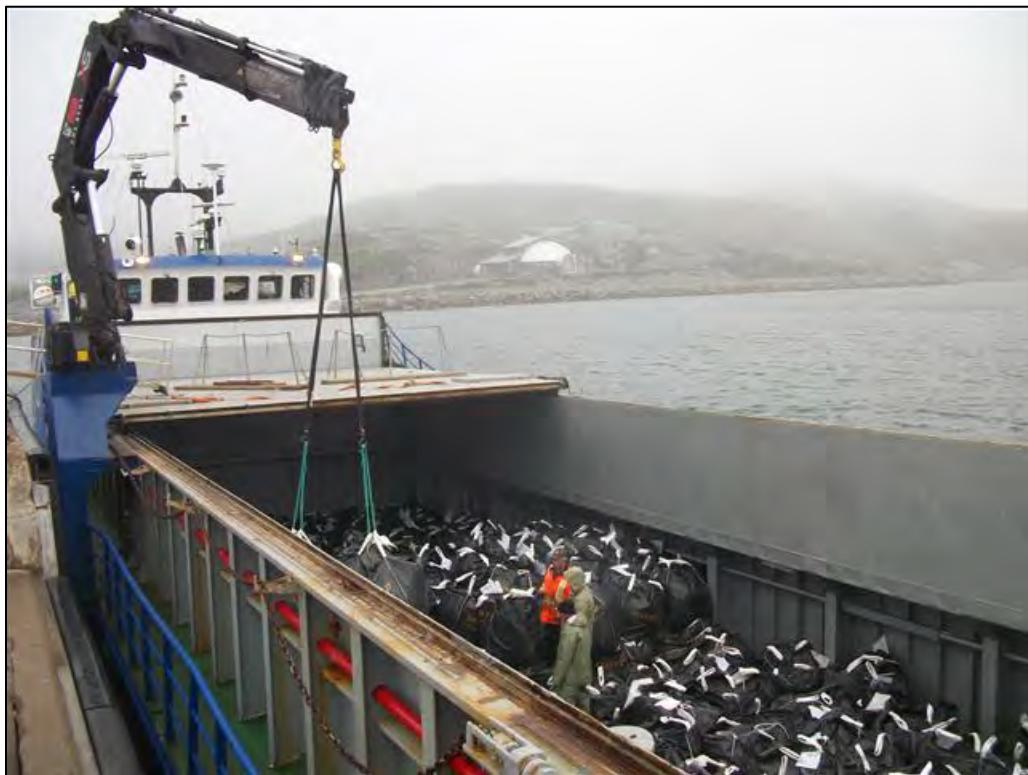
Photo 44 Long Island cargo hold, July 31, 2016.
