**Phase III Environmental Site
Assessment, Human Health and
Ecological Risk Assessment and
Remedial Action Plan for the Former
U.S. Military Site at Northwest Point,
Labrador, NL**

Newfoundland and Labrador
Department of Environment and
Conservation

Final Report

Date: November 28, 2011

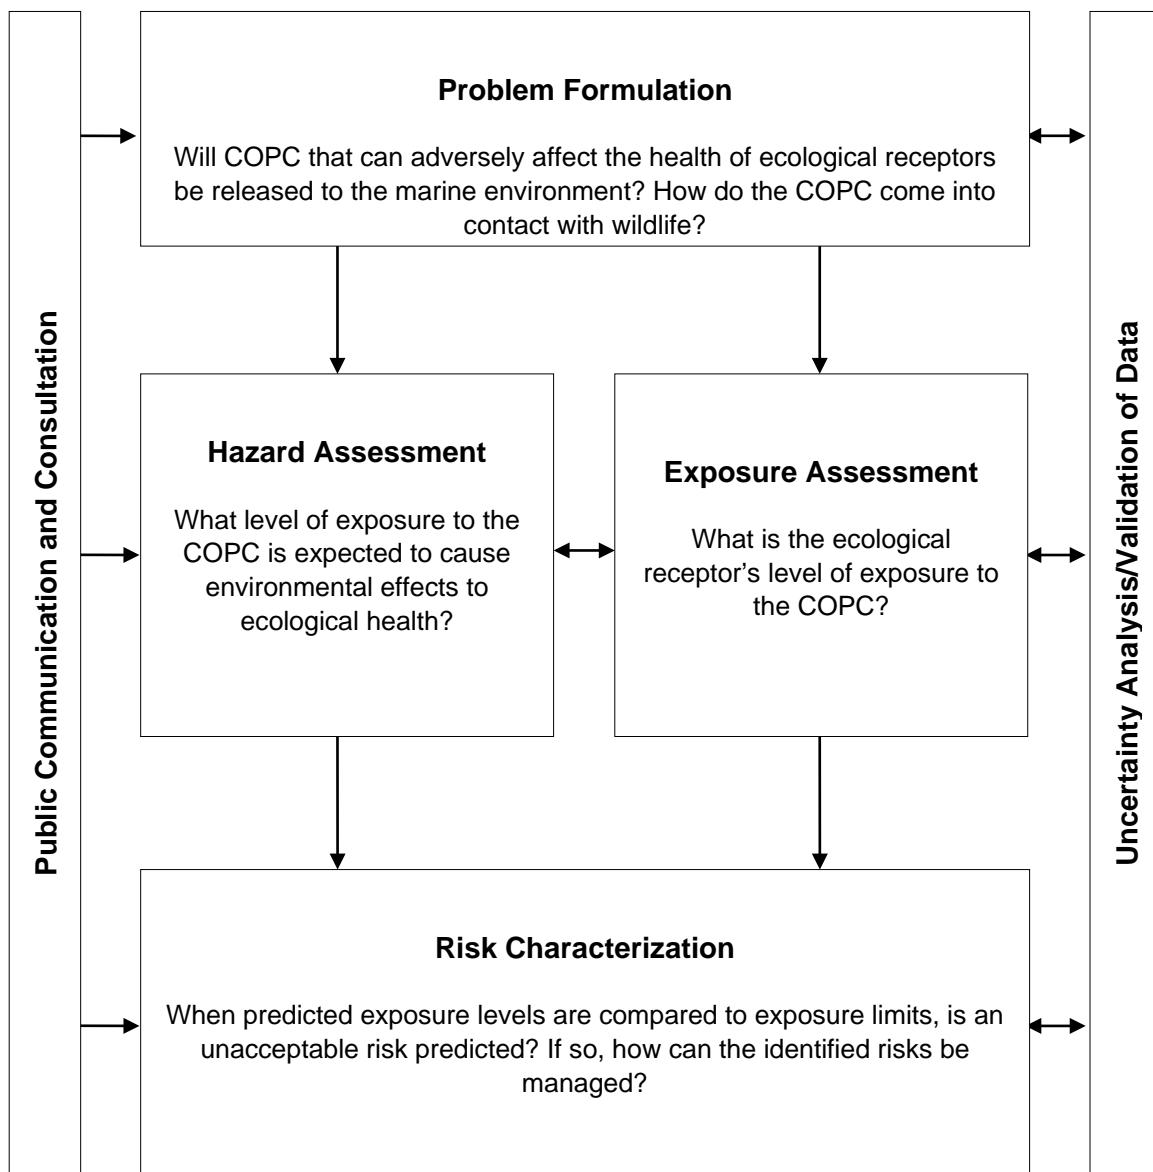
Figure 8.1 ERA Framework

Following this, a discussion of the uncertainties inherent to ERA, and conclusions and recommendations stemming from the assessment are discussed. The ERA framework is conceptually illustrated in Figure 8.1.

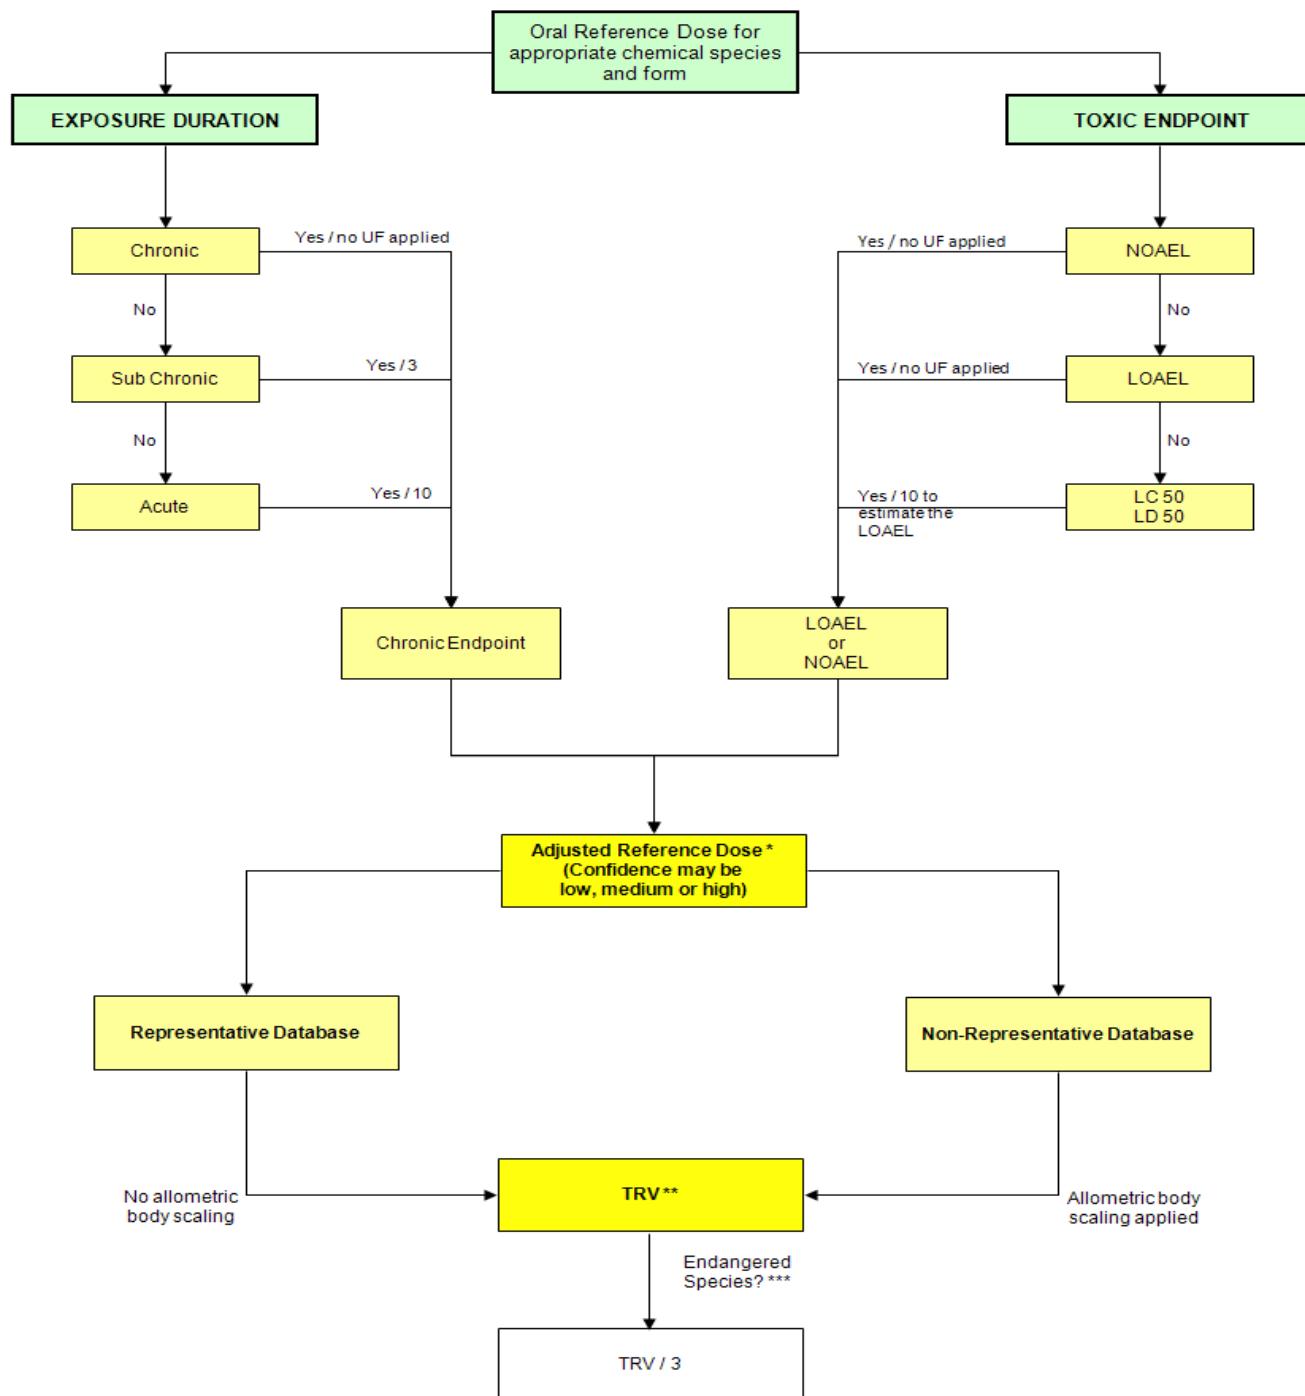
Figure 8.2 Tiered Approach for the Application of Uncertainty Factors in ERA

For COCs where LOAELs or NOAELs were not available, sub-chronic or acute toxicity measures such as median lethal dose (LD50) were obtained and modified using Uncertainty Factors (UFs) to convert these values to surrogate chronic values. Chronic LOAEL data derived from studies that assess reproductive, survival, or growth endpoints, as the basis for predicting wildlife population-level responses to contaminants is preferred. The LOAEL-based benchmark represents a threshold level at which adverse health outcomes are likely to become evident (Sample *et al.* 1996). The use of the LOAEL is appropriate because a TRV based on the LOAEL is used as the denominator in the hazard quotient (HQ) calculation, and HQ greater than 1.0 are considered indicative of potential adverse environmental effects. In cases where no chronic LOAEL is available, a NOAEL toxicity value may be selected, or UFs may be applied to other existing exposure and toxicological data using a tiered process to derive suitable ecological TRVs. When TRVs are based on US EPA Ecological Soil Screening Levels (Eco-SSLs), NOAELs are often the selected endpoint, but can vary depending on the chemical. The UF scheme outlined here (Figure 8.2) is based on guidance provided by Ohio EPA (2003, 2008), US EPA (2002), Sample and Arenal (1999) and professional judgment.

* A NOAEL can be used if no appropriate LOAEL is available but the resultant RfD should be considered more conservative than if it was derived using the LOAEL. Refer to document text for details.

** No inter-class UF is used to derive TRVs (i.e., mammalian data are not used as the basis to derive avian TRVs)
