Canada-Newfoundland and Labrador
Water Quality Monitoring Agreement

Assessment of Wastewater Impacts in the
Churchill River near Happy Valley-Goose Bay

March 2010

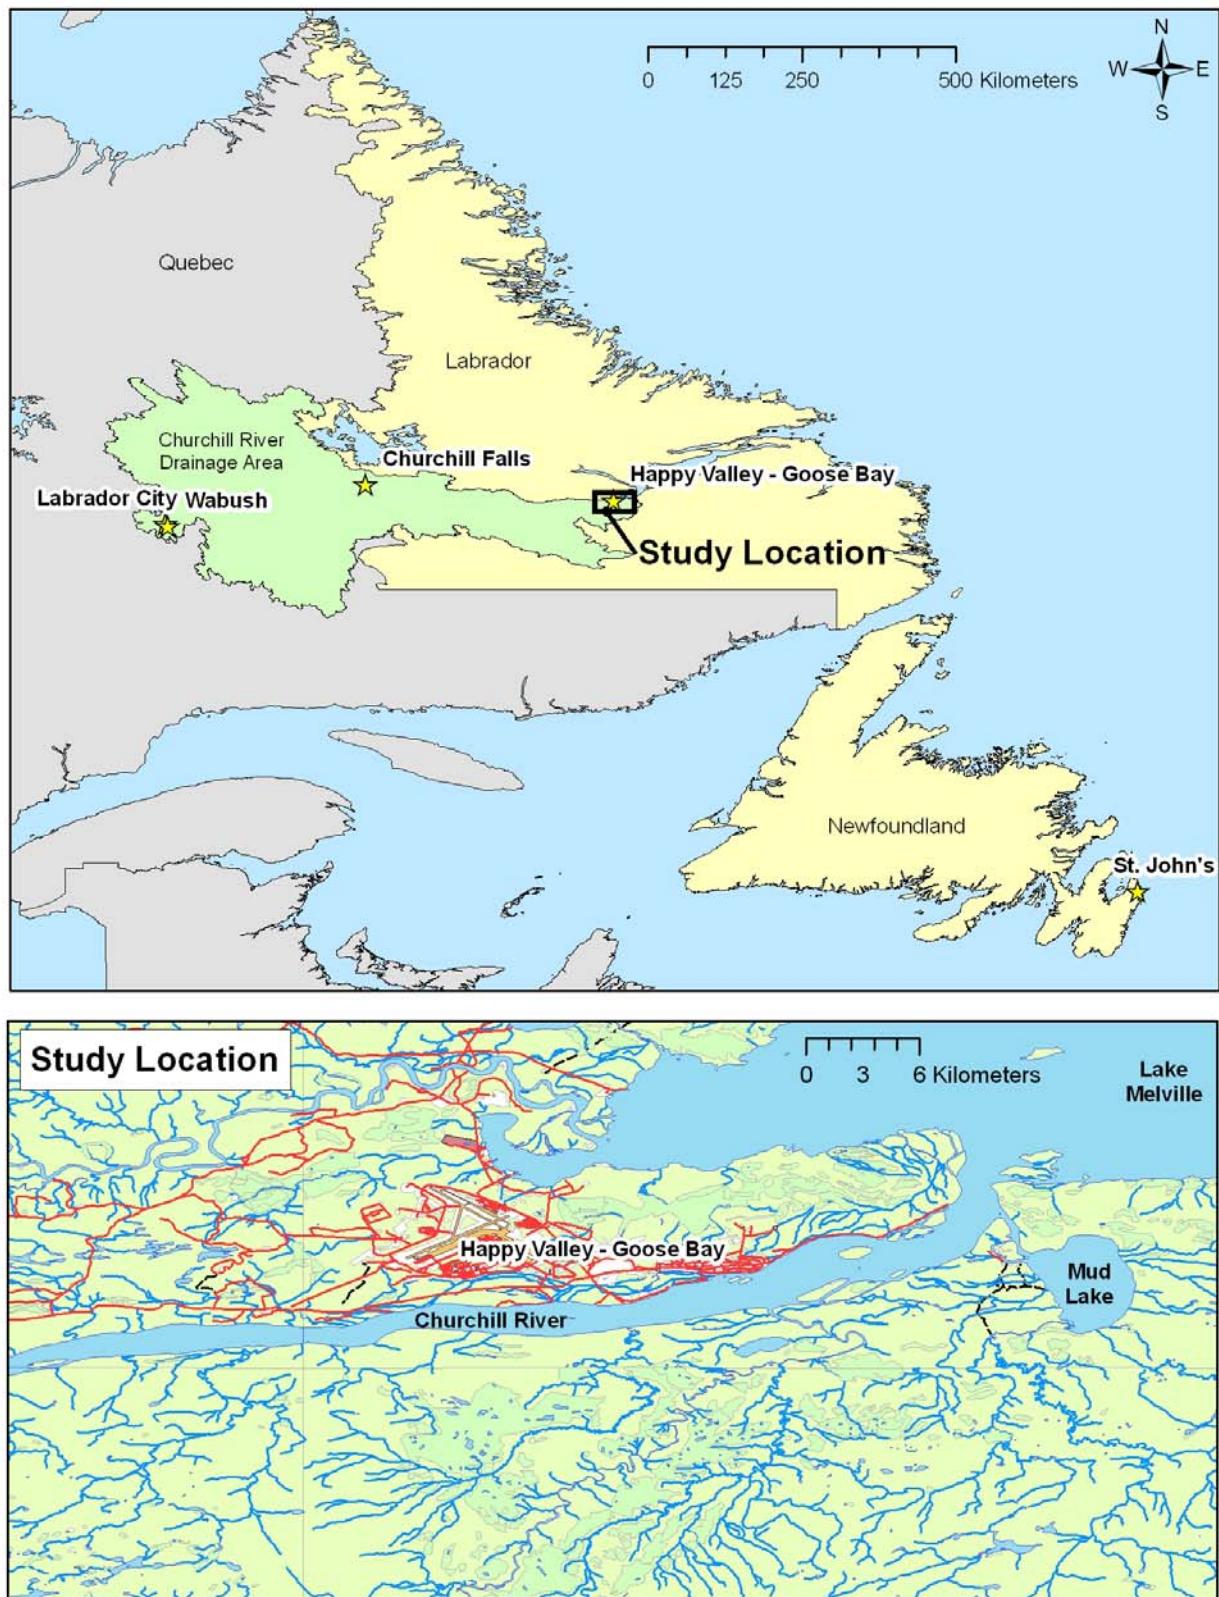
Figure 1 - Study Location

The Churchill River is located in Labrador (Figure 1) and is the largest river within the province of Newfoundland and Labrador. Figure 1 has the Churchill River drainage area highlighted in light green. The river has a drainage basin that is approximately 94,000 square kilometres (km^2) and has a mean annual flow of 1740 cubic metres per second (m^3/sec) at Muskrat Falls which is approximately 25 kilometres upstream of HV-GB. Significant alterations have been made in the upper watershed to provide for hydroelectric generation at the Churchill Falls Generating Station (CANAL, 2009).

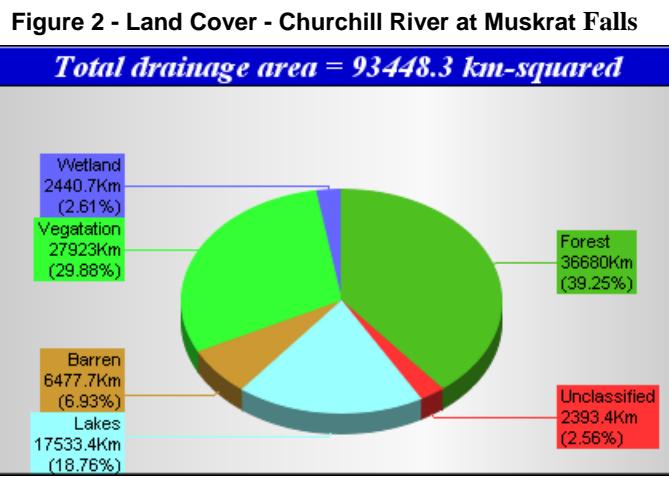
Figure 2 shows the distribution of land cover within the drainage area upstream of Muskrat Falls. Land cover is predominantly forest and vegetation comprising about 69.1 % of the drainage area. Lakes account for approximately 18.8 % of the drainage area while wetlands cover about 2.6 % (CANAL, 2009).

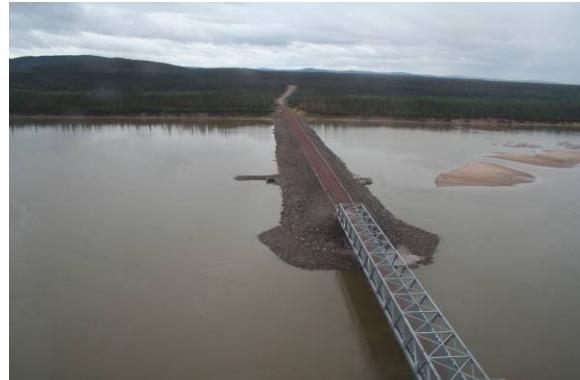
Photo 1 – Trans Labrador Highway Bridge and Causeway over Churchill River

Construction on Phase III of the Trans Labrador Highway was taking place at the time of the study in the region south of the Churchill River. The bridge was completed at the time of the study but was not yet open to the public.

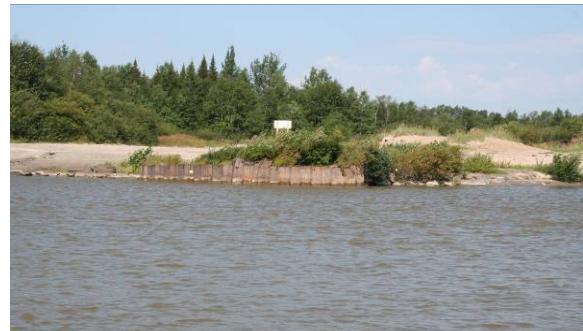
Photo 2 - Birch Island Outfall

This outfall is commonly referred to as the Lower Outfall. The approximate locations of the outfalls are indicated on Figure 3.

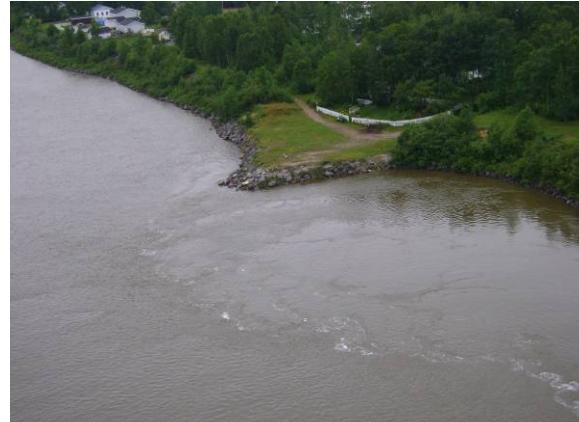
Photo 3 - Lower Outfall (Corte Real Rd)

Sewage from 5 Wing Goose Bay, the north side of Goose Bay, Spruce Park and Hamilton Heights are collected at different locations and are eventually conveyed to a 300 mm (12") diameter concrete trunk sewer that carries the untreated sewage to the Birch Island outfall (photo 2). The Birch Island outfall discharges untreated municipal sewage to the southern shore of the Churchill River (Town of HV-GB, 2009). Sewage from the remaining areas is collected at different locations and is eventually discharged untreated by way of a 600 mm (24") diameter corrugated metal pipe in proximity to the intersection of Corte Real Road and Hamilton River Road (photo 3).

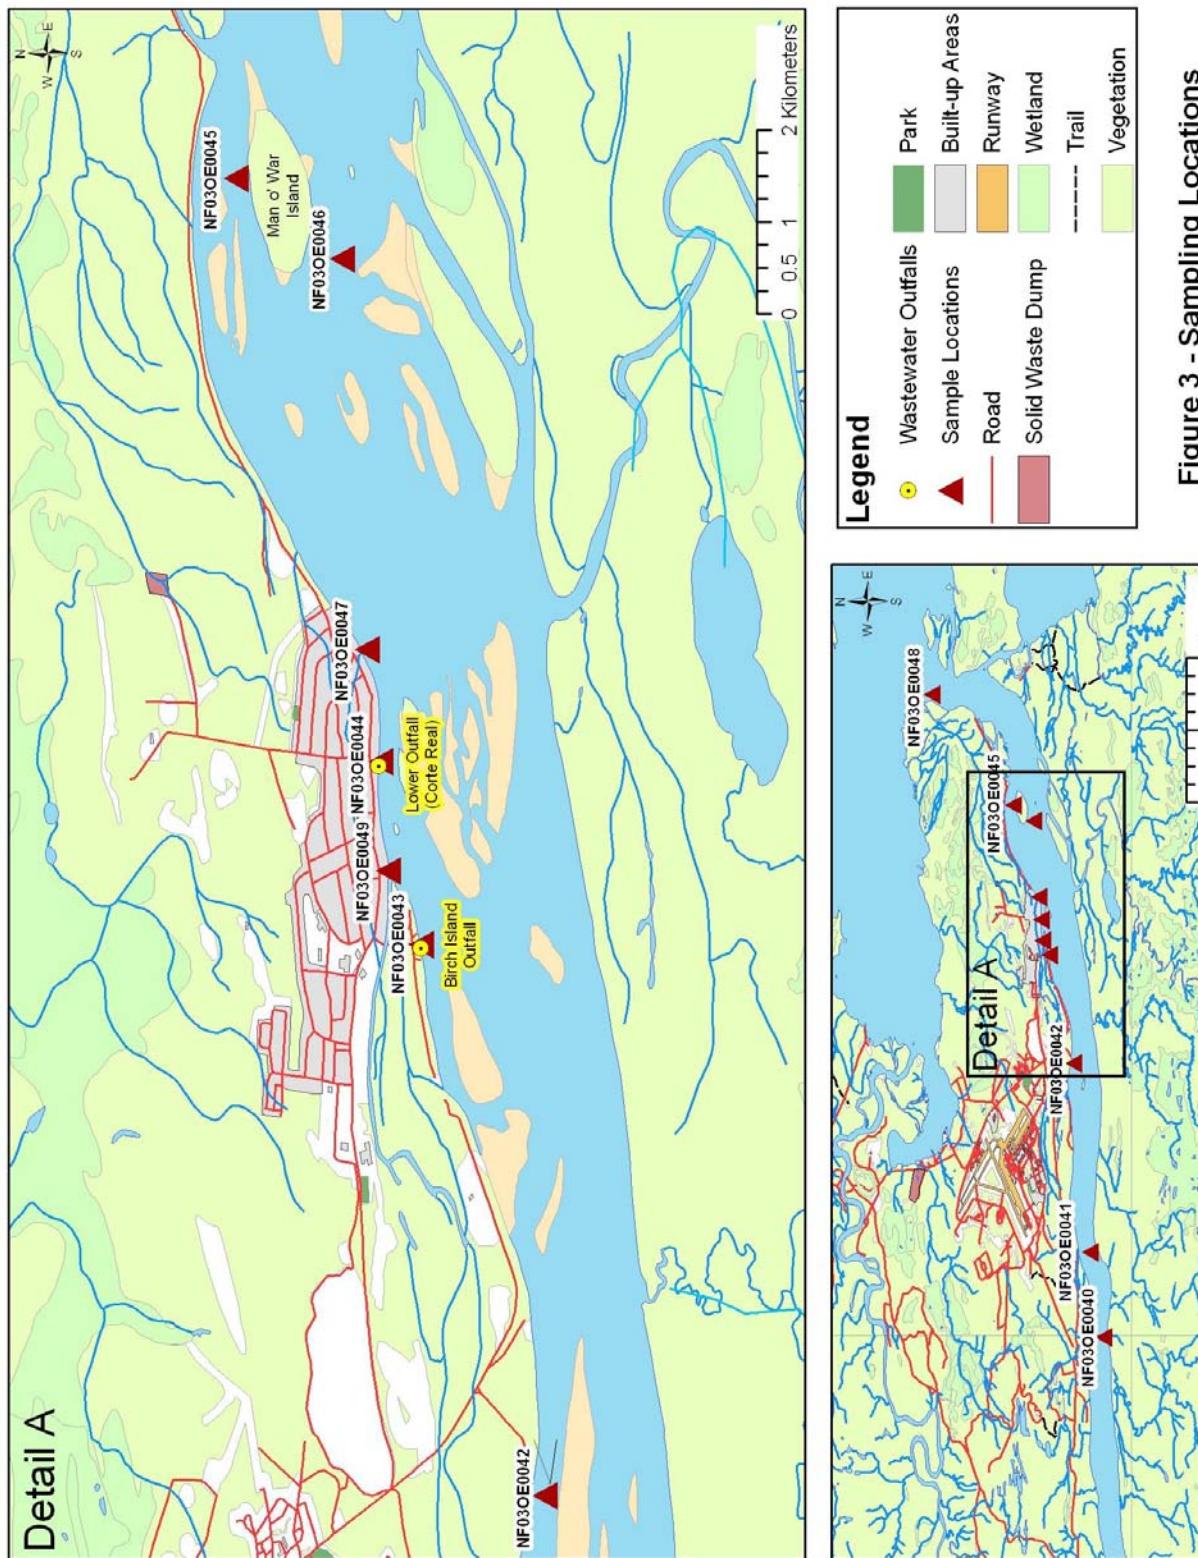
Figure 3 - Sampling Locations

Sample locations for water, sediment, and biota are presented in Figure 3. Sample location co-ordinates were obtained using a Garmin® Rhino 530 GPS unit. The following Table 5 identifies the sample locations and the rationale behind the selection of the sample locations.

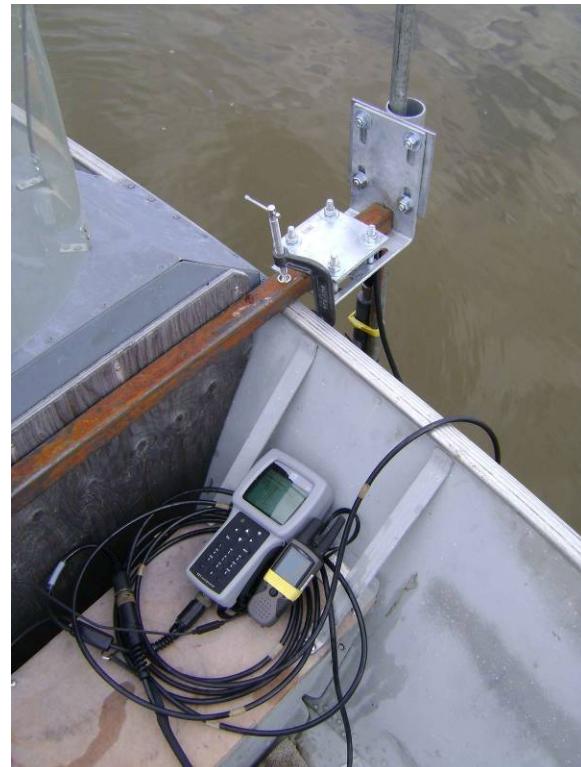
Photo 4 - Multi-parameter Meter with GPS

Field measurements were taken using a recently calibrated multiparameter YSI® 600 OMS sonde connected to a Garmin Rino® 530 GPS unit. The sensors on the sonde were situated at a depth of 0.3 m at the front side of the boat to minimize influence from the boat and motor. This set-up was capable of logging in-situ temperature, dissolved oxygen, specific conductance and pH while simultaneously obtaining the co-ordinates at each measurement location. This set-up enabled logging of field parameters at 5 second intervals while the boat was moving. The logged data was plotted on a map to assess spatial variability in the parameters. A photo of the set-up is shown in Photo 4 – Multi-parameter Meter with GPS. Data obtained from this set-up is referred

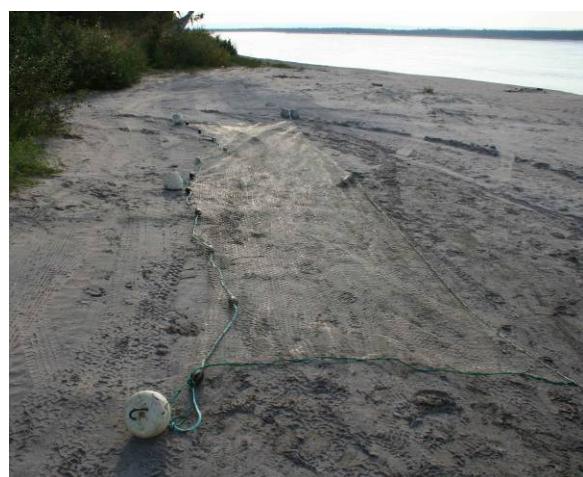
Photo 5 - Gill Net

Fish were collected using a 9 x 1.5 metres gill net with a 62 millimetre opening. The gill net was deployed at three different locations for varying amounts of time. A photo of the net

used is shown in Photo 5. Flow velocities in the Churchill River made it difficult to deploy the net in the main channels. Deployments were limited to shallow areas (<3 metres) with lower flow velocities.

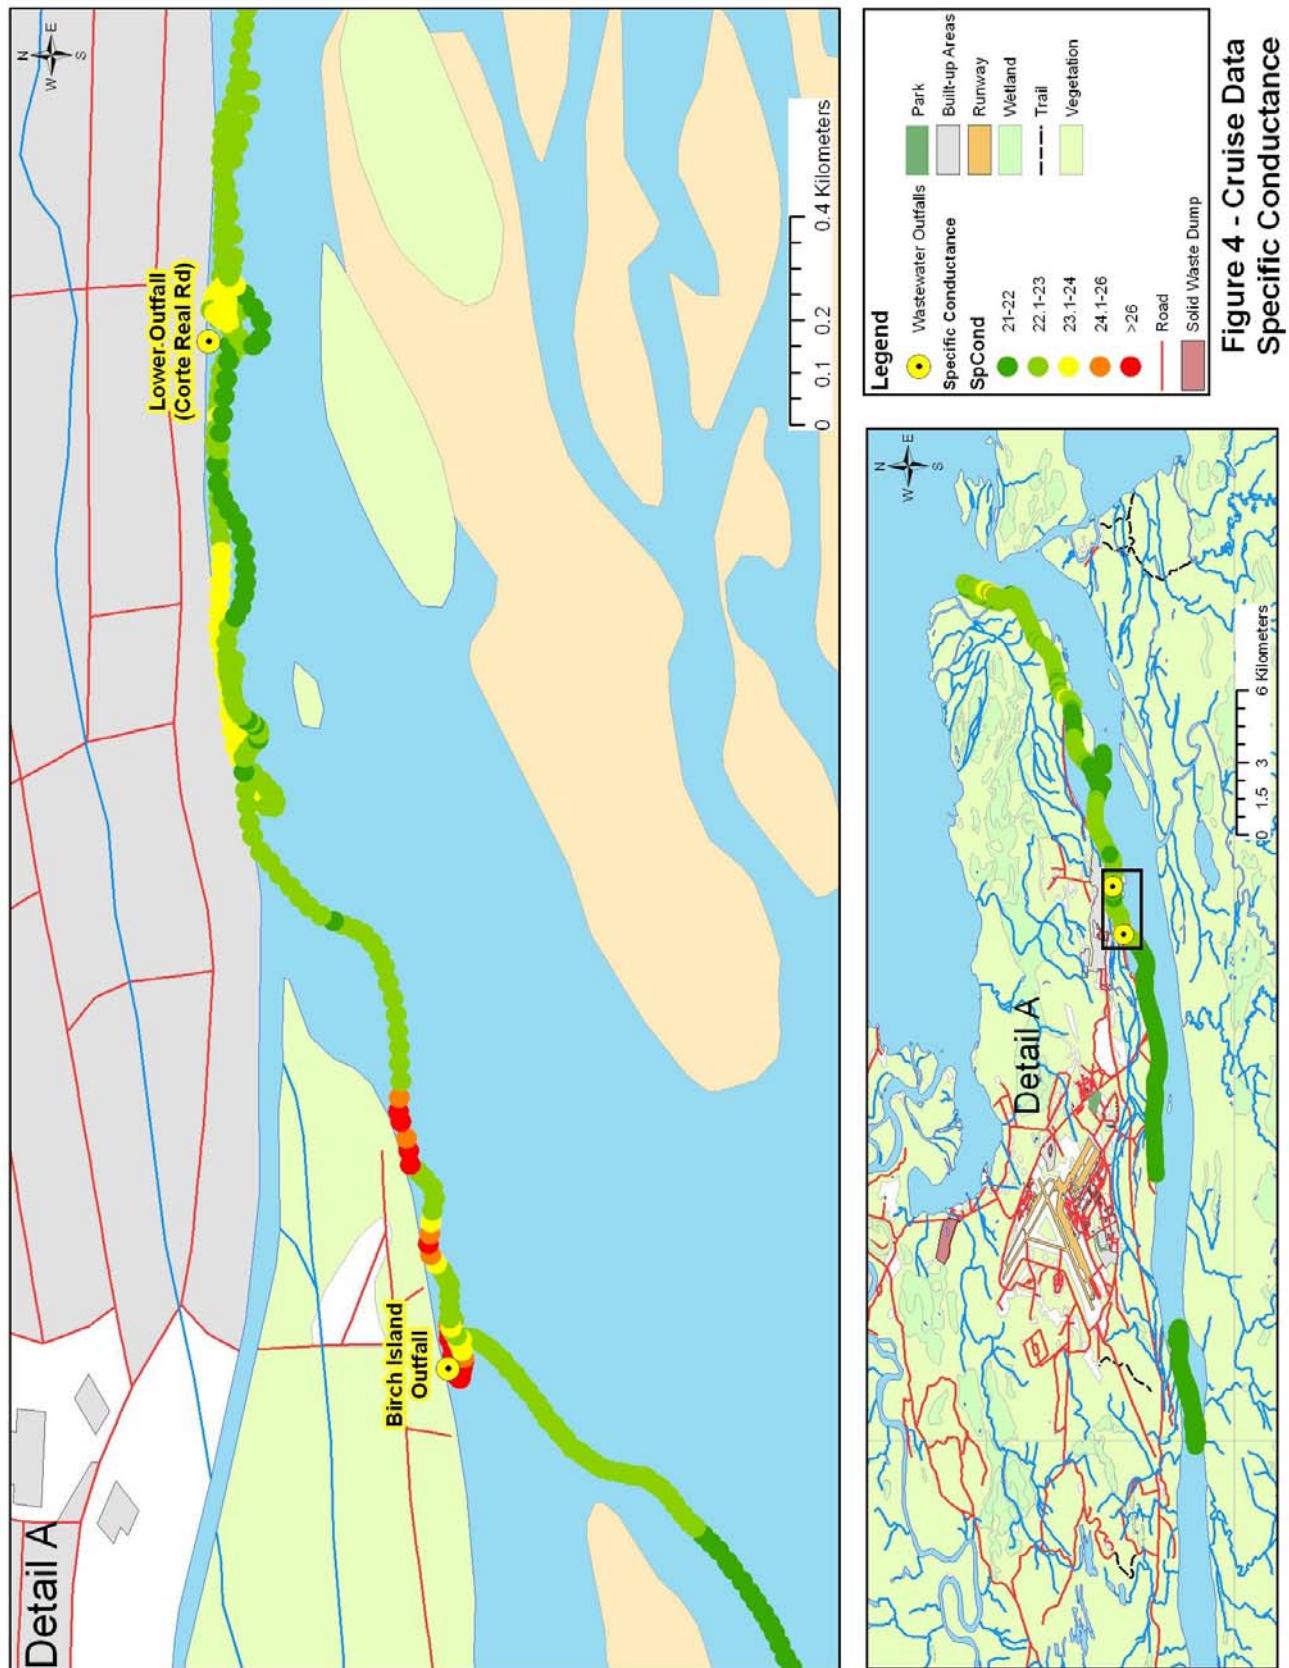
Specific conductivity was found to be higher around the two outfalls and in downstream sections than in the upstream sections where the conductivities were quite stable at 21-22 microSiemens/centimetre ($\mu\text{S}/\text{cm}$) as illustrated in Figure 4 – Cruise Data – Specific Conductance. Specific conductance also appeared to be slightly higher in the shallower, near bank areas downstream of the outfalls as compared to the deeper channel where the majority of flow was concentrated. Higher conductivities ($>24 \mu\text{S}/\text{cm}$) were encountered at greater

distances (up to 400 metres) downstream of the Birch Island Outfall than at the Lower Outfall where conductivities quickly returned close to background levels encountered in upstream sections. This indicated that there was better mixing at the Lower Outfall where the channel was narrower, deeper and flow velocities were greater than near the Birch Island Outfall.

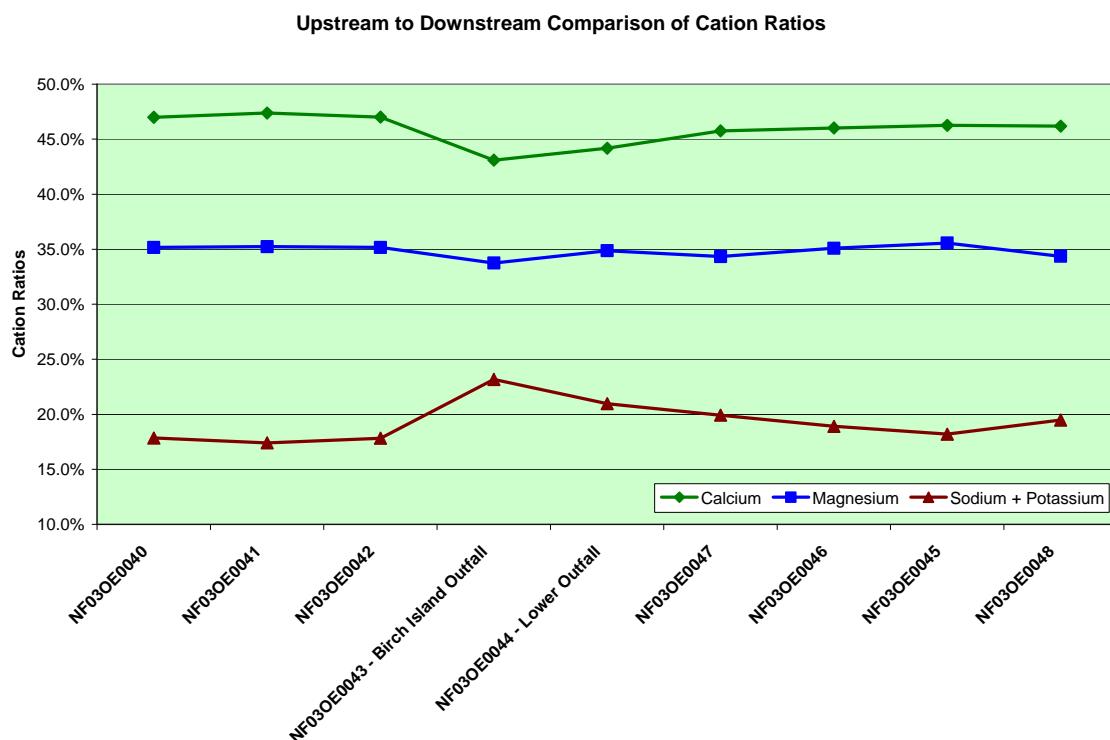
Figure 5 – Major Ion Ratios - Cations

Figure 5 clearly shows the change in cation ratios that occurs near the Birch Island Outfall (NF03OE0043), and does not return to upstream conditions until sample location NF03OE0045. This indicates the influence of water with a different chemical composition dominated by sodium. The anions show a similar trend with chloride showing the greatest increase in percentage. This would indicate a sodium chloride type water influencing the calcium bicarbonate type water found in the Churchill River at these stations. Ratios return to upstream (NF03OE0040) conditions by sample location NF03OE0045.

There is also a change in cation ratios visible at the sample location NF03OE0048 where the saltwater influence of downstream Lake Melville could start to influence ratios. A vertical profile of water quality field parameters at the location NF03OE0048 showed no change in parameters with depth indicating that the freshwater-saltwater interface was still some distance downstream during the sampling period.

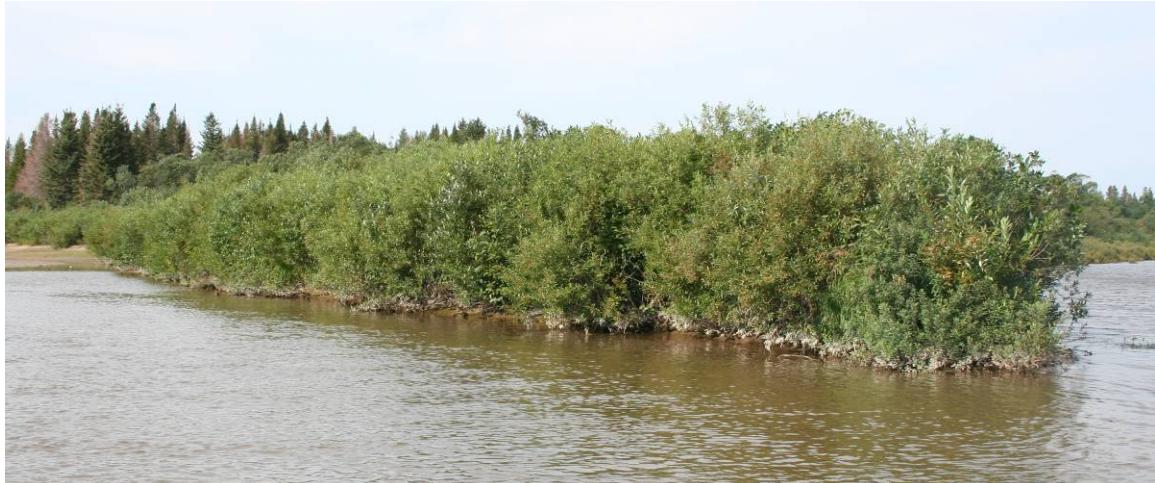
Photo 6 – Residue on Vegetation near B13 Downstream of Birch Island Outfall

The highest concentration of fecal coliforms was detected in the area downstream of the Birch Island Outfall at B13 in the vicinity of NF03OE0049. The concentration at this location was 30,000 colony forming units per 100 millilitres (cfu/100ml). This is also the location of the gill net where biota samples were collected. The water in this area appeared to have lower velocities in comparison to the main channel of the river to the south. Water depth at the sampling location was approximately 1.8 metres. There was also increased staining of the shoreline rocks and vegetation with a light colored residue in this area relative to sections upstream. Photo 6 shows the degree of residue on the vegetation at B13 downstream of the Birch Island Outfall while Photo 7 shows the vegetation at B1 on the southern shore with no residue visible.

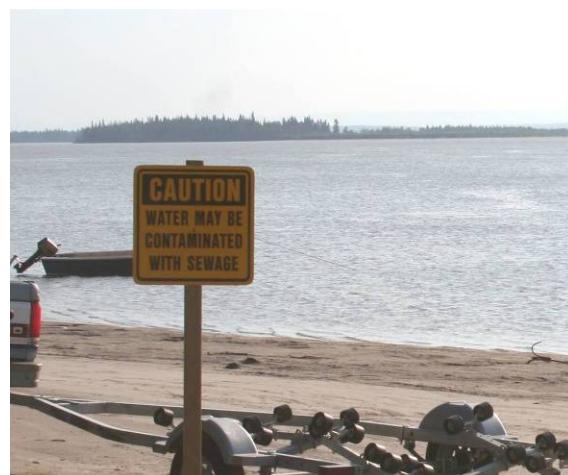
Photo 8 – Warning Sign at Happy Valley Marina (Zone A)

Zone A includes one of the major recreational boating area launches in the HV-GB at the Happy Valley Marina (indicated on Figure 7). There are also numerous private boat launches and dock structures within this Zone. There is currently a permanent warning sign posted at the Happy Valley Marina and this can be seen in Photo 8. The sign reads, "CAUTION –WATER

MAY BE CONTAMINATED WITH SEWAGE" and it is posted in plain view for all those using the marina.

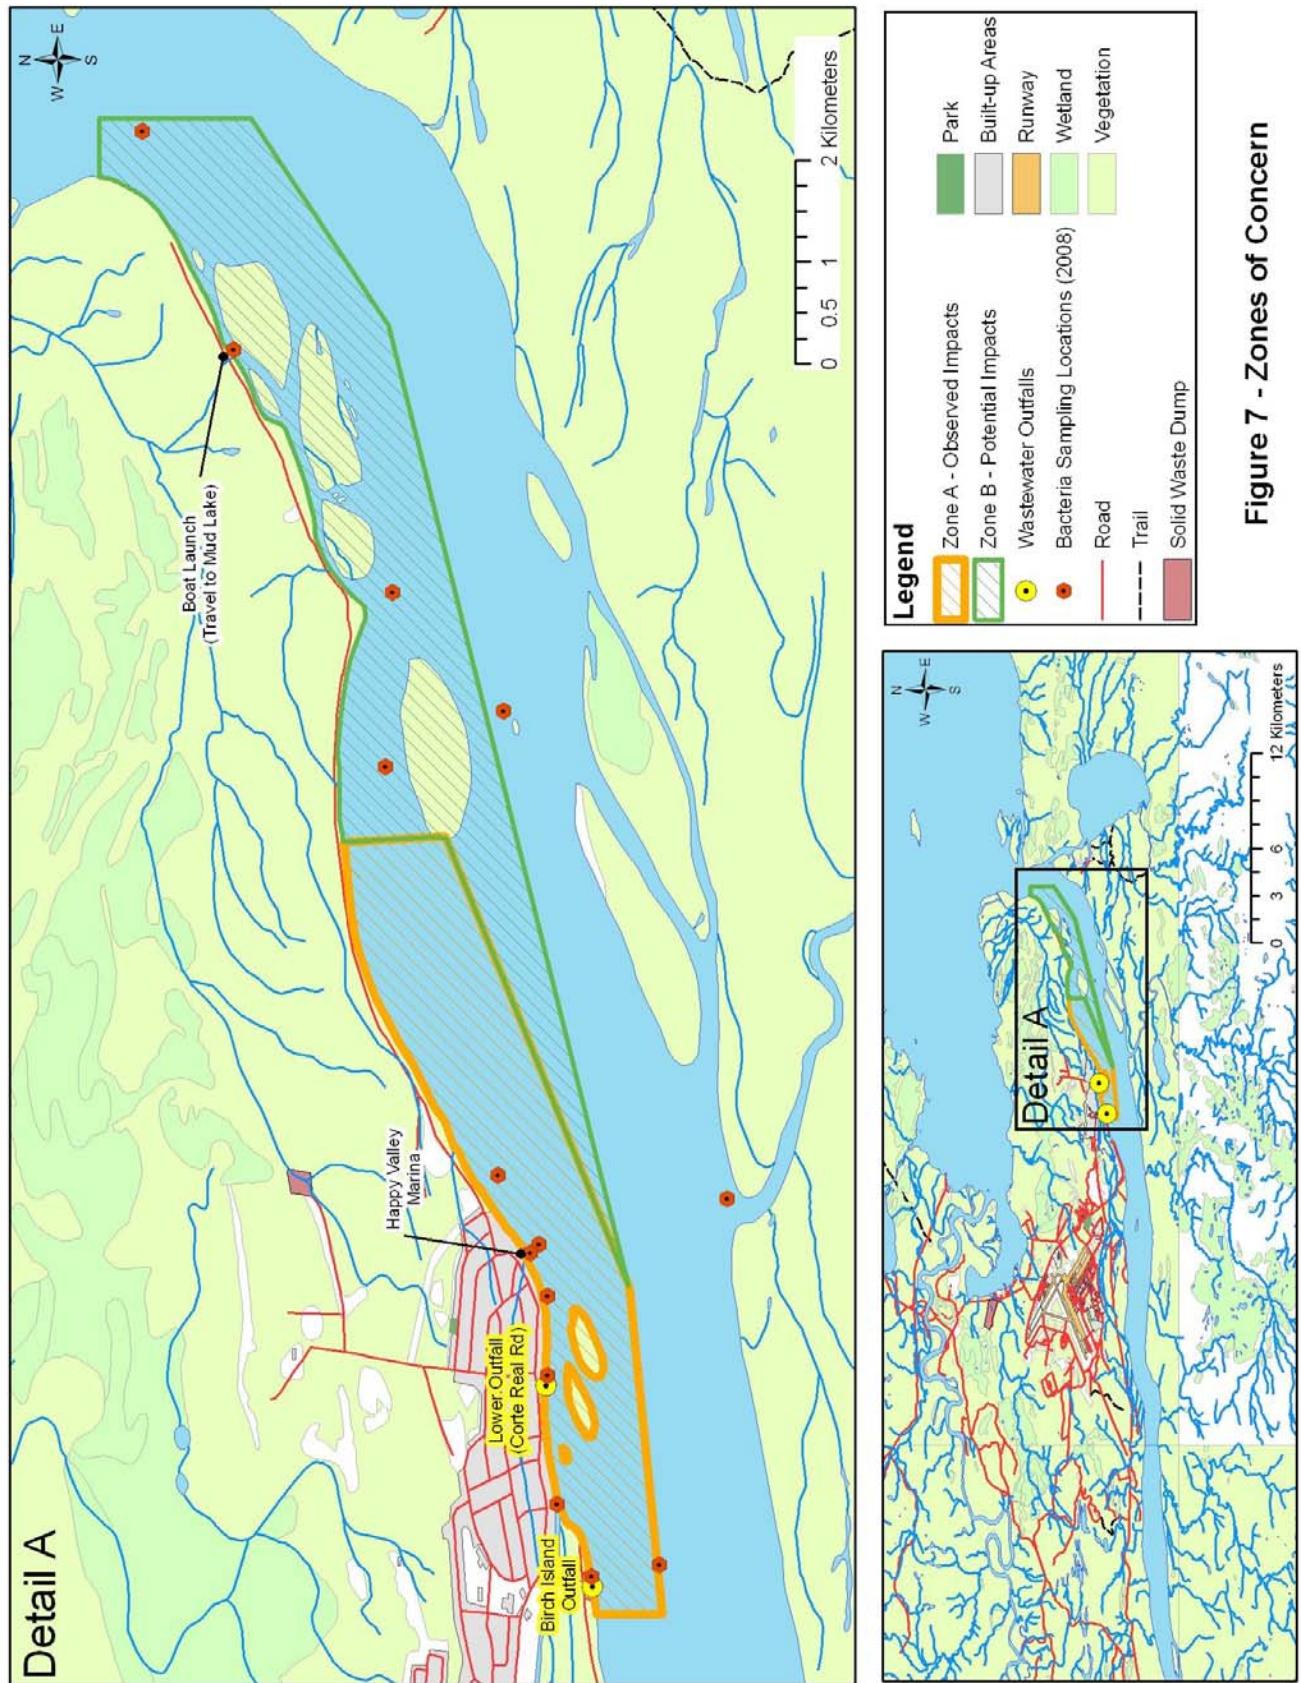
- Based on the results of this study, it was possible to identify two potential zones of impacts from the wastewater. Zone A (Figure 7) is located in the

vicinity of the two outfalls and in the immediate downstream sections. Zone A represents an area where fecal coliforms measured exceeded the CCME guideline for recreational water use. Zone B (Figure 7) is an area downstream of Zone A where the potential for impacts from the wastewater (including exceedances of the recreational guideline) exists given the observed dispersion characteristics of the wastewater into the Churchill River near HV-GB. Zone B ends at the eastern edge of the study area at NF03OE0048. Areas to the east of NF03OE0048 may still have the potential for wastewater impacts but these areas were not studied during this assessment.

Zone A includes the area where exceedances of the CCME recreational water use guideline have been observed for fecal coliforms. There was also visual evidence of wastewater impacts in this zone including discoloured water, floatables and solids. There was also increased staining (light coloured residue) along shoreline rocks and shrubs in this zone. The highest conductivities were found along the shore in this zone which indicated that the wastewater plume is remaining close to the northern shore and is not mixing readily with the main flow.

- The two identified zones of concern should have management plans developed to minimize any risk to human health for people living in the area or for those who use the area for recreational activities (e.g. boating). At a minimum, Zone A should be restricted for swimming and wading and/or any activity requiring direct contact with the water (e.g. fishing). Boaters should be warned to avoid direct contact with water in this zone and to take necessary precautions. In Zone B all users should be warned to minimize contact with water and take precautionary measures to reduce the risk to human health.

- Additional signage should be erected to notify residents of the boundaries of the two zones of concern and restricted activities.
- An education program should be initiated to inform residents about the risks of contact with water impacted by raw sewage and also to identify precautions to take should contact with water be required. This program could include public information sessions, posters, pamphlets and signage.
