**REPORT ON SURFACE AND GROUNDWATER QUALITY
OF THE NUT BROOK SUB-BASIN,
KELLIGREWS RIVER**

**DEPARTMENT OF ENVIRONMENT
Water Resources Division**

August 1994

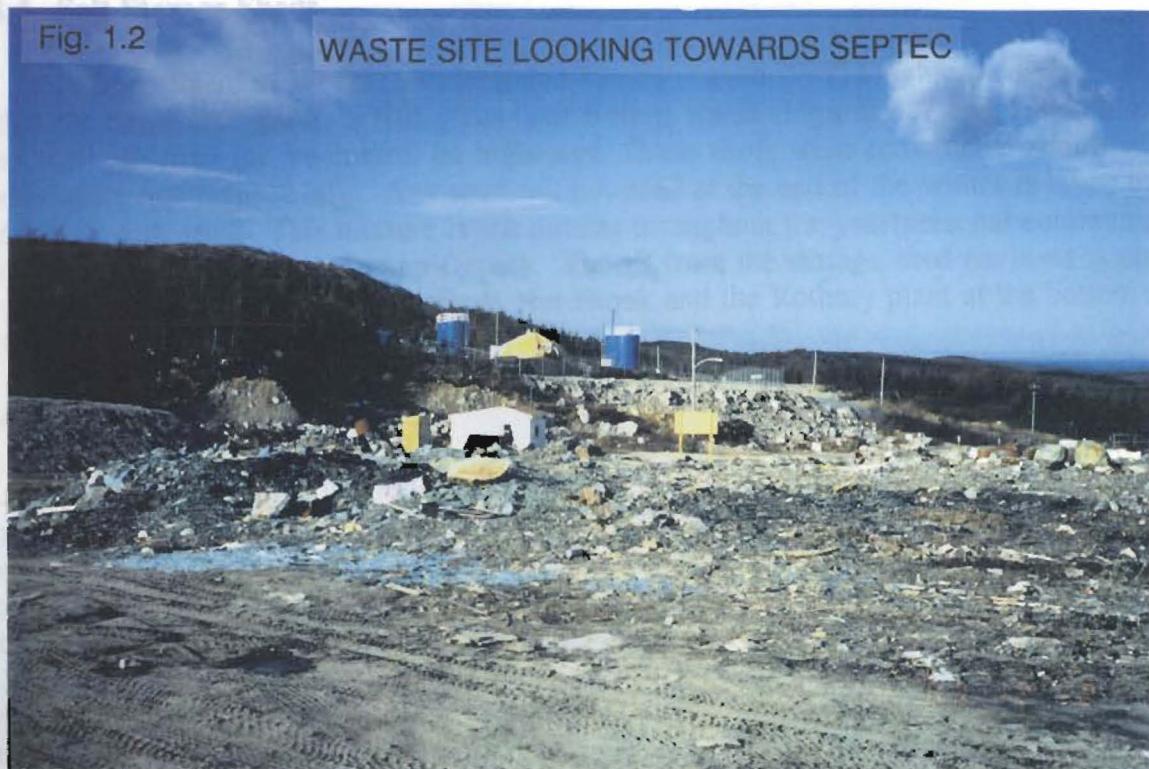
Fig. 1.2

A municipal landfill (Figures 1.1 and 1.2) has been in operation since 1973. This landfill receives garbage from the Conception Bay South(CBS) area. Garbage is placed, compacted and buried at the site. The landfill is not lined. Since the waste site has been in operation for over twenty years, a groundwater contaminant plume probably exists down gradient of the site. Practically all waste sites in Newfoundland are unlined which allows rainwater percolating down through the compacted and buried waste to dissolve waste constituents and reach the water table. Groundwater movement then transports this solute solution, called leachate, down gradient to form a leachate plume. Waste sites are usually located either near the coast so that any contaminants emanating from them enters the ocean and are diluted, or are located sufficiently far away from water bodies and developed areas to allow for the natural decay of contaminants into the environment with time.

WASTE SITE LOOKING TOWARDS SEPTEC

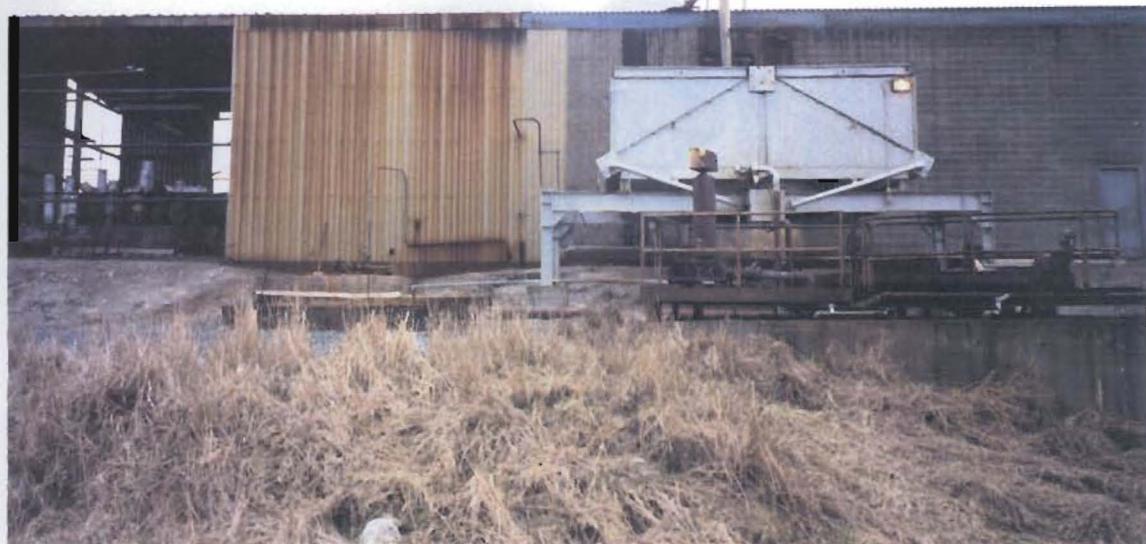
Fig. 1.5

Situated in the valley bottom next to Nut Brook Pond, the Rothsay Rendering Plant (Figures 1.5 and 1.6) was constructed in 1974. The plant accepts biological wastes from abattoirs, henneries, and dead animals such as horses and cows for disposal by rendering down this matter to produce meat meal. Effluent from this plant is piped to an aerobic bacteria aerator, and then into a marsh that drains into Nut Brook Pond (personal communication with plant operator).

ROTHSAY RENDERING PLANT FROM REAR

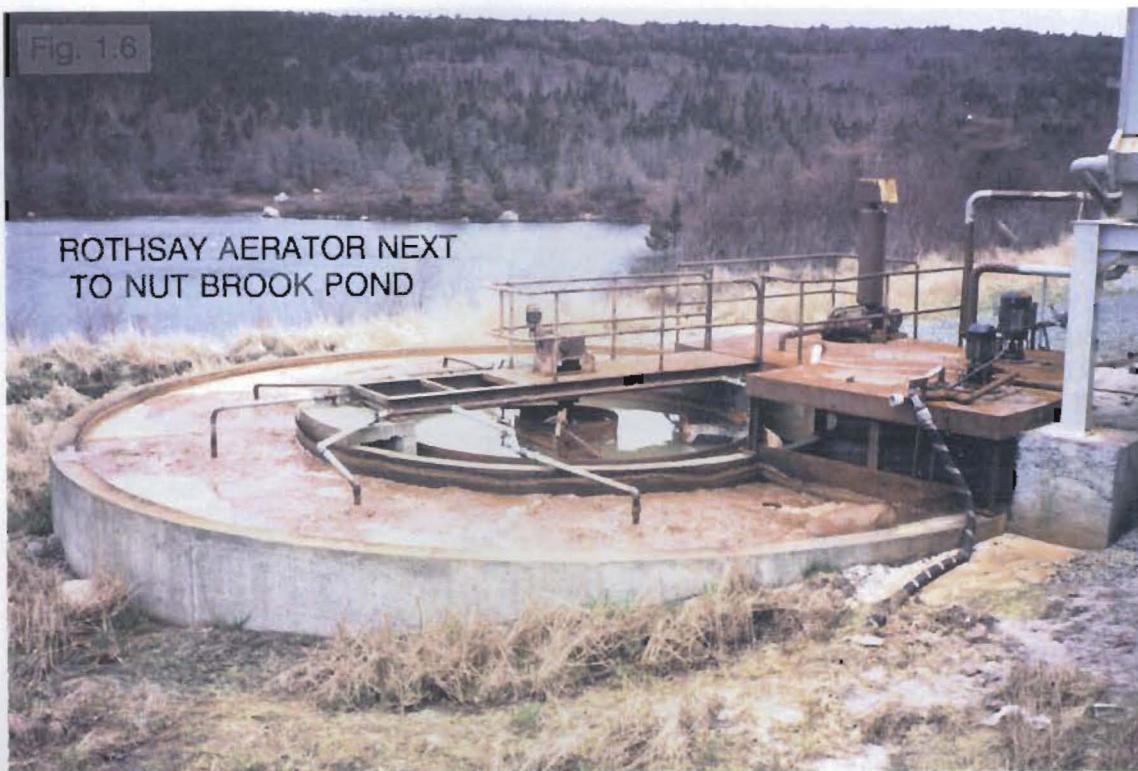
Fig. 1.6

ROTHSAY AERATOR NEXT
TO NUT BROOK POND

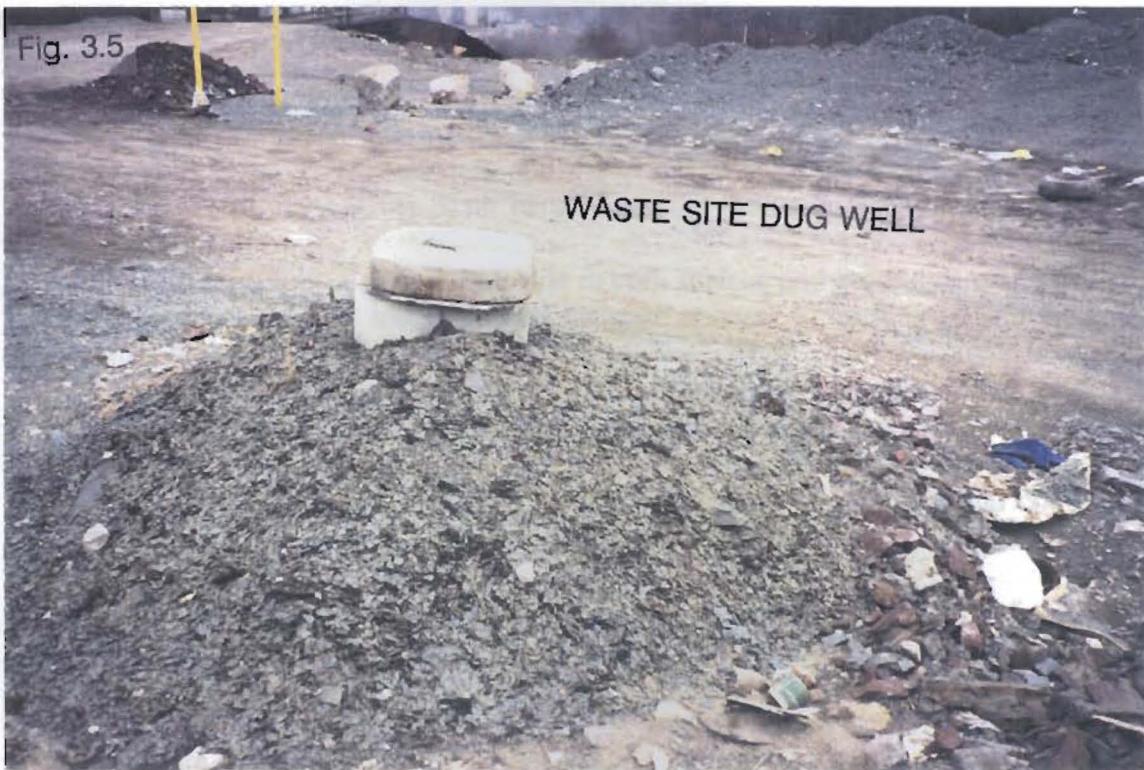
This well is likely less than 5m deep. Chemical and physical parameters exceed MAC for drinking water for iron, pH, manganese and turbidity. The well is situated immediately up-gradient of the waste site fill area. The well appears to be located in reworked ground as seen in Figure 3.5. The high concentrations could be naturally occurring as this well obtains its water from shallow subsurface waters above the bedrock.
