# Real-Time Water Quality Deployment Report

## Rattling Brook Network

December 21, 2012 to February 27, 2013

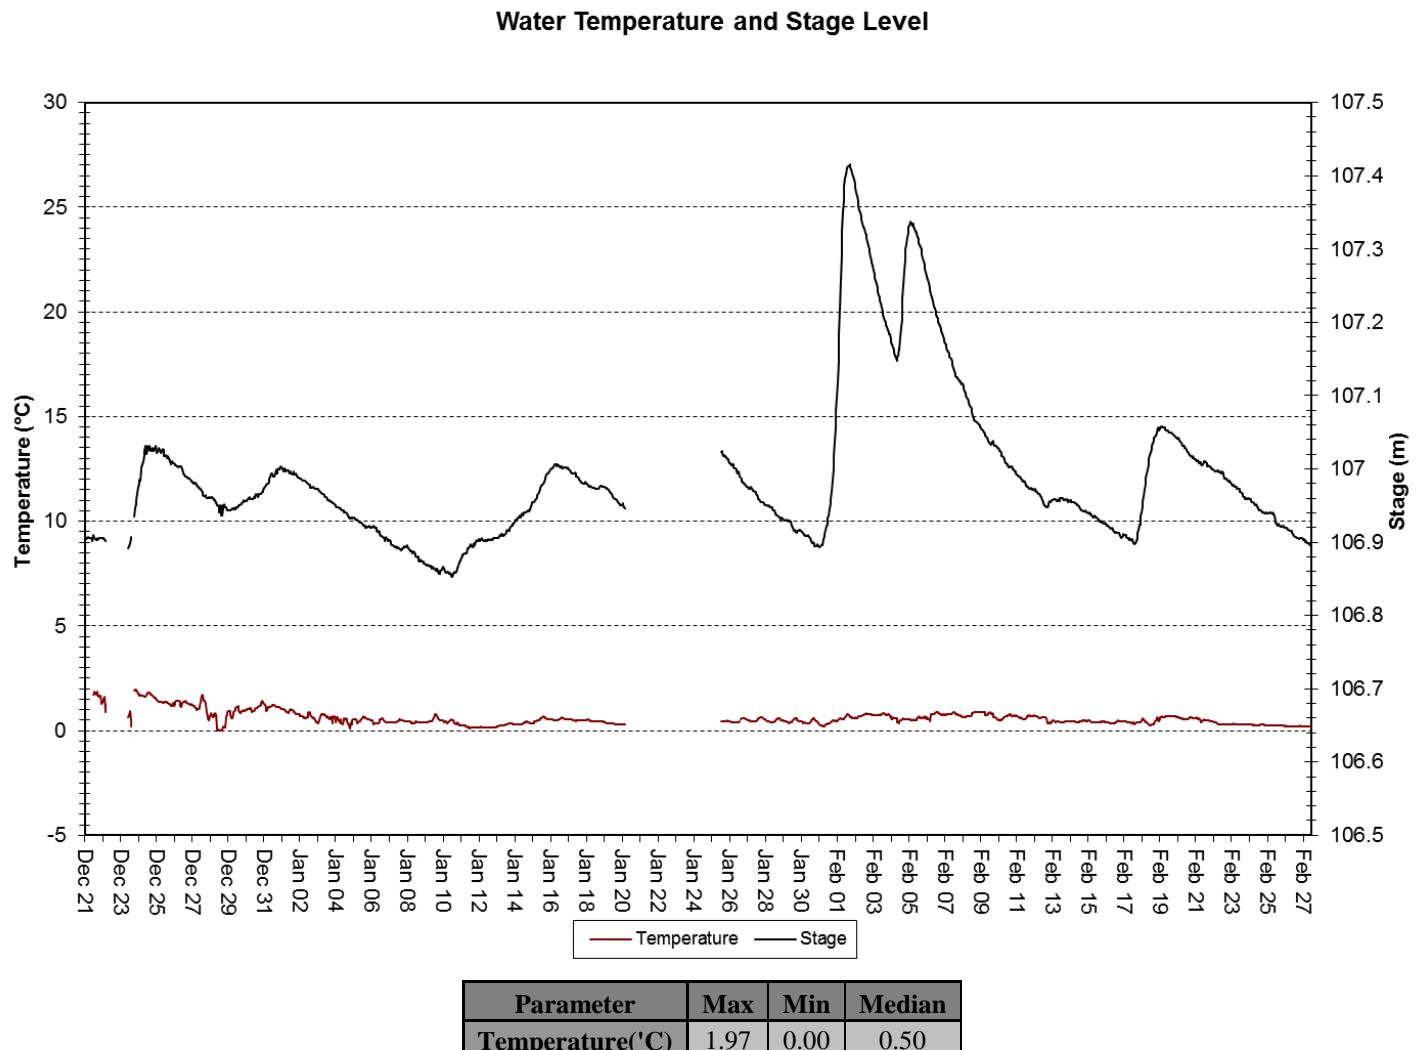
**Figure 1: Water Temperature at Rattling Brook Big Pond from December 21, 2012 to February 27, 2013**

- Big Pond water temperatures reached their annual low during this deployment period and showed no major diurnal variation. On February 27<sup>th</sup>, during the removal of the Hydrolab for regular maintenance and calibration, a hole had to be chopped in ice approximately 30 cm in some places.

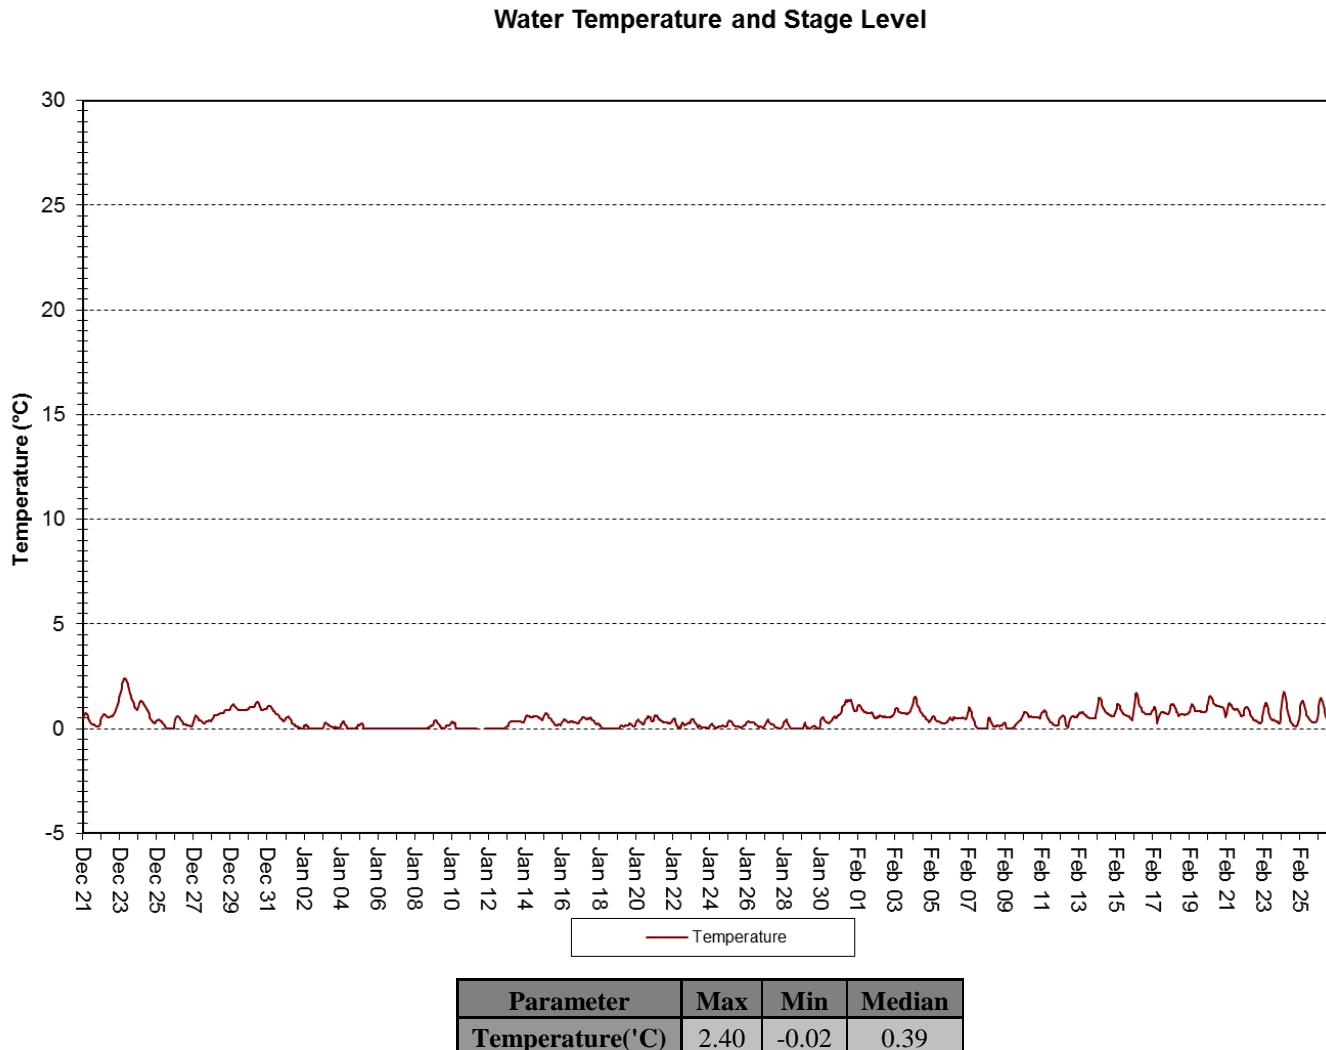
**Figure 2: Water Temperature at Rattling Brook below Bridge from December 21, 2012 to February 27, 2013**

- Water at Bridge station showed a larger range in temperatures compared to those upstream at Big Pond station; however the median temperature was recorded lower. Approximately 15% of the river surface was covered in ice during removal.

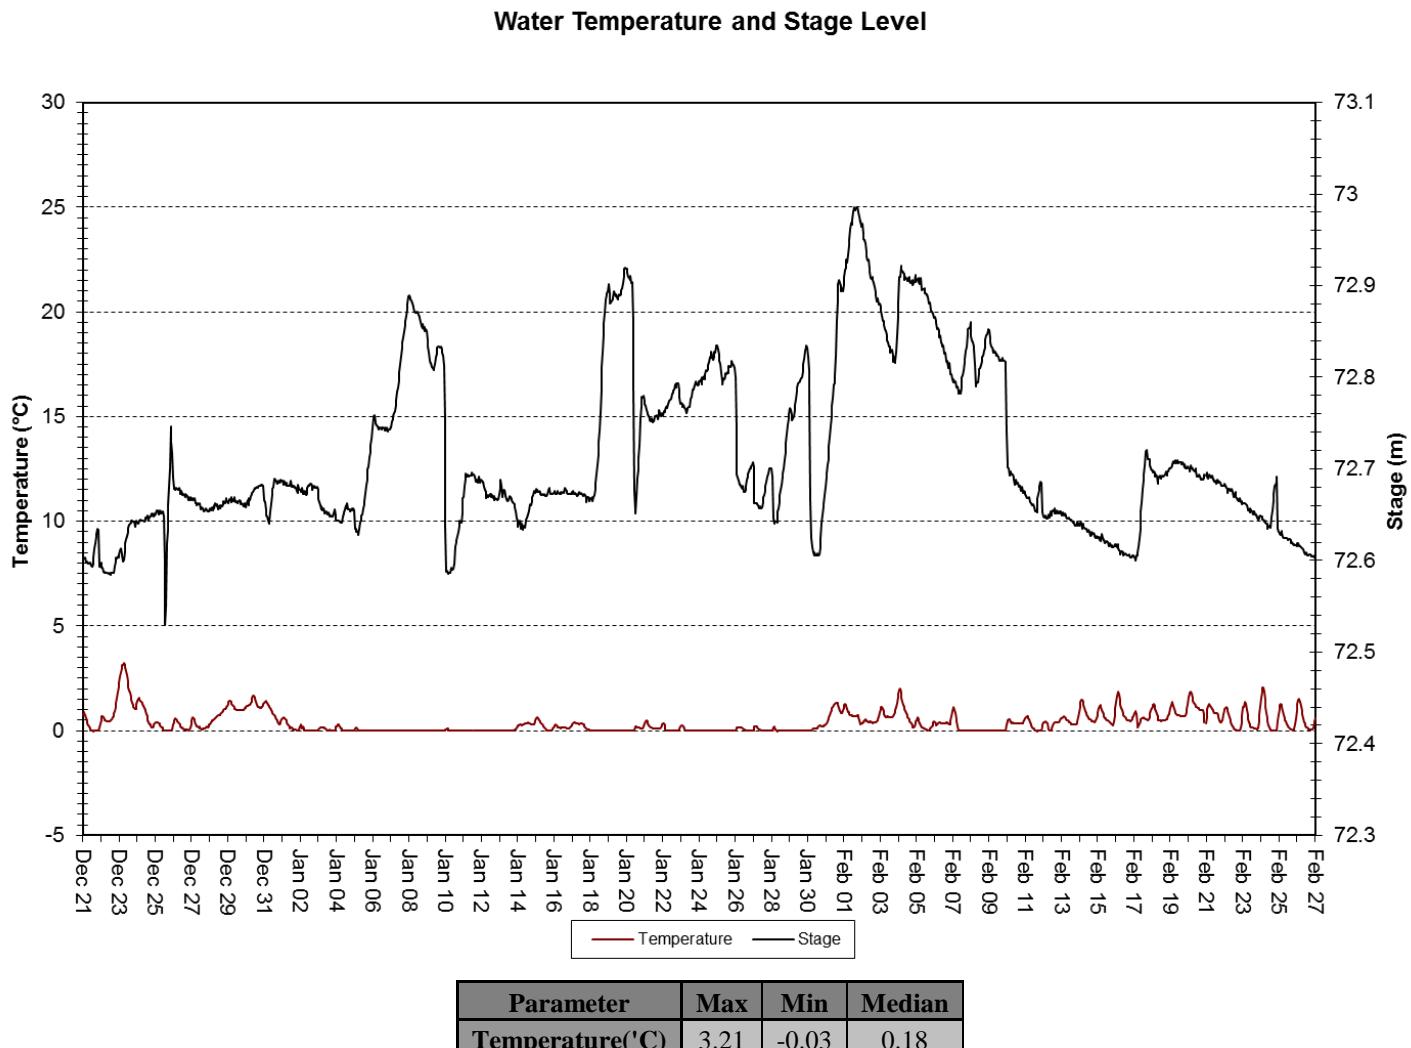
**Figure 3: Water Temperature at Rattling Brook below Plant Discharge from December 21, 2012 to February 27, 2013**

- Plant Discharge station has the highest range in water temperatures over the deployment period, but also the lowest median temperature of the three stations. At removal time, approximately 10% of the river contained ice.

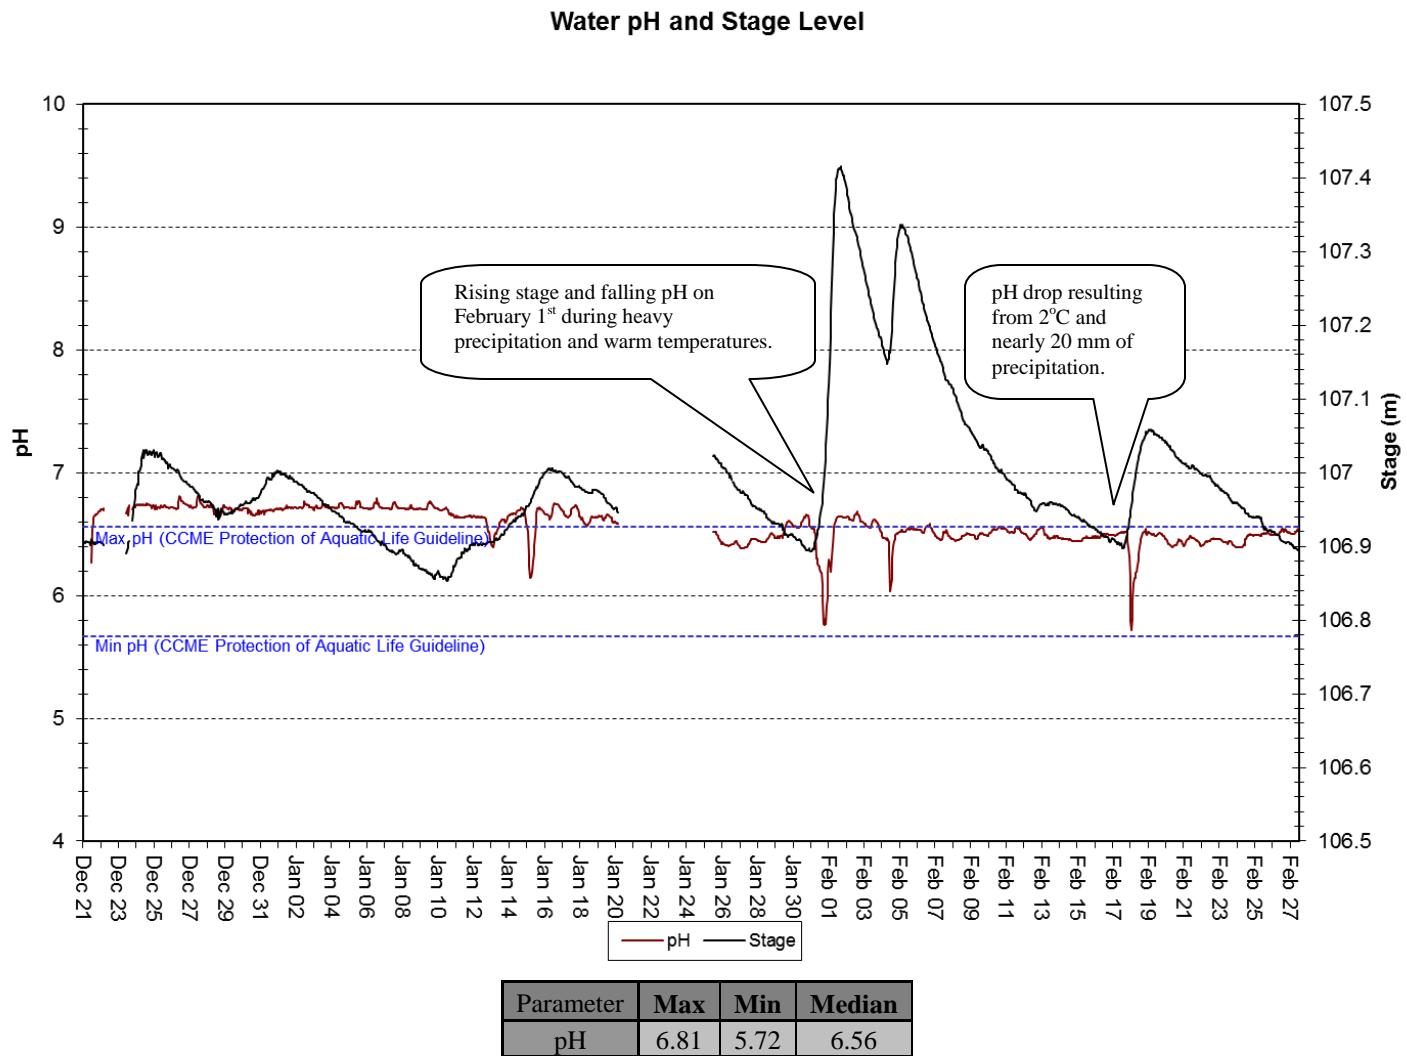
**Figure 4: pH at Rattling Brook Big Pond from December 21, 2012 to February 27, 2013**

- A slightly declining trend was observed in pH during the deployment period from above the upper Site Specific Guideline to just below. A drop in pH was observed with a simultaneous rise in stage level related to approximately 20 mm of precipitation and a daily mean temperature of 8°C.

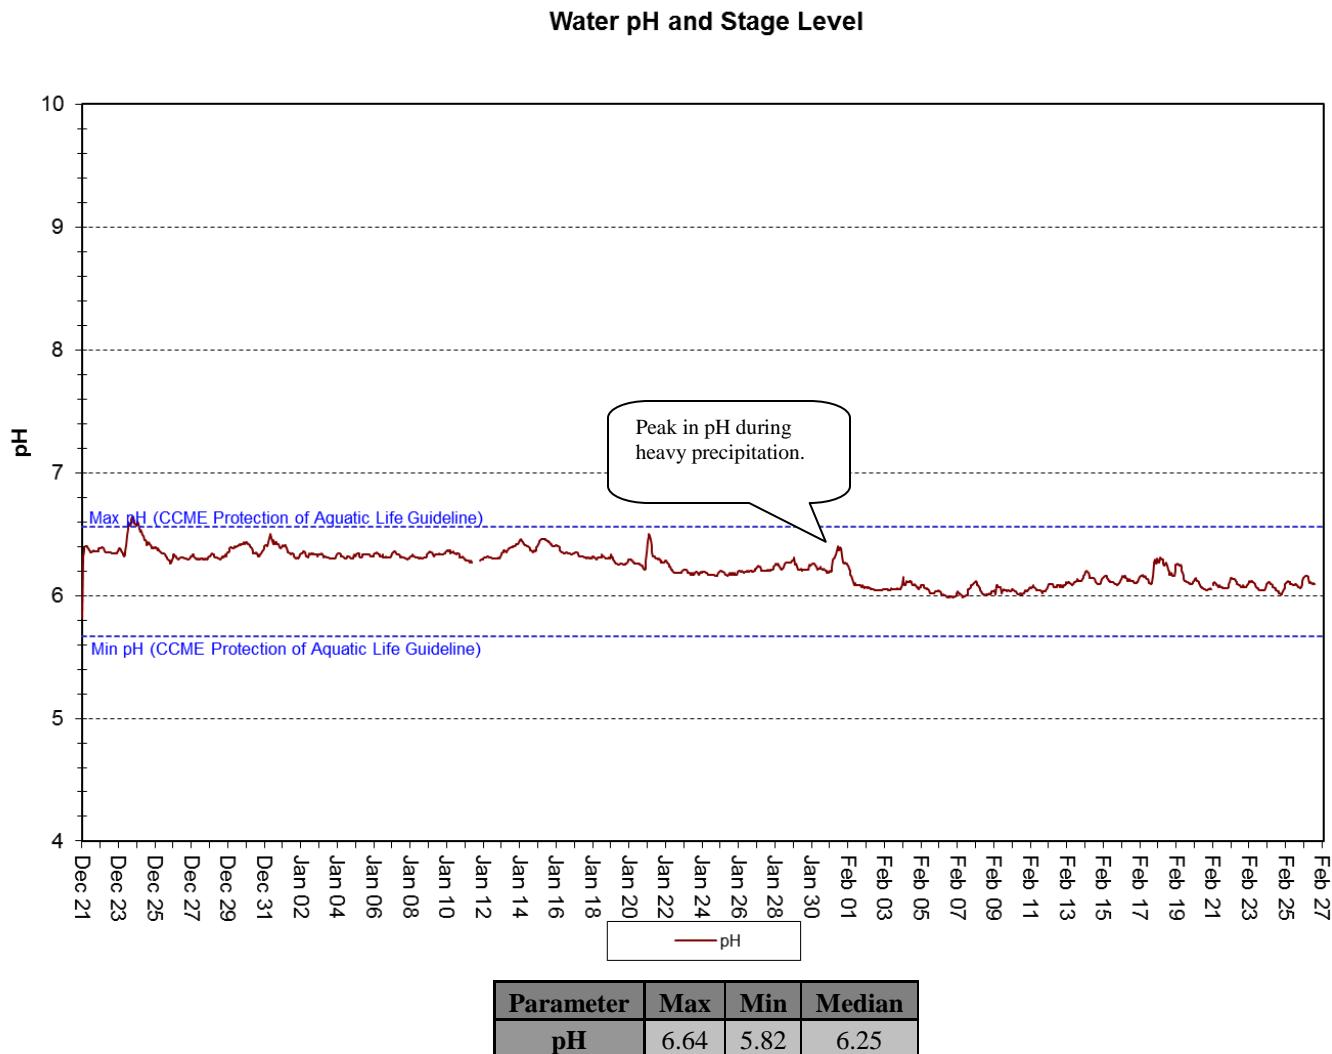
**Figure 5: pH at Rattling Brook below Bridge from December 21, 2012 to February 27, 2013**

- Another declining trend in pH was observed during the deployment at Bridge station. Although stage data is not presented for Bridge station during this deployment period, a small peak in pH values was noted on February 1<sup>st</sup> during heavy precipitation, instead of the decline seen upstream at Big Pond station.

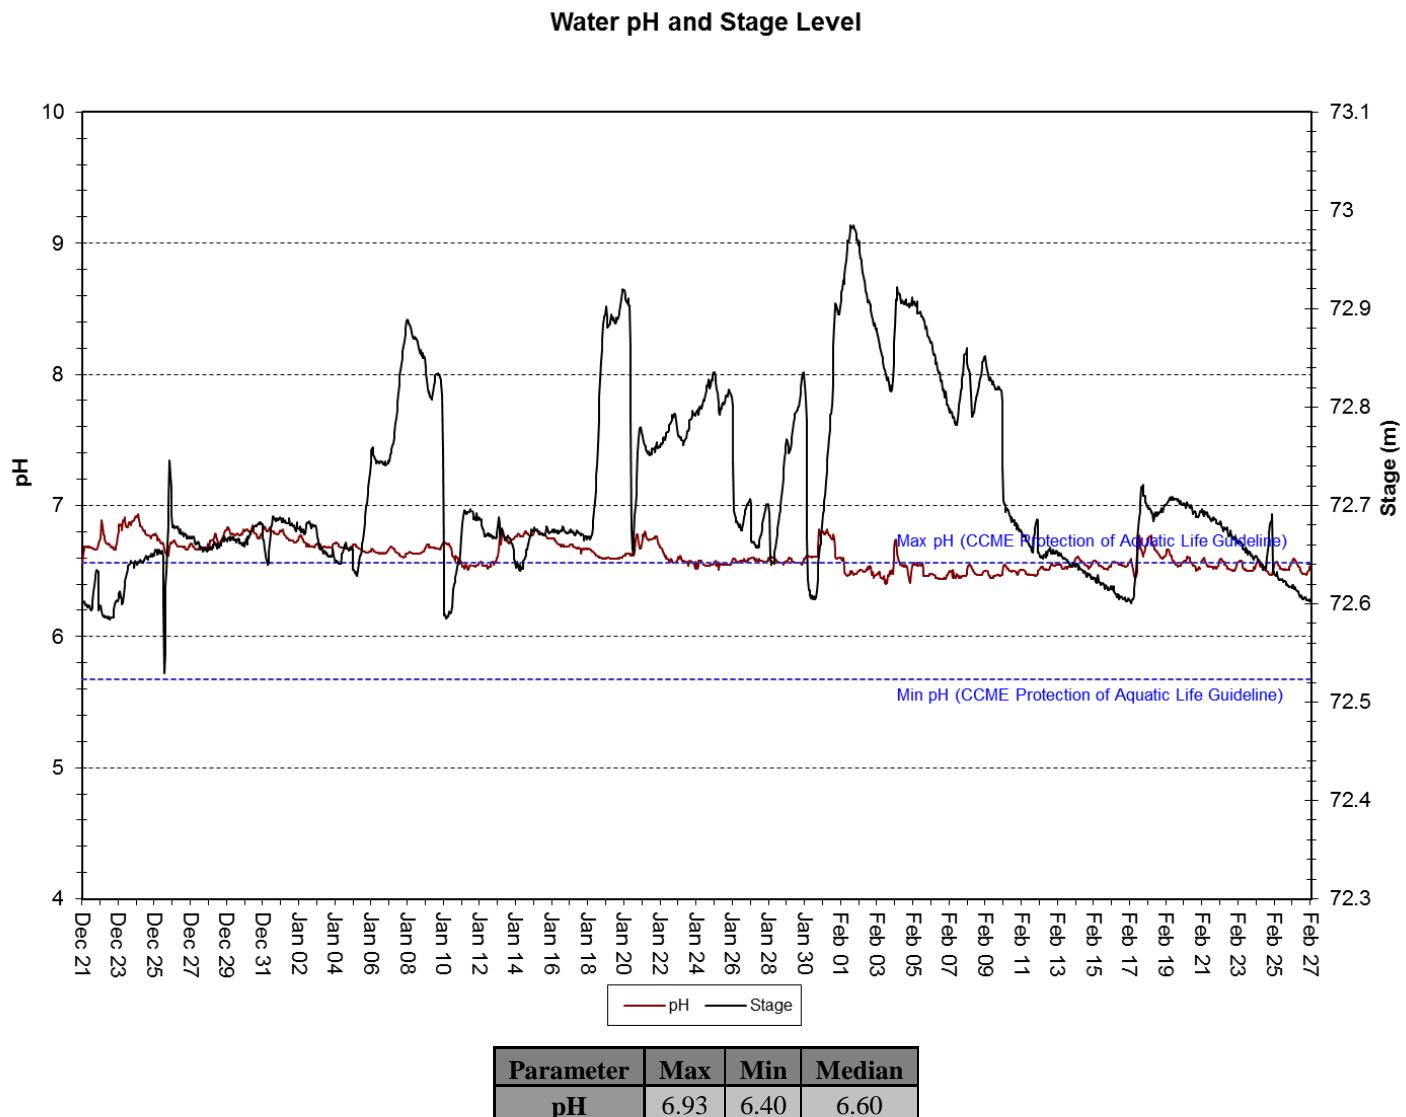
**Figure 6: pH at Rattling Brook below Plant Discharge from December 21, 2012 to February 27, 2013**

- pH levels were mostly level, or with a very slight downward trend, at Plant Discharge station during this deployment period. Most pH values recorded were just at the upper Site Specific Guideline for the second half of the deployment. Unlike the two stations upstream, there was no pH event observed on February 1<sup>st</sup> at Plant Discharge station.

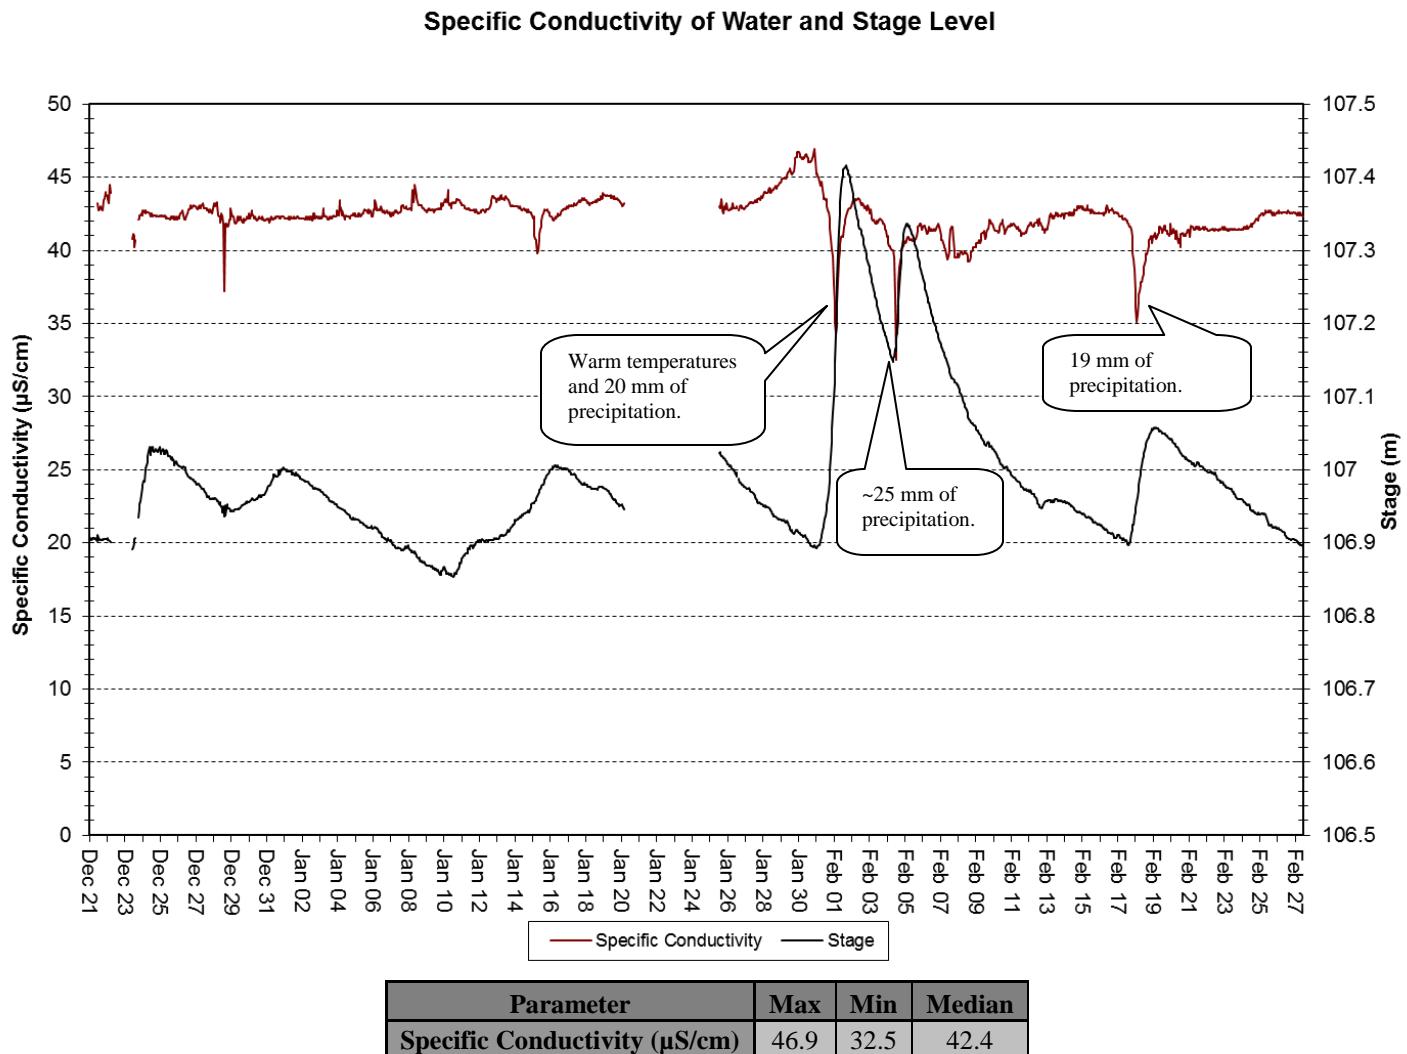
**Figure 7: Specific Conductivity at Rattling Brook Big Pond from December 21, 2012 to February 27, 2013**

- Specific Conductivity showed several notable drops during stage level increases during this deployment period, relating to dilution of Big Pond by rainwater and/or snowmelt.

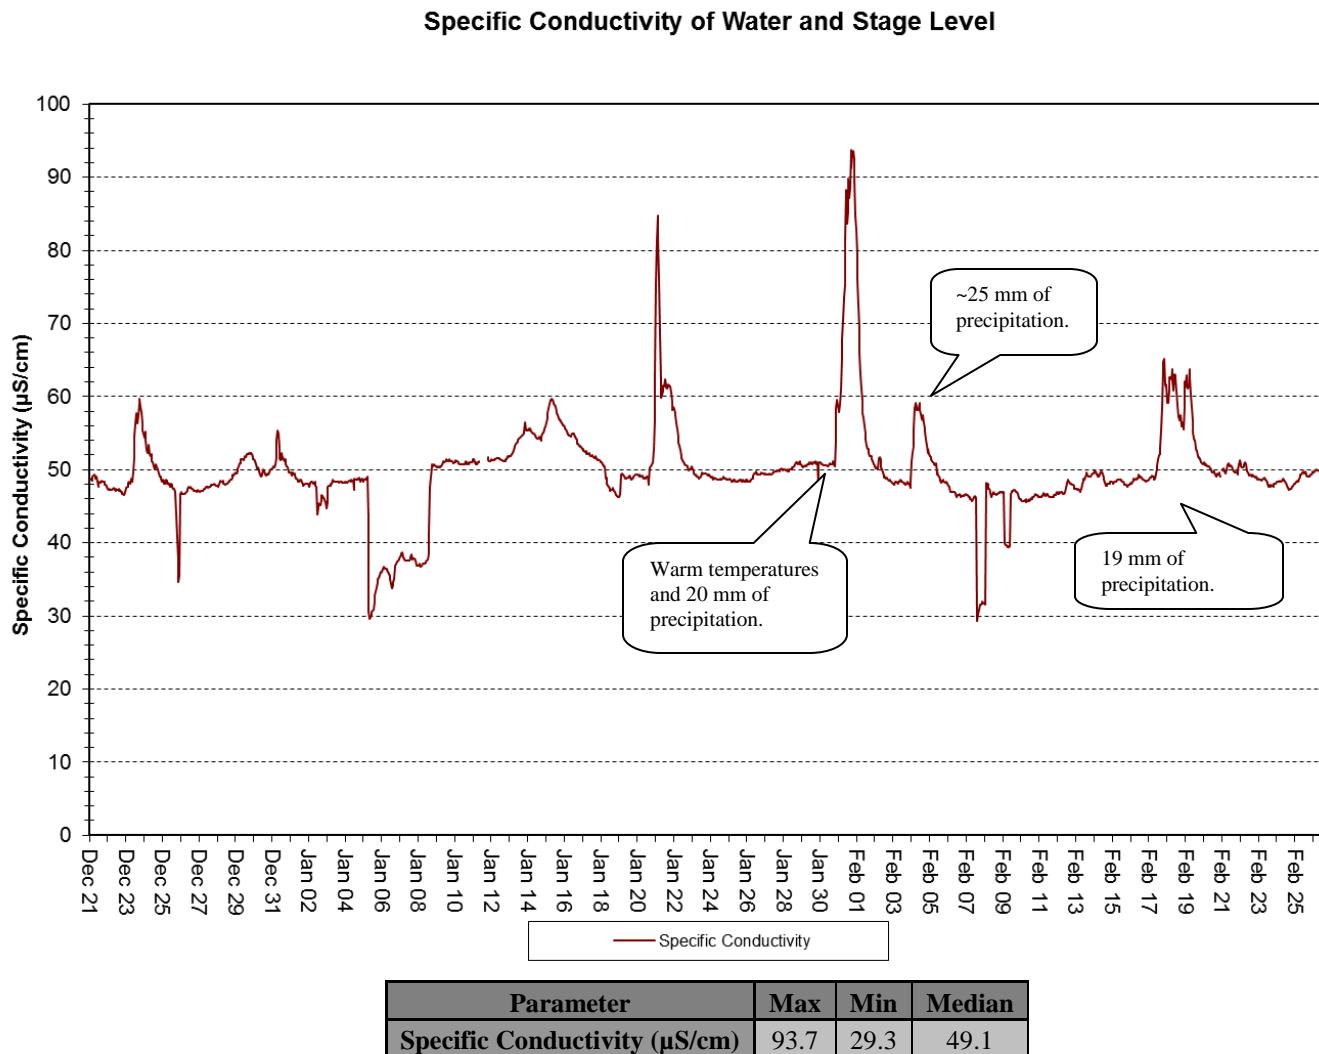
Figure 8: Specific Conductivity at Rattling Brook below Bridge from December 21, 2012 to February 27, 2013

- Conductivity was higher than values seen upstream at Big Pond station. Interestingly, the drops in conductivity values at Big Pond are often registered as peaks in conductivity values downstream. This may be related to dissolved solids being washed downstream in a plume-like fashion.
- During this deployment period, a slightly upward trend is observed.

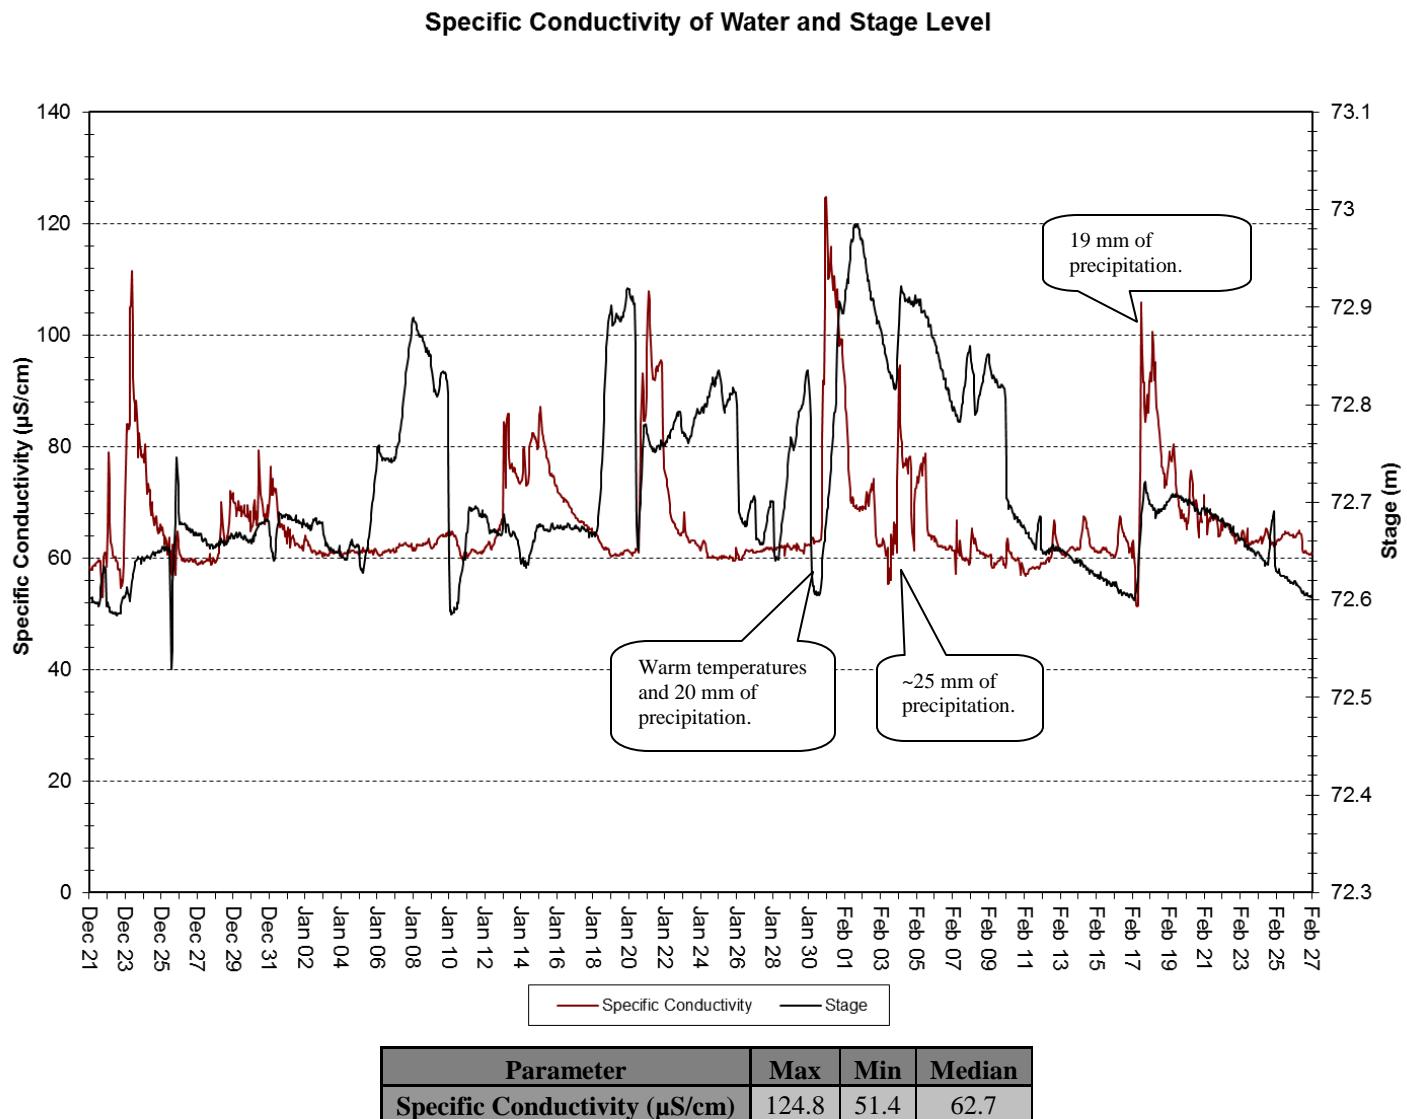
Figure 9: Specific Conductivity at Rattling Brook below Plant Discharge from December 21, 2012 to February 27, 2013

- Specific conductivity is highly variable at Plant Discharge station compared to values seen upstream at Big Pond and Bridge stations. The same conductivity events are observed at Bridge and Plant Discharge stations, although those events downstream tend to be of higher magnitude.
- A slight upward trend in conductivity is apparent during this deployment period.

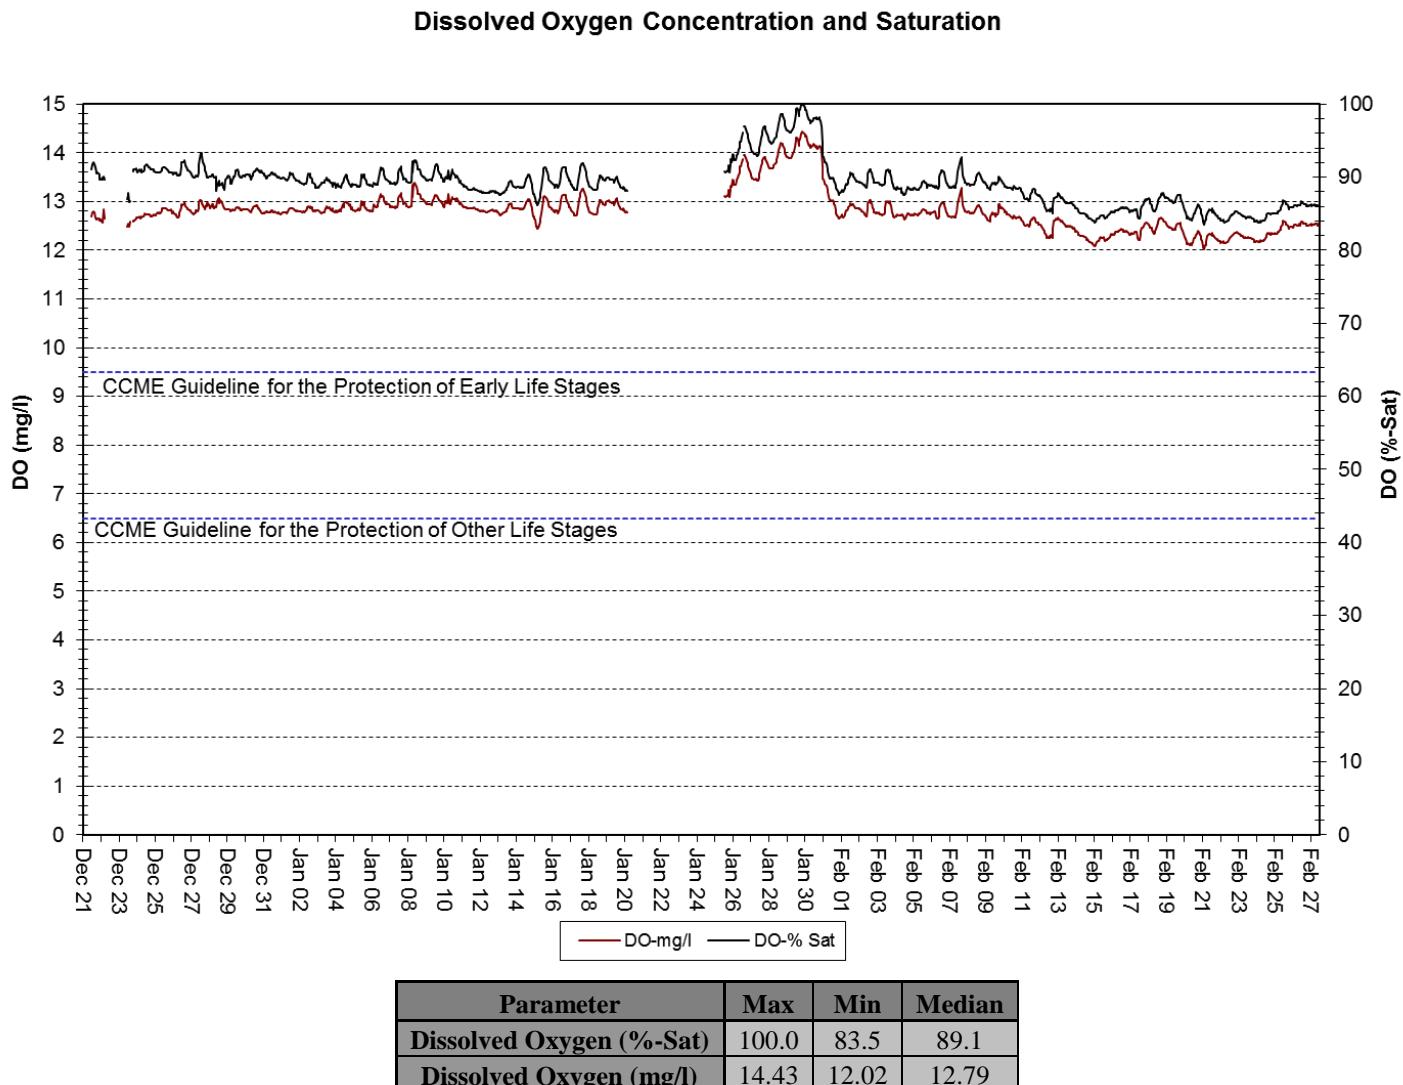
**Figure 10: Dissolved Oxygen at Rattling Brook Big Pond from December 21, 2012 to February 27, 2013**

- Dissolved oxygen showed a dropping trend from December 21<sup>st</sup> to February 27<sup>th</sup> as freezing conditions resulted in complete ice cover across Big Pond. Ice cover reduces the impact of wave action, preventing oxygenation of the water. Decreased respiration by aquatic life, however, prevents DO levels from falling below CCME Guidelines.

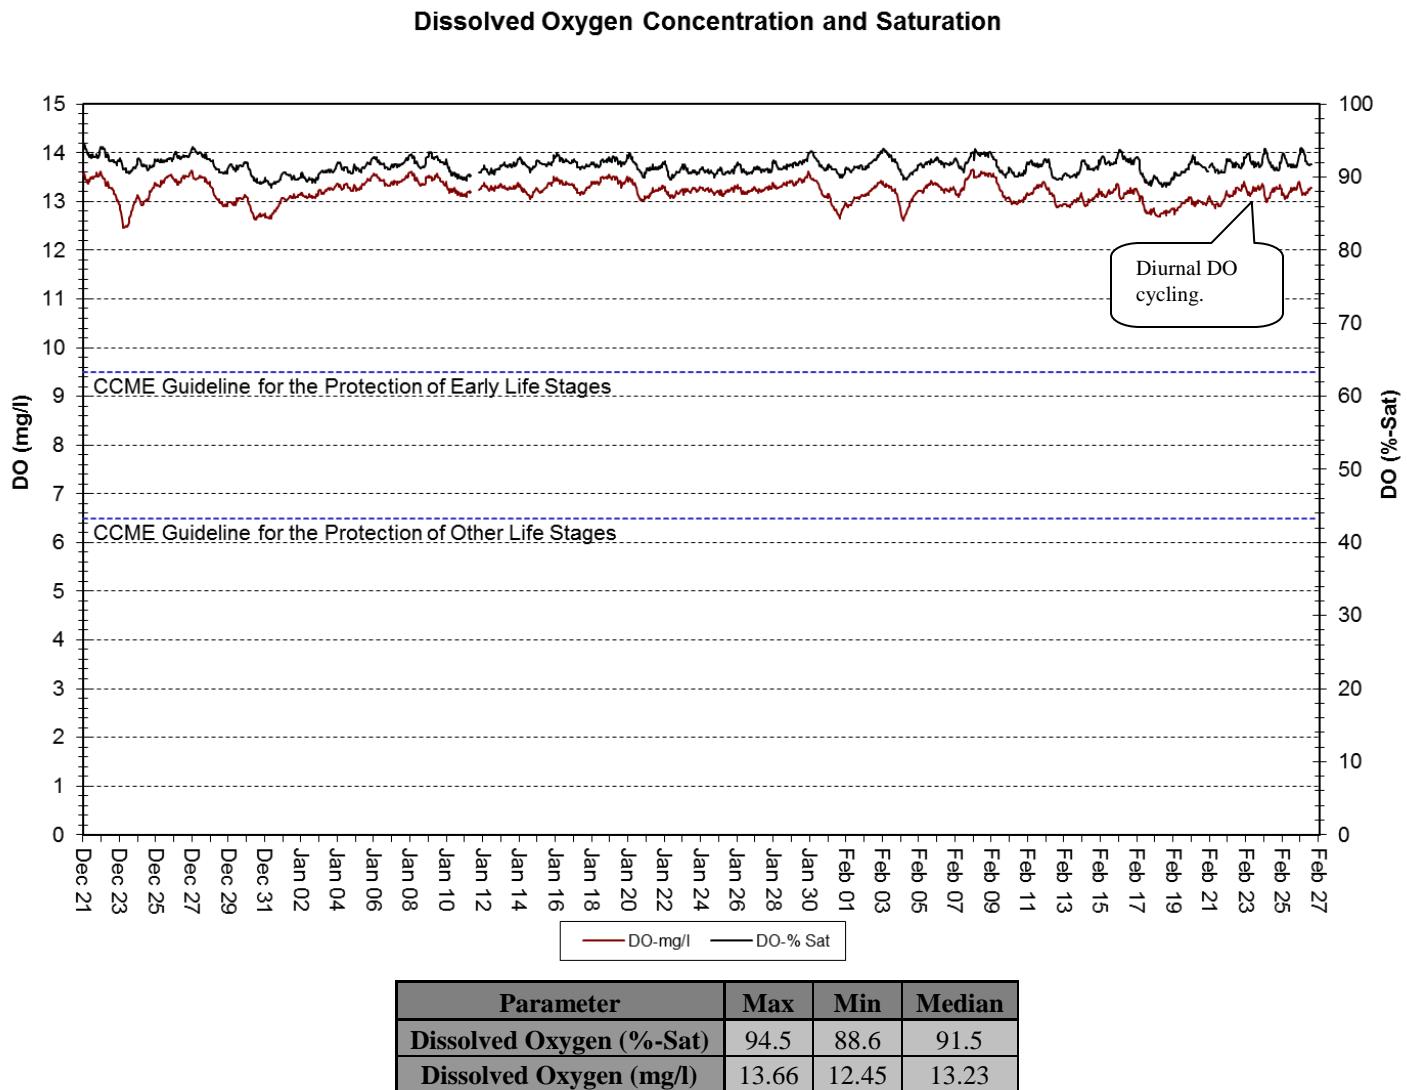
Figure 11: Dissolved Oxygen at Rattling Brook below Bridge from December 21, 2012 to February 27, 2013

- Dissolved oxygen levels at Bridge station were largely consistent during the deployment period, owing to open water conditions allowing oxygen admission through vigorous flow over rapids. All values were above CCME Guidelines.
- As of the end of February, diurnal DO cycles began to reappear after being largely absent since the beginning of December. These cycles are the result of increased solar insolation and air temperatures influencing DO concentrations in the water. During routine maintenance at removal on February 27<sup>th</sup>, a large number of larval insects were found attached to the protective casing in the river.

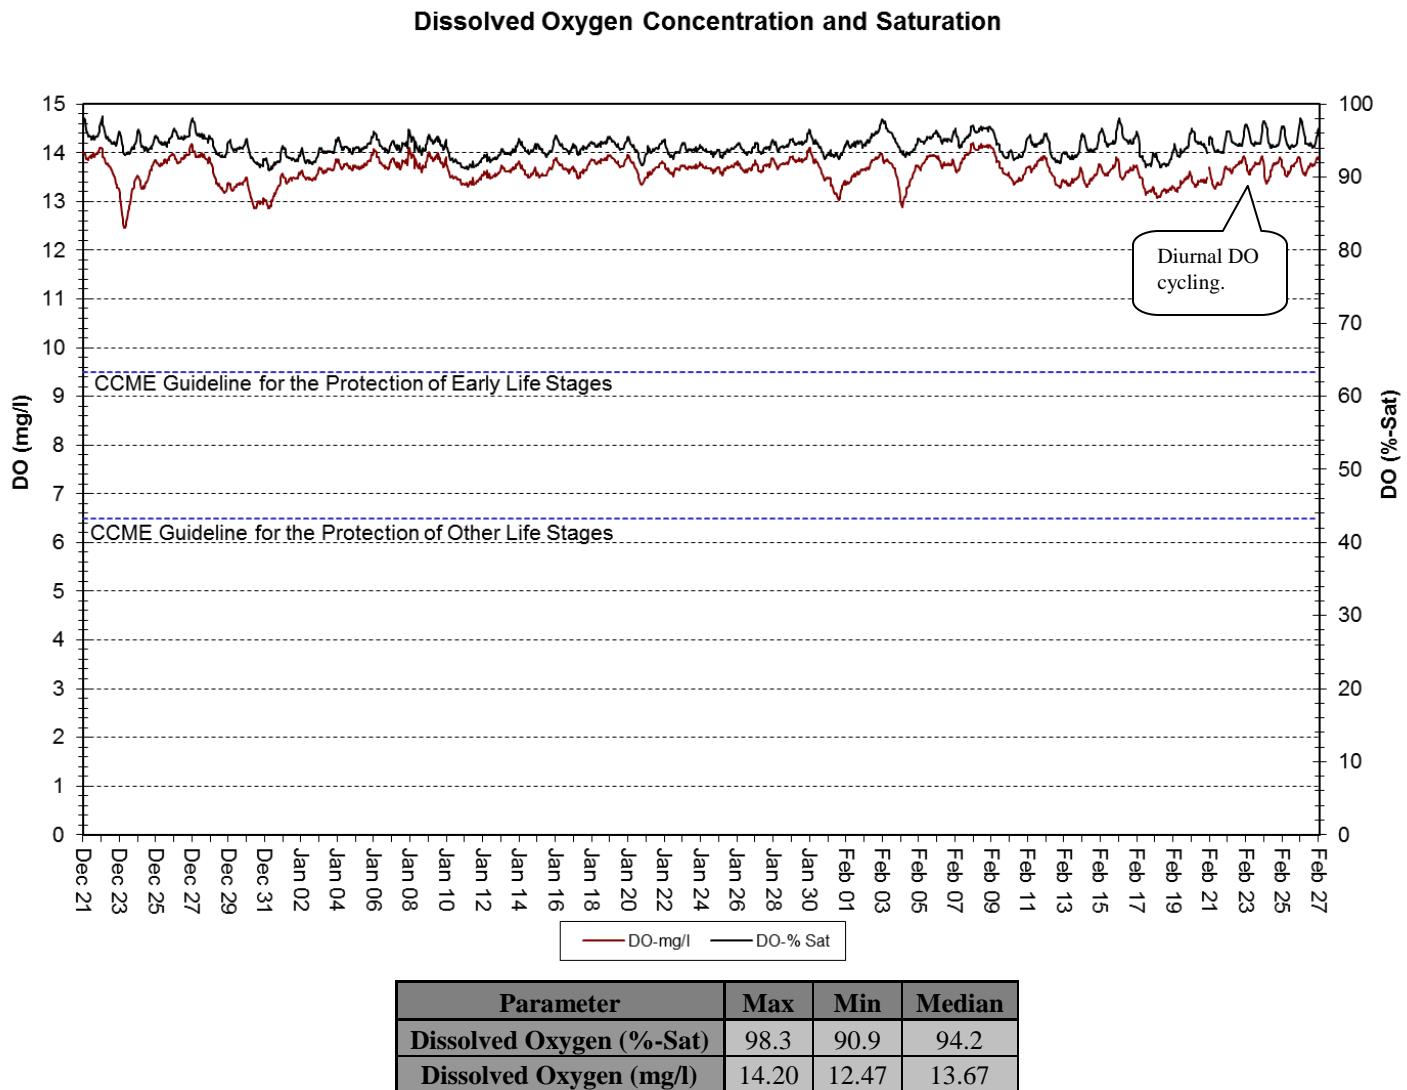
**Figure 12: Dissolved Oxygen at Rattling Brook below Plant Discharge from December 21, 2012 to February 27, 2013**

- Dissolved oxygen levels were higher here than those found upstream at Bridge station. All values were above CCME Guidelines.
- Similar to Bridge station, diurnal DO cycles have returned to Plant Discharge station.

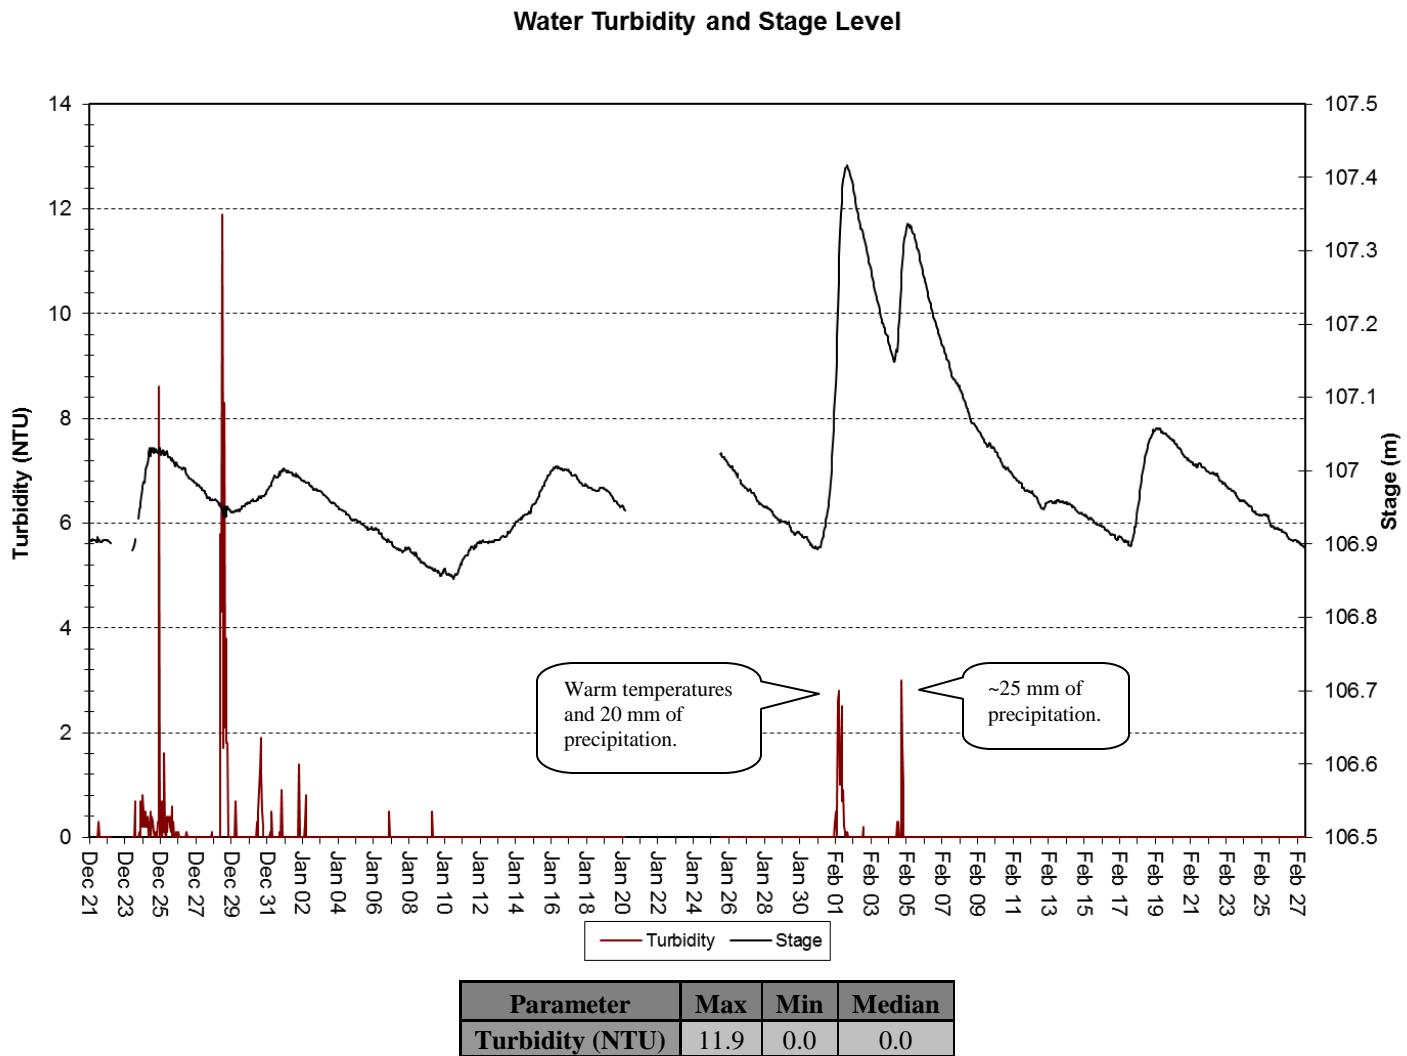
**Figure 13: Turbidity at Rattling Brook Big Pond from December 21, 2012 to February 27, 2013**

- Some disturbance in turbidity levels were seen in late December during a period of precipitation and before freeze-up. At this time, turbidity levels peaked at 11.9 NTU. During the remainder of the deployment – and especially after ice had begun to form across the Pond – turbidity levels were low, and mostly zero.

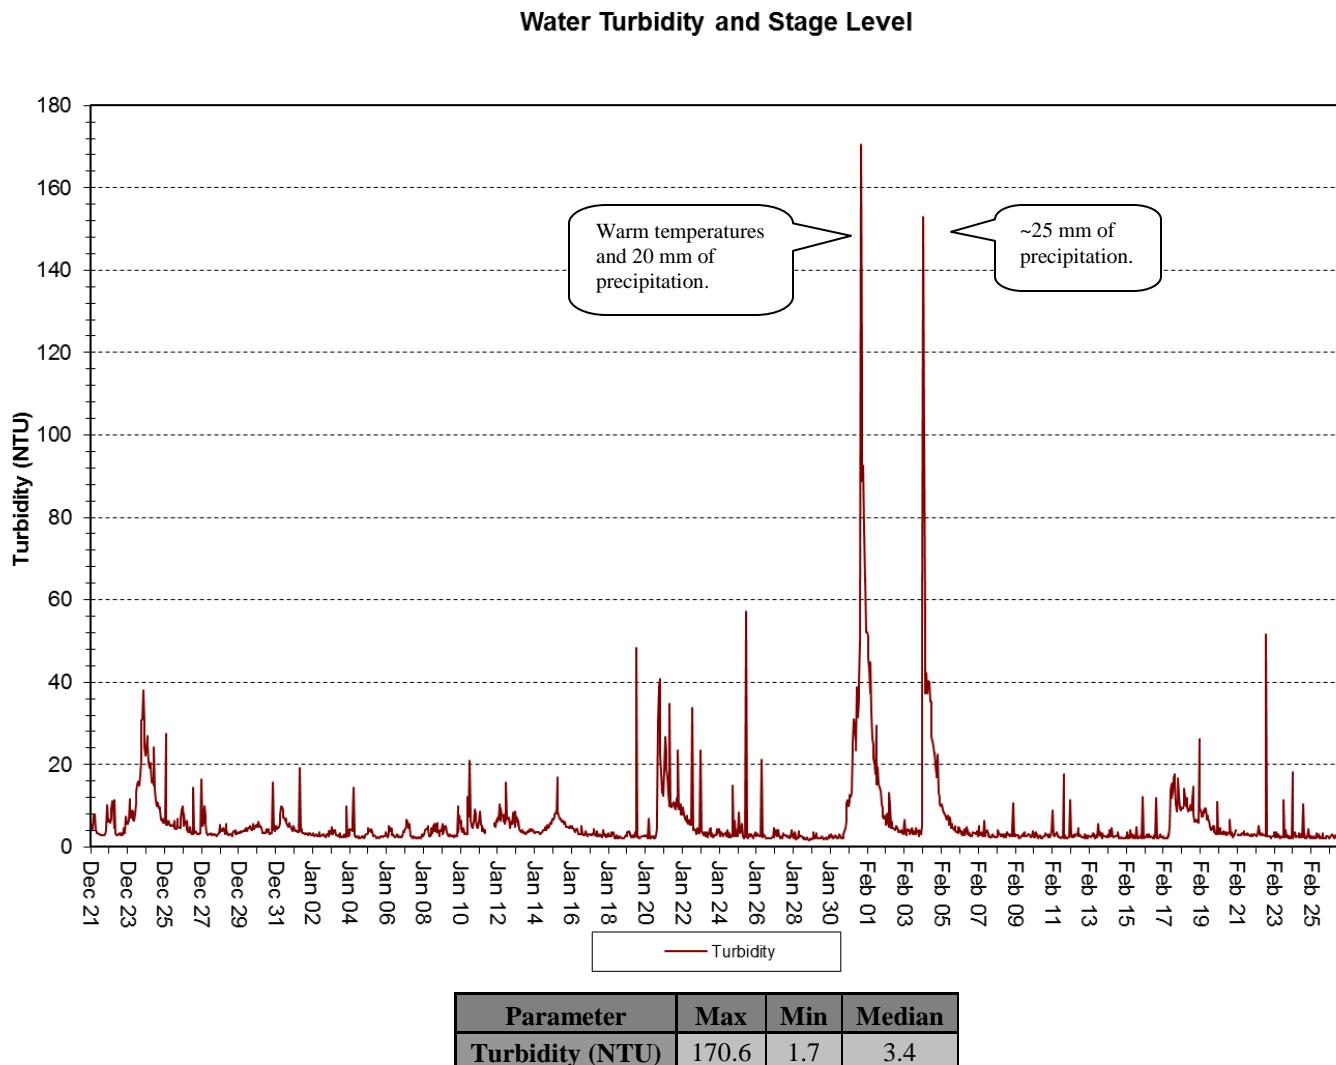
**Figure 14: Turbidity at Rattling Brook below Bridge from December 21, 2012 to February 27, 2013**

- Variable turbidity was the norm from December 21<sup>st</sup> to February 27<sup>th</sup> at Bridge station with turbidity events primarily driven by precipitation events and destabilized sediments from previous work in Forgotten Pond.
