# Real-Time Water Quality Deployment Report

## Rattling Brook Network

December 21, 2012 to February 27, 2013

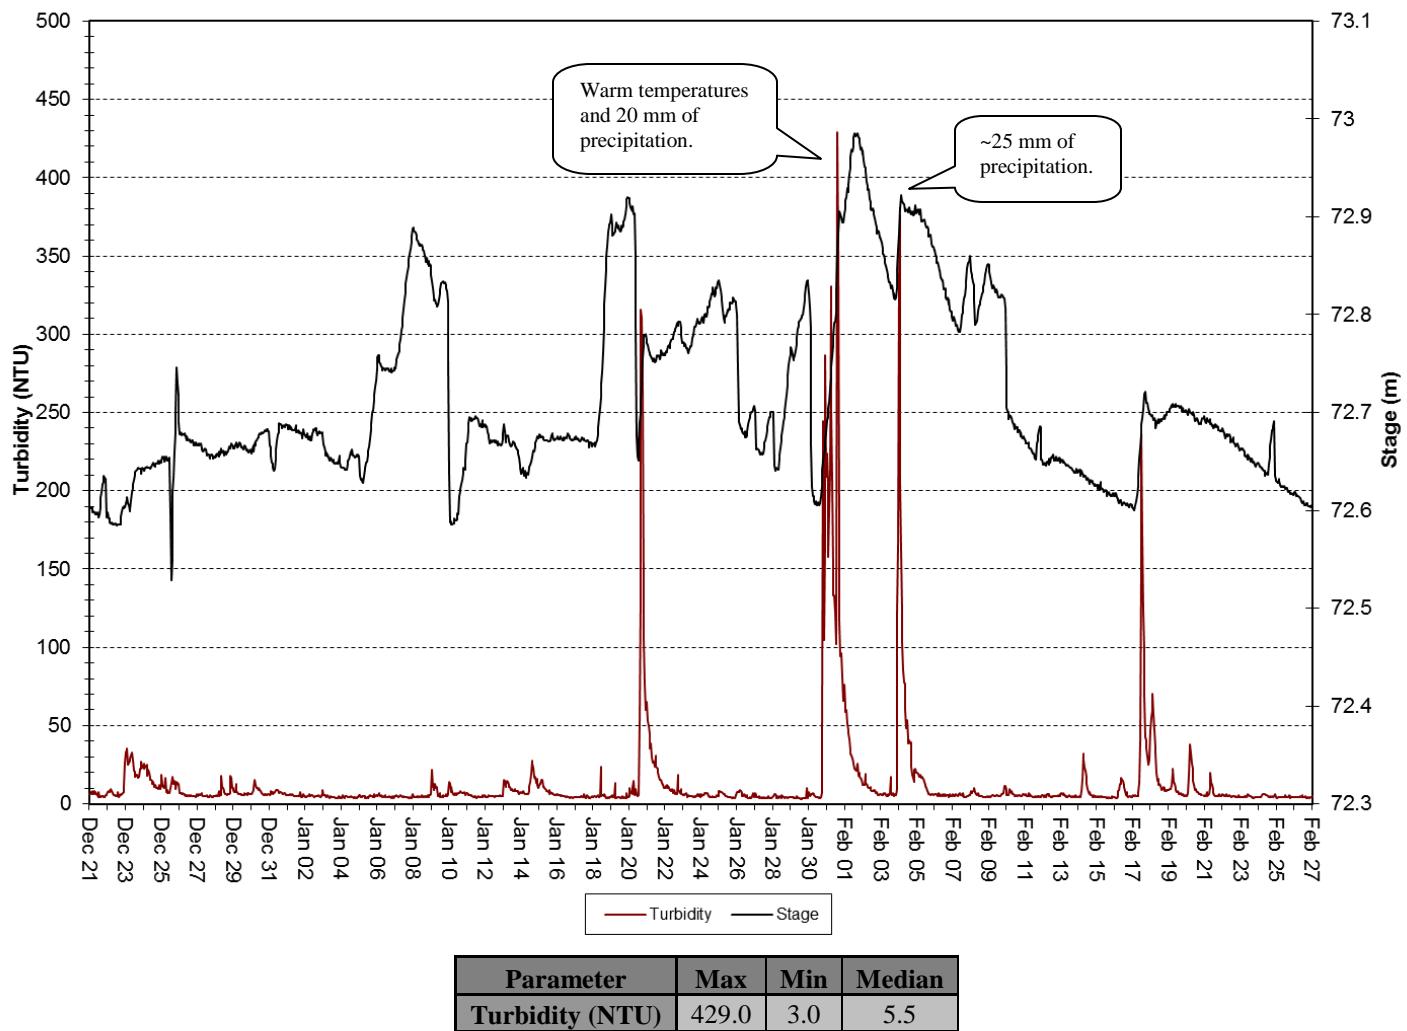
**Figure 15:**  
**Water Turbidity and Stage Level**

- Turbidity levels were slightly higher at Plant Discharge station compared to Bridge station. Events were highly concurrent with increases in stage level, especially on January 31<sup>st</sup> and February 5<sup>th</sup>.
