Waterford River @ Kilbride

NF02ZM0009

March 2010

Real Time Water Quality Monthly Report
Waterford River - St. John's NL
March 2010

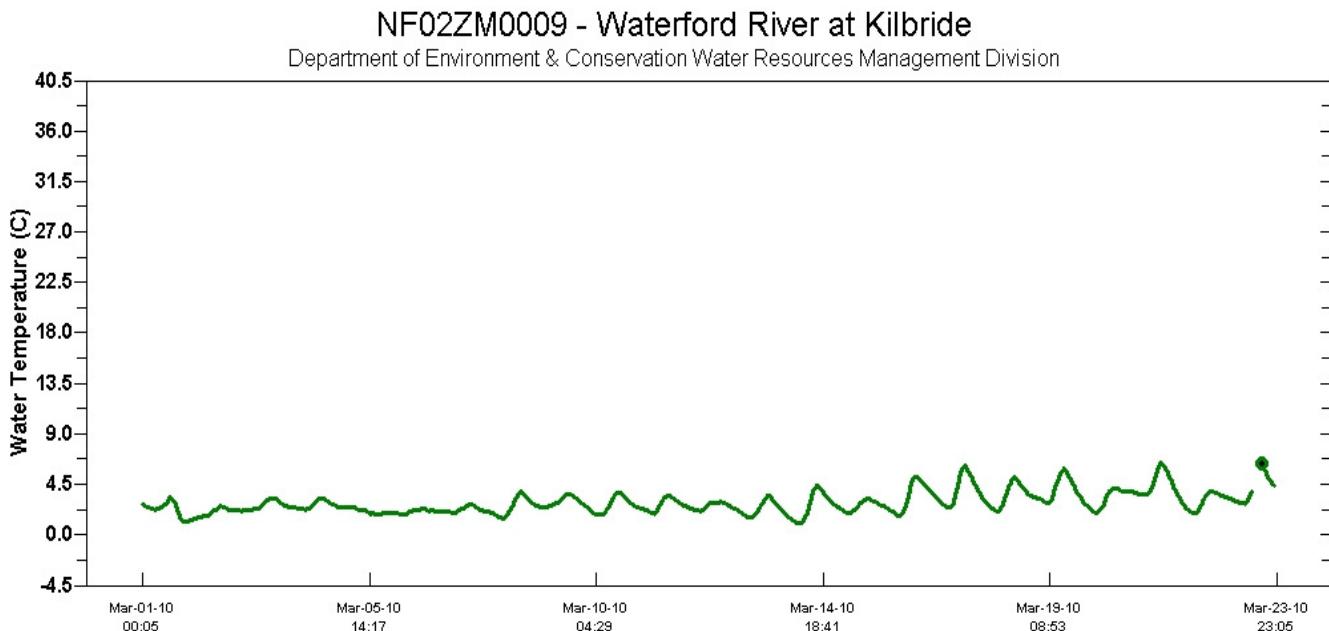
Figure 1: Water Temperature

- **Water temperatures** were fairly constant during this deployment, as shown in **Figure 1** below. Water temperatures ranged between 0.55 and 5.90°C, which was within the seasonally expected range.

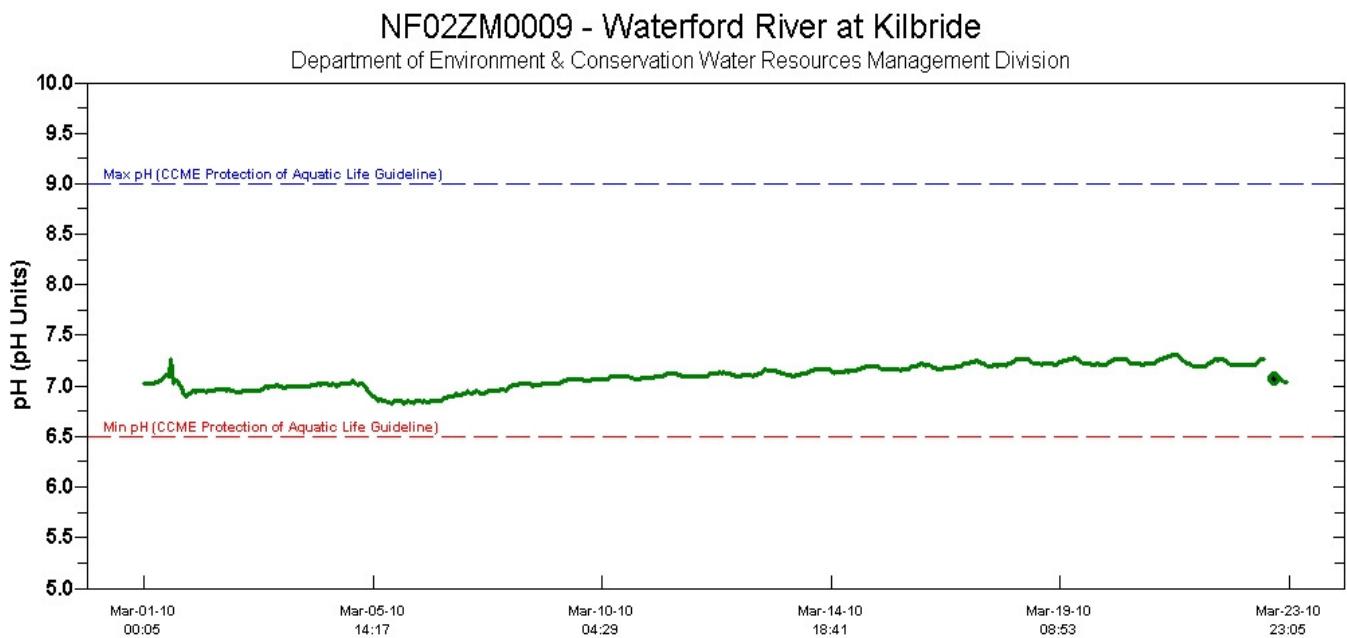
Figure 2: pH Levels

- **pH** levels were fairly constant throughout this deployment ranging from 6.82 to 7.31 units, as seen in **Figure 2** below. All pH values were within the range recommended by the Canadian Water Quality Guidelines for the Protection of Aquatic Life of 6.5 to 9 pH units (**Figure 2**).

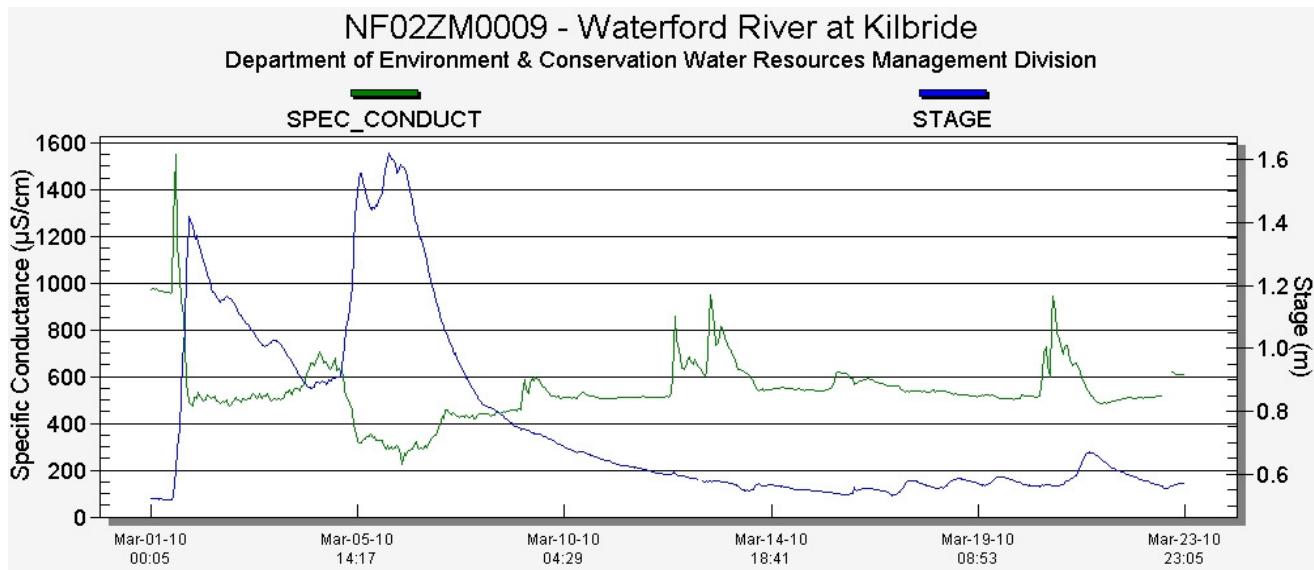
Figure 3: Specific Conductance

- **Specific conductance levels** were somewhat variable from March 1st to March 8th as seen in **Figure 3** below, in green ink. This may be the result of heavy rainfall that occurred in the region between these dates, which can be seen in the peaks in stage height shown in blue ink in **Figure 3**. Canadian climate data for St. John's for March 2010, as provided by Environment Canada, is given in **Appendix 1** at the end of this report, and indicates approximately 150mm of rain fell from March 1-8. Specific conductance values were fairly constant for the remainder of the deployment, with a couple of peaks occurring near March 13th and 21st. These peaks may have been the result of light rain that occurred immediately prior to those dates, or may be the result of water quality events. The large spike in specific conductance seen on March 1 in Figure 3 is an error reading that occurred at the instant the instrument was connected for deployment.

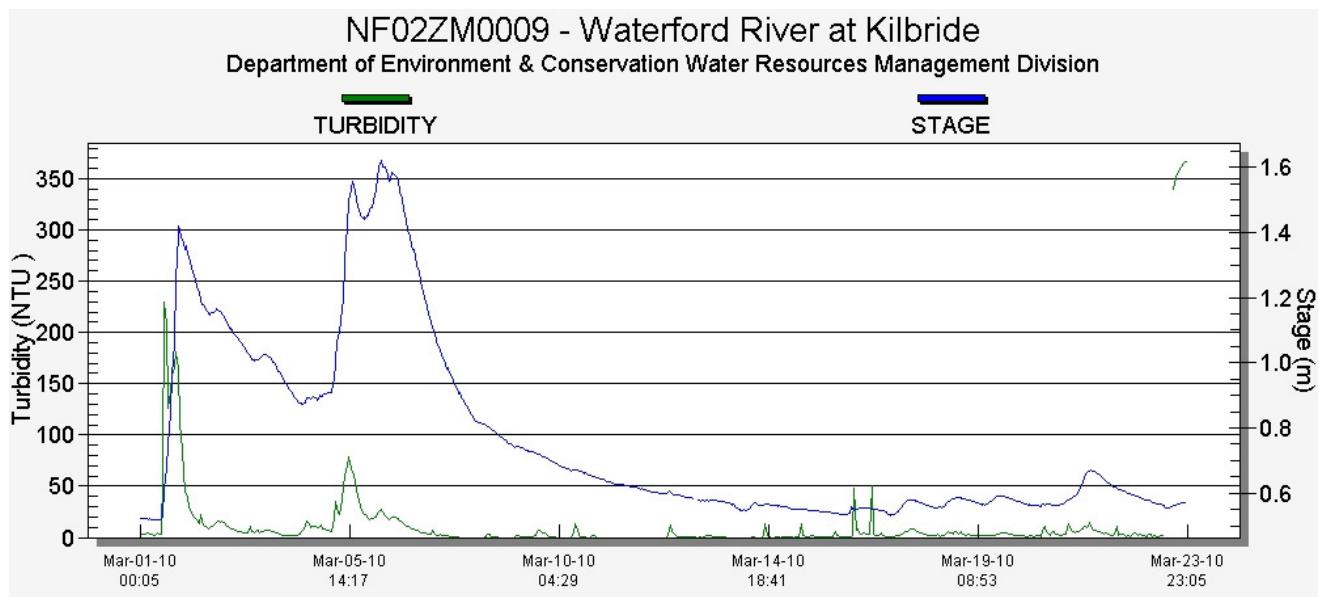
Figure 4: Turbidity

Turbidity was at background levels for most of the deployment period with the exception of spikes occurring on March 2nd and March 5th, as shown in **Figure 4** below. The spikes were the result of heavy rain and increased run-off that occurred on these dates. Turbidity values ranged from 0-230 NTU during this deployment.
