Real-Time Water Quality Report

Outer Cove Brook Network

Deployment Period
March 6 to April 9, 2013

Outer Cove Brook, Newfoundland and Labrador

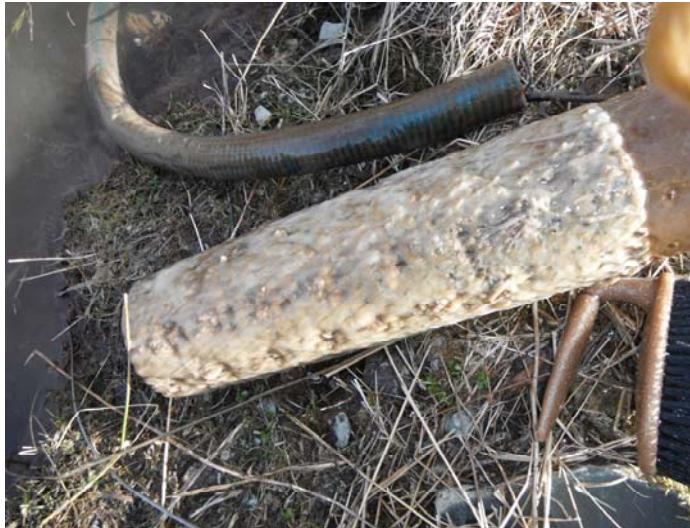
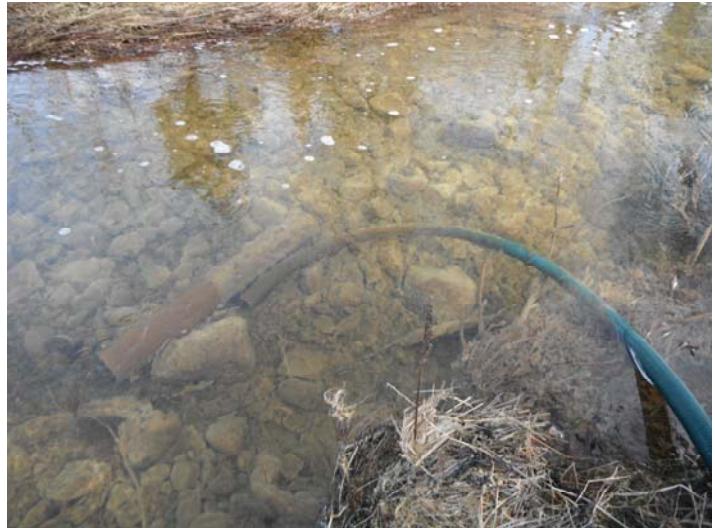
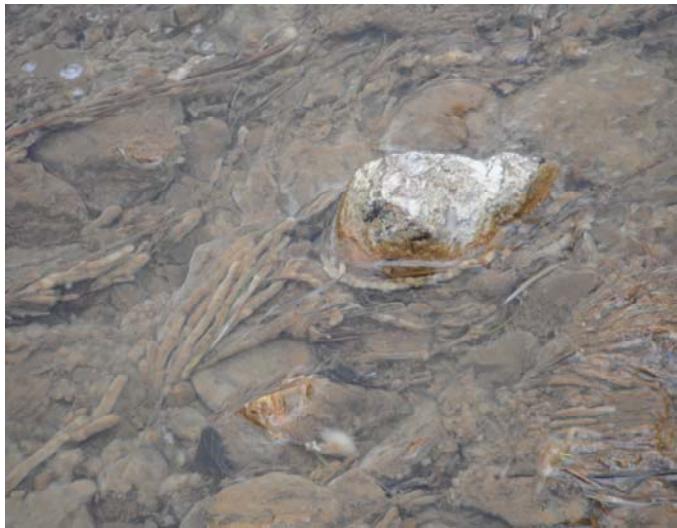
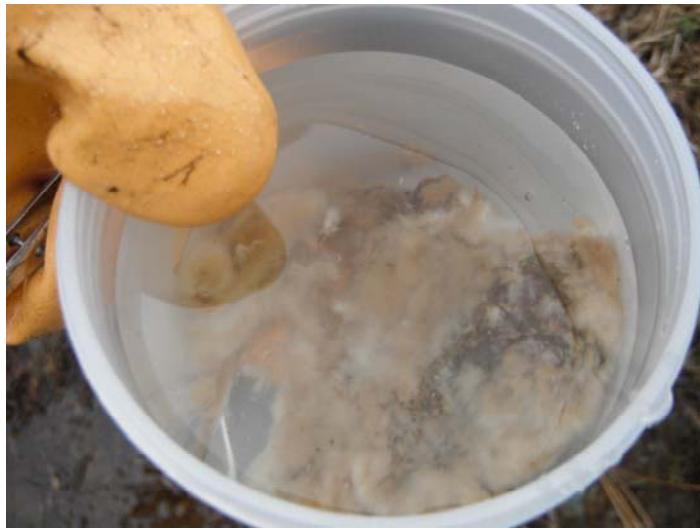
- This sensor received a 'poor' performance ranking at removal due to the large amount of biofouling occurring around the sensors and on the casing (see Appendix 1). The substance which fouled the sensors was a thick, whitish-brown 'furry slime', which coated all the equipment in the water as well as the river bed and surrounding vegetation.

- The majority of turbidity events were correlated with increases in stage and thus precipitation events. High turbidity values at removal and a 'poor' sensor ranking are explained by the presence of a thick slime coating the casing, probe, and all rocks and vegetation in the river.

During the removal of the instrument at the below Airport station on April 9, 2013, a thick coating of a whiteish-brown 'slime' was noted attached to the vegetation, substrate, and equipment in the water.
