Real-Time Water Quality Report

Outer Cove Brook Network

Deployment Period
September 30, 2014 to November 3, 2014

Government of Newfoundland & Labrador
Department of Environment and Conservation
Water Resources Management Division

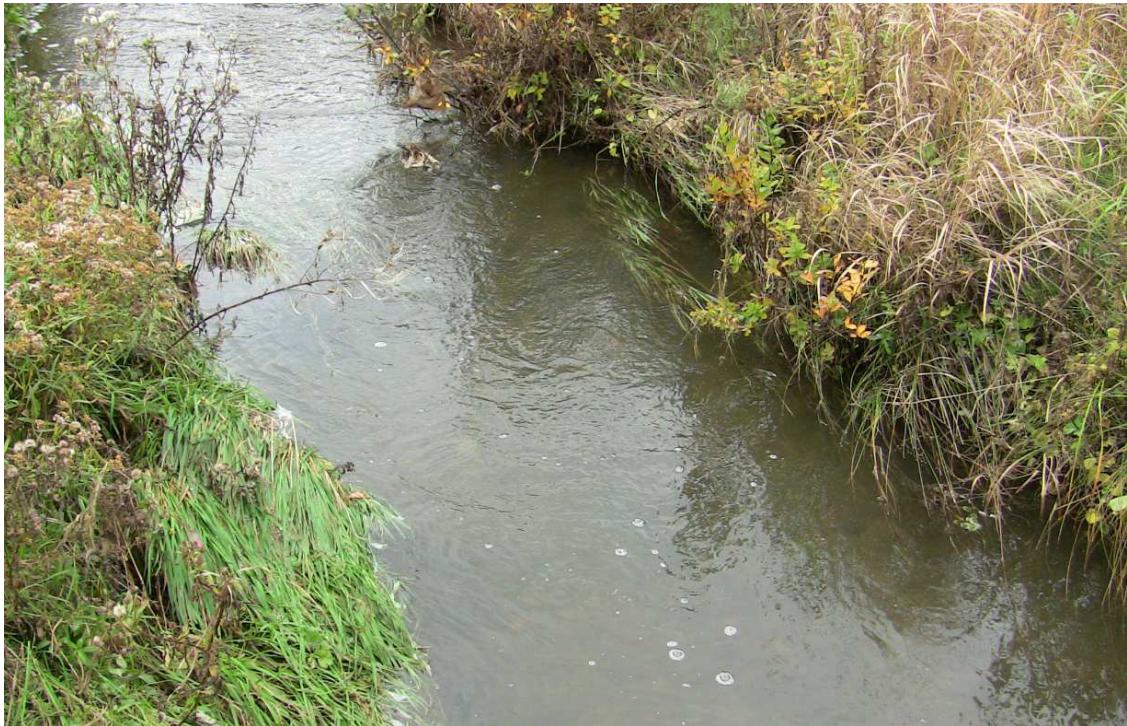
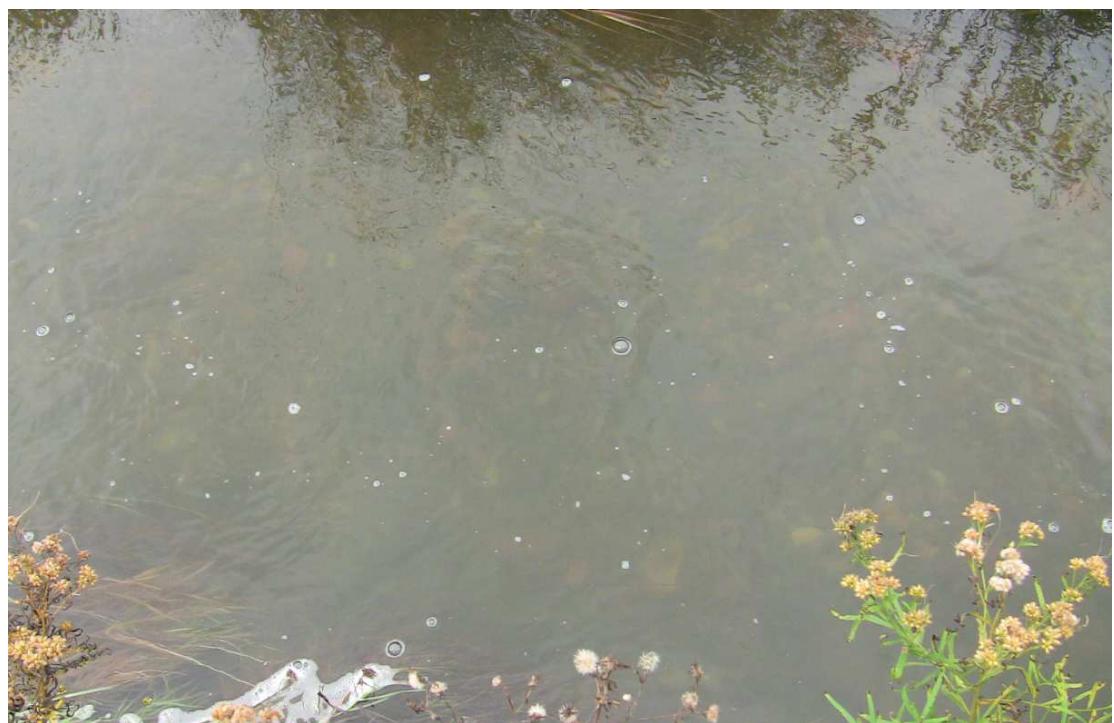
Figure A-1: Turbidity in brook at Outer Cove Brook below Airport (Oct 21, 2014)

Figure A-2: Turbidity in brook at Outer Cove Brook below Airport (Oct 21, 2014)

- On October 21st, 22nd and 23rd there is unexplained turbidity events that are also evident slightly on the conductivity graphs for the same dates. On October 22nd Water Resources staff was at the site to capture the turbidity event occurring upstream from the station. However we can only speculate that the other two turbidity events (October 21st and October 23rd) were likely related to the same upstream disturbance. (Pictures in Appendix I)

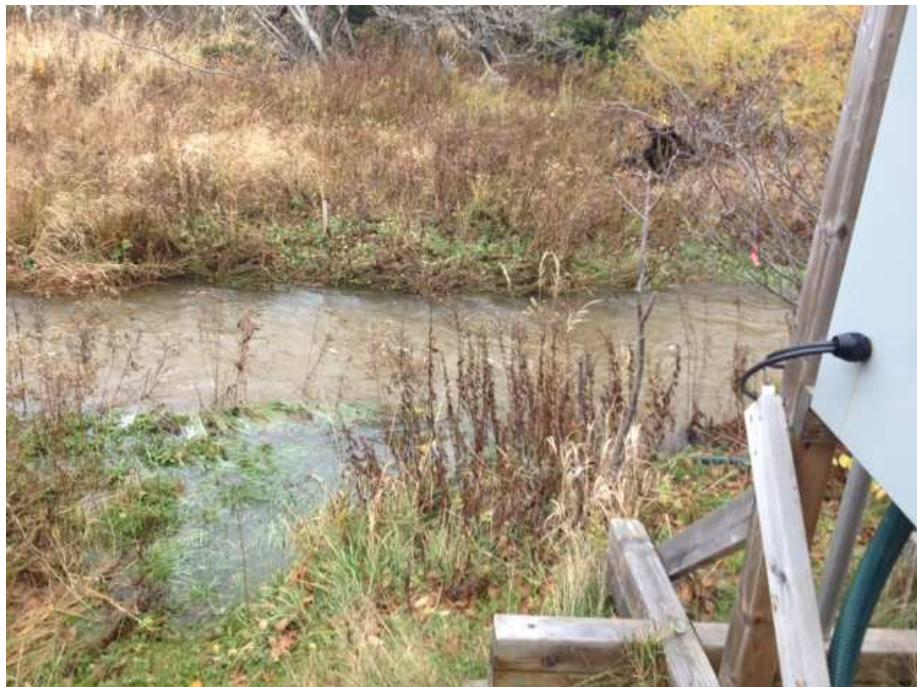
Figure A-3: Picture of turbidity in brook during visit for monthly removal on November 3, 2014

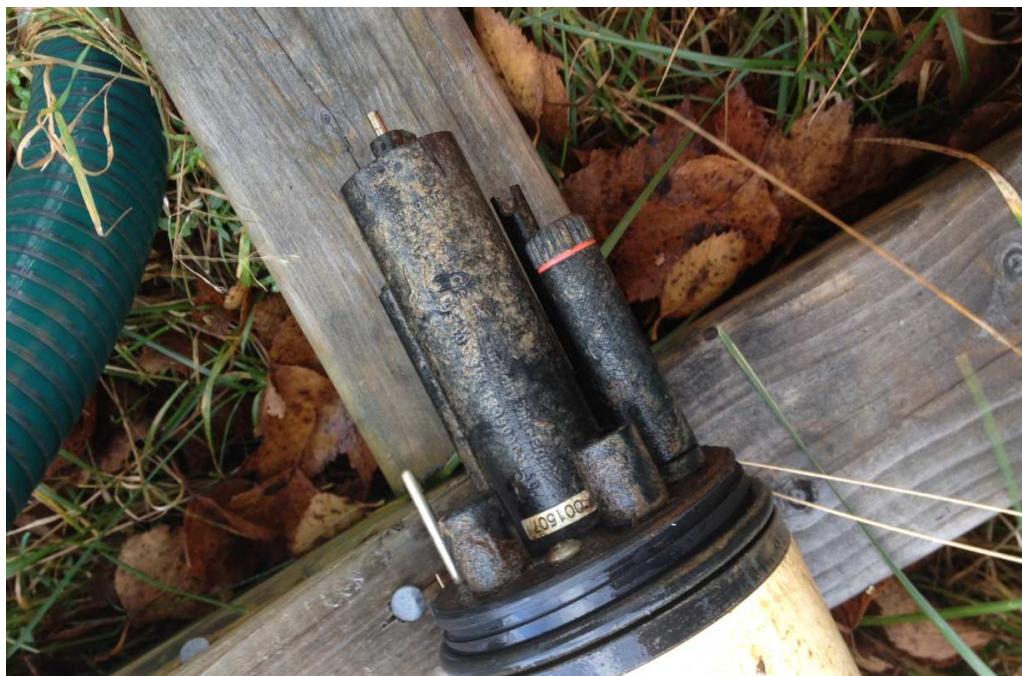
Figure A-6: Fouling on sensors after monthly deployment at Outer Cove brook below Airport

present on the field sensor. As debris covers the sensor window it can impede on the accuracy of the turbidity reading. The 'fair' ranking for dissolved oxygen was also likely a result of fouling on the sensor (Pictures taken Appendix I).

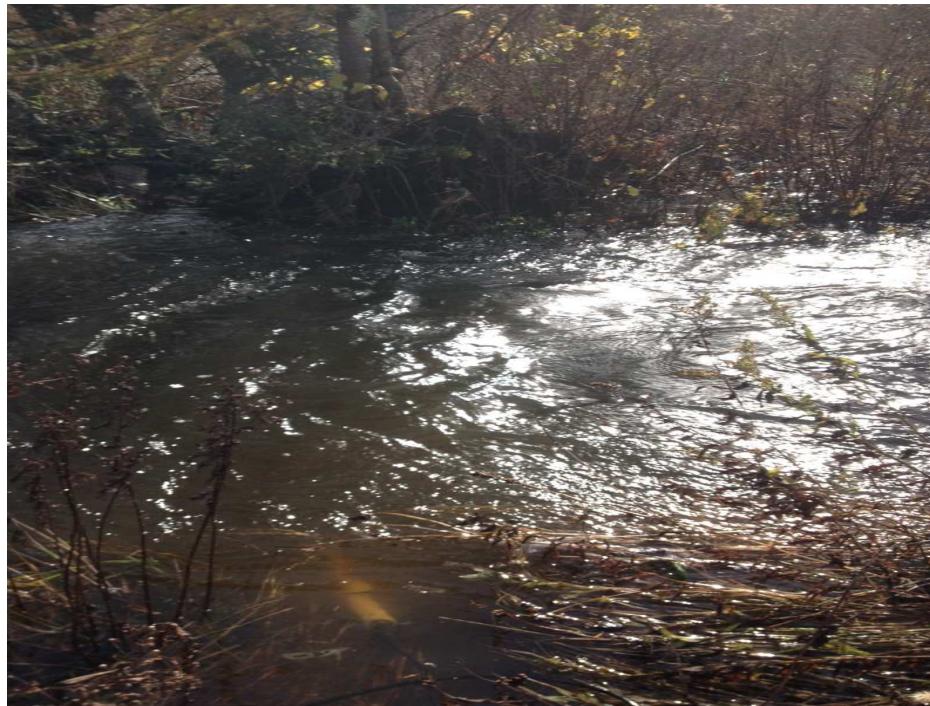
Figure A-7: Turbidity at Outer Cove Brook at Clovelly Golf Course on November 3, 2014

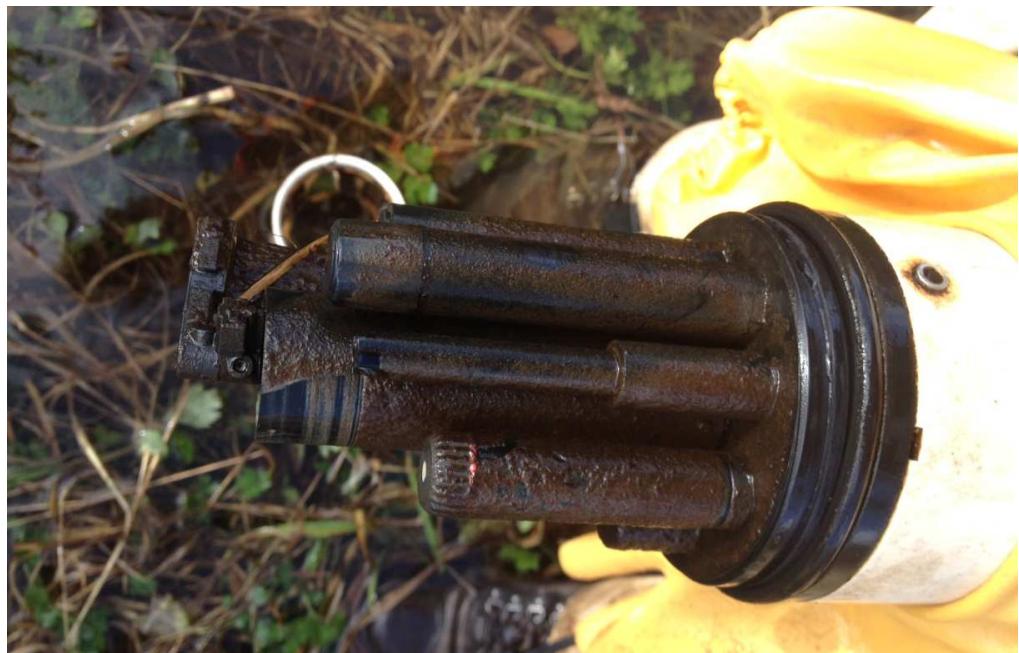
Figure A-9: Fouling on sensors after monthly deployment at Outer Cove brook at Clovelly Golf Course

- At removal the comparison between the field sonde and QAQC sonde indicated that, water temperature, and dissolved oxygen ranked as 'excellent'. Specific Conductivity ranked as 'Good'. pH and Turbidity ranked as 'Poor' at the end of the deployment period. During removal there was evidence of fouling on the sensors. The fouling can interfere with the accuracy of the data (Appendix I pictures of fouling on sensors).
