Real Time Water Quality Report

City of St. John's Outer Cove Brook Network

Annual Deployment Report 2015

January 1, 2015 to November 12, 2015

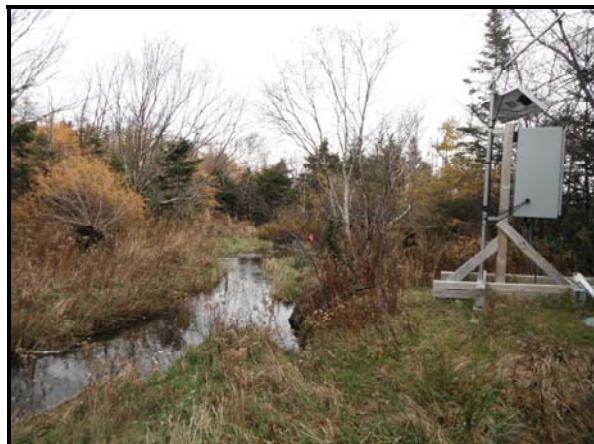
Figure 3: (a) Outer Cove Brook below Airport

The headwaters of Outer Cove Brook originate in a boggy area of Airport Heights, just east of Windsor Lake (Figure 2). The brook flows beneath Portugal Cove Road, north toward St. John's International Airport, where it is partially channeled beneath the runways before emerging in a forested area on the eastern perimeter of the airport. The Outer Cove Brook below Airport station is approximately 400m downstream of the airport's perimeter. At this station, the river is surrounded by tall grasses and marshland, with mature conifer forests (see Figure 3a). The sonde is located in a deep section of the well-defined channel.

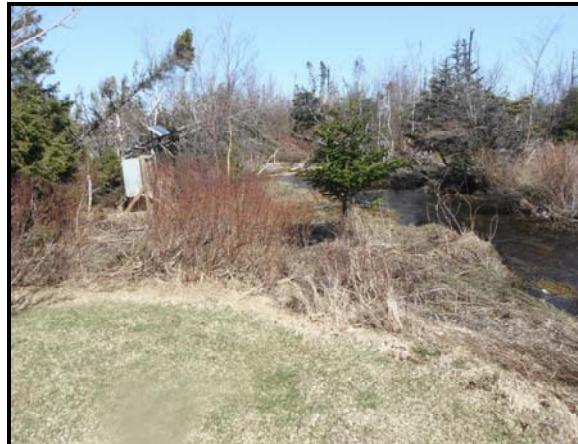
(b) Outer Cove Brook at Clovelly Golf Course

Outer Cove Brook then flows through the new Torbay Road North Commercial Development Area before passing beneath Torbay Road. The brook continues flowing north-east through marshlands surrounded by forest, bordering along the Aberdeen Extension development area, before entering and flowing through a buffer zone within Clovelly Golf Course. The second real-time station, Outer Cove Brook at Clovelly Golf Course, is located in a patch of trees on the eastern side of Golf Course Road adjacent to the clubhouse. The station sits in a marshy area which is heavily saturated during high flows and surrounded by tall grasses and some conifers (Figure 3b). The sonde typically sits in a deep, defined channel upstream of the braided portion of the river.

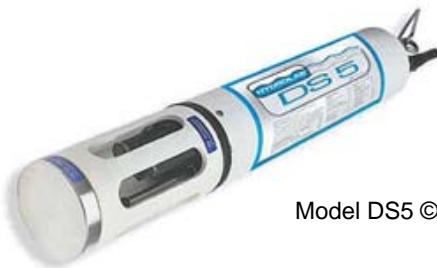
Figure 4: Hydrolab DataSonde used for monitoring water quality parameters.

Water quality parameters are measured at each station using a Hydrolab DataSonde instrument (Figure 4).

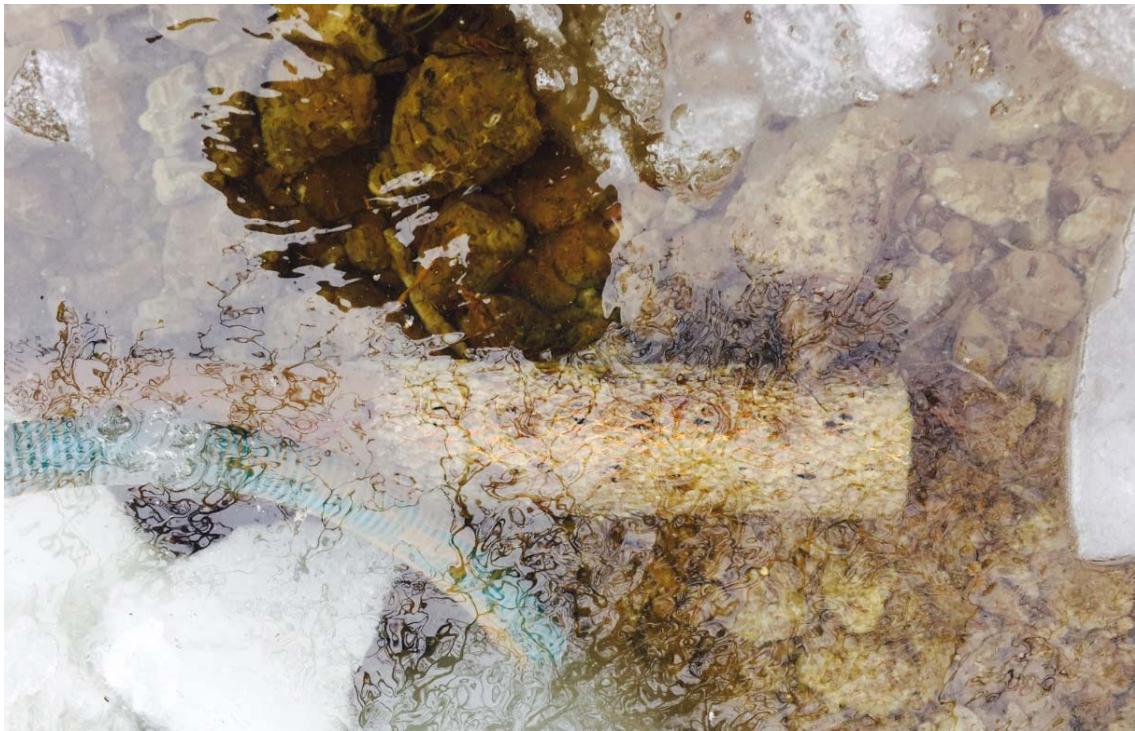
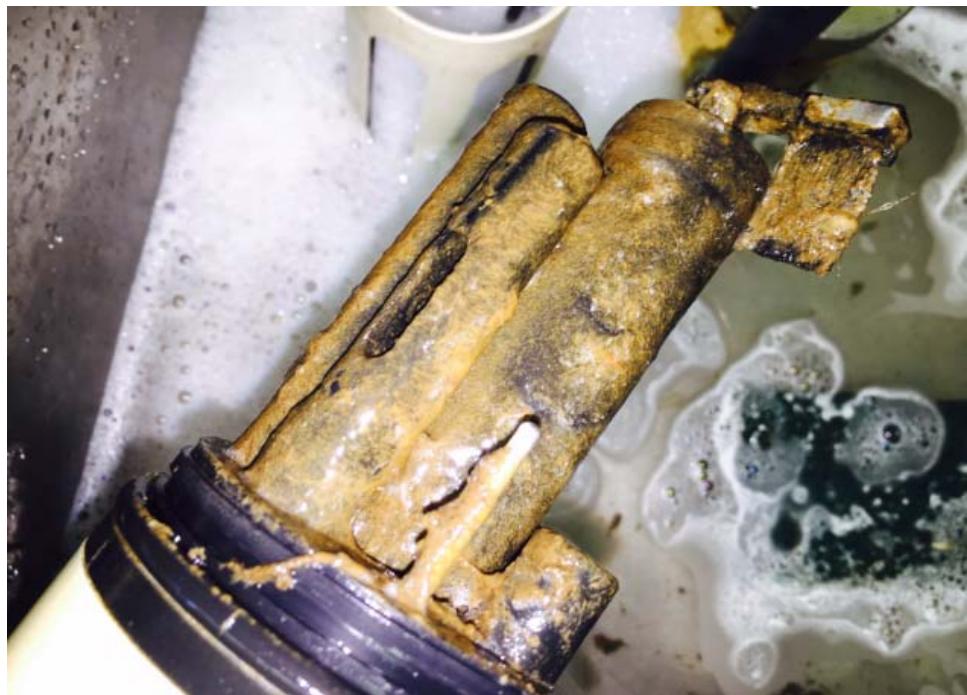
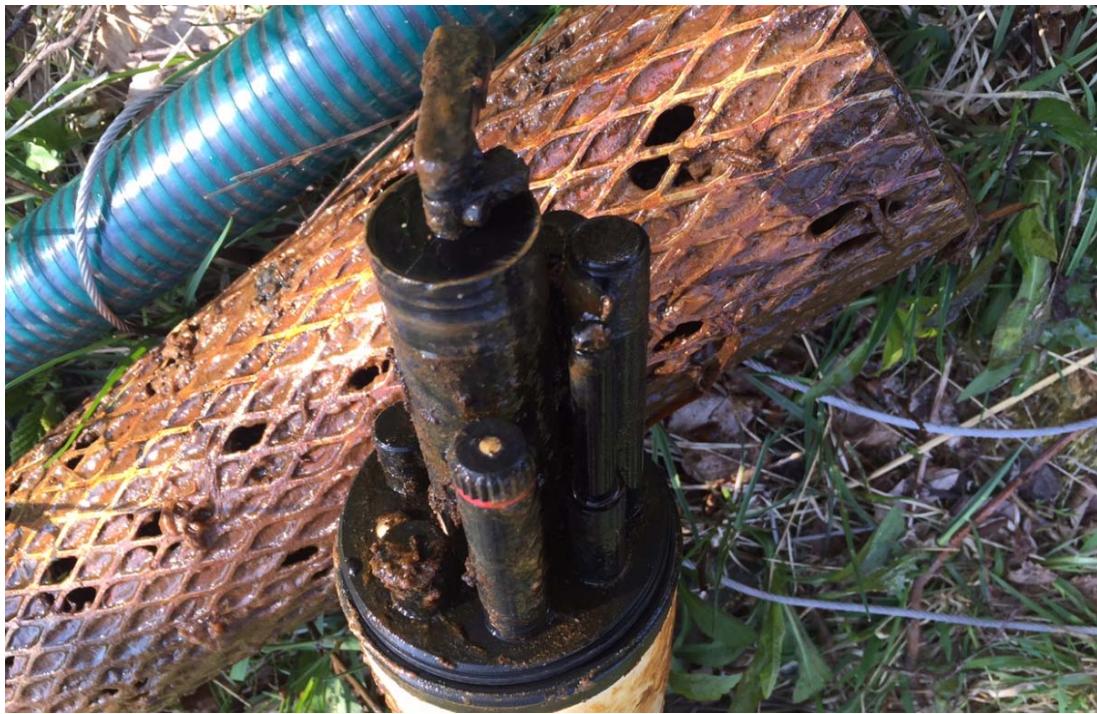
Figure 20: Slime on Airport Instrument in brook

Figure 23: Slime on Airport Water Quality Instrument

Figure 25: Slime on Airport instrument and sensor cage

It was identified during a field visit in March that the annual growth of the slime-like aquatic substance had returned to this brook (Appendix V). The substance completely coats anything in the water body, including the instrument and its protective casing. The fouling created issues with the data that was being recorded; the sensors have trouble taking an accurate reading through the substance (Appendix V). During die-off of the algae there is an excessive amount of oxygen being used in the brook and this is possibly captured in the data with the lower dissolved oxygen readings from mid-May.

During the months of January to early June there is a heavy growth of slime-like substance present in the brook. This substance coats the instrument and anything in the water during the time frame. It has caused some issues with the actual data due to the fouling of the sensor and it also impacted the water parameters (i.e. pH, dissolved oxygen content and turbidity) during the growth and die-off periods of the slime-like substance (Appendix V).

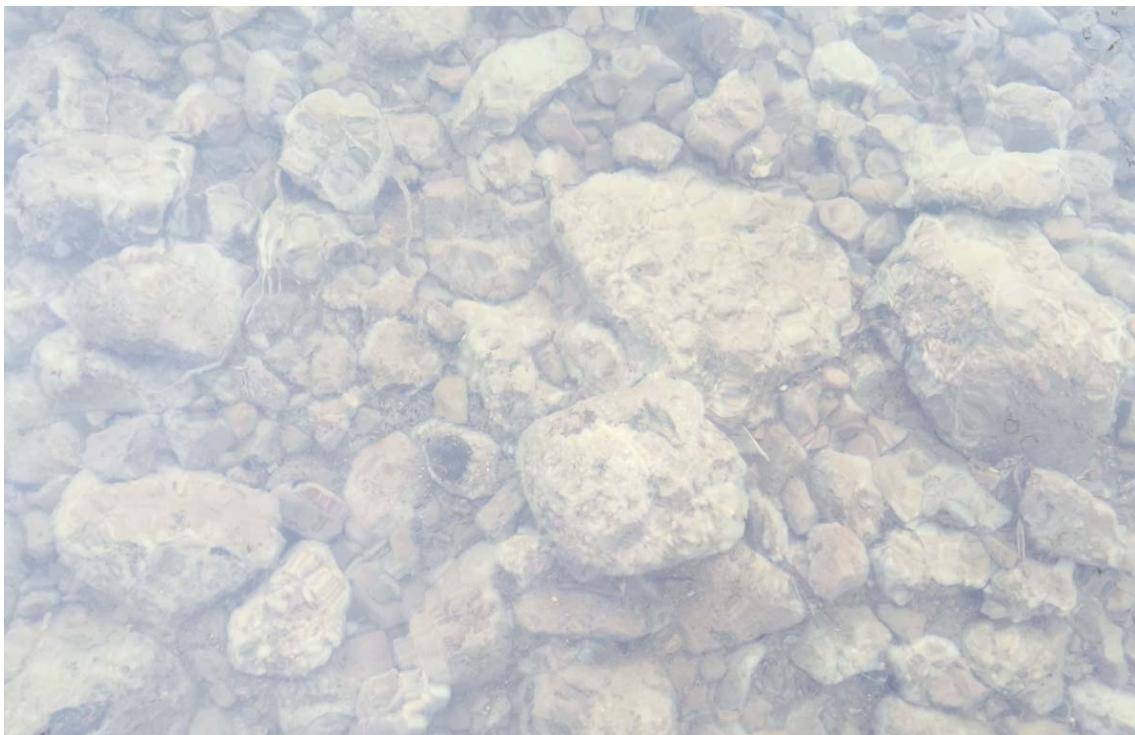
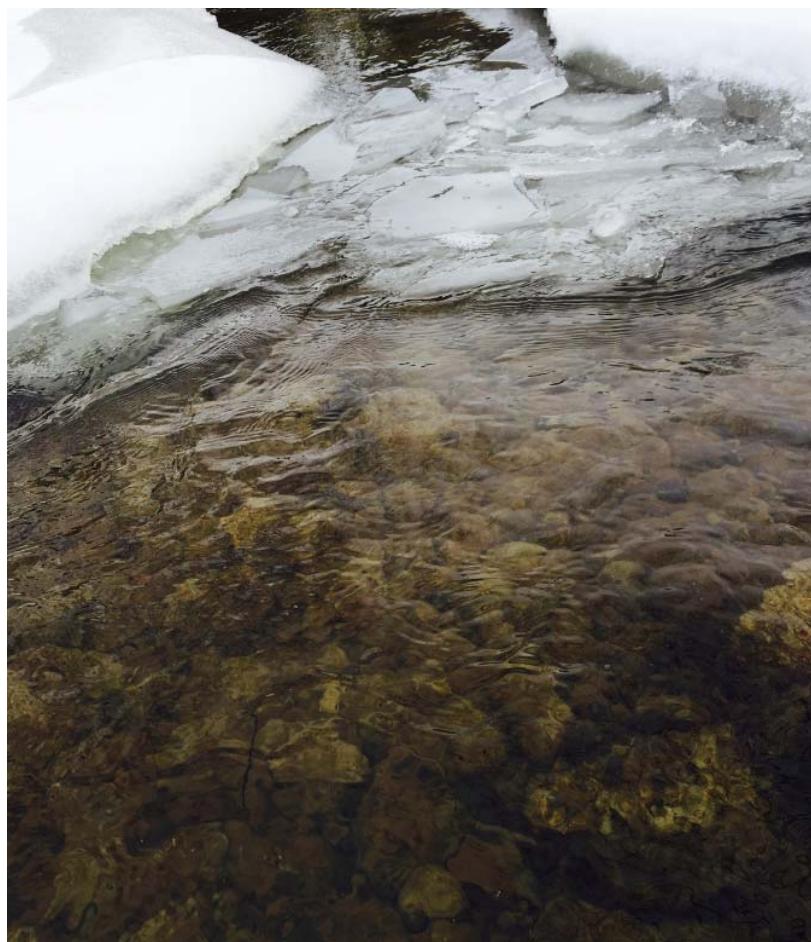
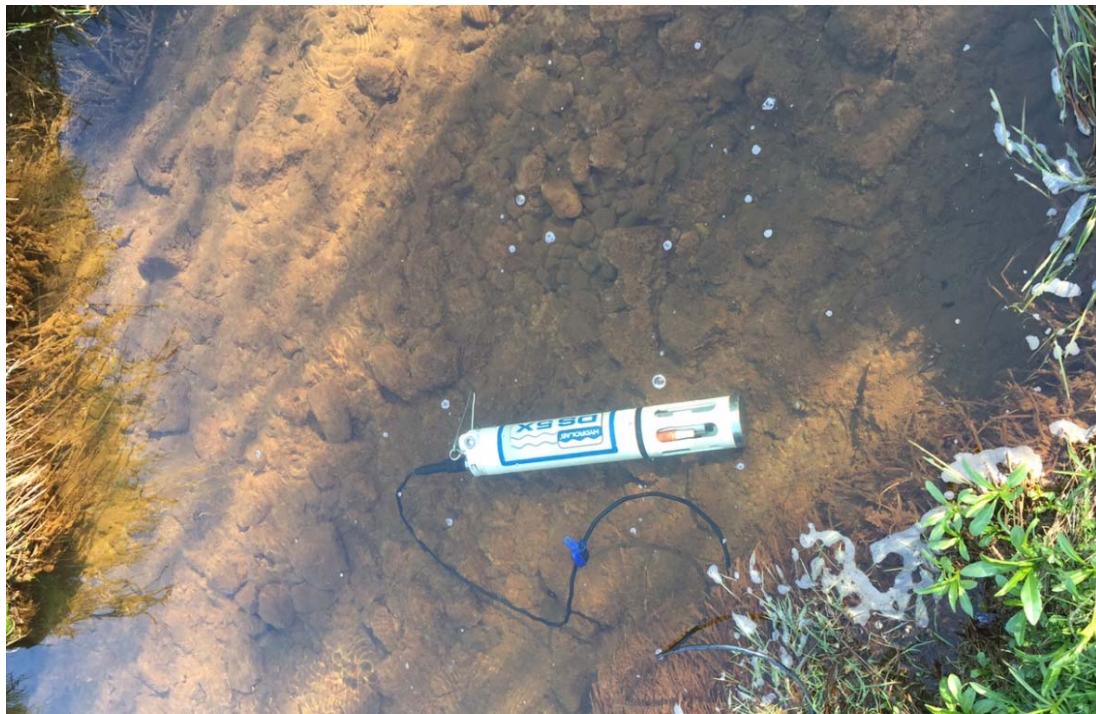
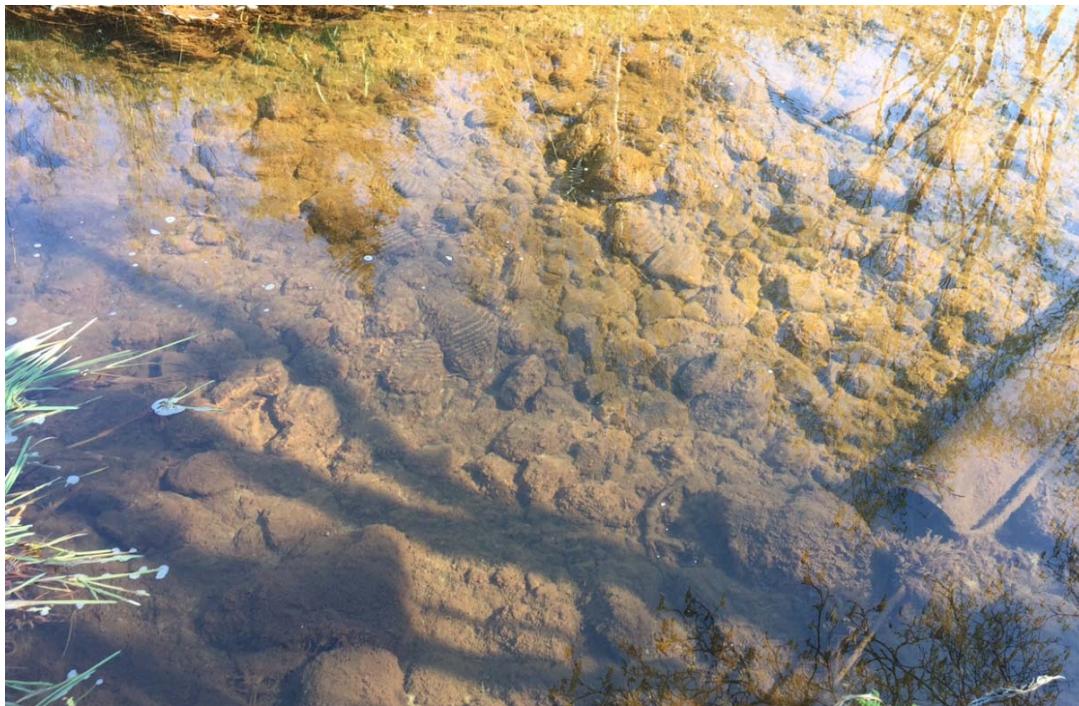
Figure 21: Slime on stream bed at Outer Cove Brook below Airport

Figure 22: Slime on stream bed at Outer Cove Brook below Airport

Figure 24: Covering of slime like algae on the stream bed at Airport

Figure 26: Coverage of the slime-algae at Airport station.

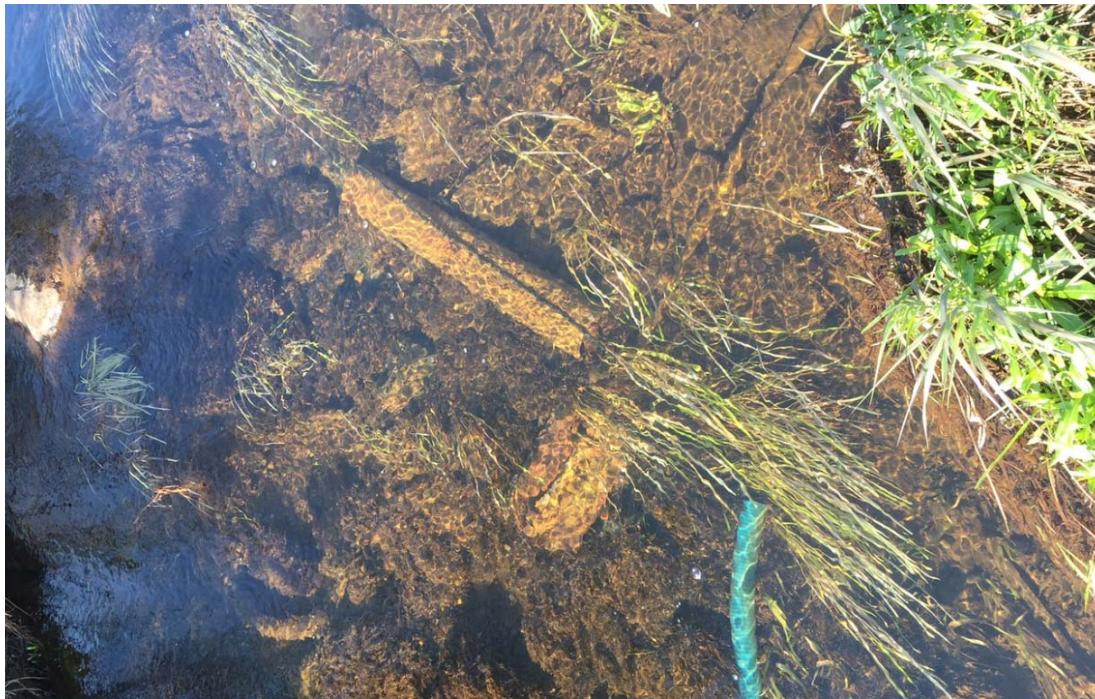
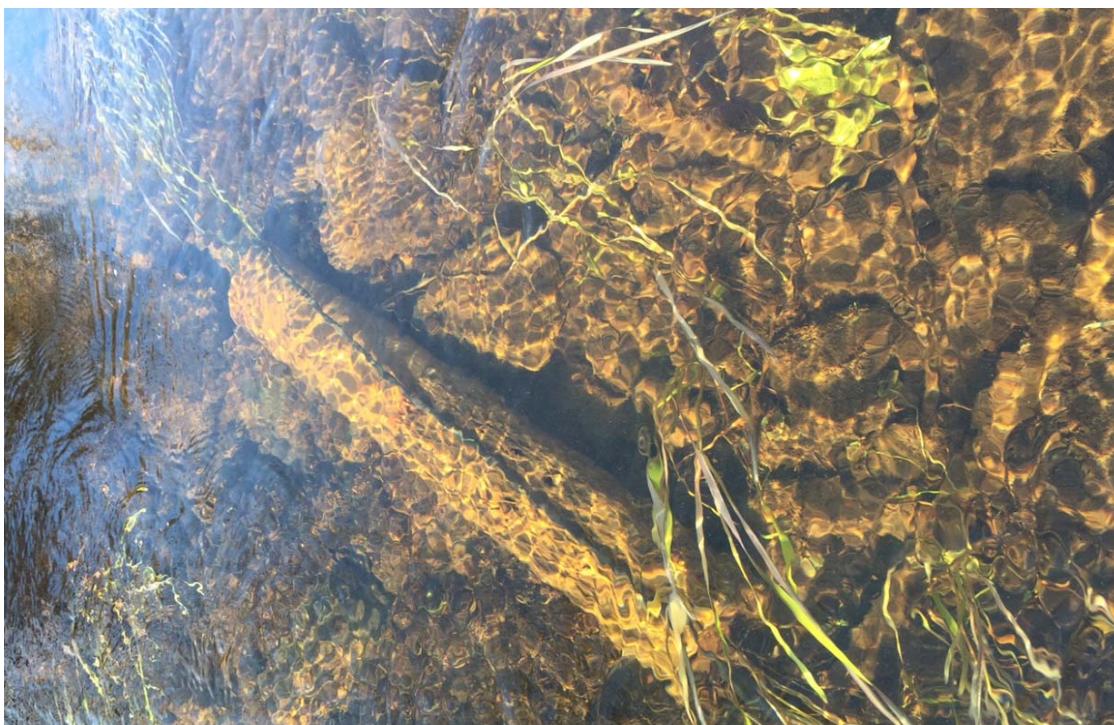
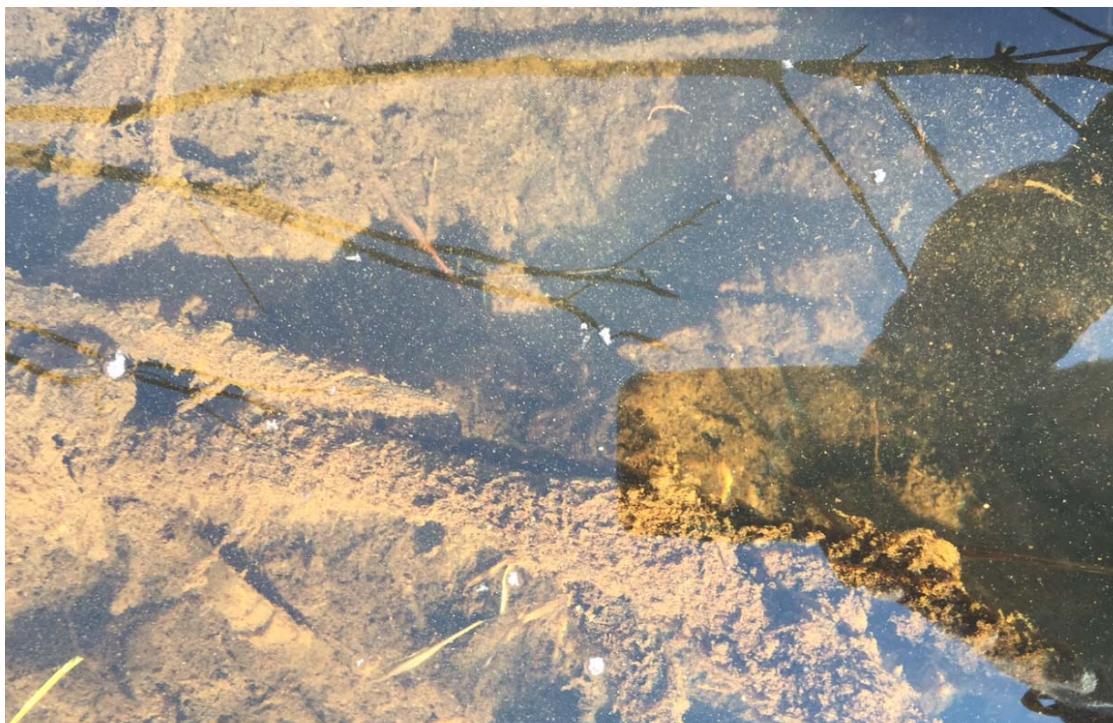
Figure 27: Slime-line algae in the brook at Clovelly Station

Figure 28: Slime-line algae in the brook at Clovelly Station

Figure 29: Slime-line algae in the brook at Clovelly Station

During the months of January to early May there is evidence of the heavy slime-like substance at Clovelly (that is present in the Outer Cove Brook below Airport). While the incident of the substance is not as bad as the Airport Station, there was still a coating of it on the instrument and on the streambed. It has caused some issues with the actual data due to the fouling of the sensor and it also has the potential to change the water parameters during the growth and die-off periods of the algae.

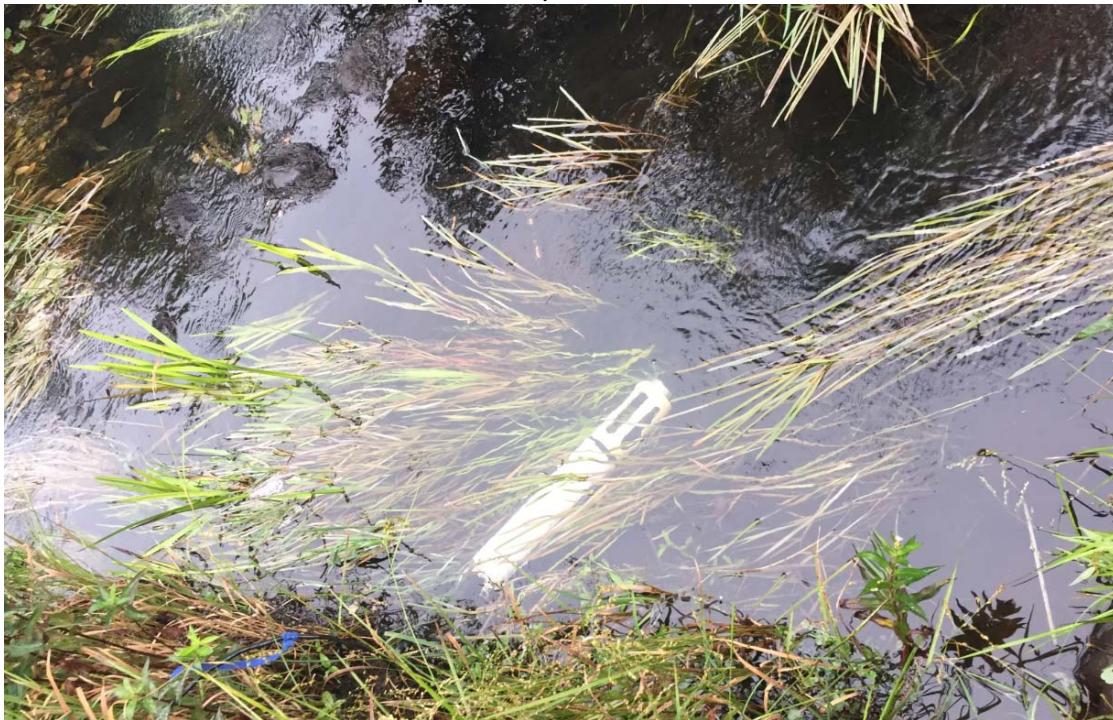
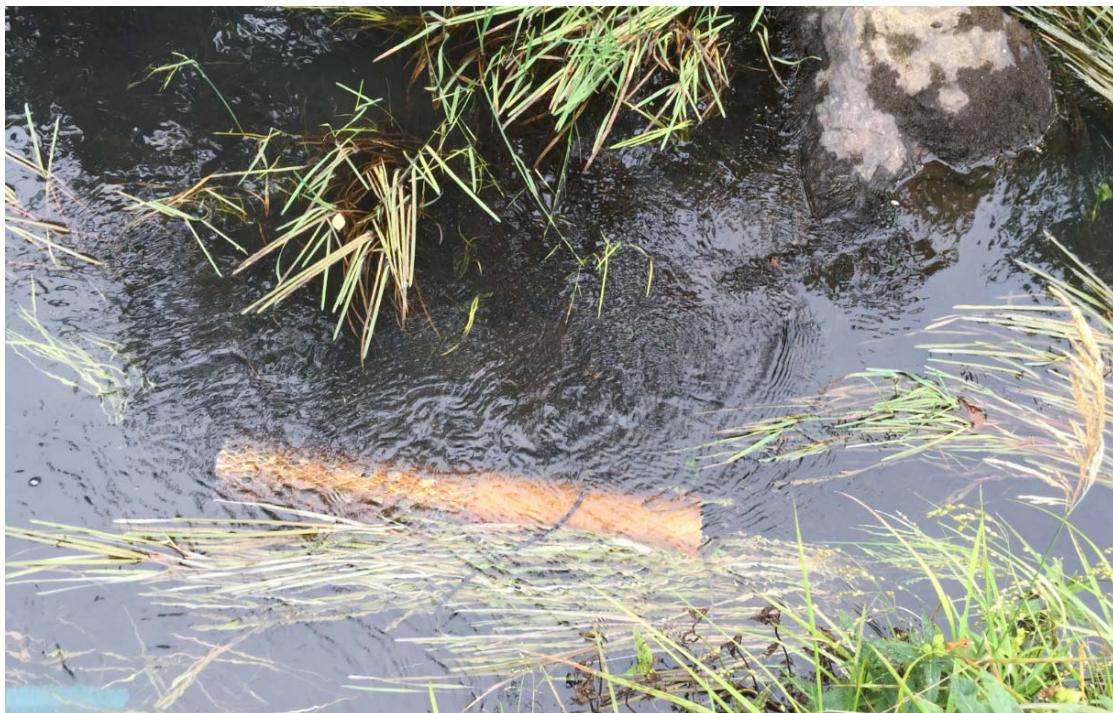
Figure 30: Vegetation present in the brook at Clovelly Station

Figure 31: Vegetation present in the brook at Clovelly Station

The large fluctuations in DO during summer are due to the presence of large amounts of algae and vegetation around this station. During the day, the plants are photosynthesizing, producing oxygen, but cease this process as night due to the absence of sunlight, causing the depletion of oxygen in the water at night.

The turbidity increases corresponded with the precipitation events that can influence the amount of suspended sediments in the water column. Outer Cove Brook at Clovelly Golf Course had large amounts of aquatic vegetation growing in the brook that can cause interference for the turbidity sensor (Appendix VI). Shallow urban brooks can be heavily influenced by their surroundings and there is a lot more movement in the turbidity data.
