## COASTAL MONITORING IN NEWFOUNDLAND AND LABRADOR: 2012 UPDATE

M. Irvine  
Geochemistry, Geophysics and Terrain Sciences Section

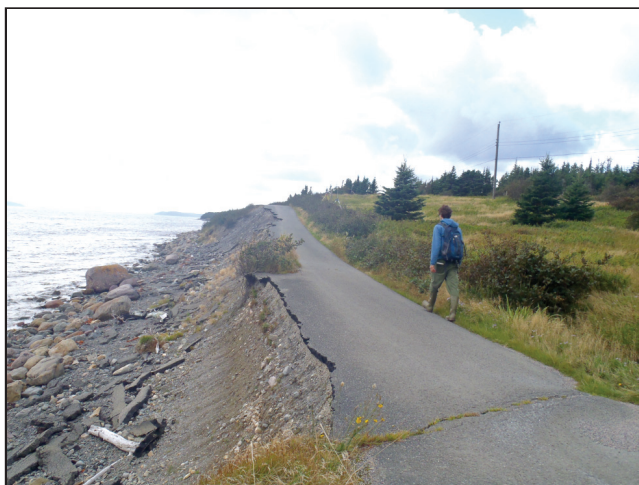
**Plate 1.** Coastal erosion is occurring along this road in O'Donnells, Avalon Peninsula. Ground- and surface-water flow are causing the sand and gravel to wash down the bank. During high tides, waves impact the base and wash the sediment away from the base of the slope.

Coastal environments are dynamic, with changes caused by both terrestrial and marine processes (Moore, 2002). Terrestrial processes include slope movement (*e.g.*, landslides, rockfalls, gullying and slumps), and surface- and ground-water flow (Plate 1). Wave action is one of the primary causes of coastal change, with most of the erosion and retreat occurring when waves produced by a storm or storm surge (defined as an increase in the level of the water due to pressure and wind changes) coincides with a high tide. Material is deposited when waves transfer energy as they reach the shoreline, and examples of landforms formed by deposition include spits, bars and tombolos.

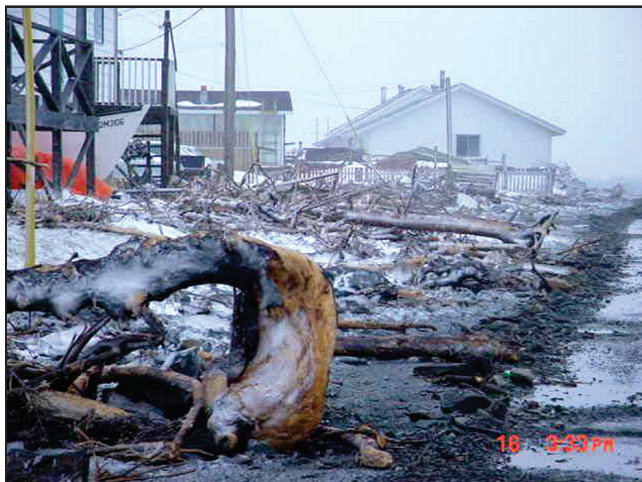
**Plate 2.** Storm surge caused coastal flooding, erosion and overwash on the main road in the Beaches, White Bay.

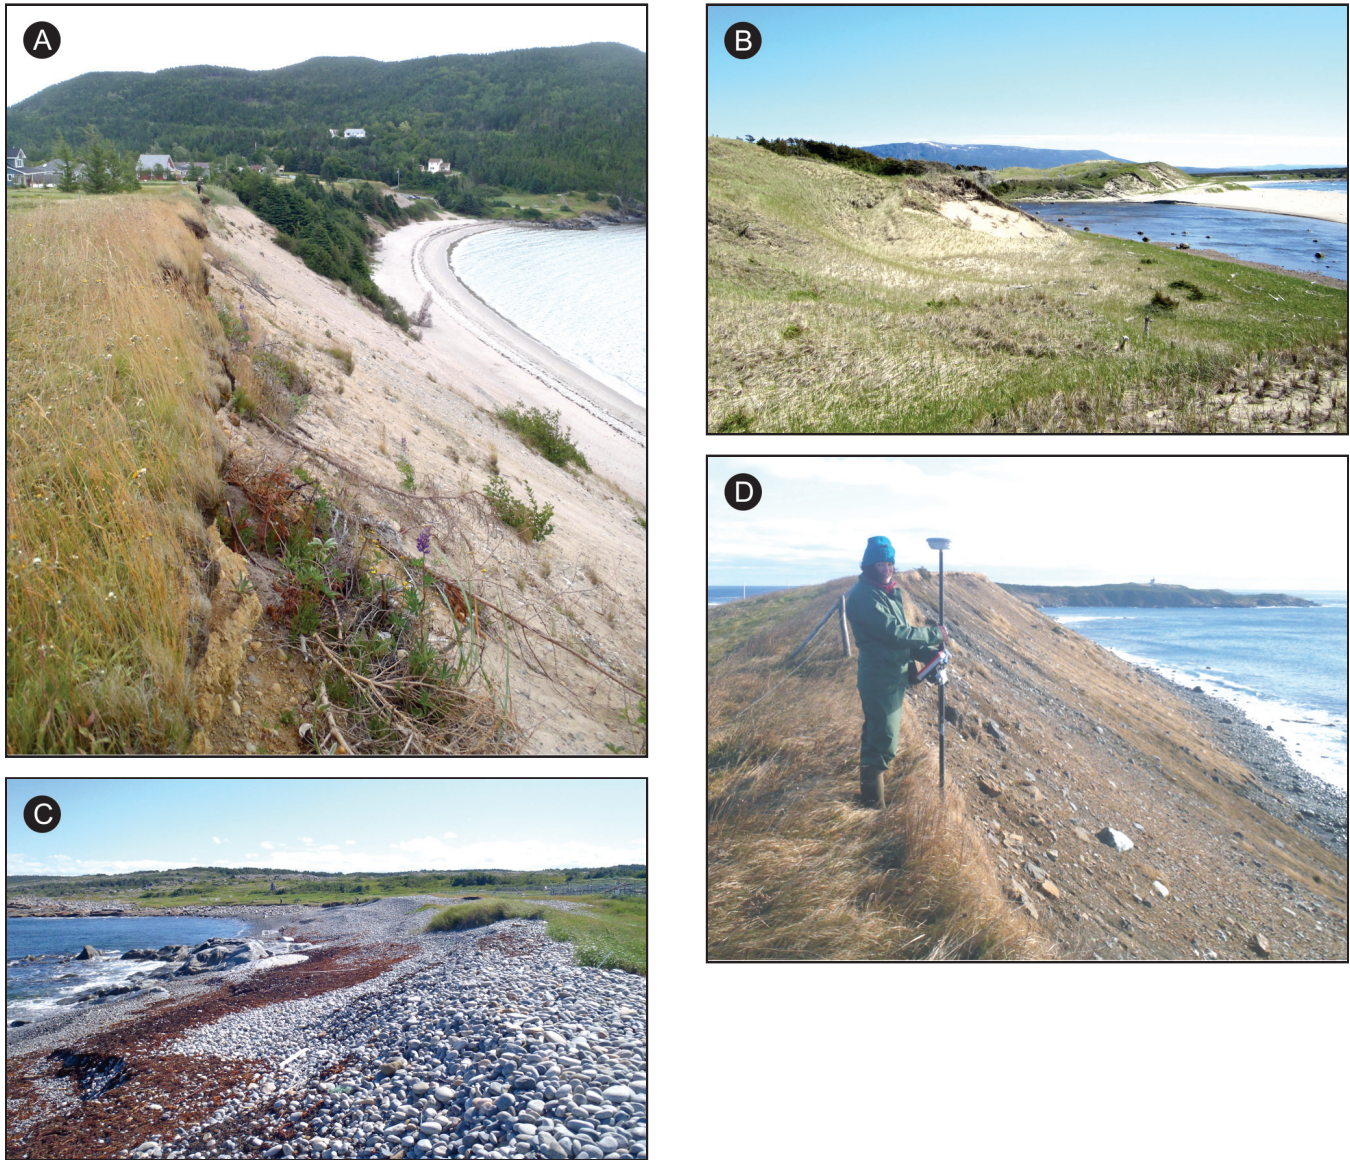
**Plate 3.** Examples of coastal monitoring sites: A) The sandy delta in the community of Sandy Cove is exposed at the coast as a bluff up to 35 m high and 1 km long. Summer houses are built along the top of the delta, and the beach is used by locals and tourists. The cliff is eroding due to foot and ATV traffic, surface- and ground-water flow, and wave impact during high tides and storms. B) Sand dunes at Western Brook–Broom Point area in Gros Morne National Park. A sand-dune management plan was initiated in the 1970s to stabilize the dunes and decrease erosion. Adaptations included the construction of boardwalks, stopping of animal grazing, construction of snow fences, planting of marram grass, and informing users of the importance of maintaining the sand dunes (Betts, 1988). Currently, marram grass has vegetated the area resulting in most of the dunes being stabilized. C) Well-rounded cobble and boulder beach at Olivers Cove, Fogo Island. D) Unconsolidated bluff at Ferryland; lighthouse in background. This bluff is eroding, and waves have damaged the low-lying road that leads out to the lighthouse, residential homes and the Colony of Avalon, a 17<sup>th</sup> century Archaeology site. Significant damage to the road occurred in 2004, 2009 and 2010 despite boulders being placed along the shoreline to protect the area from erosion.

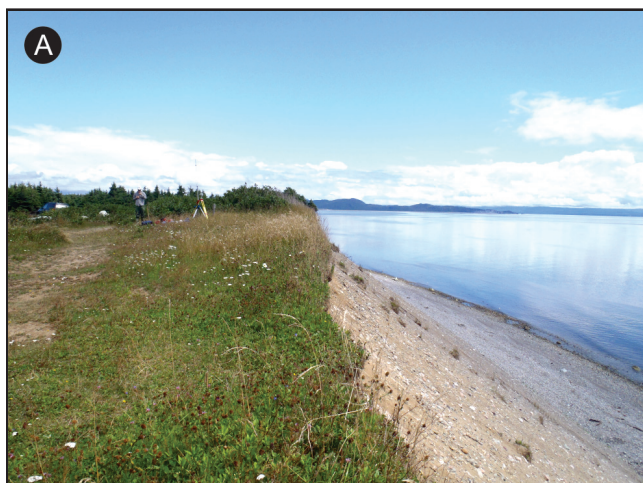
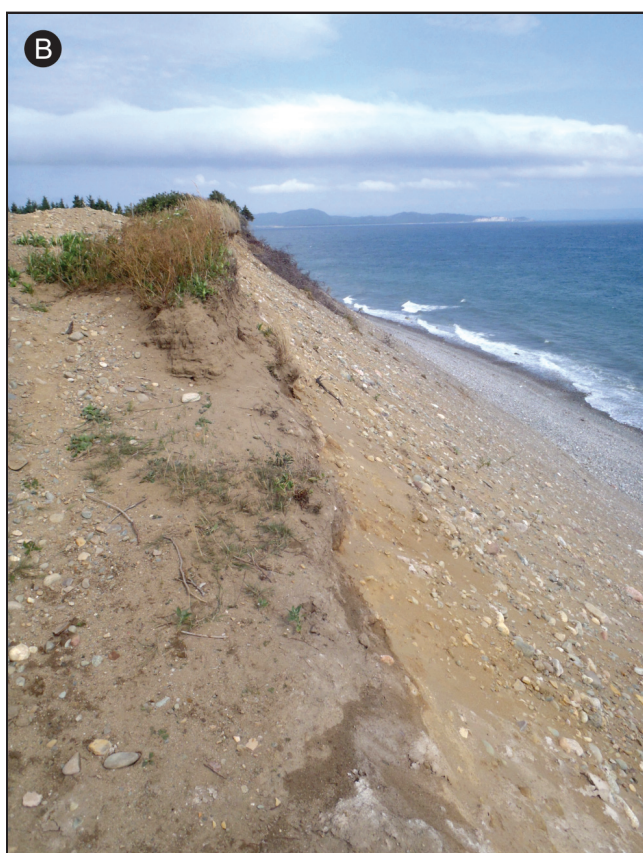
**Plate 5.** Cliff-top change at Seaside Drive. A) Coastal cliff in 2011. B) Coastal cliff in 2012. In 2011 this portion of the site had grass on the top of the cliff. Between 2011 and 2012, this property had been developed for a new house, and the vegetation from the cliff top was removed. Removal of vegetation will impact the surface water flow.

Seaside Drive was actively retreating with an average retreat rate of 6.9 cm/a, and retreat rates ranged from -15.5 to 23.73 cm/a (Figure 4). With the exception of seven small sections of the cliff top that showed accretion, the entire area retreated between 2000 and 2012. For the areas that showed accretion at Seaside Drive, errors in data collection or material being deposited along the cliff top could be related to the negative retreat rates. Erosion rates at Seaside Drive are currently not rapid. However, change to the cliff-top area was observed between 2011 and 2012, with new development in the area changing the landscape (Plate 5).

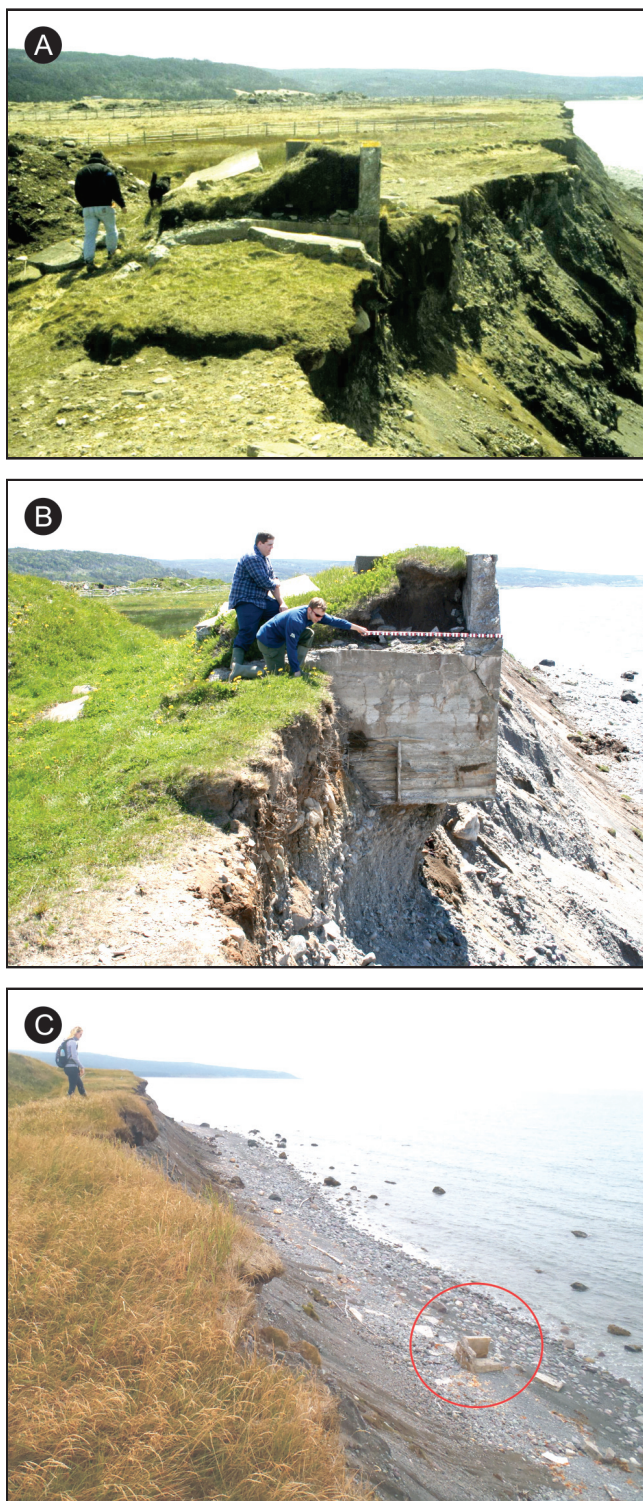
**Plate 6.** Cliff erosion at Point Verde. A) Cliff line in 1995. B) Cliff line in 2005. C) Cliff line in 2012. The concrete structure associated with the lighthouse shown in the 1995 and 2005 photos has now fallen to the base of the cliff.

west with a fetch greater than 100 km. The fetch is 45 km to the west and less than 15 km to the northwest. The cliff face is devoid of vegetation, and erosion and gullying are visible (Plate 6).

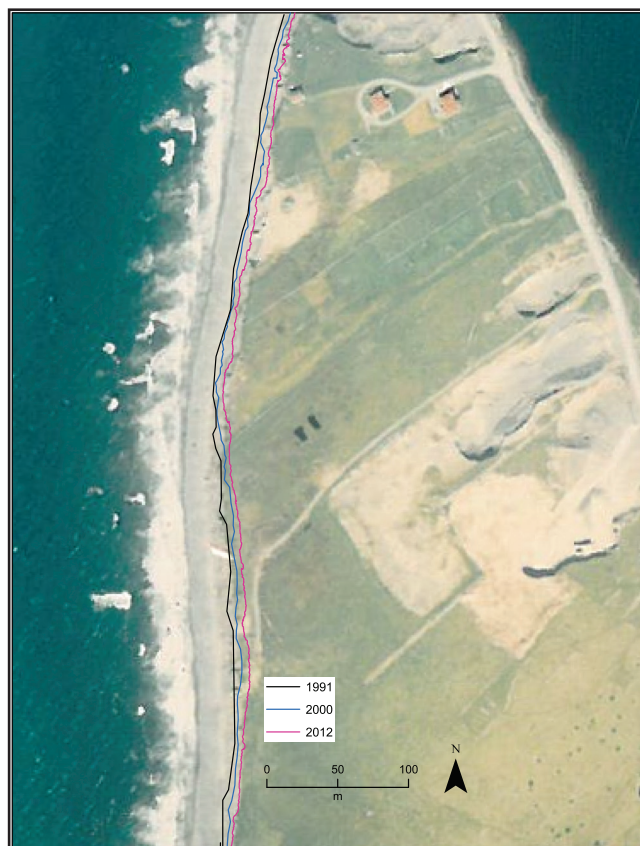
**Figure 5.** Location of the cliff-top position at Point Verde in 1991 (black), 2000 (blue) and 2012 (red) superimposed on an airphoto. The gravel pit has expanded and is now within 10 m of the cliff edge.

The area was visited in 1983, and surveyed in 1991 and 2000 by the GSC, and as part of the current project in 2011 and 2012. Data from 1991, 2000 and 2012 are shown on Figures 5 and 6, and were examined to determine the rate of cliff-top erosion. Between 1991 and 2012, erosion occurred along the entire cliff line, with an average retreat rate of 40 cm/a, ranging from 18 to 63 cm/a. The average erosion rate along the cliff between 1991 and 2000, and between 2000 and 2012 was 40 cm/a, and rates of erosion ranged from 7 to 96 cm/a, and 17 to 66 cm/a, respectively.

There is an active aggregate operation in the centre of the Point Verde Peninsula. The outside wall of the pit operation is within 10 m of the cliff edge, and the active pit wall lies 28 m from the cliff edge. If erosion continues and the peninsula is breached, the system will be altered. The peninsula will no longer protect the community of Placentia from the impact of storms from the southwest.

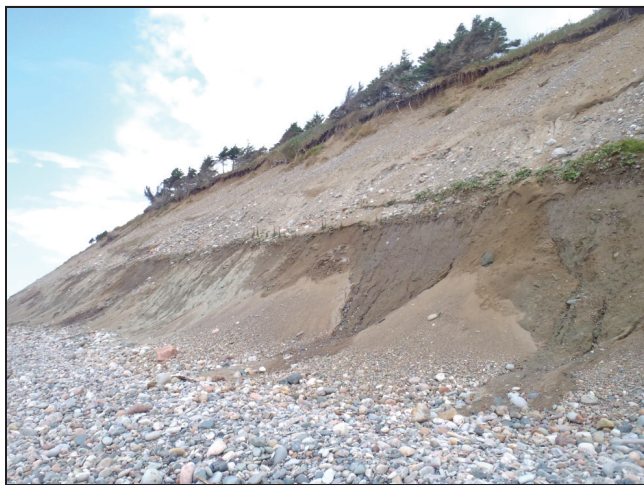
**Plate 7.** Coastal cliff on the western part of the Seaside Drive site in 2012. Note the ground water in the sandy gravel in the lower cliff face in the contact between the sandy gravel and compact diamicton.

At Seaside Drive and Point Verde cliff-top and cliff-face erosion are likely caused by surface- and ground-water flow that form gullies in the permeable sand and gravels, and this material accumulates as fans at the base of the cliff (Plate 7). Waves, particularly during high tides and storms, remove the sediment from the base of the cliff. At Point Verde there are not many boulders or other large material to armour the base cliff from erosion, and wind erosion transports sand away from the cliffs.
