Real-Time Water Quality Deployment Report

Teck Duck Pond Operations

2020

Teck Duck Pond Operations Real-Time Water Quality Monitoring Networks, near Millertown, Newfoundland and Labrador

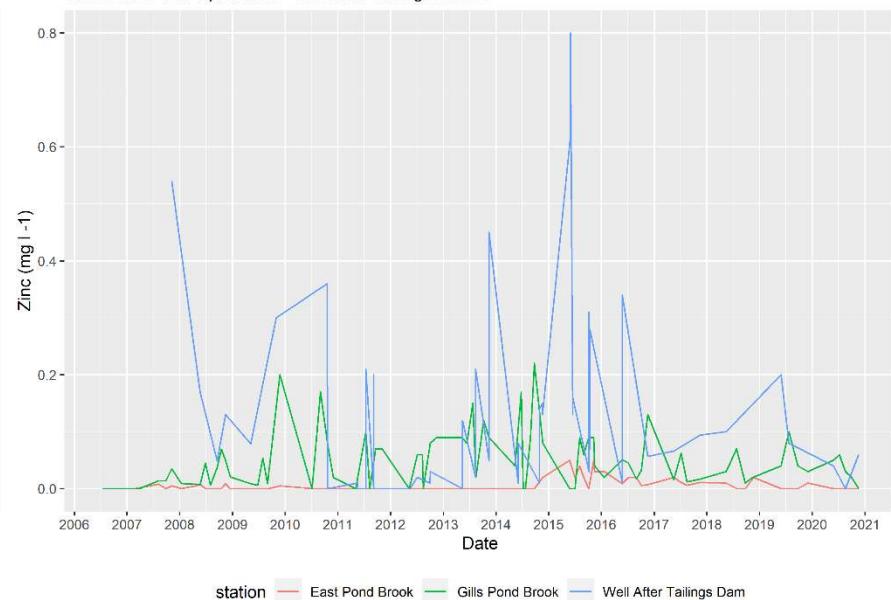
Grab samples of Zinc (mg l⁻¹)
Teck Duck Pond Operations - Well after Tailings Dam A
