TECHNICAL MEMORANDUM

Project No. 20141194A (900)-Rev 1

DAM BREACH ASSESSMENT AND INUNDATION STUDY VALENTINE GOLD TAILINGS MANAGEMENT FACILITY - ADDENDUM

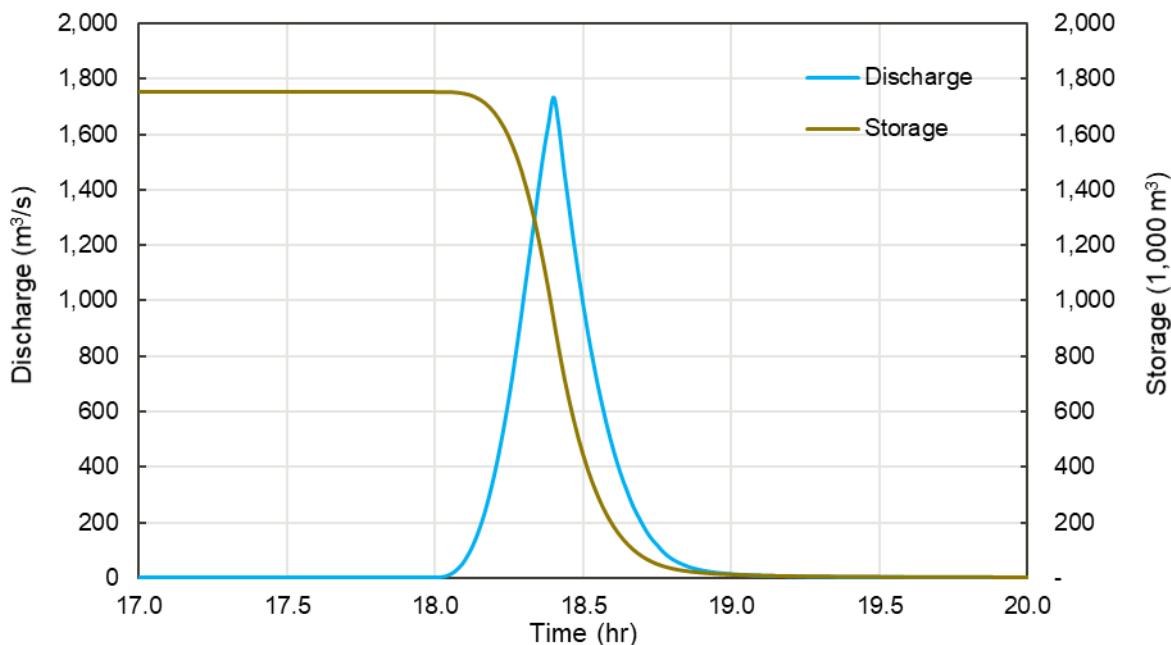
Graph 1: HEC-HMS TMF Location A Dam Breach Outflow Under PMF Conditions – Piping Failure

The piping failure mode was considered as the most plausible mechanism of failure for Location A under flooding conditions. The peak water level in the TMF was 391.0 masl (obtained by routing the PMF). Assuming the breach occurs when water levels are at their peak, an estimated 1,750,000 m³ of water and tailings would be released from a breach at Location A, with a peak outflow of 1,735 m³/s. The generated outflow hydrograph is presented on Graph 1.

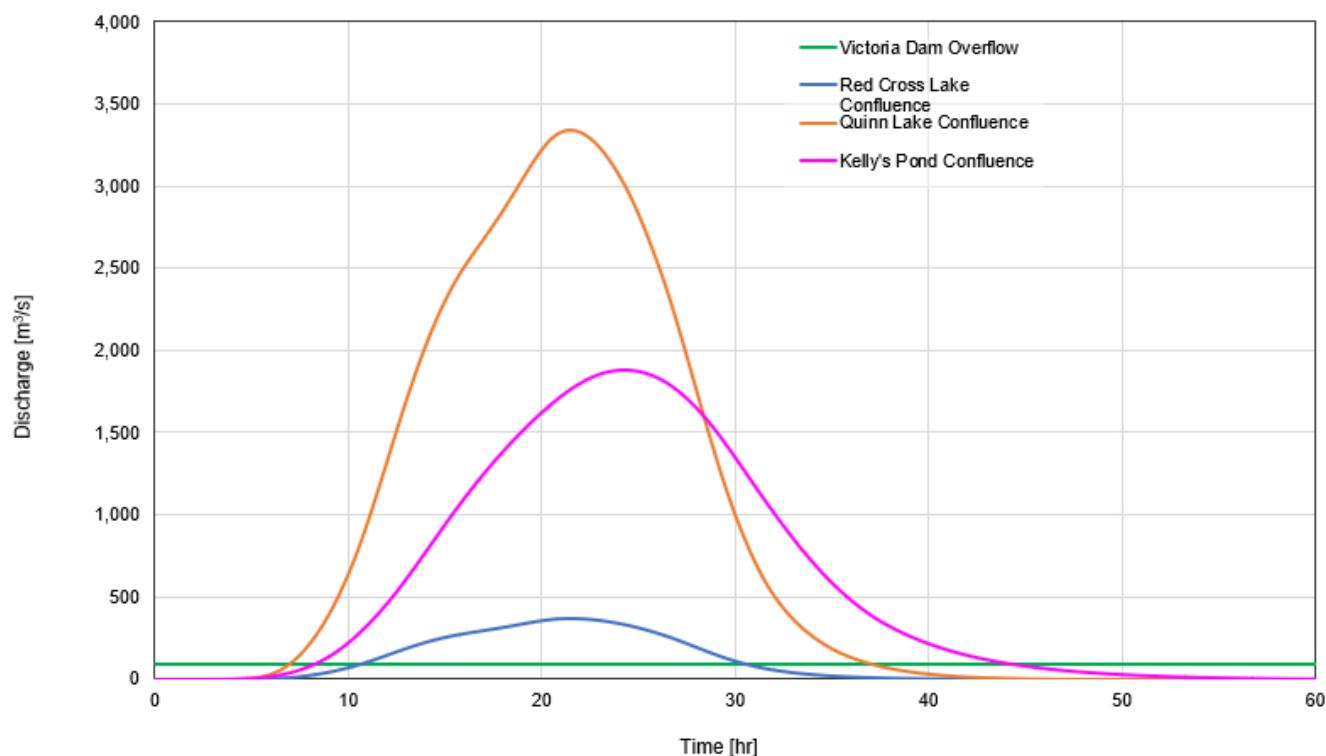
Graph 2: PMF Lateral Inflow Hydrographs Routed at Downstream Locations Along Victoria River

The generated PMF hydrographs, as shown in Graph 2, were used as inflows (i.e., natural watershed inflows to the waterways) in conjunction with the simulated TMF dam breach flood wave to assess incremental consequences of a TMF dam breach. Also included in Graph 2 is the peak discharge from Victoria Lake Dam (provided by NL Hydro – see Attachment 2), which was input as a constant flow hydrograph. The locations where the hydrographs were input in the model are shown in Figure 2.

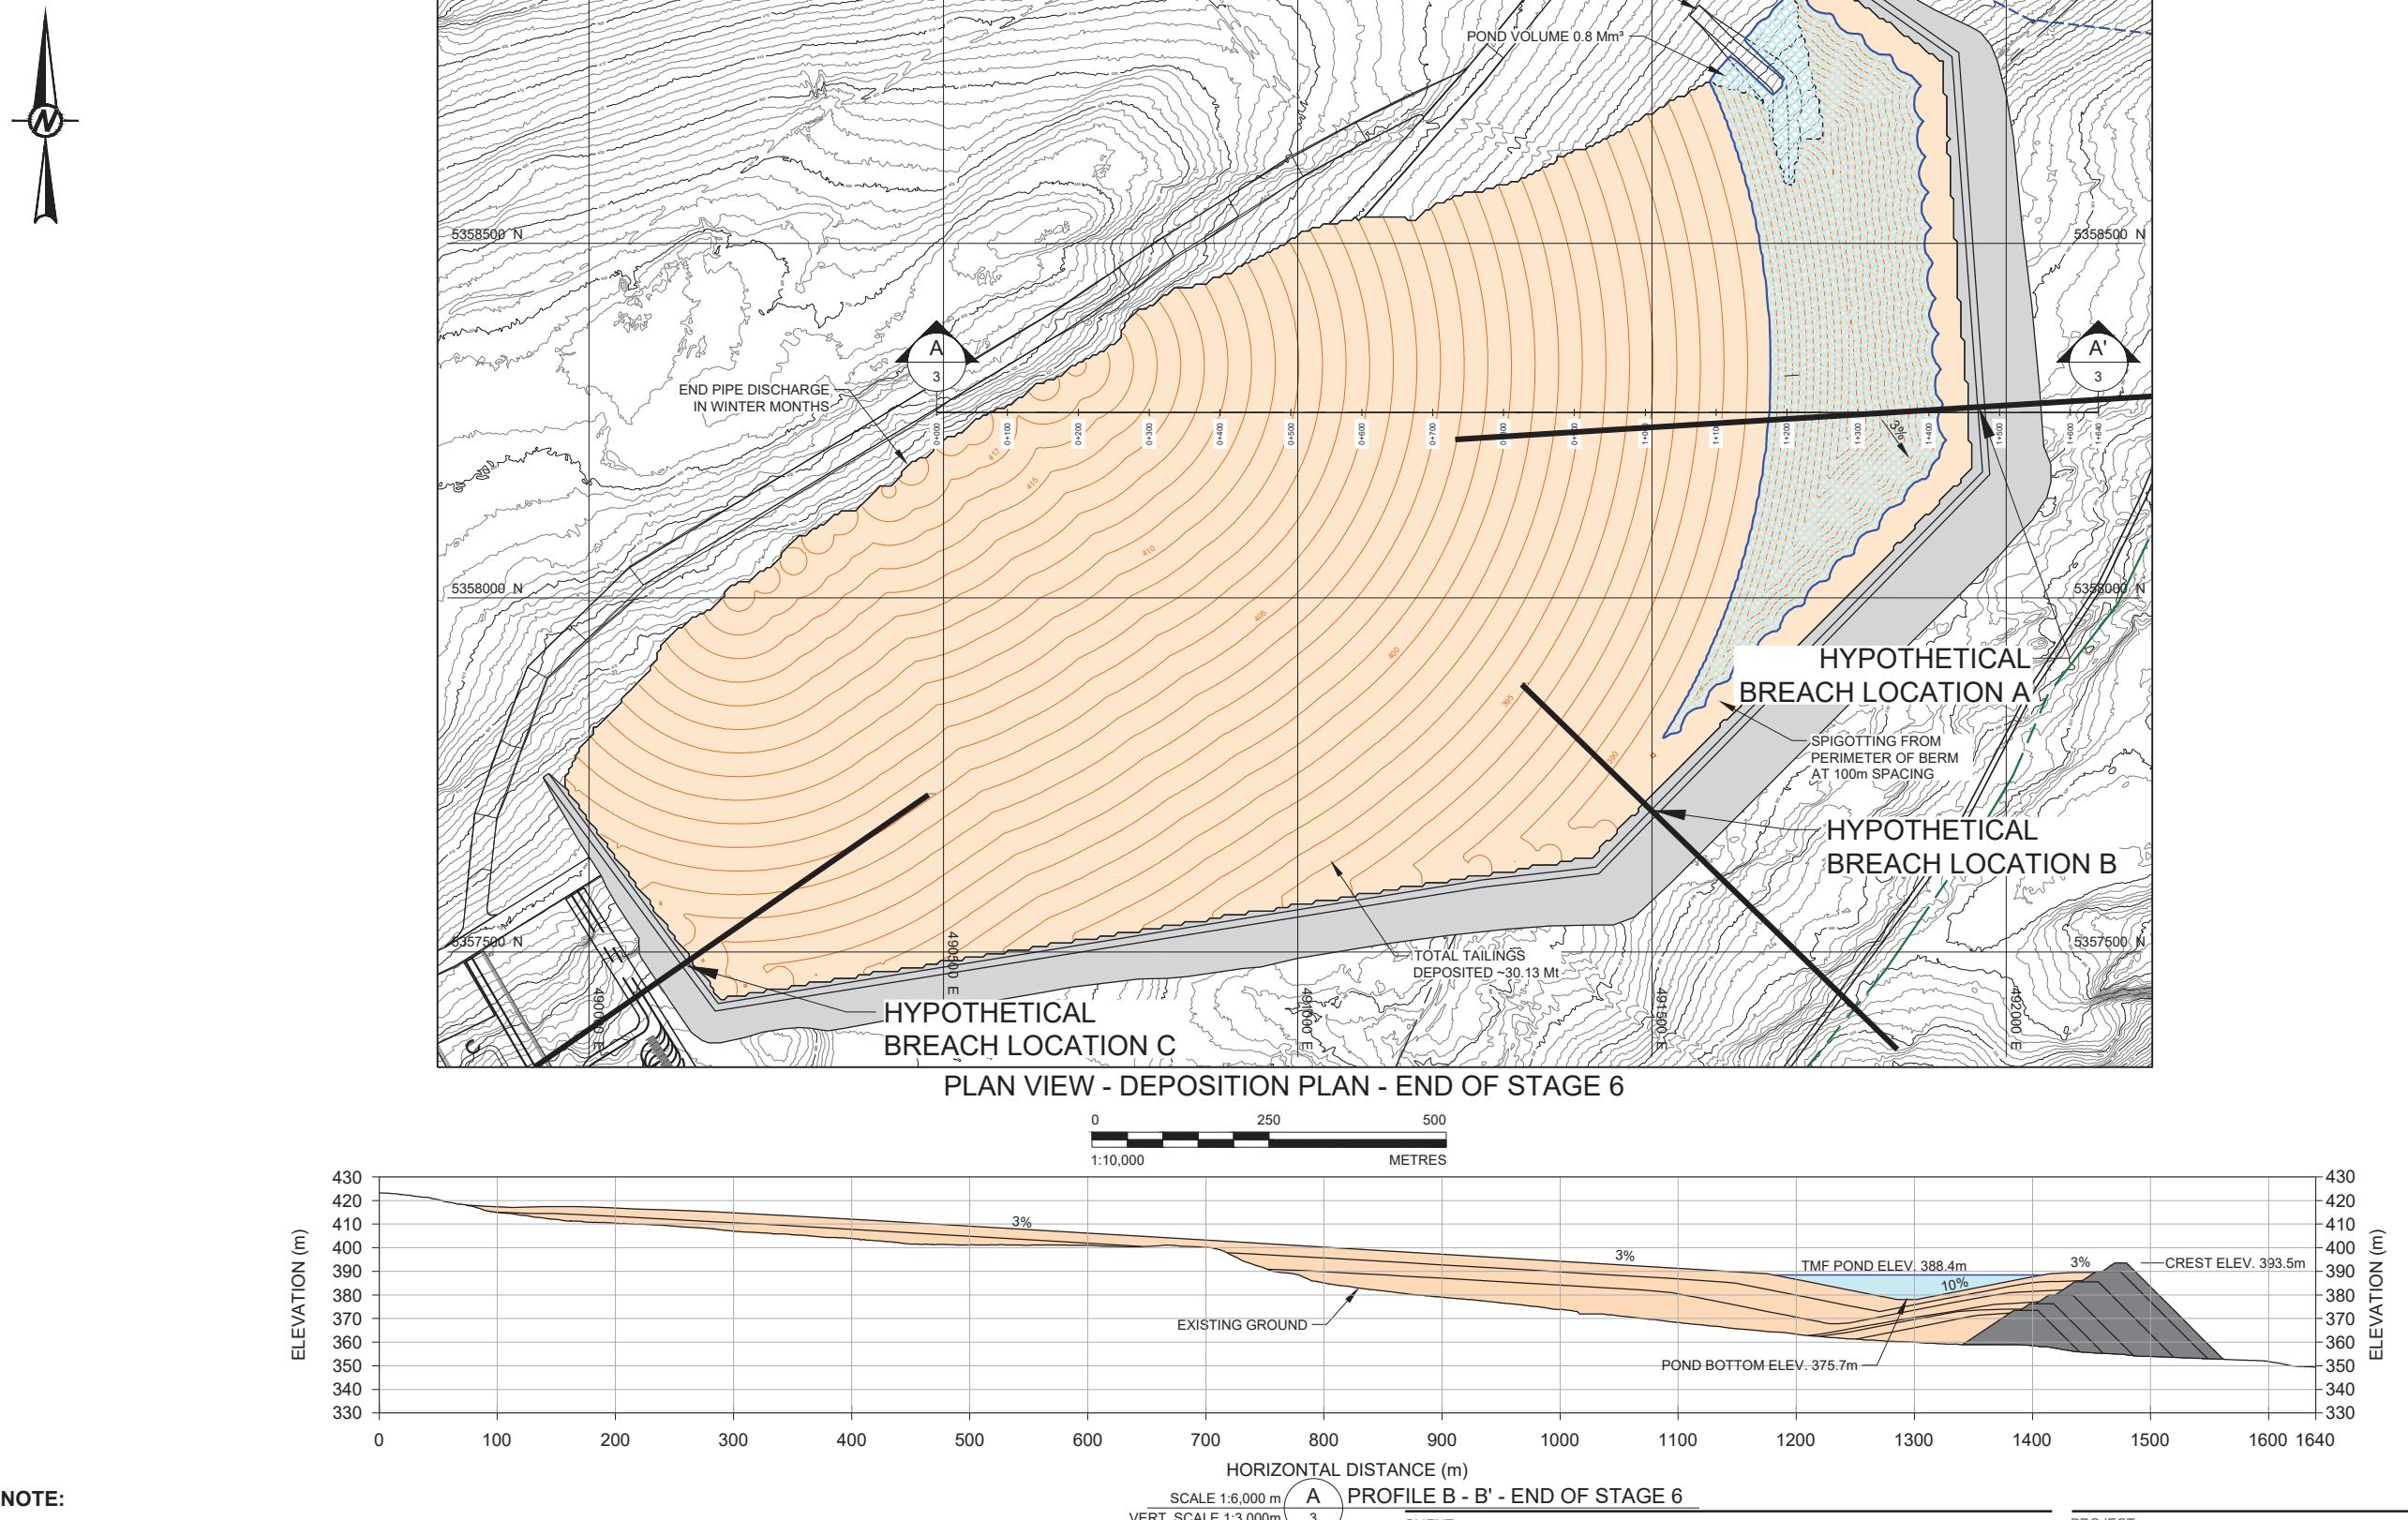
1. TYPICAL TMF POND VOLUMES AND CHARACTERISTICS WERE SELECTED FOR THE DEPOSITION MODELLING. TMF POND VOLUMES WILL FLUCTUATE SEASONALLY UP TO A MAXIMUM OF 388.4m DEPENDING ON THE OPERATIONAL MONTH.

The Golder (2021) DBA looked at breaches at three potential locations (A, B and C) as shown in Figure 1. As explained in the report, breaches in locations B and C would result in tailings release only. Only a breach at location A would result in a tailings/ water release that would flow downstream. Location A is therefore the only breach location to be revisited as it is the only one to be potentially impacted by Victoria Dam overflow. For this analysis, the tailings breach outflow remains unchanged from the Golder 2021 assessment; only the receiver flows were updated for this study.

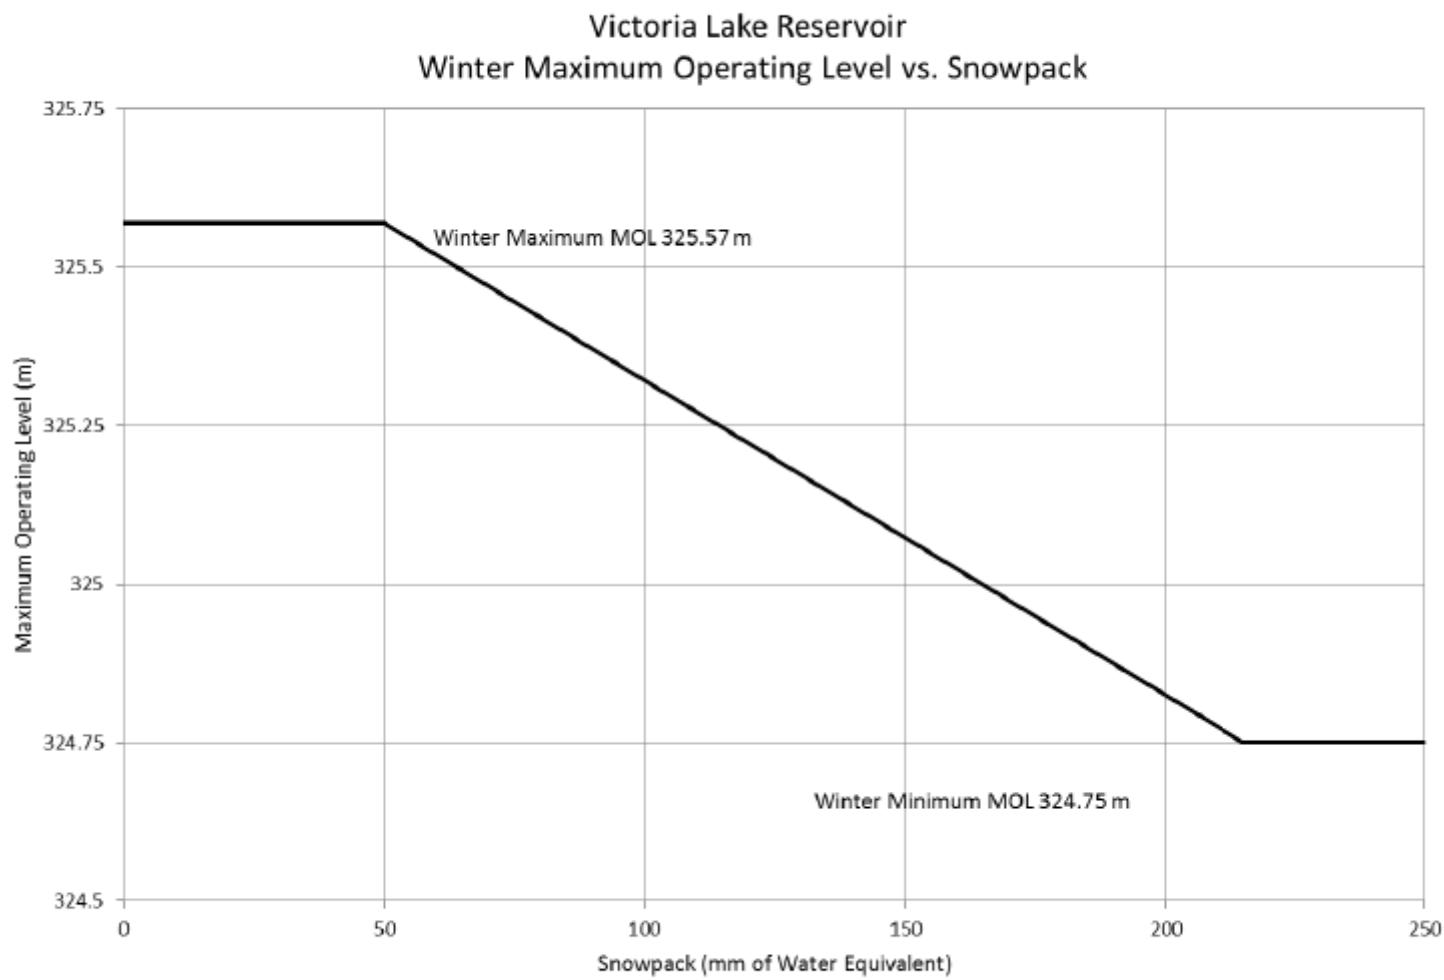
Victoria Lake handles floods principally by storage with some overflow of the gates and outflow through the Victoria Control Structure after the peak flood inflow has passed. Adequate storage capacity must be ensured in the reservoir for flood control. Figure 2.1 shows the MOLs for Victoria Reservoir during the winter (December to March) for different snow accumulations (mm of water equivalent). If Victoria is at or below these levels, it can handle the probable maximum flood (PMF).

2. If Burnt Pond continues to rise above its MOL with all spillway gates open, the emergency plan must be implemented (Section 2.3.1.4). If water levels exceed 316.06 m (the trigger elevation for the fuse plug), the fuse plug will begin to erode, and loss of the plug is imminent.
3. If the water levels in Burnt Pond do not rise high enough to trigger the fuse plug, the Victoria Control Structure gates should be opened when Burnt Pond returns to its MOL. The gates should be kept open to draw Victoria down to its MOL without causing Burnt Pond to rise above its MOL.
4. Spilling should continue through Burnt spillway until Burnt Pond is back to its MOL and Victoria Reservoir is at the appropriate level of Figure 2.1 or 2.2.

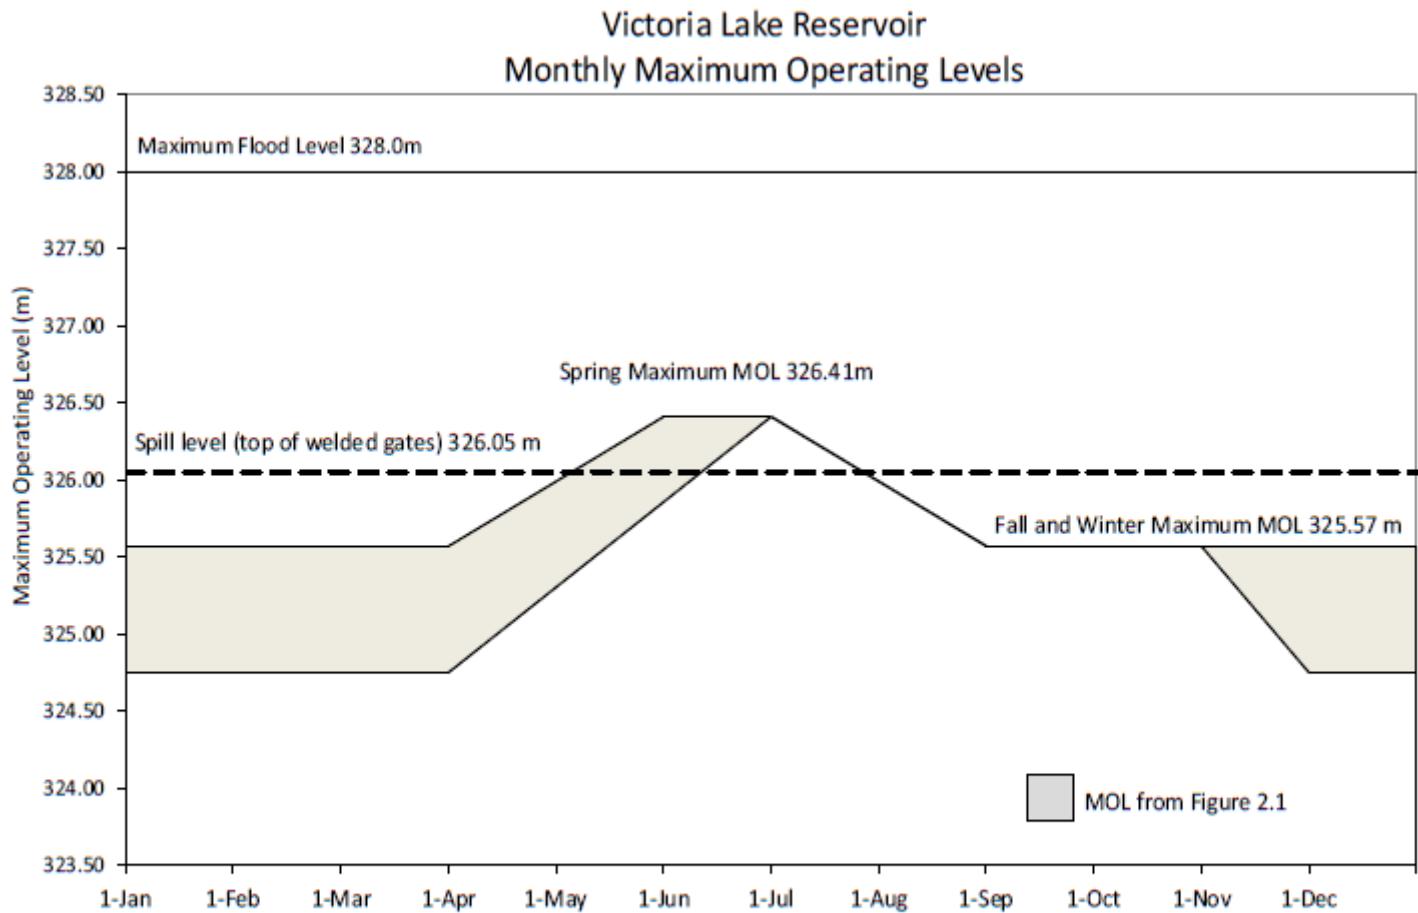
At other times of the year, Victoria Lake can handle the PMF at higher levels. If a spring, summer or fall PMF occurs it can be handled with initial reservoir elevations at the MOLs indicated in Figure 2.2.

1. Victoria Lake Reservoir can be surcharged by up to 16 Mm^3 (approximately 0.10 m) above the MOL provided in Figure 2.2 which is the full release capability of four gates at the Victoria Control Structure for a one day period. When the MOL is high, surcharge is limited because water will spill over the spillway gates.
2. Careful attention shall be paid to the long range weather forecast for the Bay d'Espoir and Burgeo areas. If heavy rainfall is forecast then Victoria Control Structure must be operated to release all surcharged water prior to the start of the storm.
3. Water released from Victoria Control Structure due to an impending storm must also be released at the Burnt Dam Spillway if Burnt Pond is at or above its MOL. The net effect
