**VALENTINE GOLD PROJECT: AMENDMENT TO THE ENVIRONMENTAL IMPACT STATEMENT**

**APPENDIX H**  
**VALENTINE GOLD PROJECT: 2020 FISH**  
**AND FISH HABITAT DATA REPORT**

**Valentine Gold Project: 2020 Fish  
and Fish Habitat Data Report**

May 3, 2021

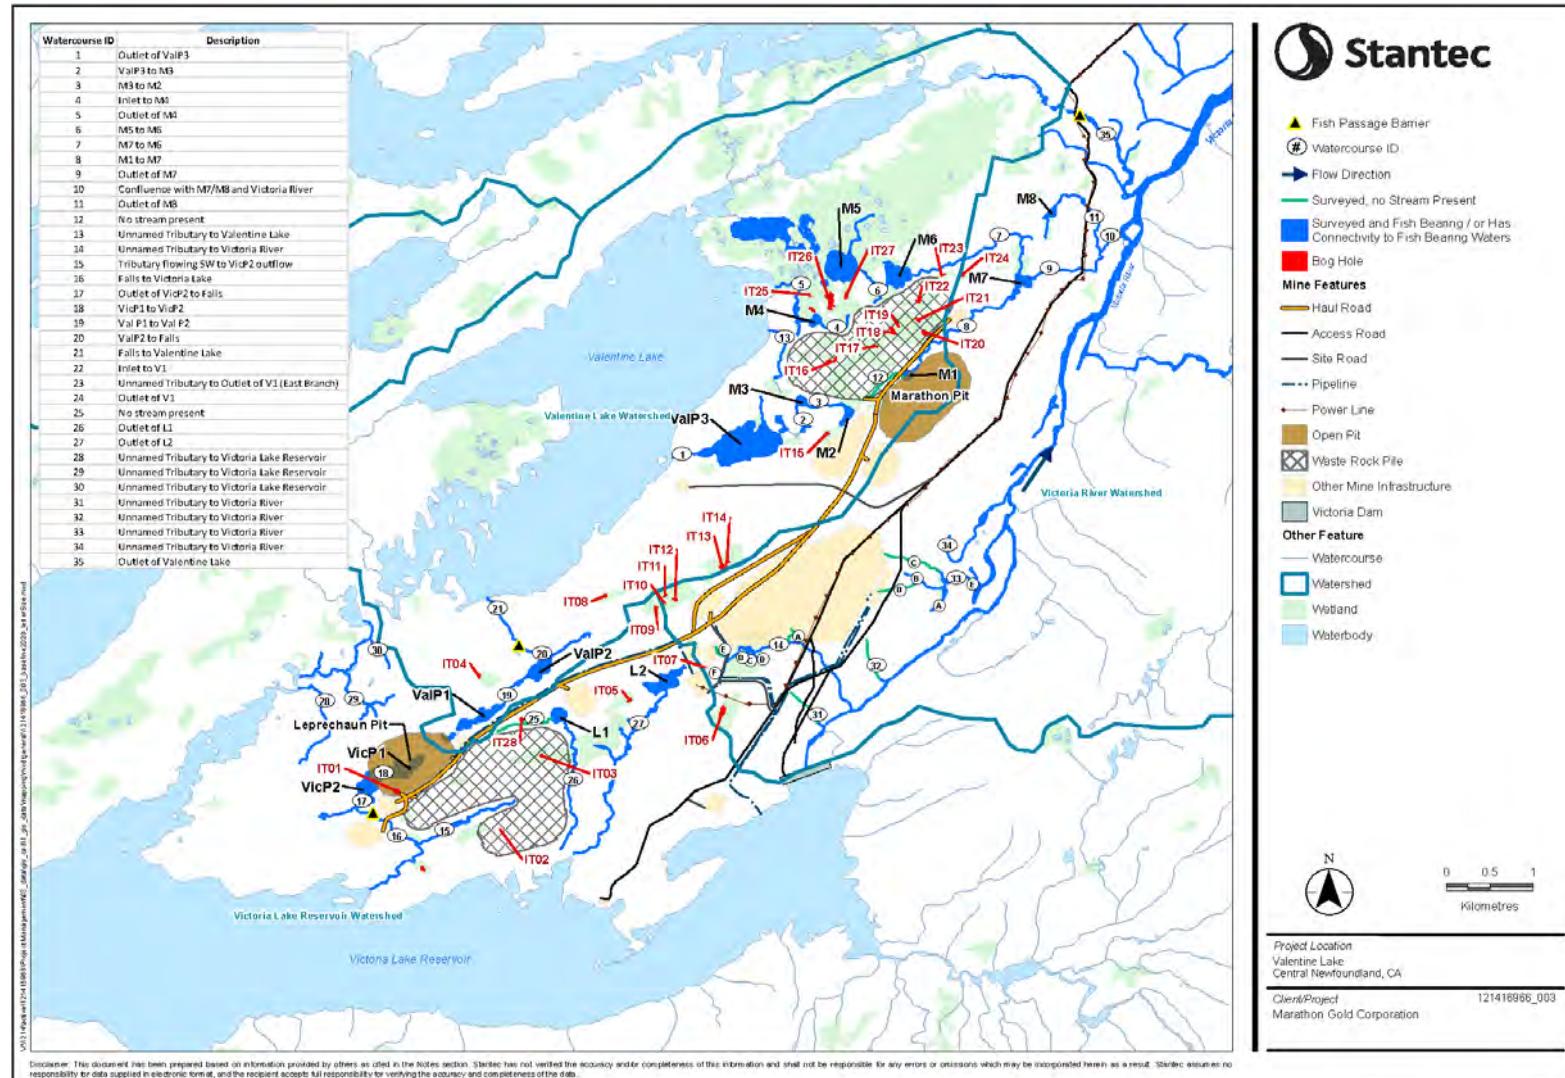
**Figure 3.1 2020 Fish and Fish Habitat Survey Areas**

The Study Area for the 2020 field study (Figure 3.1) is comprised of watersheds potentially affected by development of the Project, including upgrades to the access road and includes the bog holes, streams, and stream crossing locations noted below. For ease of reference, each stream location is given a descriptive name and identifying number on Figure 3.1.

The 2020 field study included an assessment of fish presence/absence in bog holes, habitat classification of streams and stream crossing assessments along the proposed access road (Figure 3.1). The field surveys for this study were conducted July 19 to 30, 2020, and additional bog holes assessments were completed between September 5 and November 7, 2020.

There was no defined channel at the mapped location of Stream 12 (the unnamed tributary to M1), Stream 25 (the unnamed tributary to L1), tributary A to Stream 14 under the proposed tailings management facility, or Stream 33D (Figure 3.1 and Figure 4.1).

Portions of Streams 14, 31, 32, and 33 were ephemeral, intermittent, or perennial (Figure 3.1 and Figure 4.1). Streams 14B, C, and D contained fish habitat while portions of Streams 14E and F did not constitute fish habitat. The lower portions of Streams 31 and 32 were considered fish habitat, however the ephemeral channel upstream of the perched culvert at the old forestry road crossings on both streams was not considered fish habitat. Stream 33 consists of three tributaries (A, B, C) which merge into a single tributary (E), and a mapped portion of stream which was field verified as having no visible channel (D). Streams 33A and 33B are fish habitat, while the majority of Stream 33C is not fish habitat.

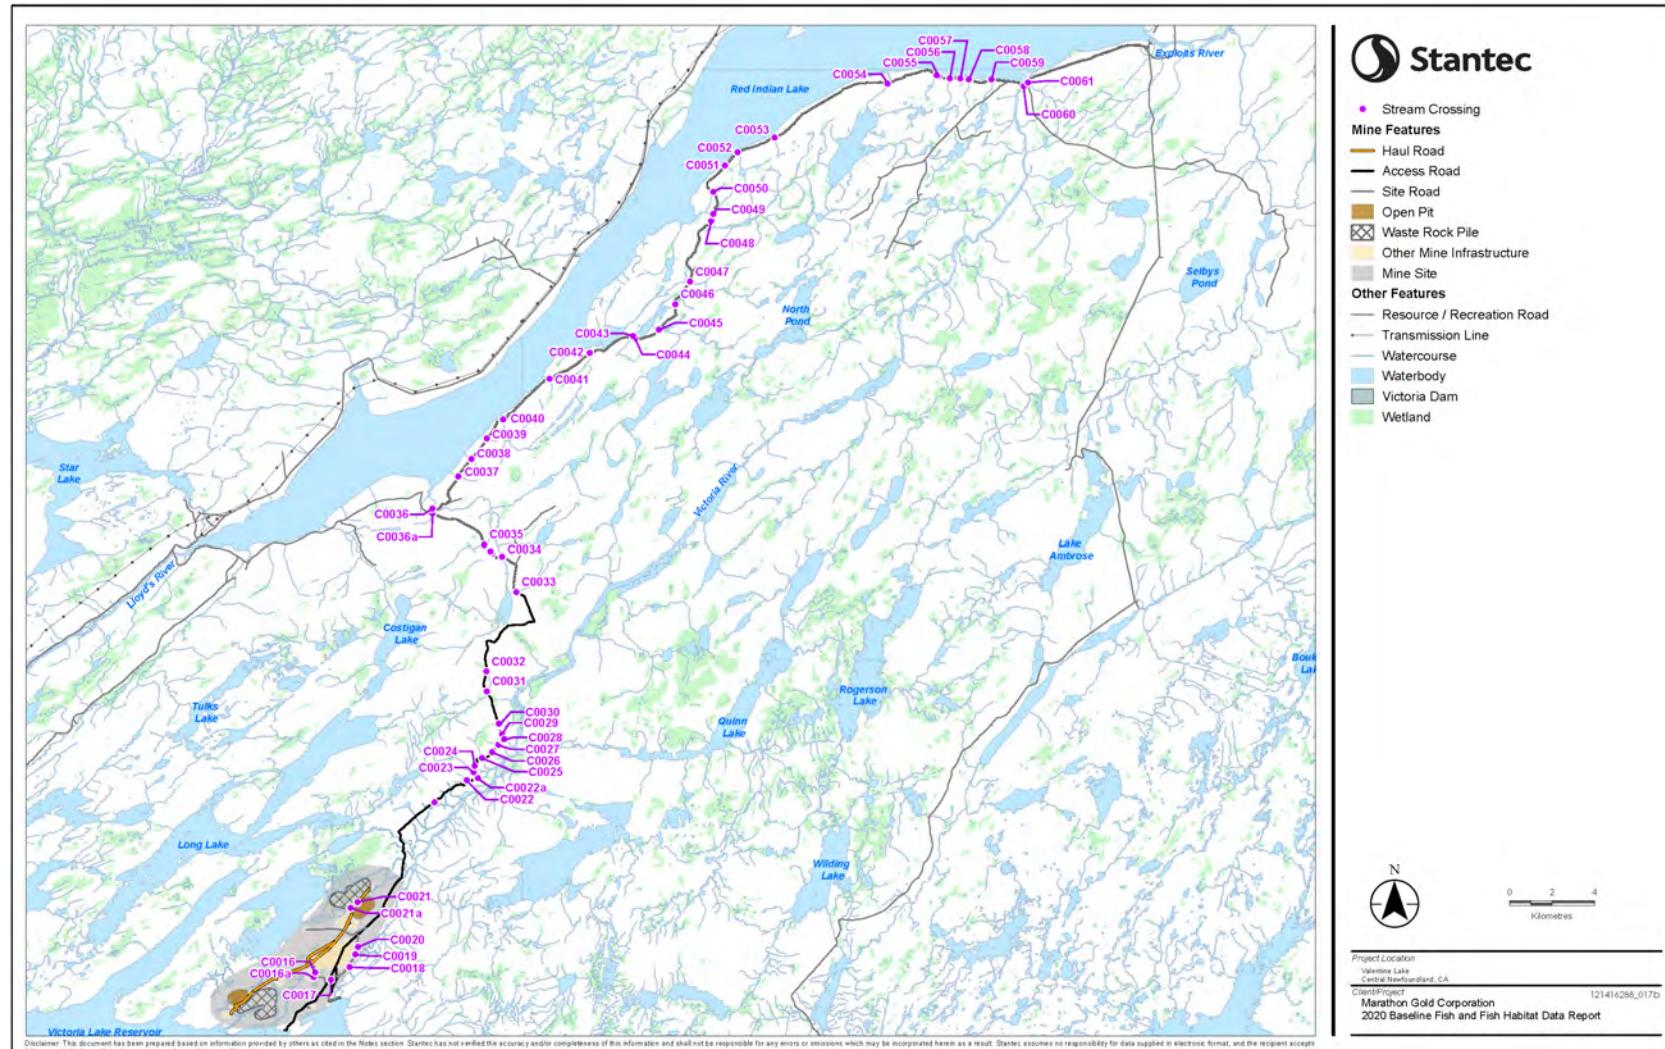
**Figure 3.2 2020 Stream Crossing Survey Locations**

Proposed stream crossings surveyed during 2020 (C0016 to C0061) are shown on Figure 3.2. Note that stream crossings C001 to C0014 were sampled as part of the 2018 baseline study (Stantec 2019) and the Stream 17 associated with stream crossing C0015 was sampled as part of the 2011 baseline study (Stantec 2012) these are not shown on Figure 3.2. More detailed figures which show stream crossings at a finer scale is included in Section 4.2. This notation corresponds to the stream location names and proposed crossings in the appendices and in tables included in Section 4.

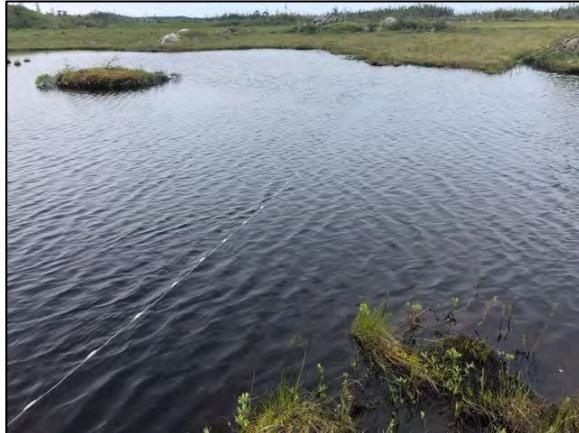
**Photo 1** Gill Net Set in Bog Hole IT18

Sampling was conducted using minnow traps and gill nets. Initially, gillnets were set for a short duration (10 min). If no fish were captured during short duration sets, fishing duration was increased to include overnight sets. Two gill nets consisting of one 15 m panel with 25 mm mesh size and another 15 m panel with 38 mm mesh size were deployed in each bog hole by stringing the gillnet across the bog hole using a rope (Photo 1). Minnow traps baited with cat food were also set to assist in confirming fish presence/absence (Photo 2). The gill nets and minnow traps were fished for one to two consecutive nights.

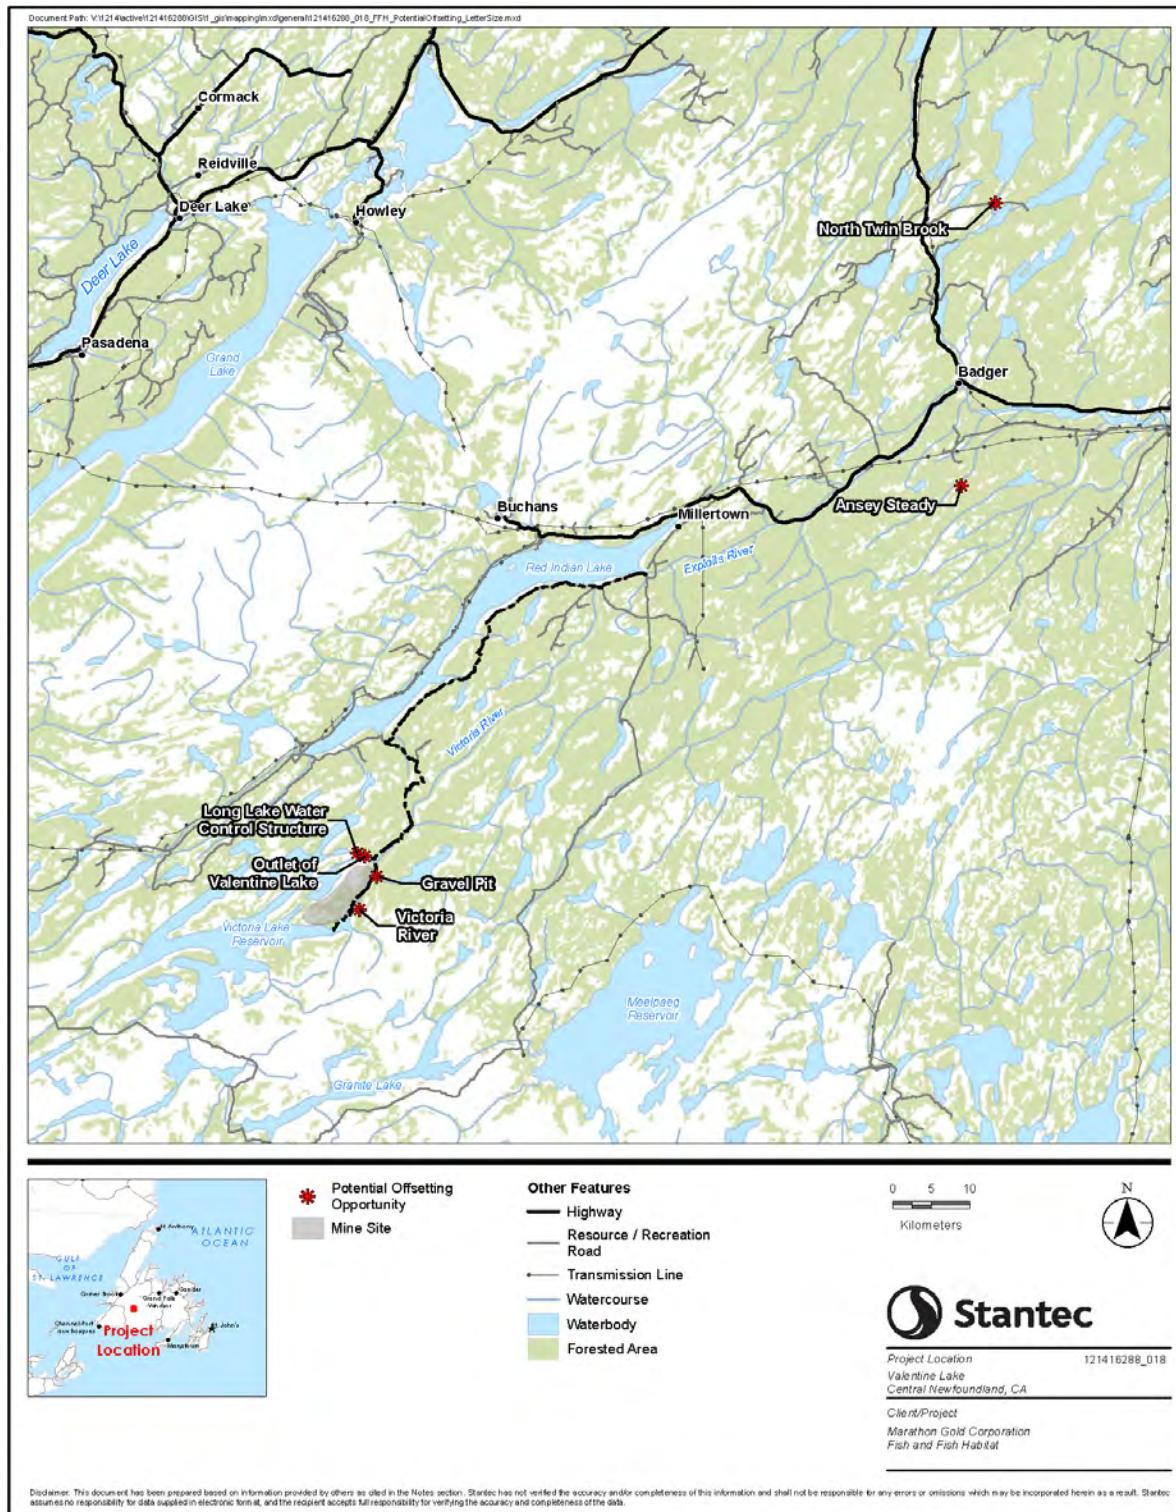
**Figure 3.3 Location of Potential Offsetting Opportunities for the Valentine Gold Project**

Five locations were surveyed in summer 2020 to assess their potential to provide offsetting for project related HADD. The opportunities are listed below, and locations are shown on Figure 3.3.

Five offsetting opportunities were surveyed in 2020 to assess their potential use as fish habitat offsetting projects (Figure 3.3).

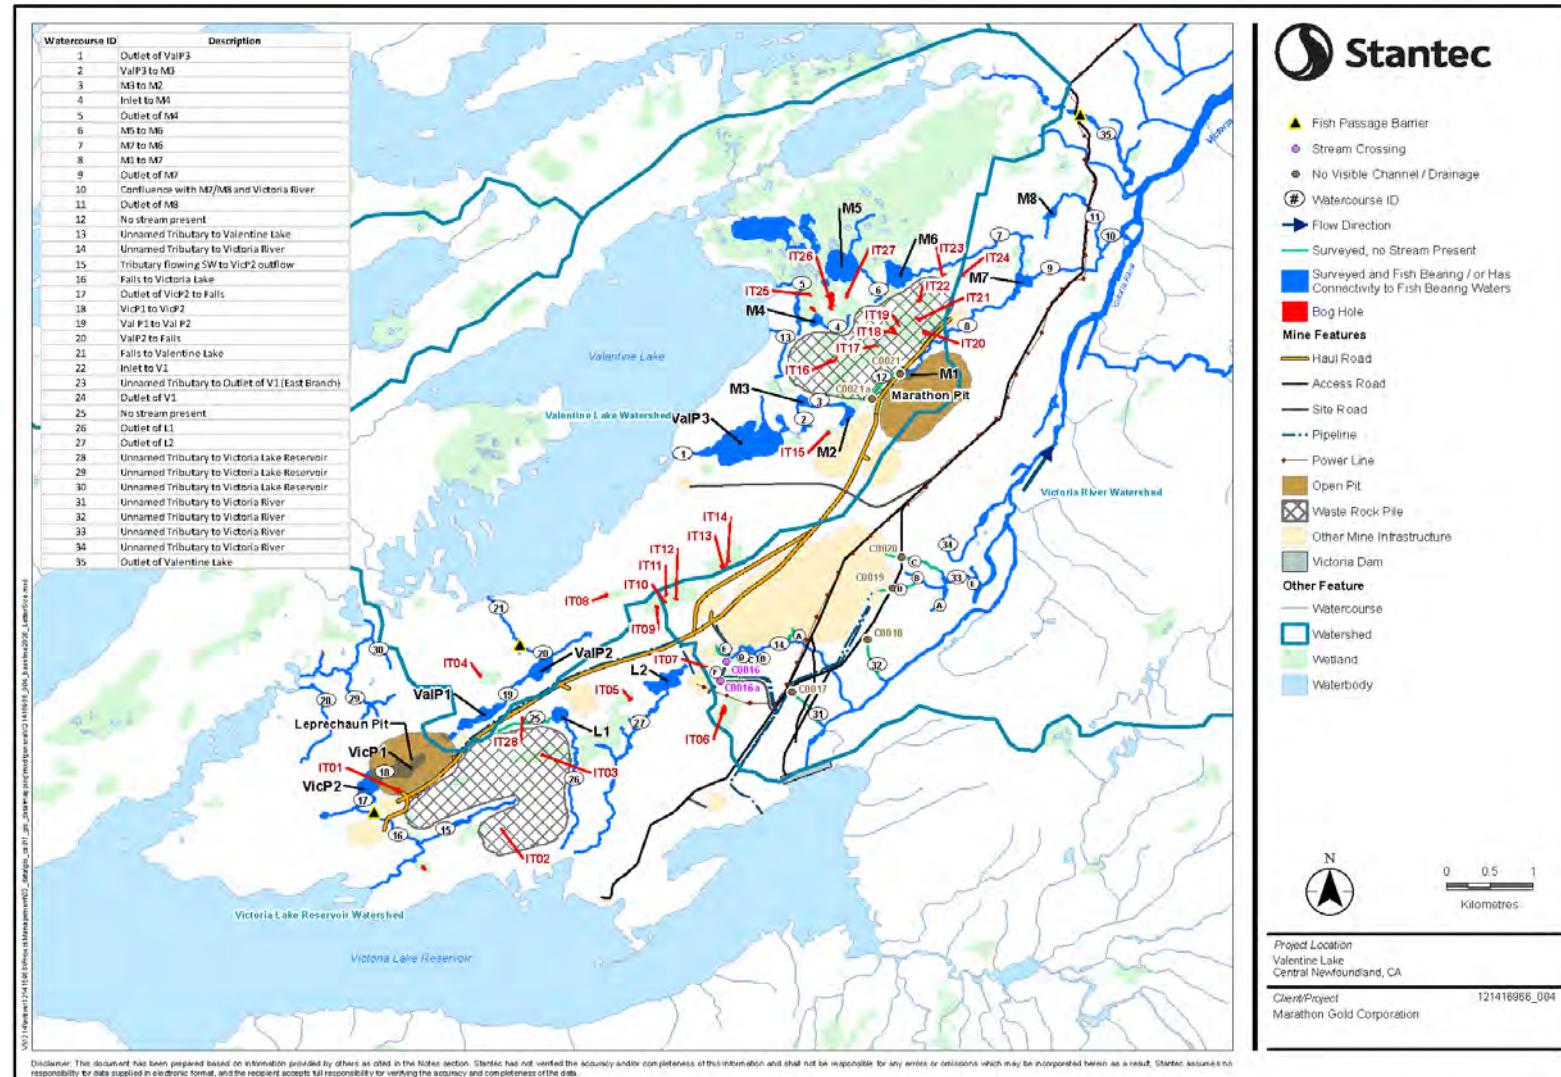
Figure 4.1 Ground-Truthed Streams and Stream Crossings 2020- Mine Site

The fish-bearing portion of Stream 15 extended approximately 220 m upstream of its mapped location. The full extent of Stream 15 is shown on Figure 4.1.

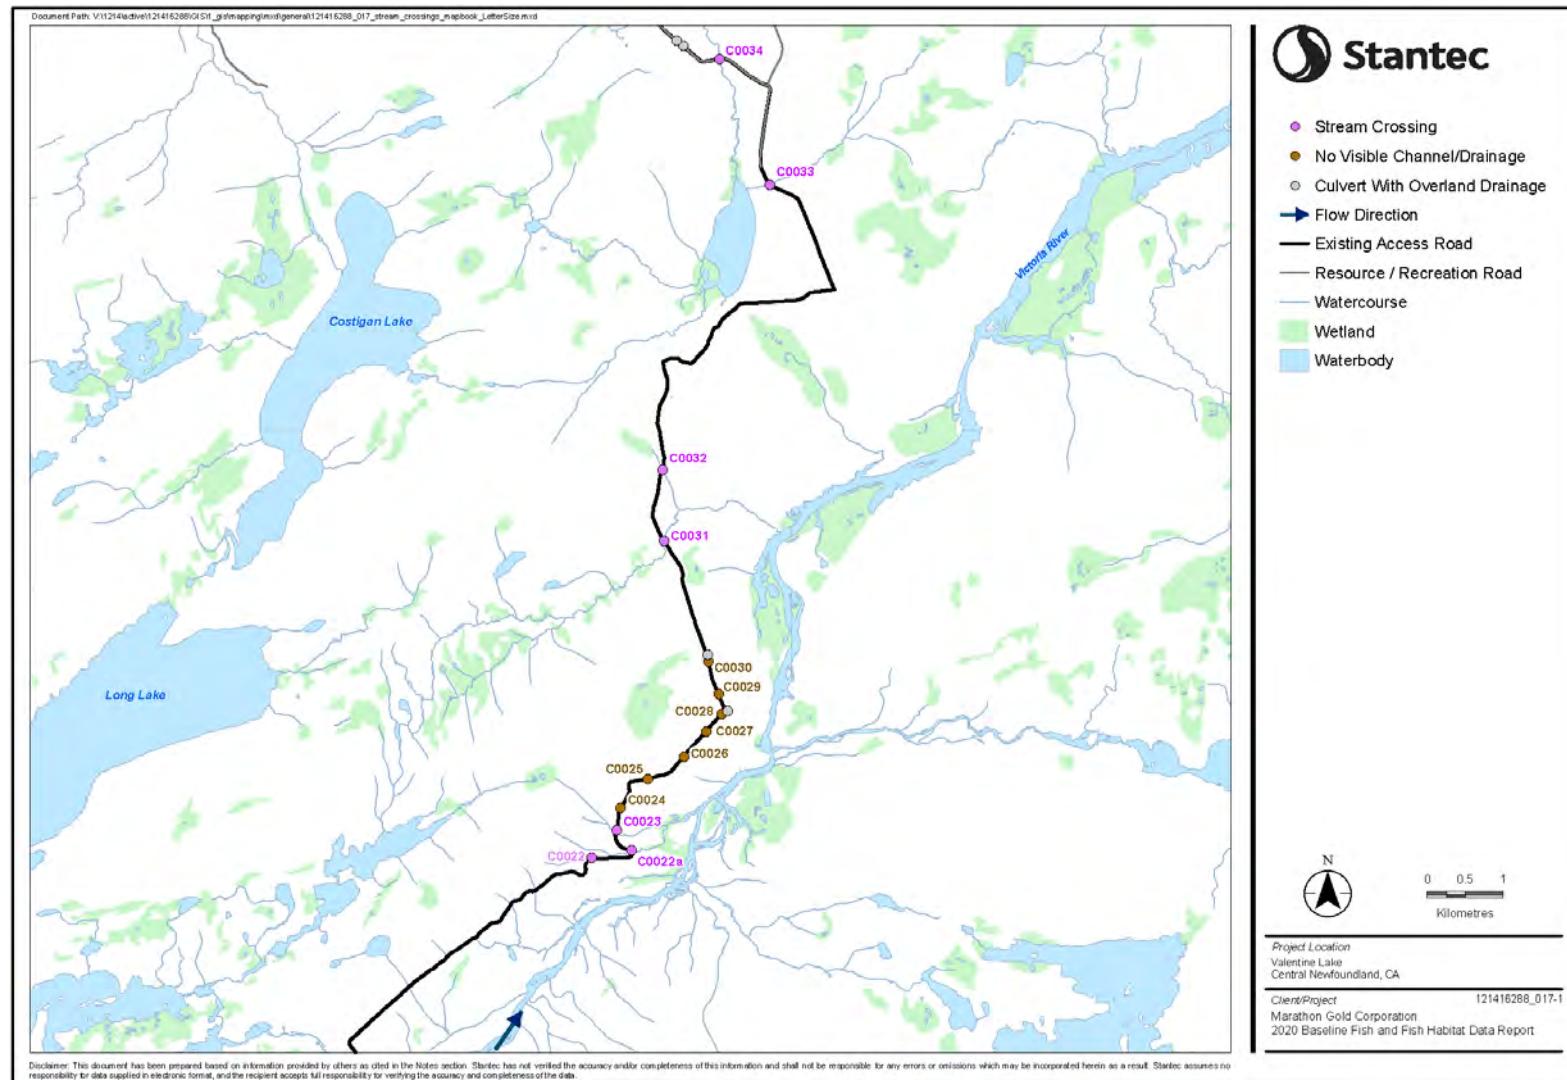
**Figure 4.2    Ground-Truthed Streams and Stream Crossings 2020, C0022 to C0034**

Fish surveys were used to confirm the absence of fish at locations identified as not constituting fish habitat, as applicable. In some cases, a berm on the upstream side of the access road appears to have altered the drainage and flow of the streams. Many drained through the existing roadside ditch, dissipated into the forest and were not connected to upstream or downstream watercourses/waterbodies. Additionally, six other culverts that provided surface drainage during rain events (no natural streambed, not fish habitat) occurred along the access road. These locations as well as the other stream crossing locations are identified in Figures 4.2 to 4.5.

Fish habitat surveys were completed on 50 potential stream crossing locations in 2020. Two of the potential stream crossings were not actually crossed by the access road; however, the streams were located within the 20 m RoW. These two streams were only assessed visually. Surveys conducted at the remaining 48 locations, indicated that 26 stream crossings are located in fish habitat and 22 are located in areas that do not constitute fish habitat (Figures 4.2 to 4.5). Streams that constituted fish habitat had a mean stream width ranging from 4.6 to 34 m. Habitat types were primarily, riffle-run with some flat or pool habitats. Stream crossings determined to not constitute fish habitat included streams that had no visible channel, were ephemeral/intermittent or had no connectivity to fish bearing waters (i.e., isolated channels or small pools of standing water). A summary of habitat attributes for stream crossings is provided in Table 4.4. The complete habitat classification data set is included in Appendix D, Table D.4.

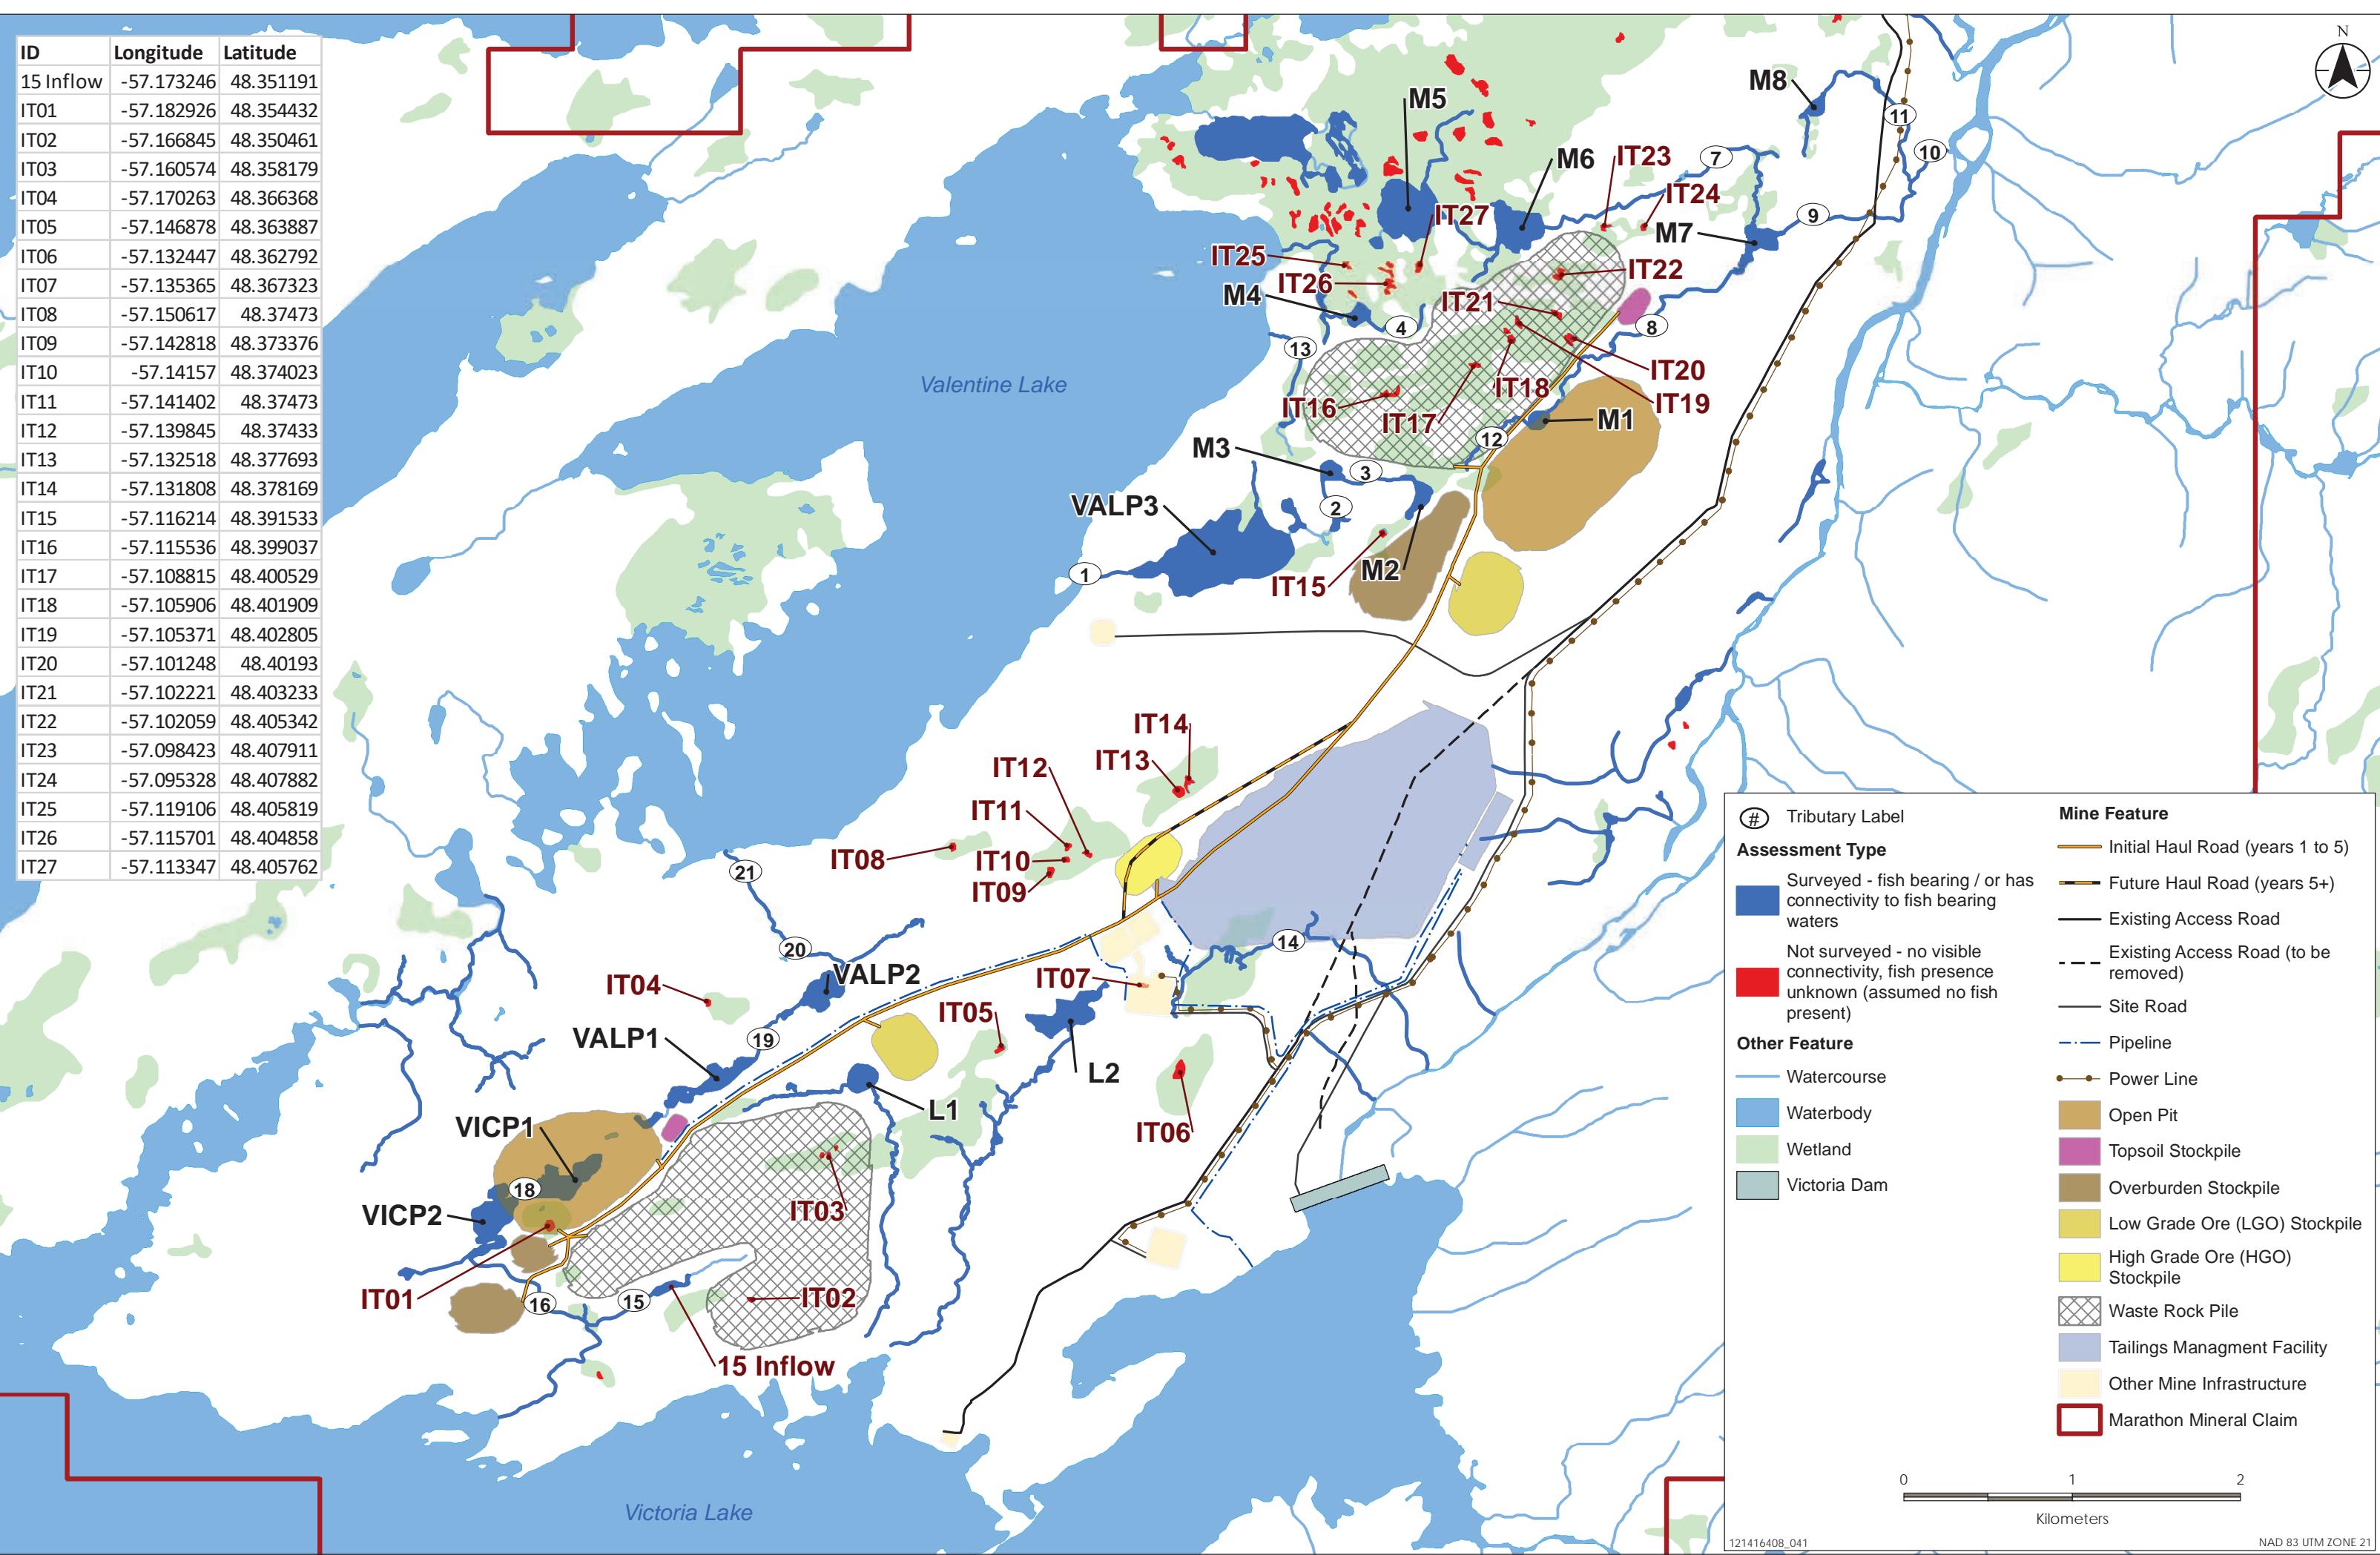
Attachment: Attachment 1 - Figure 1: Ice Thickness Survey Locations  
Attachment 2 - Photos  
Attachment 3 - Complete Data Set for all 27 Bog Holes

ID	Longitude	Latitude
15 Inflow	-57.173246	48.3511
IT01	-57.182926	48.3544
IT02	-57.166845	48.3504
IT03	-57.160574	48.3583
IT04	-57.170263	48.3663
IT05	-57.146878	48.3638
IT06	-57.132447	48.3621
IT07	-57.135365	48.3673
IT08	-57.150617	48.3741
IT09	-57.142818	48.3733
IT10	-57.14157	48.3740
IT11	-57.141402	48.3740
IT12	-57.139845	48.3740
IT13	-57.132518	48.3770
IT14	-57.131808	48.3783
IT15	-57.116214	48.3919
IT16	-57.115536	48.3990
IT17	-57.108815	48.4009
IT18	-57.105906	48.4019
IT19	-57.105371	48.4028
IT20	-57.101248	48.4028
IT21	-57.102221	48.4033
IT22	-57.102059	48.4053
IT23	-57.098423	48.4079
IT24	-57.095328	48.4078
IT25	-57.119106	48.4053
IT26	-57.115701	48.4043
IT27	-57.113347	48.4053

A two-person field team consisting of one Stantec and one Marathon employee completed the survey. The field team used a handheld GPS unit to navigate to each target sample location. Bog holes were accessed by snowmobile and/or by foot (snowshoes). The field team used a gas-powered auger, with 8-inch cutting blades, to cut a hole in the center of each bog hole. The ice thickness was determined by inserting an "improvised staff" into the hole, hooking the bottom of the ice with a flat disc attached to the base of the staff and determining the ice thickness by use of a meter stick attached to the staff (see photos 10 and 12 in Attachment 2). The water depth from the bottom of the ice to the bottom of the bog hole was also recorded. Photos were taken of each hole drilled for sampling and are provided in Attachment 2.

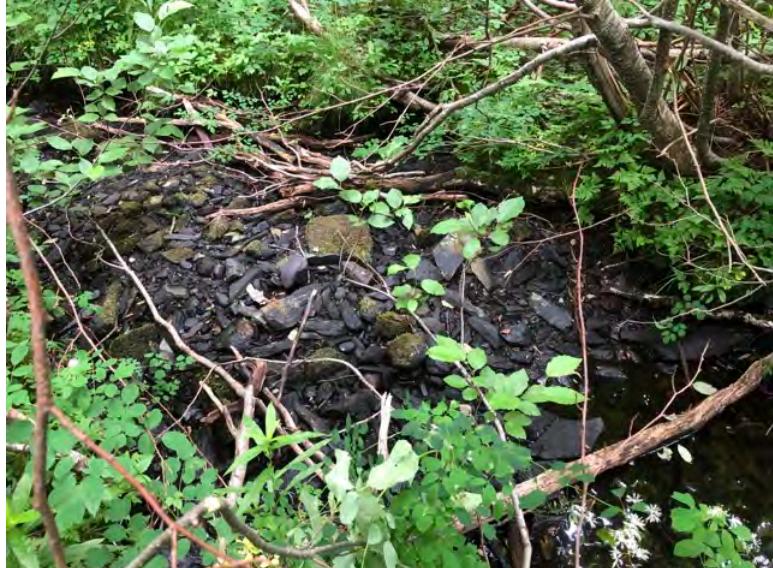
Photo 39 Stream 26 (400 to 500 m) Facing Upstream

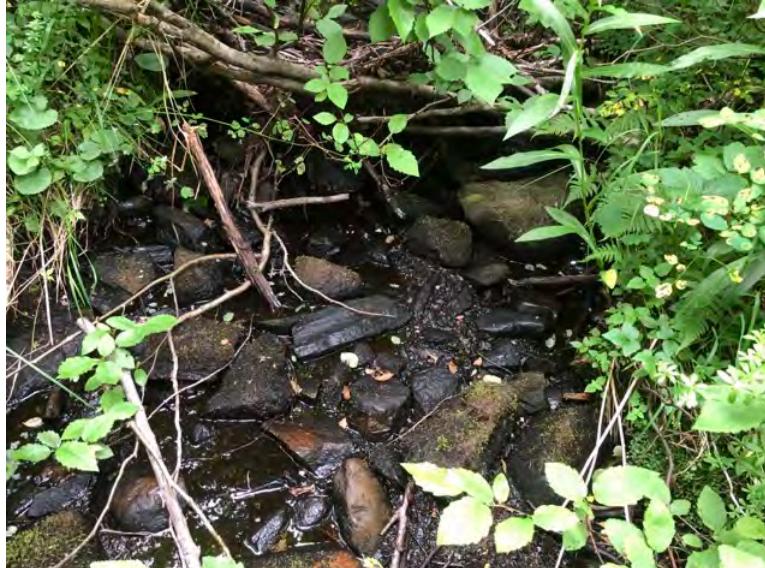
Photo 40 Stream 26 (500 to 600 m) Facing Upstream

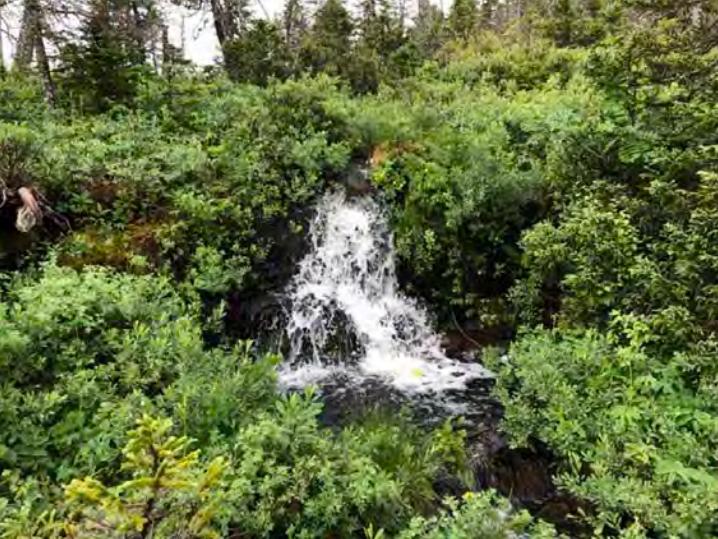
Photo 65	Stream 29 (450 m) Small Falls on Western Tributary Facing Upstream	Photo 66	Stream 29 (400 m) Middle Tributary Facing Upstream

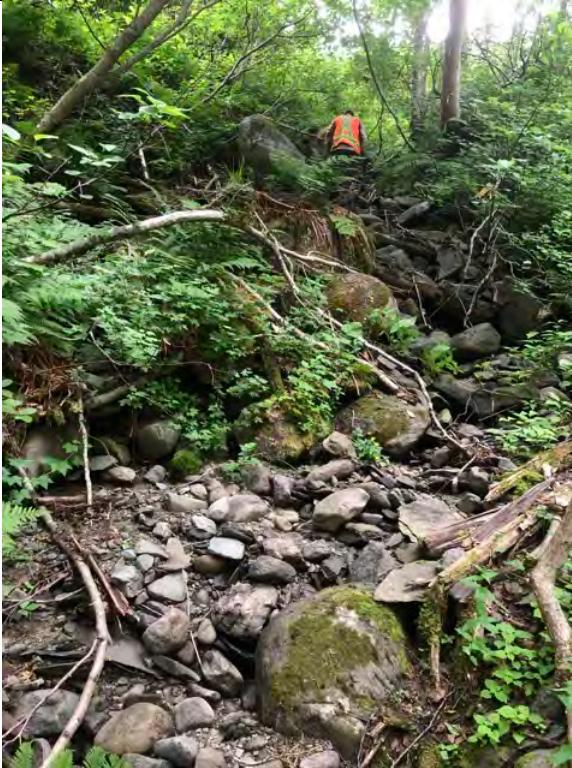
Photo 73 Stream 31 (200m) Facing Upstream

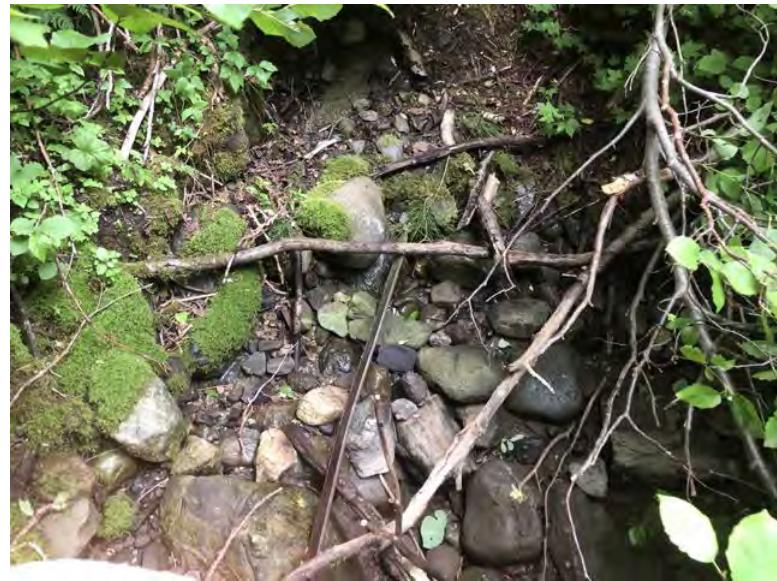
Photo 74 Stream 31 (300m) (0 m) Facing Upstream

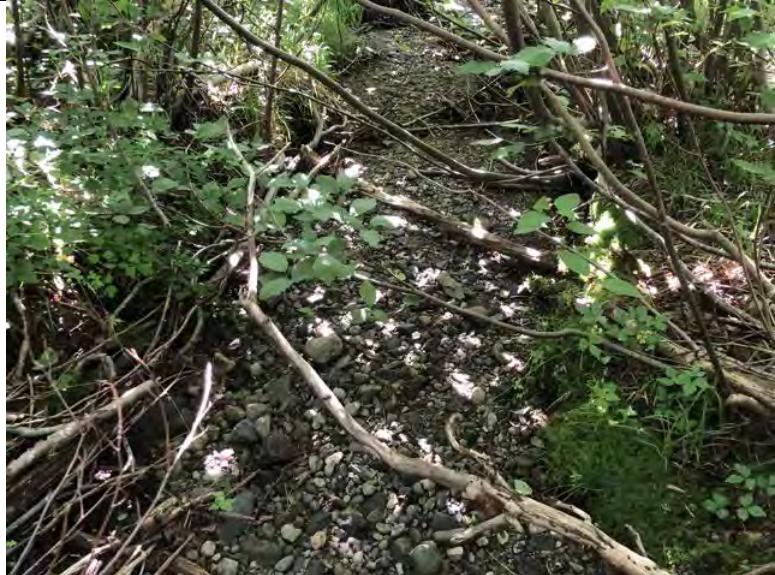
Photo 75 Stream 32 (0m) Facing Upstream

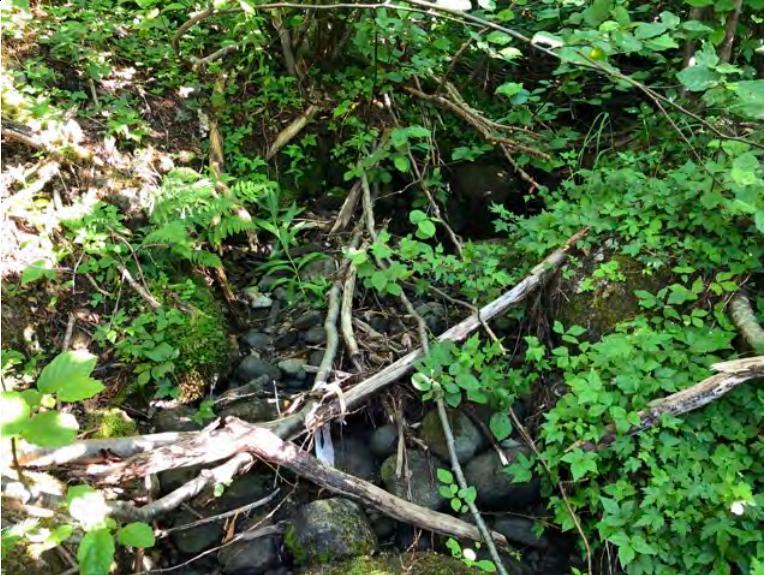
Photo 76 Stream 32 (100 m) Facing Upstream

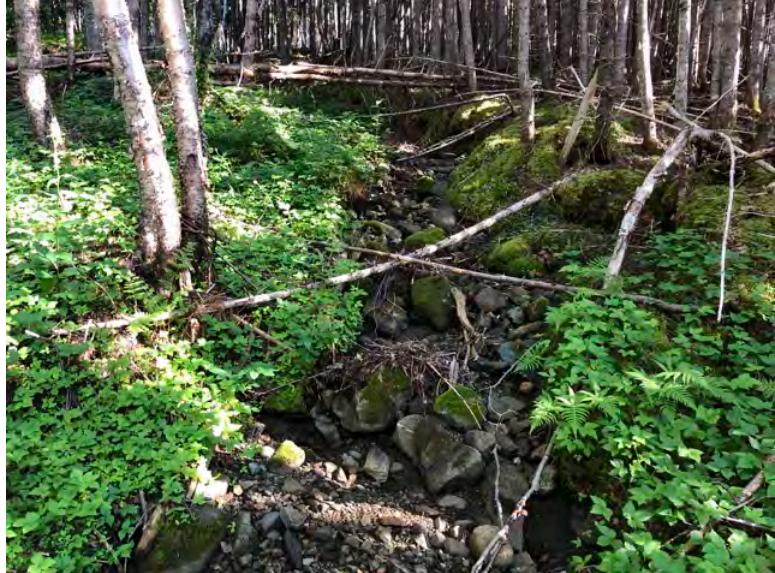
Photo 77 Stream 32 (200 m) Facing Upstream

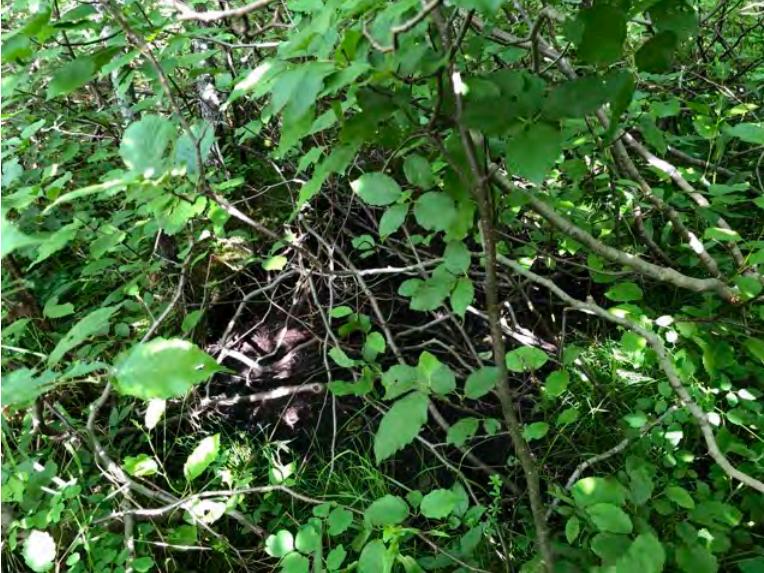
Photo 78 Stream 32 (300 m) Facing Upstream

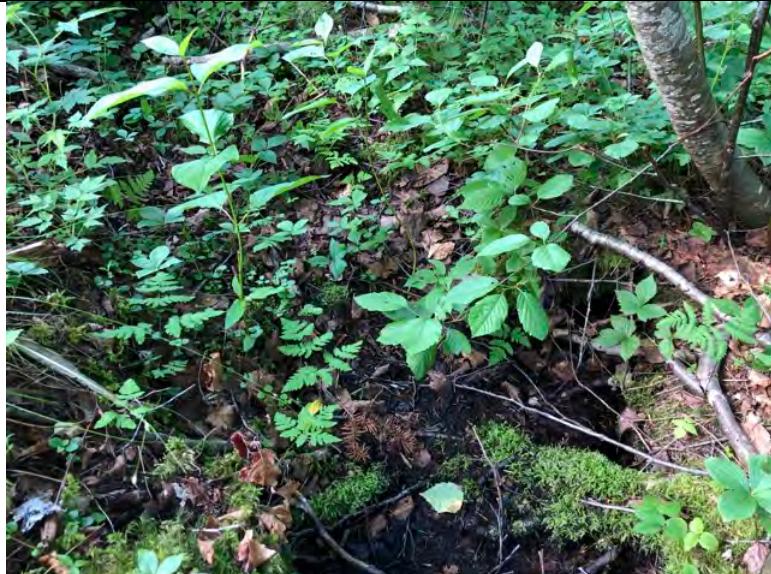
Photo 79 Stream 32 (300 m) Facing Upstream

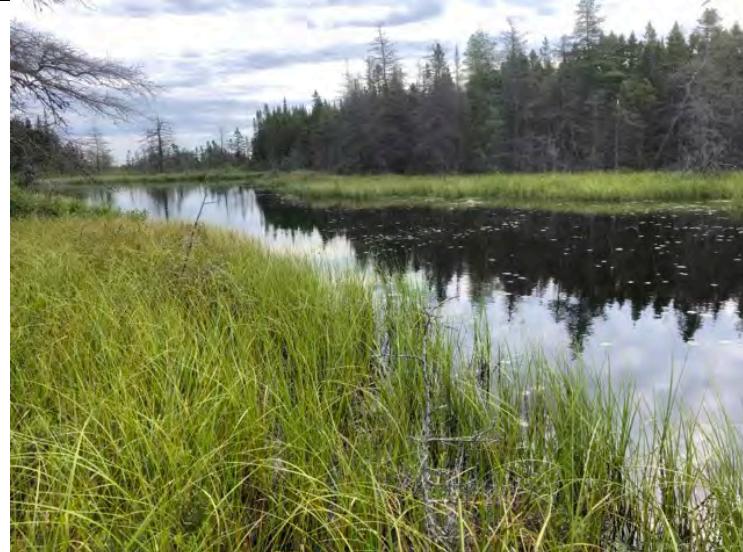
**Photo 120** Stream Crossing C0016 0 to 50 m Downstream Facing Downstream

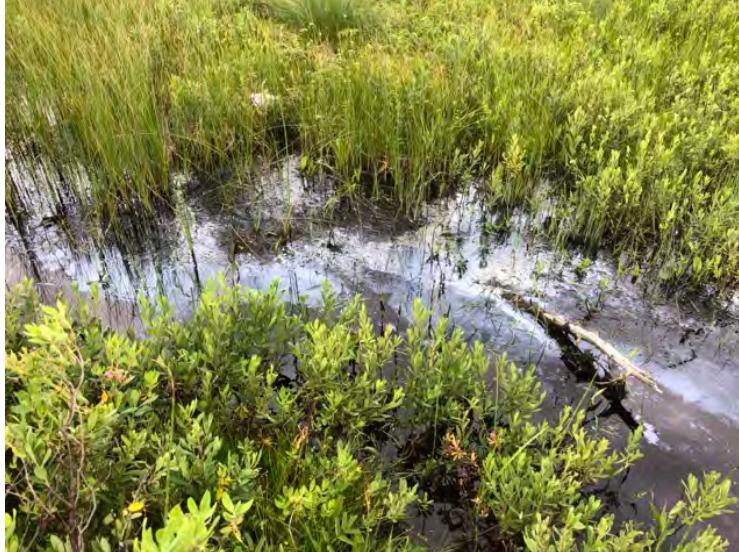
**Photo 121** Stream Crossing C0016a 0 to 50 m Upstream Facing Upstream

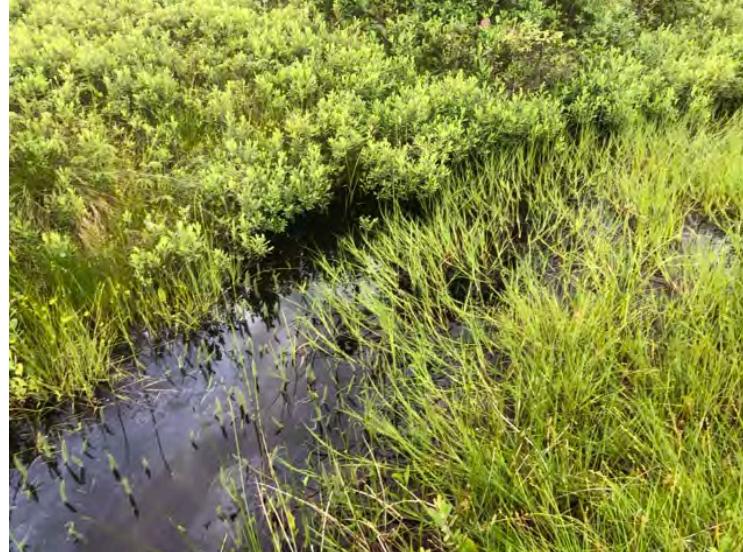
**Photo 122** Stream Crossing C0016a 0 to 50 m Downstream Facing Downstream

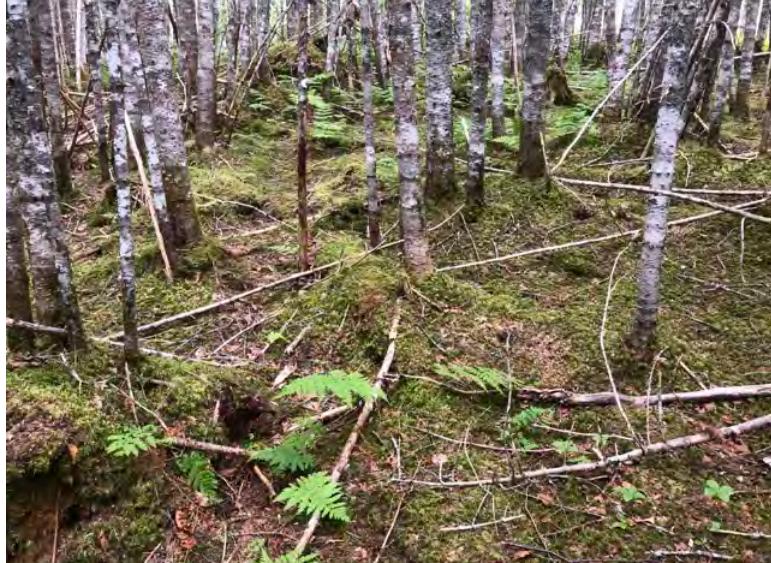
Photo 123 Stream Crossing C0017 0 to 50 m Upstream Facing Upstream

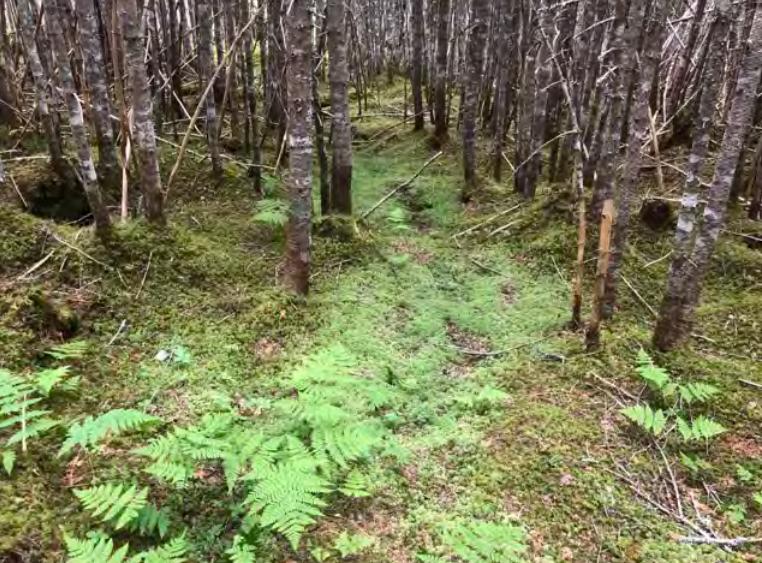
Photo 124 Stream Crossing C0017 0 to 50 m Downstream Facing XXX

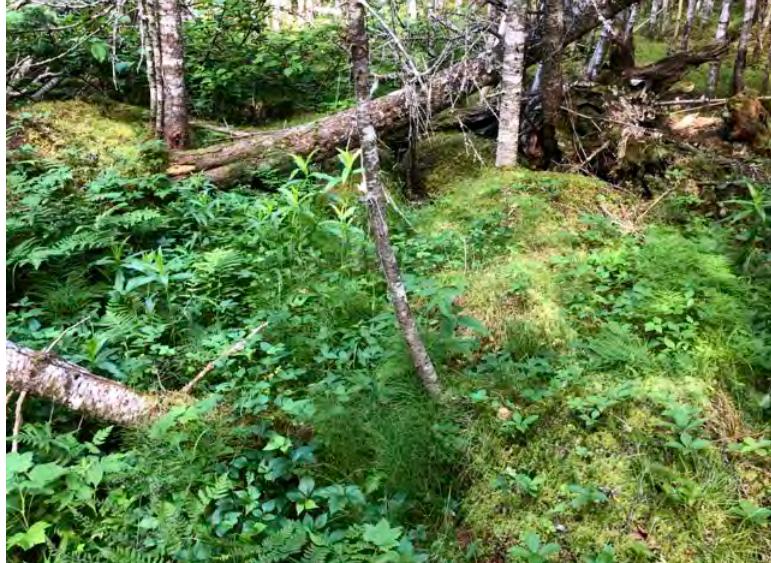
Photo 125 Stream Crossing C0018 0 to 50 m Upstream Facing Upstream

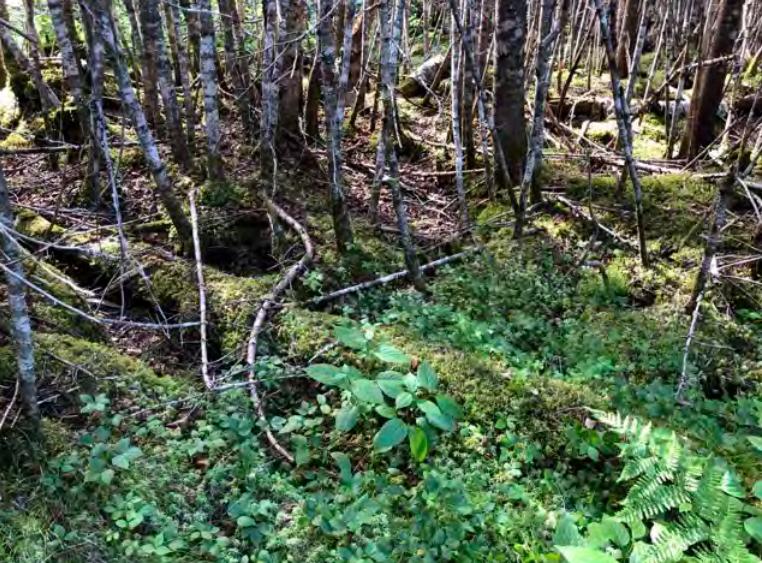
Photo 126 Stream Crossing C0018 0 to 50 m Downstream Facing Downstream

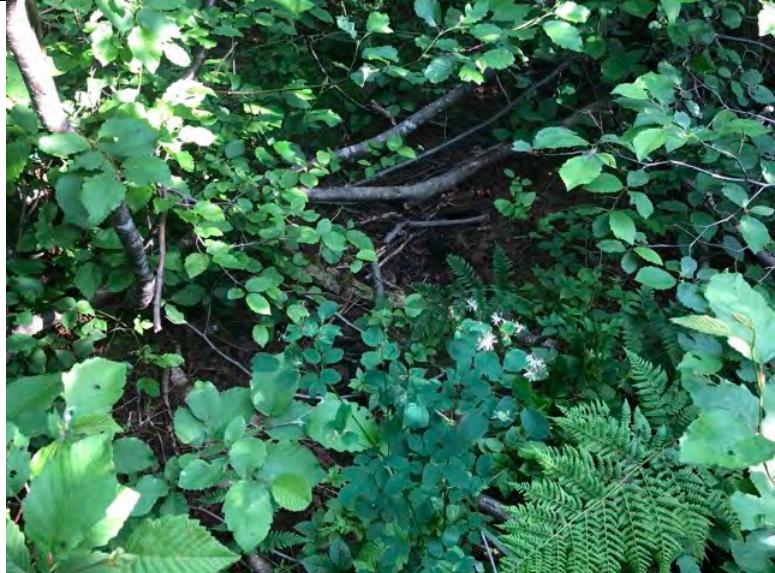
Photo 127 Stream Crossing C0019 0 to 50 m Upstream Facing

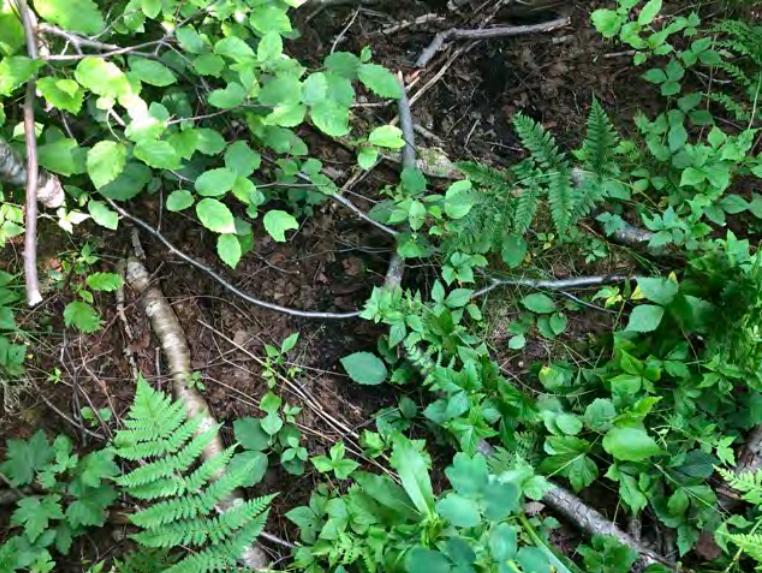
Photo 128 Stream Crossing C0019 0 to 50 m Downstream Facing Downstream
