**VALENTINE GOLD PROJECT: AMENDMENT TO THE ENVIRONMENTAL IMPACT STATEMENT**

**APPENDIX H**  
**VALENTINE GOLD PROJECT: 2020 FISH**  
**AND FISH HABITAT DATA REPORT**

**Valentine Gold Project: 2020 Fish  
and Fish Habitat Data Report**

May 3, 2021

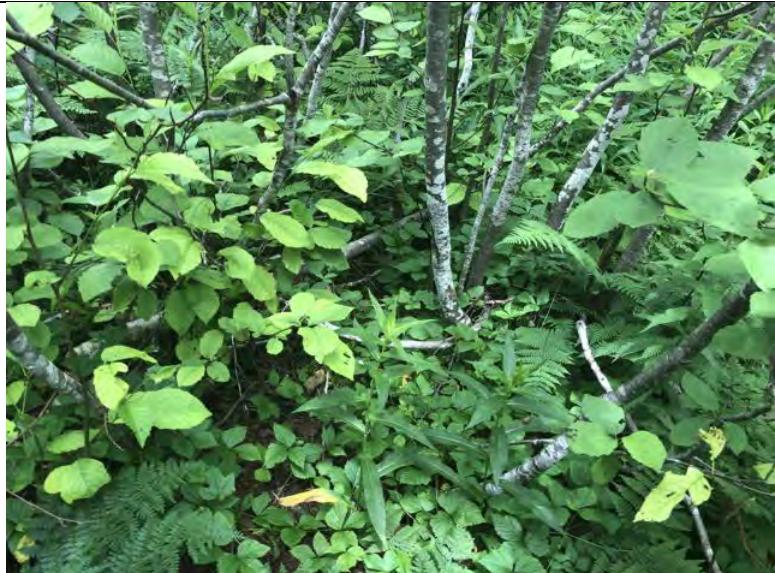
Photo 129 Stream Crossing C0020 0 to 50 m Upstream Facing Upstream

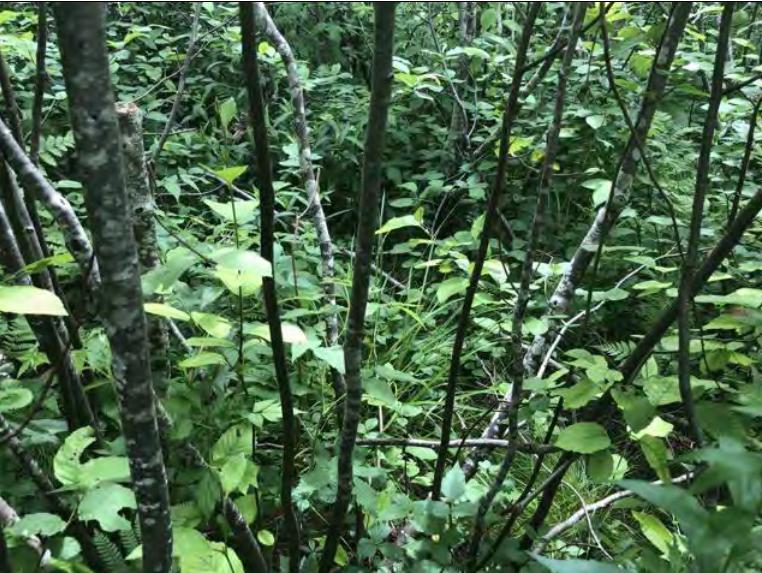
Photo 130 Stream Crossing C0020 0 to 50 m Downstream Facing XXX

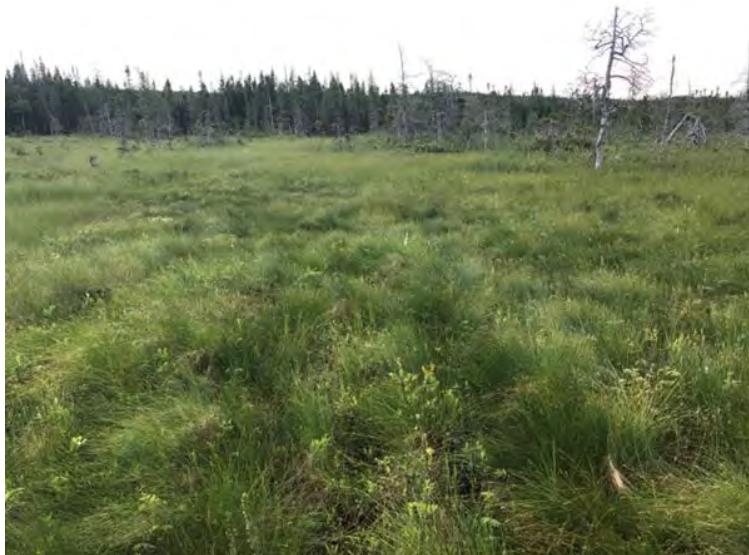
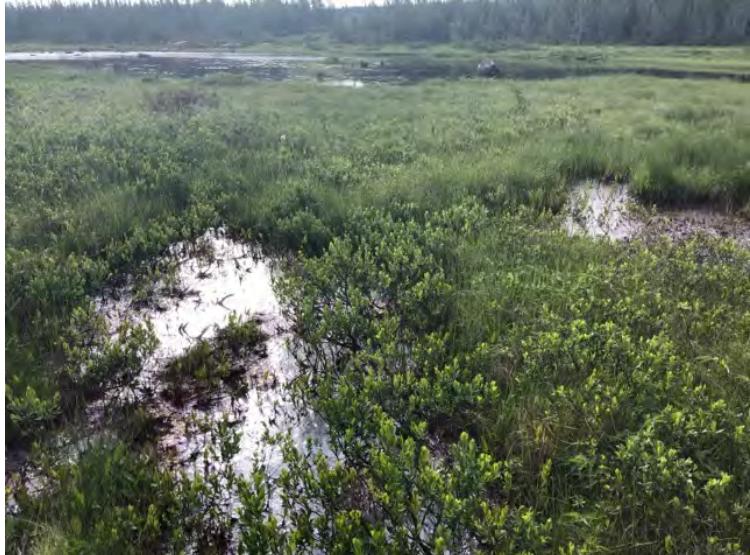
<p><b>Photo 131</b> Stream Crossing C0021 0 to 50 m Upstream Facing Upstream</p>		<p><b>Photo 132</b> Stream Crossing C0021 0 to 50 m Downstream Facing Downstream</p>

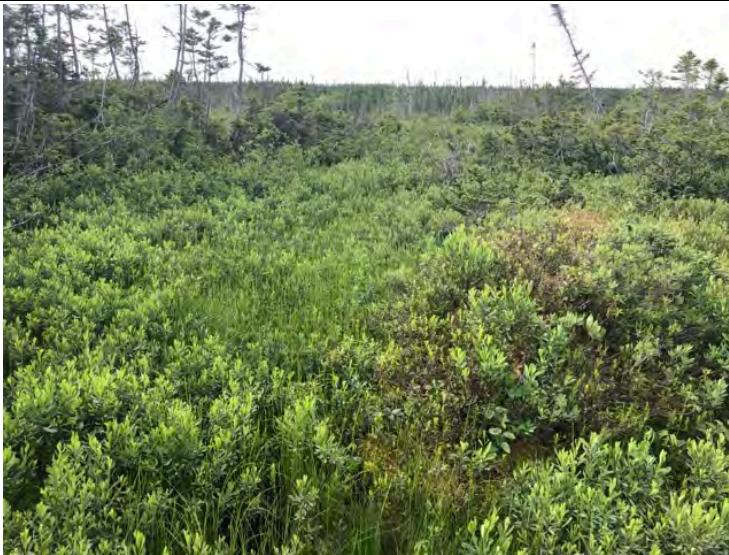
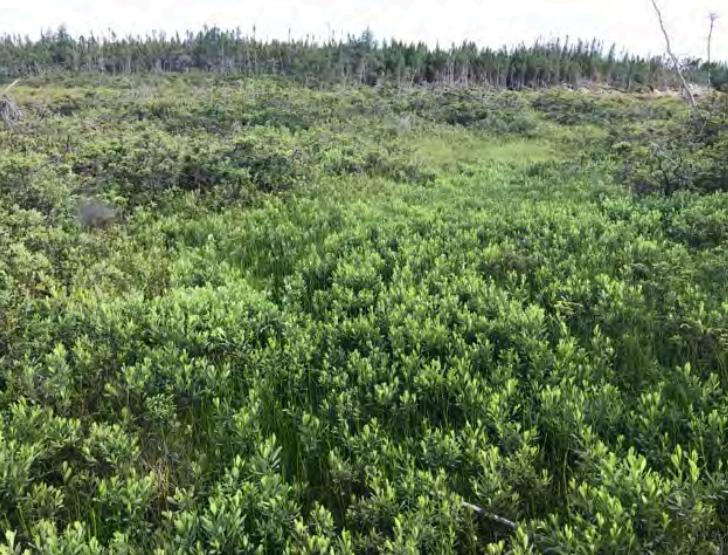
<p><b>Photo 133</b> Stream Crossing C0021a 0 to 50 m Upstream Facing Upstream</p>		<p><b>Photo 134</b> Stream Crossing C0021a 0 to 50 m Downstream Facing Downstream</p>

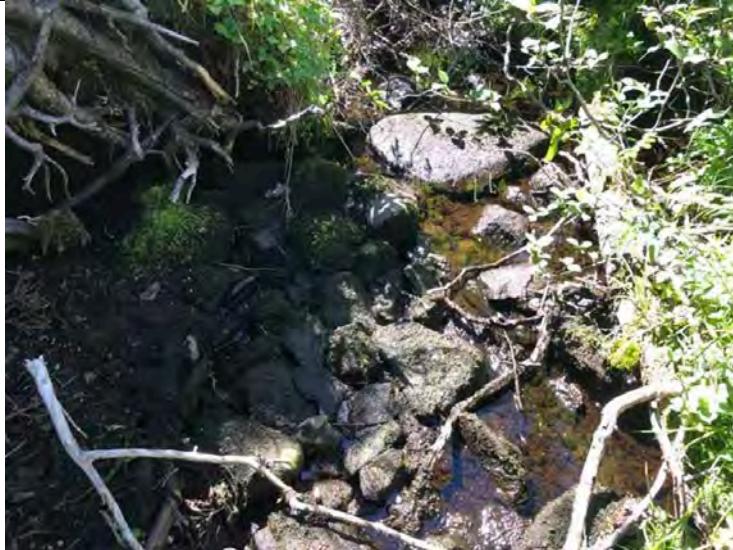
**Photo 135** Stream Crossing C0022 at Crossing (0 m) Facing Upstream

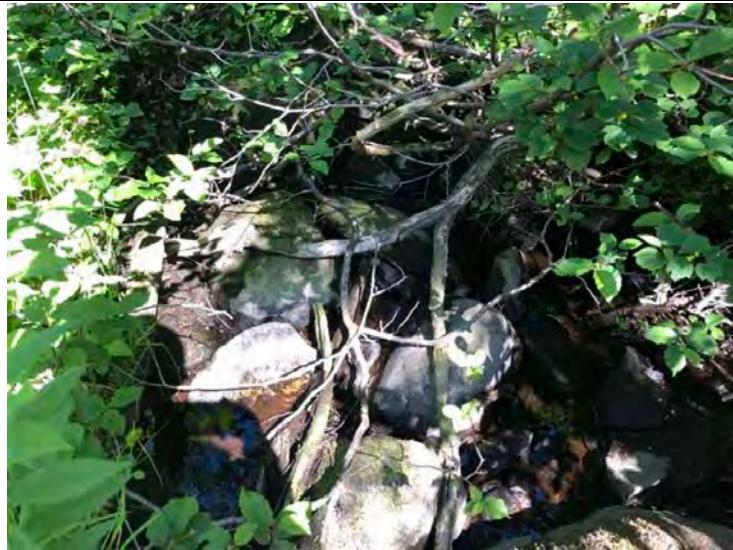
**Photo 136** Stream Crossing C0022 at Crossing (0 m) Facing Downstream

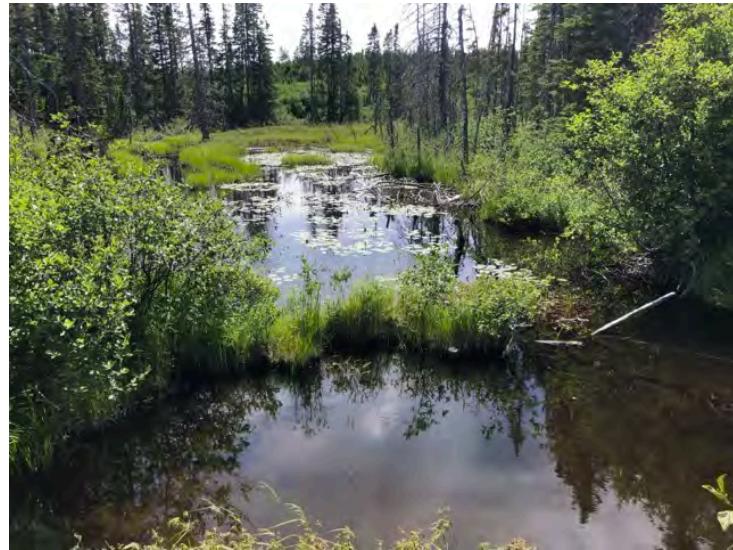
**Photo 137** Stream Crossing C0022a 0 to 50 m Upstream Facing Upstream

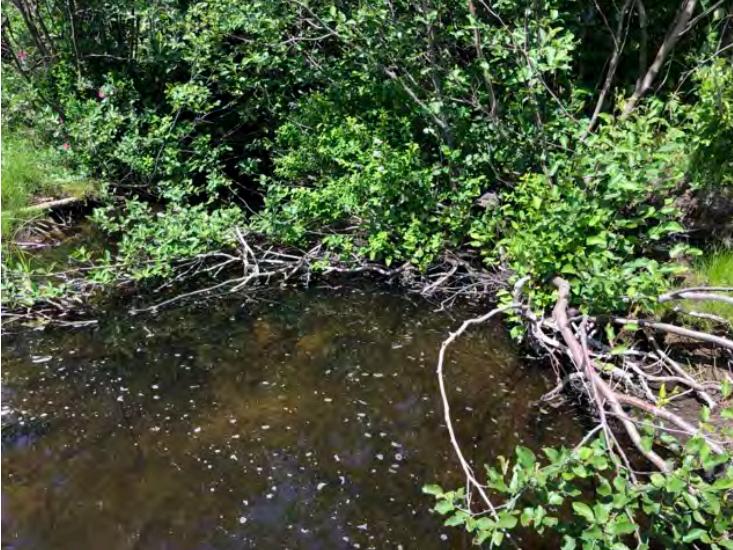
**Photo 138** Stream Crossing C0022a 0 to 50 m Downstream Facing Downstream

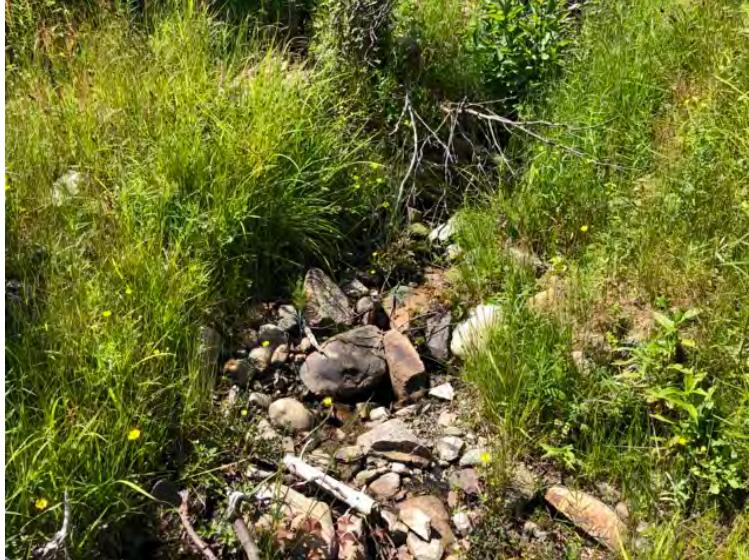
Photo 139 Stream Crossing C0023 0 to 50 m Upstream Facing Upstream

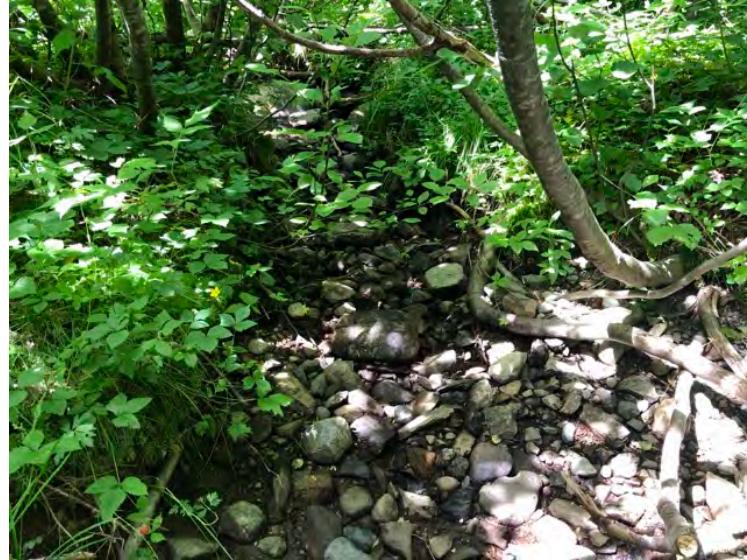
Photo 140 Stream Crossing C0023 0 to 50 m Downstream Facing Downstream

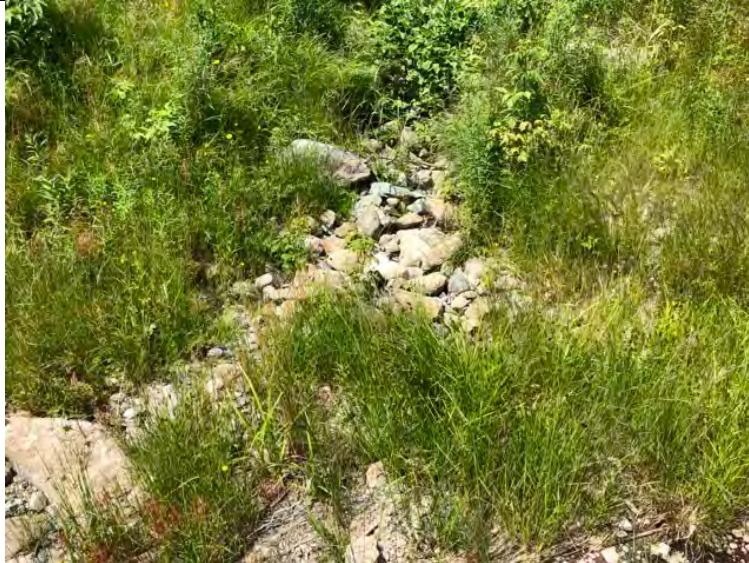
Photo 141 Stream Crossing C0024 0 to 50 m Upstream Facing Upstream

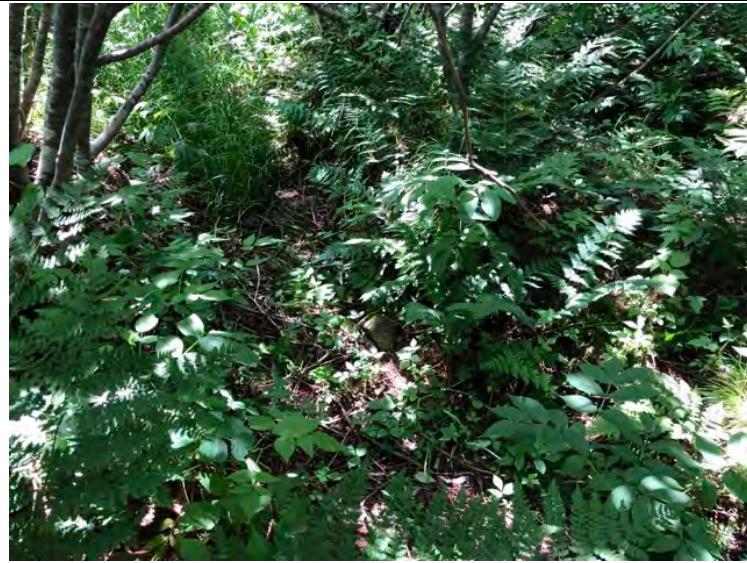
Photo 142 Stream Crossing C0024 0 to 50 m Downstream Facing Downstream

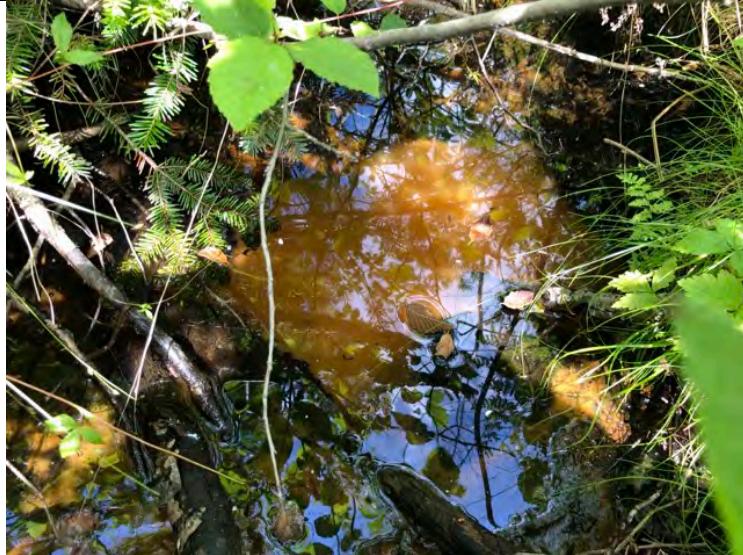
Photo 143 Stream Crossing C0025 0 to 50 m Upstream Facing Upstream

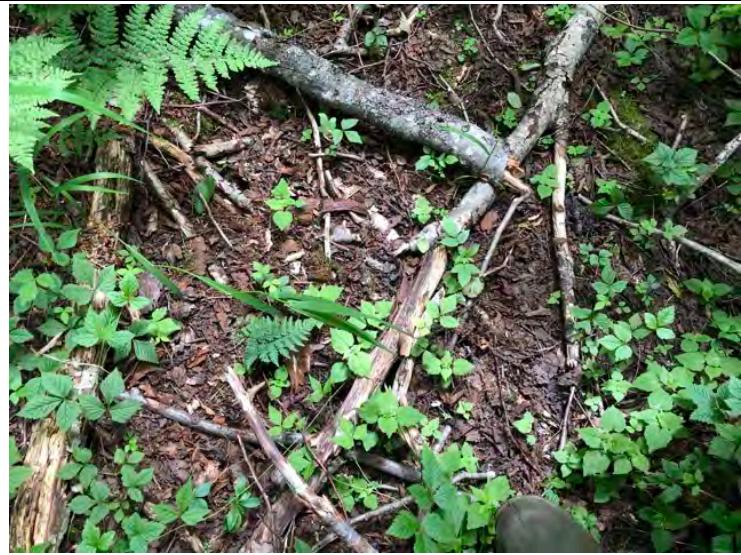
Photo 144 Stream Crossing C0025 0 to 50 m Downstream Facing Upstream

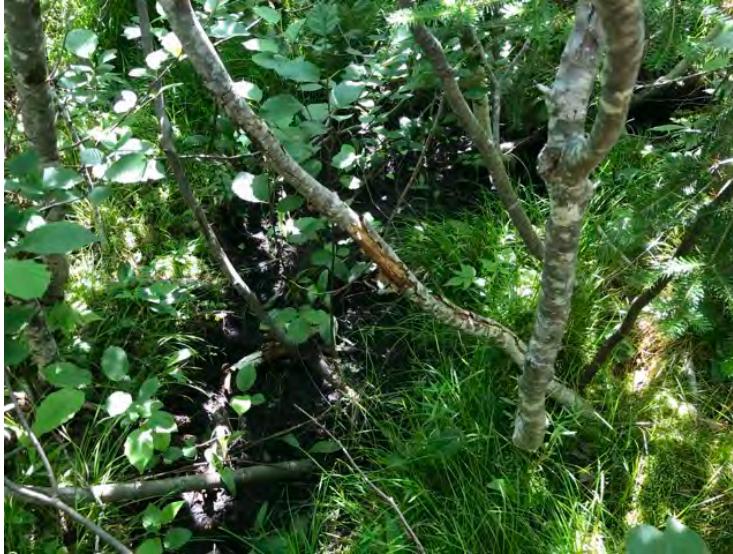
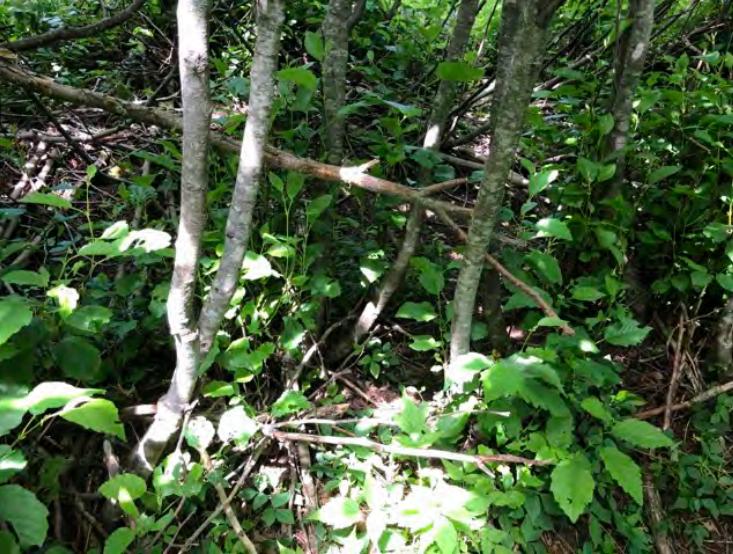
Photo 145 Stream Crossing C0026 0 to 50 m Upstream Facing Upstream		Photo 146 Stream Crossing C0026 0 to 50 m Downstream Facing Downstream

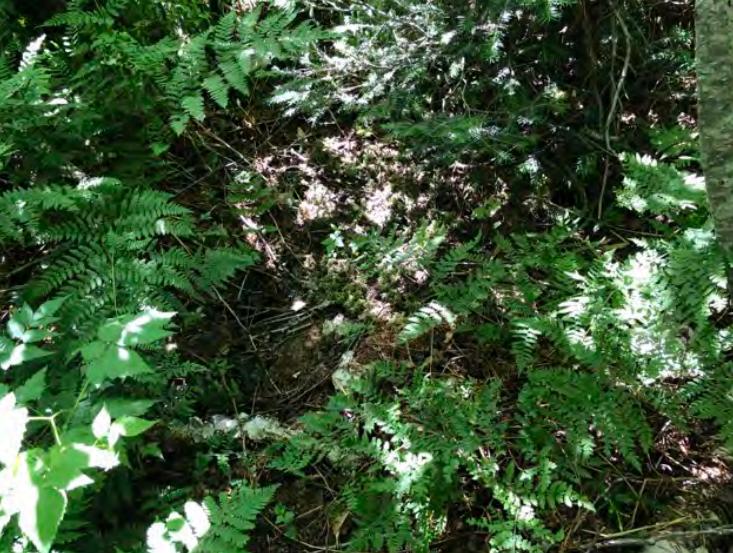
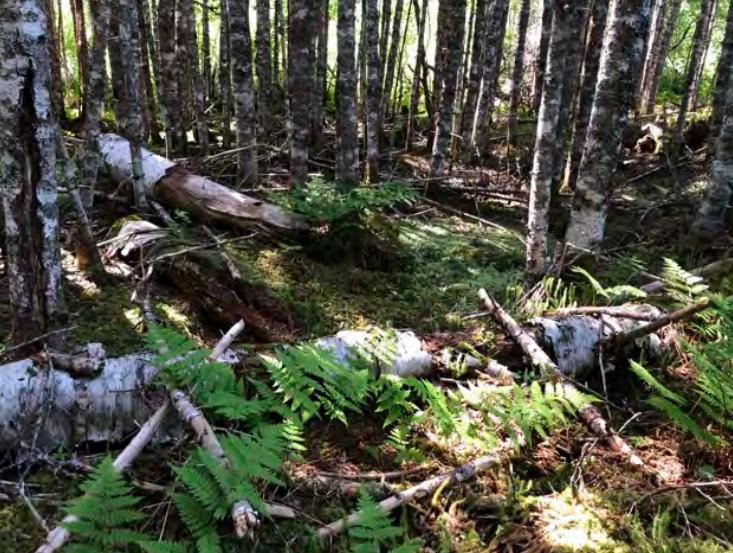
Photo 147 Stream Crossing C0027 0 to 50 m Upstream Facing Upstream		Photo 148 Stream Crossing C0027 0 to 50 m Downstream Facing Downstream

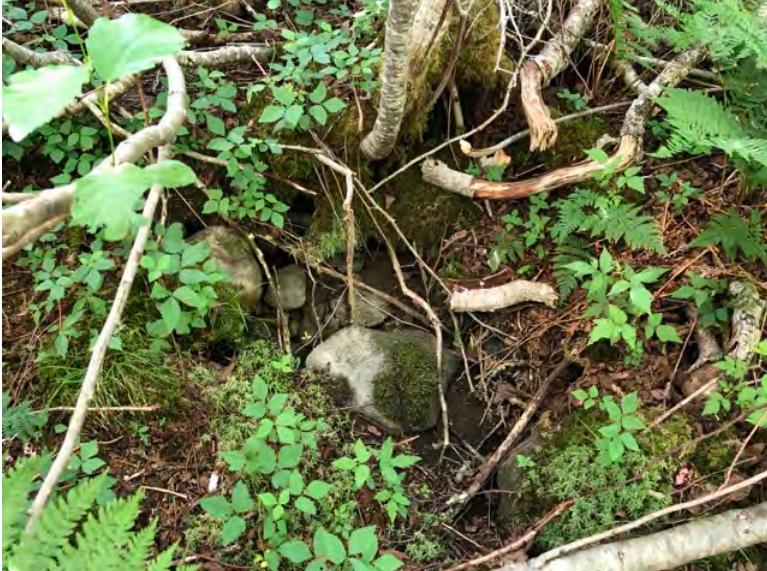
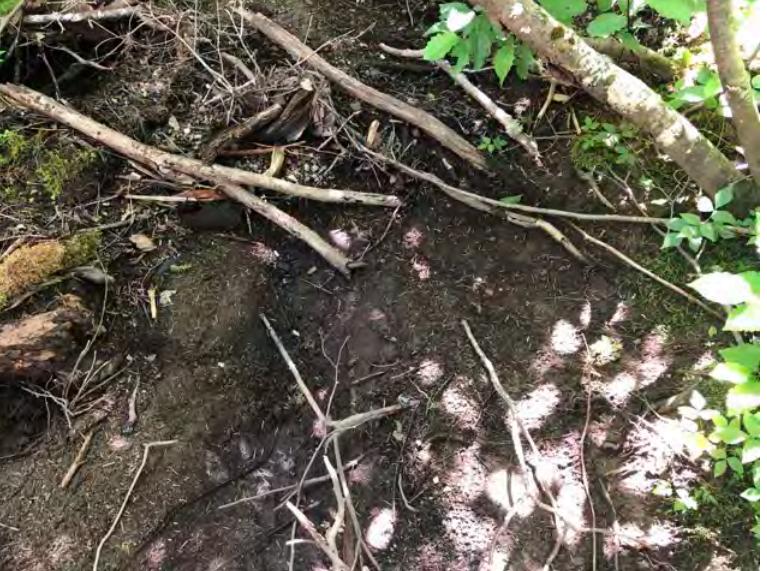
Photo 149	Stream Crossing C0028 0 to 50 m Upstream Facing Upstream	Photo 150	Stream Crossing C0028 0 to 50 m Downstream Facing Downstream

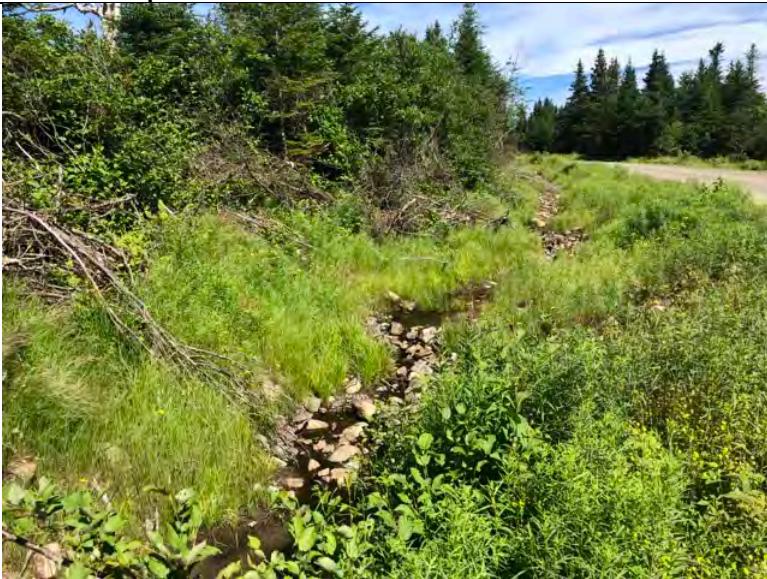
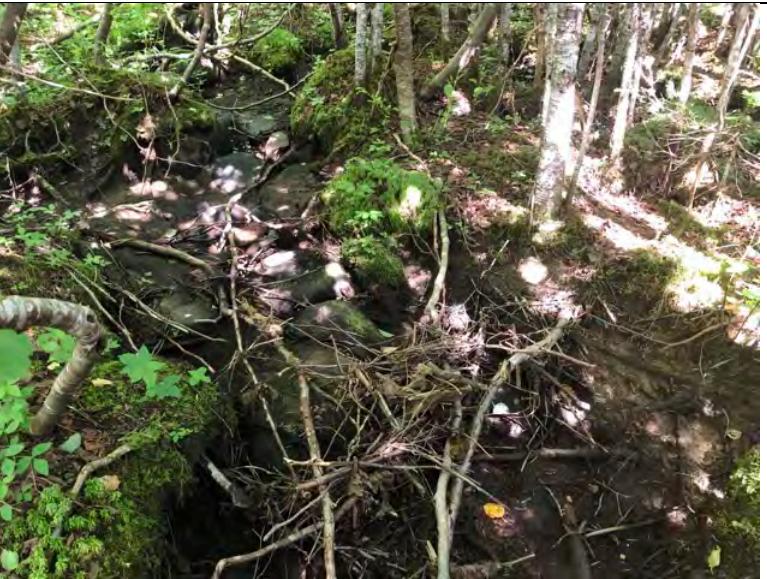
Photo 151	Stream Crossing C0028a 0 to 50 m Ditch Facing East	Photo 152	Stream Crossing 28a 0 to 50 m Downstream Facing Upstream

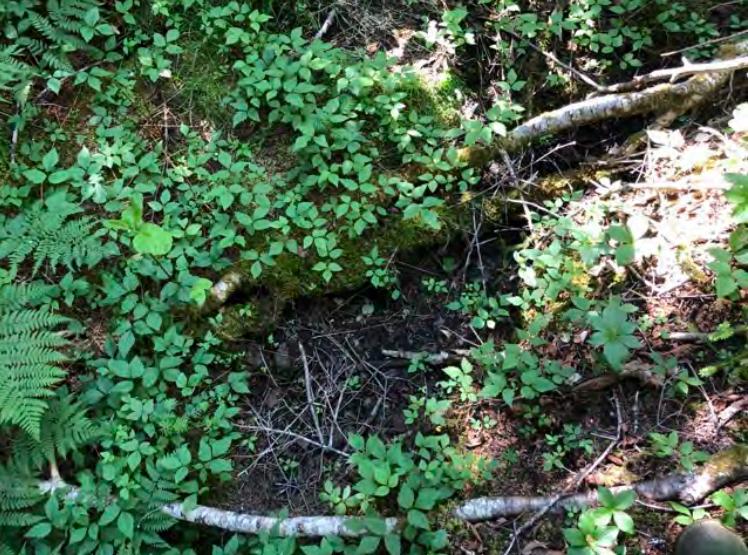
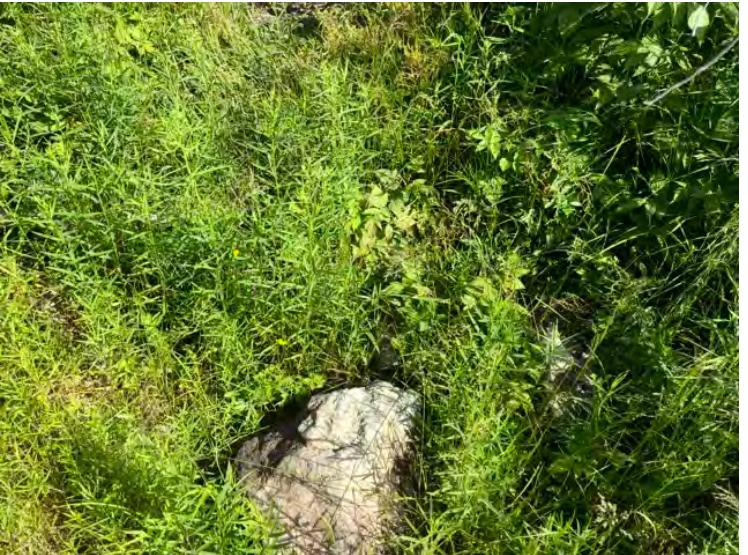
<b>Photo 153</b> Stream Crossing C0029 0 to 50 m Upstream Facing Upstream		<b>Photo 154</b> Stream Crossing C0029 0 to 50 m Downstream Facing Downstream

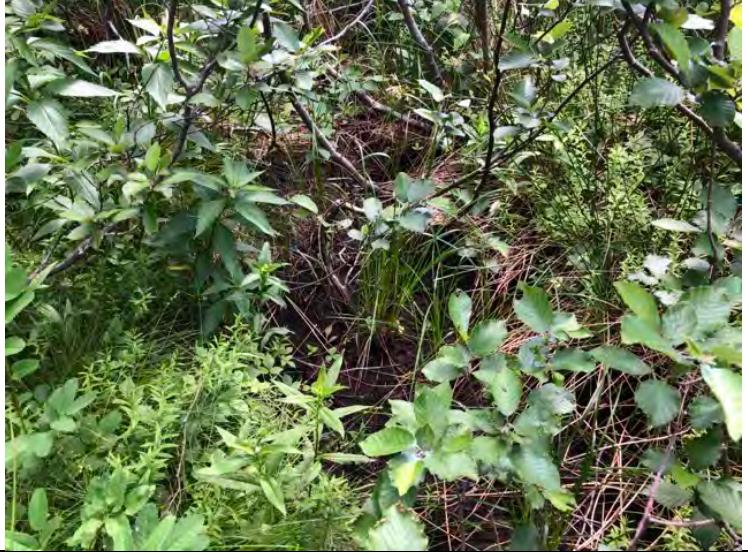
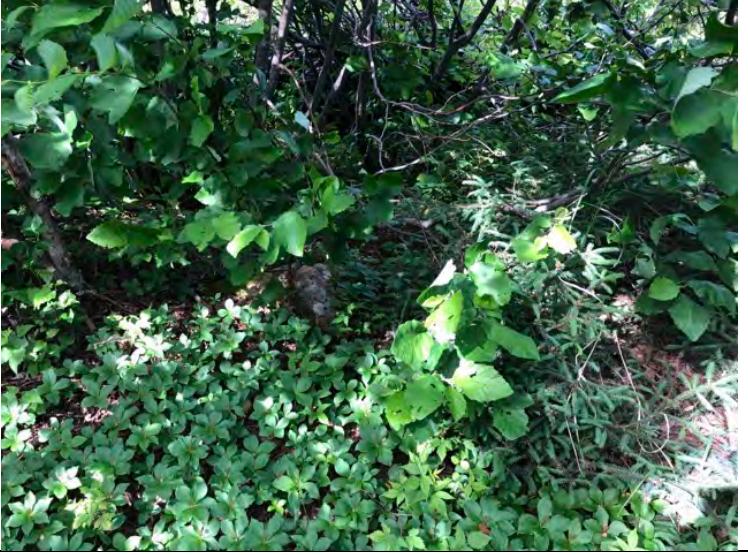
<b>Photo 155</b> Stream Crossing C0030 0 to 50 m Upstream Facing Upstream		<b>Photo 156</b> Stream Crossing C0030 0 to 50 m Downstream Facing Downstream

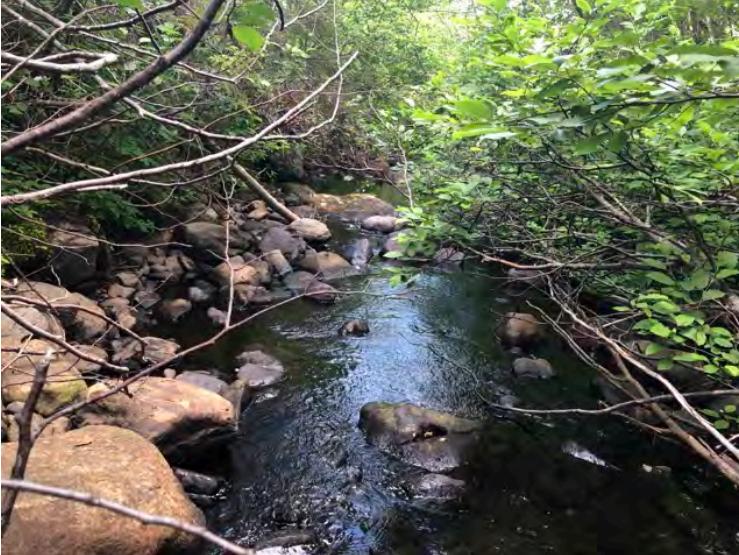
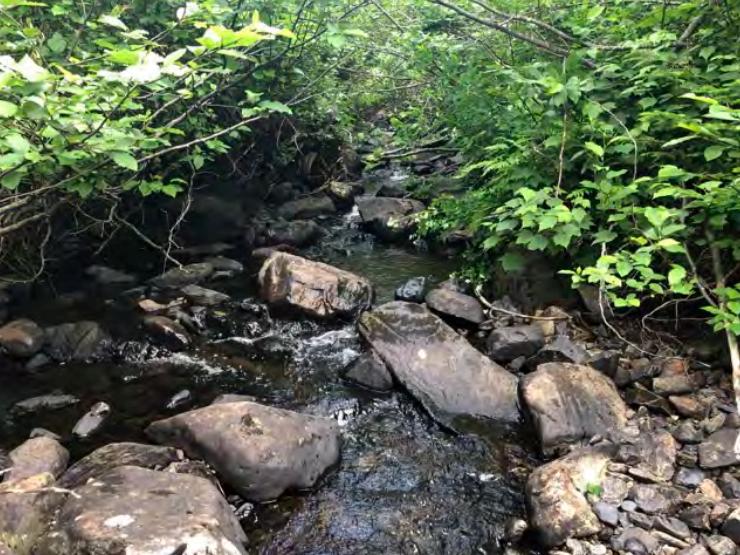
<b>Photo 157</b> Stream Crossing C0031 0 to 50 m Upstream Facing Downstream		<b>Photo 158</b> Stream Crossing C0031 0 to 50 m Downstream Facing Downstream

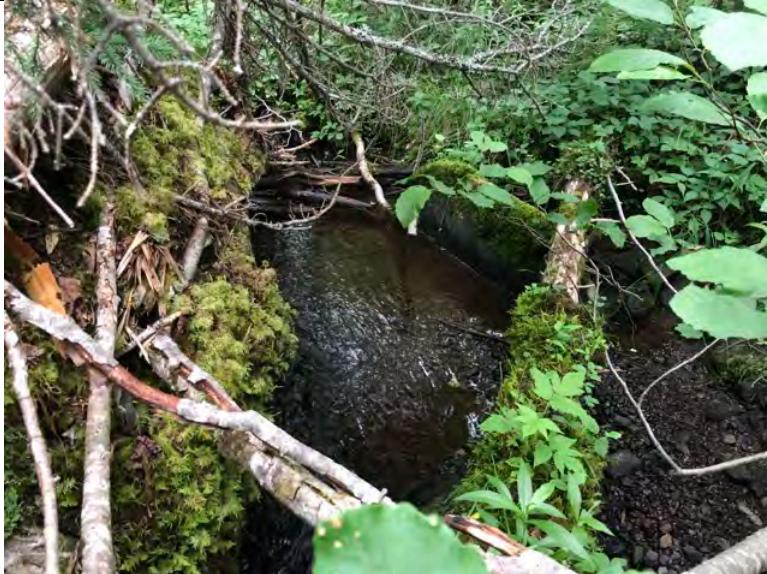
Photo 199 Stream Crossing 49 0 to 50 m Downstream Facing Upstream

C0049	0 to 50 m US	50	41341	48.6884	-56.8778	0.50	1.40	0.06	0.03	0.03	0.300	0.250	0.200	4.0	60	40	0	0	50	40	10	0	0	25	50	25	40	0	Trout observed in ditch. Stream drains forested wetland. Stagnant pockets of water eventually consolidating US of ditch ~25 m into forest.								
Summary							0.86	1.75		0.07			0.186		3.7	75%	25%	0%	0%	35%	35%	25%	5%	0%	23%	55%	23%	45	0	Fish habitat - fish observed							
C0050	0 to 50 m US	50	41783	48.6983	-56.8777	0.71	0.84	0.14	0.11	0.13	-	-	0.5	80	20	0	0	45	30	5	20	0	30	40	30	50	100	Stream runs through ditch the up berm into old beaver meadow/wetland. Unable to measure velocity.									
	0 m (Crossing)	0	-	48.6983	-56.8777	0.94	1.21	0.04	0.05	0.06	-	-	-	-	-	-	-	-	-	-	-	-	-	-	-	-	-	Insufficient flows to get velocity									
C0050	0 to 50 m DS	50	41784	48.6982	-56.8779	0.90	1.30	0.10	0.21	0.22	0.001	0.003	0.033	3.0	80	5	15	0	50	5	45	0	0	25	50	25	50	0	Small single channel

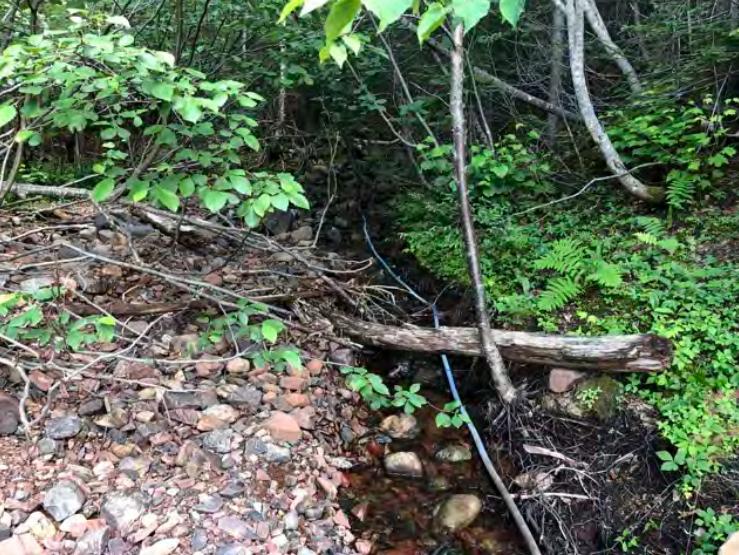
<b>Photo 204</b> Stream Crossing C0052 0 to 50 m Upstream Facing Upstream	<b>Photo 205</b> Stream Crossing C0052 0 to 50 m Downstream Facing Upstream

C0052	0 to 50 m DS	50	41772	48.7151	-56.8626	3.40	3.60	0.04	0.05	0.03	0.200	0.160	0.200	10.0	90	10	0	0	15	15	30	40	0	25	20	55	15	5	Flows through steep ravine. Fish observed.								
C0052	0 m (Crossing)	0	-	48.7149	-56.8624	1.12	4.2	0.07	0.13	0.15	0.250	0.150	0.160	3.0	-	-	-	-	-	-	-	-	-	-	-	-	-	-									
C0052	0 to 50 m US	50	41773	48.7150	-56.8625	2.65	2.70	0.12	0.13	0.11	0.200	0.200	0.150	5.0	100	0	0	0	5	10	45	40	0	60	0	40	20	10	Nice stream								
Summary							2.39	3.50		0.09			0.186		6.0	95%	5%	0%	0%	10%	13%	38%	40%	0%	43%	10%	48%	17.5	7.5	Fish habitat - confirmed fish present							
C0053	0 to 50 m US	50	41755	48.7212	-56.8386	0.60	0.65	0.08	0.06	0.05	-	-	2.0	95	5	0	0	20	20	35	25	0	35	35	30	45	5	To shallow to collect velocity									
C0053	0 m (Crossing)			48.7211	-56.8385	1	2.2	0.05	0.05	0.02	-	-	1.0	-	-	-	-	-	-	-	-	-	-	-	-	-	-	-									
C0053	0 to 50 m DS	50	41756	48.7213	-56.8385	0.80	1.00	0.03	0.05	0.05	0.050	0.080	0.001	3.0	95	5	0	0	30	10	50	10	0	35	15	50	30	0	Very erosional and dispersed 20 m downstream of proposed crossing.

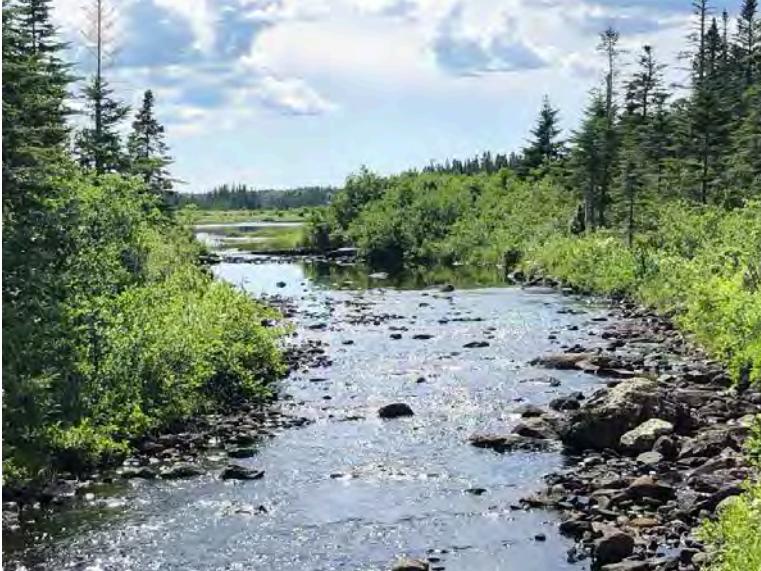
<b>Photo 229</b> Remains of Old Forestry Dam in Tom Joe Brook (Outlet of Ansey Steady)		<b>Photo 230</b> Representative Habitat in Ansey Steady

Anstey Steady is located on Tom Joe Brook within the Exploits River watershed. The site was visited on July 19, 2020. The remains of the old forestry dam were apparent at the outlet of Anstey Steady, however did not present a barrier to fish passage (Appendix C, Photos 229 to 232). Cottage owners in the area indicated that the forestry dam and associated pulp wood had been removed approximately five years prior. Stantec verified the observations of the cottage owners and assessed the areas in the steadies further upstream of Anstey Steady. No large areas of pulp wood were observed that could merit an offsetting opportunity.

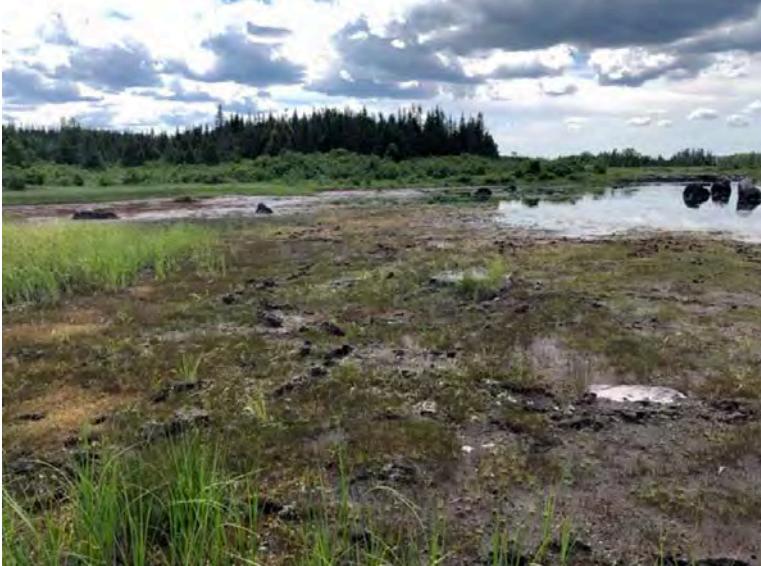
<b>Photo 231</b> Shoreline Habitat in Ansey Steady		<b>Photo 232</b> Few Remains of Pulpwood in Tom Joe Brook

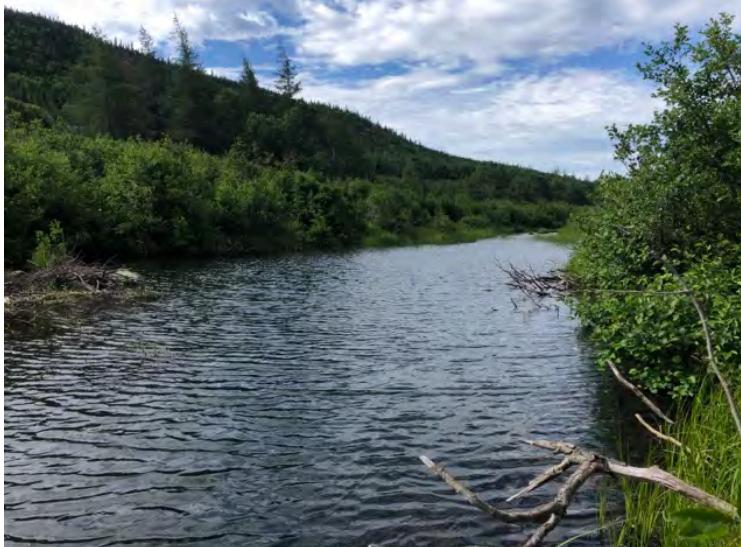
**Photo 233** Representative Habitat in Victoria River Downstream of Victoria River Dam

Victoria River was visited on July 23, 2020. The fish habitat in Victoria River downstream of the Victoria River Dam was assessed visually from shore, while stream surveys were conducted nearby. The areas assessed generally consisted of short riffles with gravel or sand substrates and deeper pools resulting from beaver activity or previous river side channels (Appendix C, Photos 233 to 236). There was abundant overhead and instream cover. Water temperatures were cool (i.e., <18°C). Salmonids were abundant and multiple life stages were noted. Given the abundance of salmonids directly observed and the good quality of the habitat present, this opportunity was not pursued further.

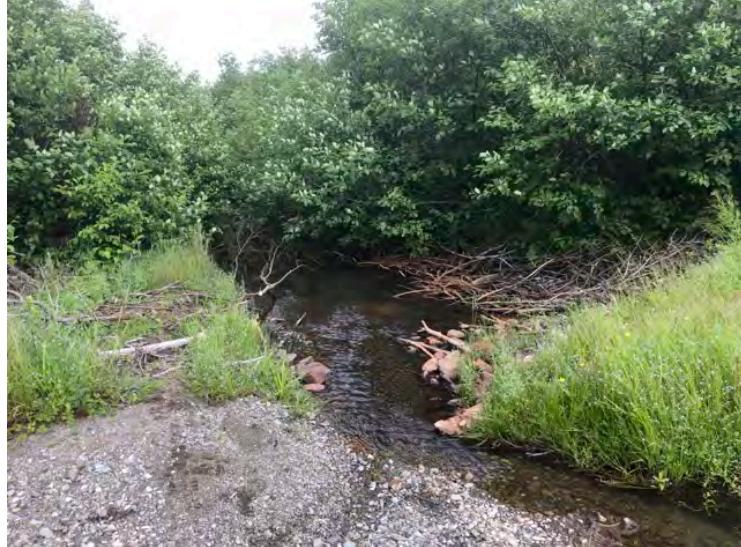
**Photo 234** Representative Habitat in Victoria River Downstream of Victoria River Dam

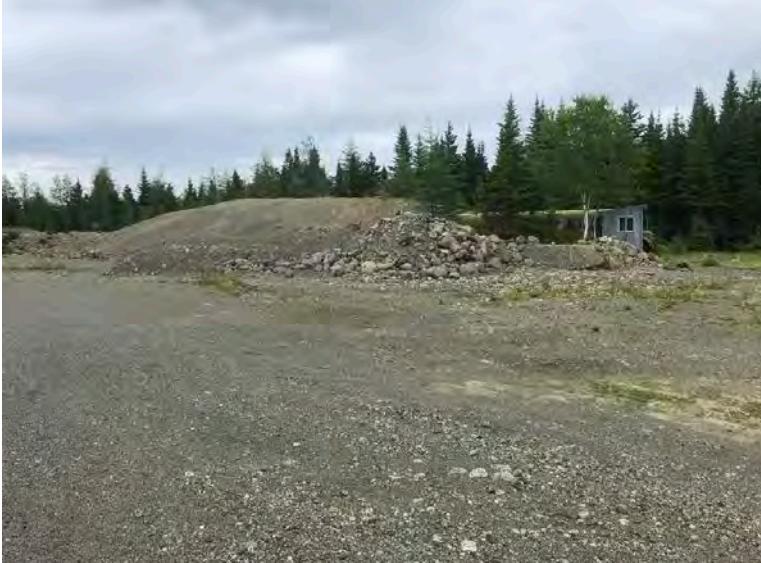
A photograph showing a gravel pit in the foreground, a small concrete structure on a rocky embankment, and a dense forest of coniferous trees in the background under a cloudy sky.

A photograph of a dense forest floor with fallen branches and green undergrowth, with a forested hillside visible in the background.	
<b>Photo 237</b> Gravel Pit		<b>Photo 238</b> Forest in Direction of Victoria River Facing Downhill

The gravel pit was visited on July 25, 2020. The general area of the gravel pit was assessed visually and potential channels to the Victoria River were assessed (Appendix C, Photos 237 to 240). The development of the gravel pit is constrained by its small size relative to the total area required for offsetting, the topography (e.g., steep slopes approaching the river) and potential lack of surface water inputs, therefore is not being pursued further.

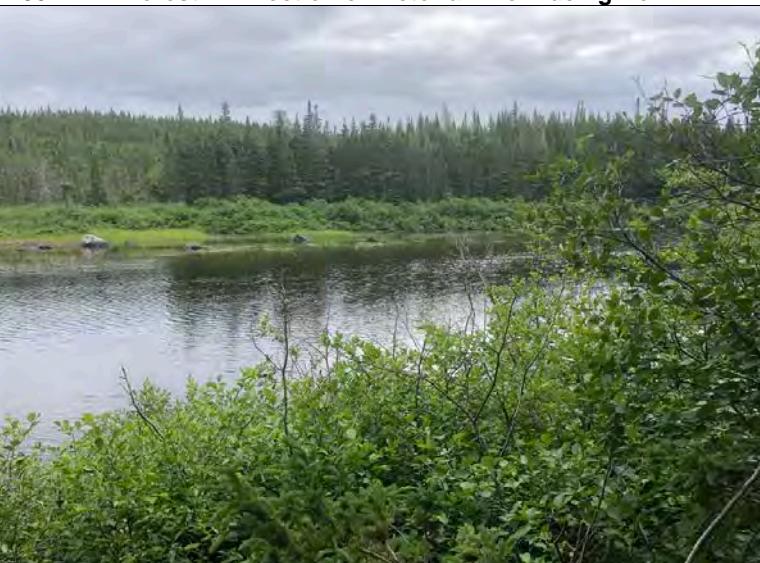
A photograph of a river with a grassy bank in the foreground, a dense forest in the middle ground, and a forested hillside in the background under a cloudy sky.	
<b>Photo 239</b> Forest in Direction of Victoria River Facing Uphill		<b>Photo 240</b> Elevation Change in To Victoria River Facing Downhill

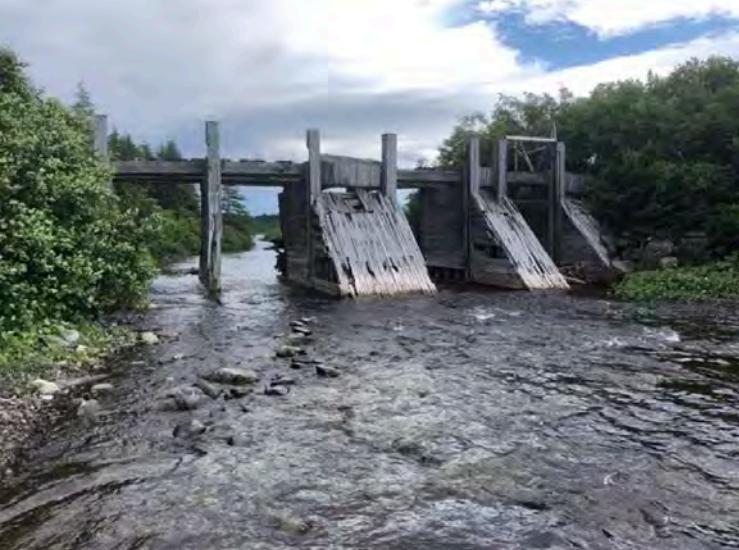
<b>Photo 241</b> Long Lake Water Control Structure Facing Downstream		<b>Photo 242</b> Deck of Long Lake Water Control Structure Facing Downstream

The Long Lake Water Control Structure was visited on July 25, 2020 and was in a state of disrepair. A sign indicated that the Long Lake Water Control Structure is owned by Abitibi-Bowater. The water control structure is constructed of timber and measures approximately 3 m high x 12 m wide m x 11 m long (Appendix C, Photos 241 to 246). The structure was likely constructed to allow for temporary damming of Long Lake, to facilitate log driving downstream. The bottom of the structure appears to consist of wood. Holes in the deck and side of the structure were observed in the site visits. The relatively smooth timber surface results in high velocities at the downstream end of the water control structure where it discharges into the pool below (Appendix C, Photos 245 and 246).

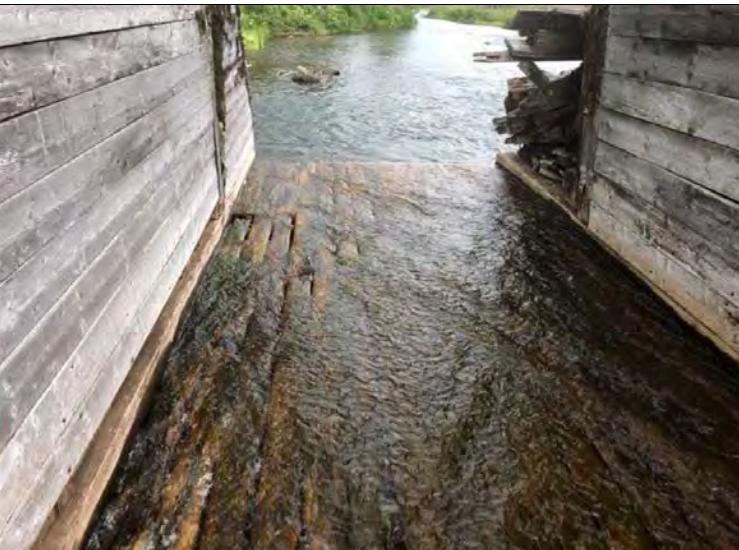
<b>Photo 243</b> Deck of Long Lake Water Control Structure Facing Downstream		<b>Photo 244</b> Substrate in Riffle in Front of Water Control Structure

There is the potential that the water control structure creates a barrier to fish passage due to shallow water depth and high velocity. The water control structure is elevated relative to the downstream water's surface (~0.5 m); however, a deep pool downstream allows fish to jump the 0.5 m elevation. During the site visit a brook trout was observed jumping into the water control structure, then swept back downstream due to shallow depth and high velocity. Low water depths in the water control structure increase the likelihood of injury to leaping fish (Appendix C, Photo 243). The existing water control structure does not impound water in Long Lake.

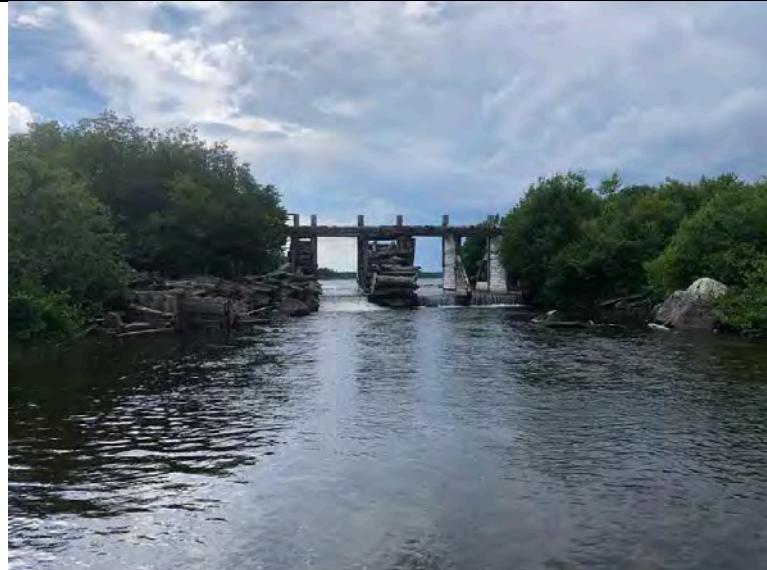
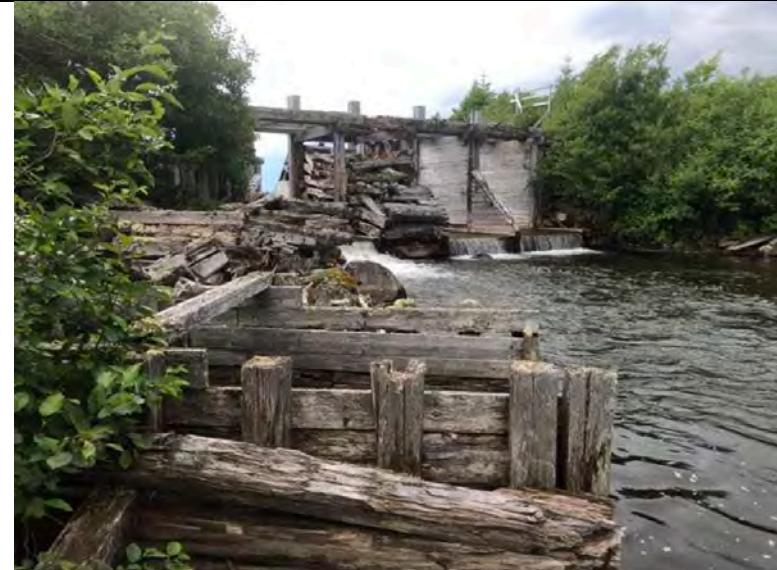
Photo 245 Long Lake Water Control Structure Facing Upstream

Photo 246 Long Lake Water Control Structure Facing Upstream

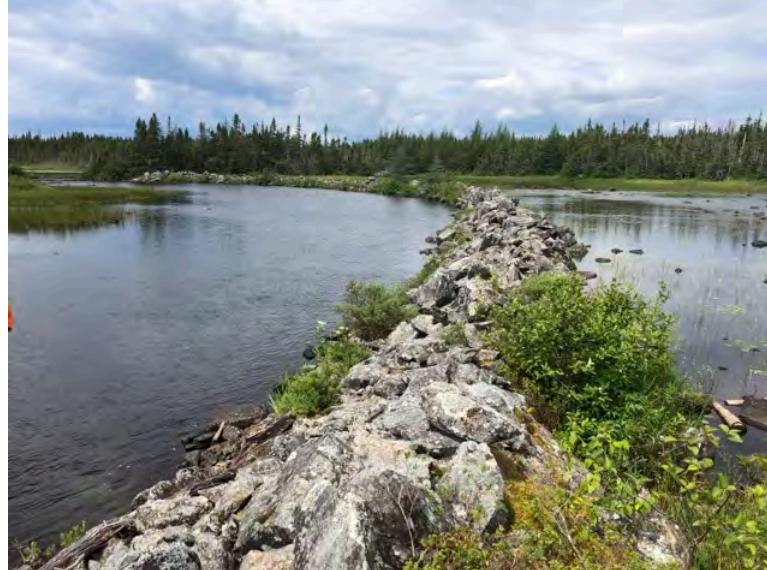
Photo 247 Main Channel Rock Wall (~130 m) in Outlet to Valentine Lake

The unknown structures in the outlet of Valentine Lake were visited on July 25, 2020. The structures were observed to be rock walls constructed in the lower portion of the steady, likely to divert logs away from the side channels and contain them within the main river channel (Appendix C, Photos 247 to 253). In total there are three large walls, measuring 130, 20, and 55 m in length. The removal of the rock walls could facilitate increased flow through the downstream and southern portion of the steady, resulting in scouring of fine sediments to expose coarser sediments. As the majority of substrates consists of small and large boulders, the addition of small and large gravel would increase the available spawning habitats or provide additional areas for benthic invertebrates (i.e., food for salmonids). Small and large boulders which make up the rock walls could be used to create “boulder” clusters within the steady to provide structure for fish and additional areas for food production. The outlet of Valentine Lake has high potential as an offsetting project.

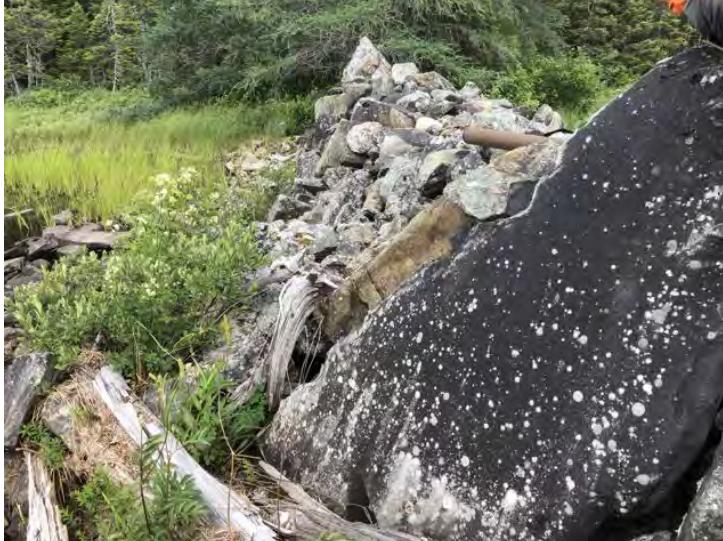
Photo 249 Upstream (20 m) Rock Wall in Outlet to Valentine Lake

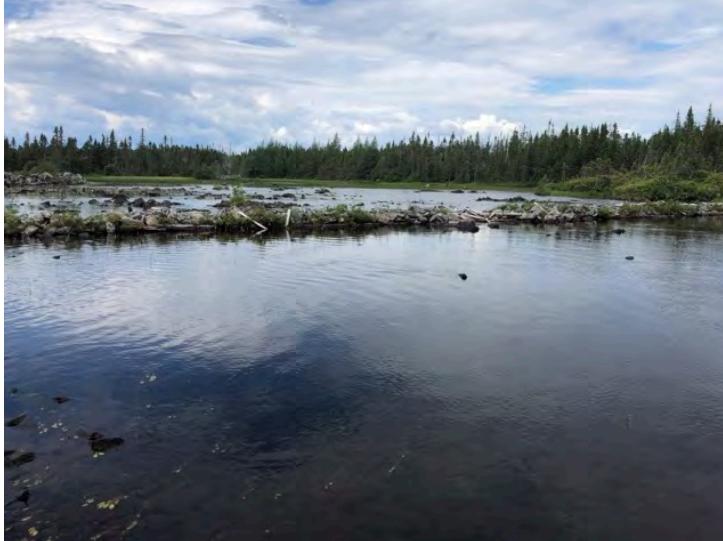
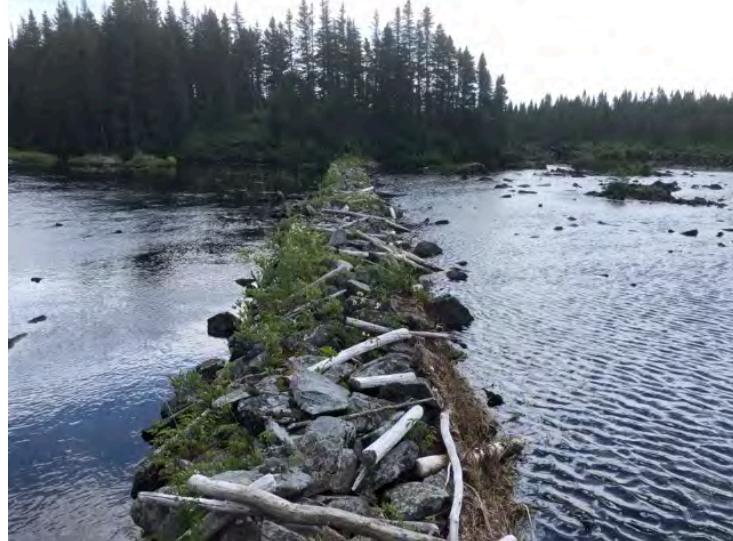
Photo 251 Downstream (55 m) Rock Wall in Outlet to Valentine Lake

Photo 252 Downstream (55 m) Rock Wall in Outlet to Valentine Lake

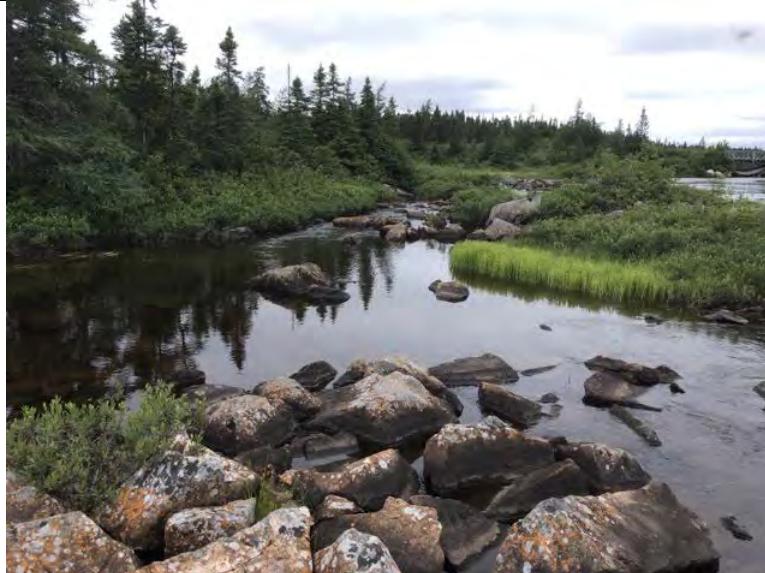
**Photo 259** North Twin Brook Area 2 – Behind Rock Wall

Five locations on North Twin Brook that have been modified for historical logging operations were visited on July 30, 2020. The locations consisted of rock walls to channelize flow and divert logs away from side channels and concentrate flow within the main river channel. In some areas, the rock walls and channelization resulted in dewatering of side channels or substantially reduced flow (Appendix C, Photos 254 to 289). The channelized area of the main river was observed to have high velocities, even when water levels were very low. The modification or removal of the rock walls would facilitate flow to areas of North Twin Brook which were historically wetted, even during low flow periods. As the majority of substrates consists of small and large boulders the addition of small and large gravel would increase the available spawning habitats or provide additional areas for benthic invertebrates (i.e., food for salmonids). Small and large boulders which make up the rock walls could be used to create boulder clusters within slower moving areas or the main channel to reduce flows, provide resting places and structure for fish, and additional areas for food production. Remediation of channelized areas of North Twin Brook has high potential as an offsetting project.
