**VALENTINE GOLD PROJECT: AMENDMENT TO THE ENVIRONMENTAL IMPACT STATEMENT**

**APPENDIX H**  
**VALENTINE GOLD PROJECT: 2020 FISH**  
**AND FISH HABITAT DATA REPORT**

**Valentine Gold Project: 2020 Fish  
and Fish Habitat Data Report**

May 3, 2021

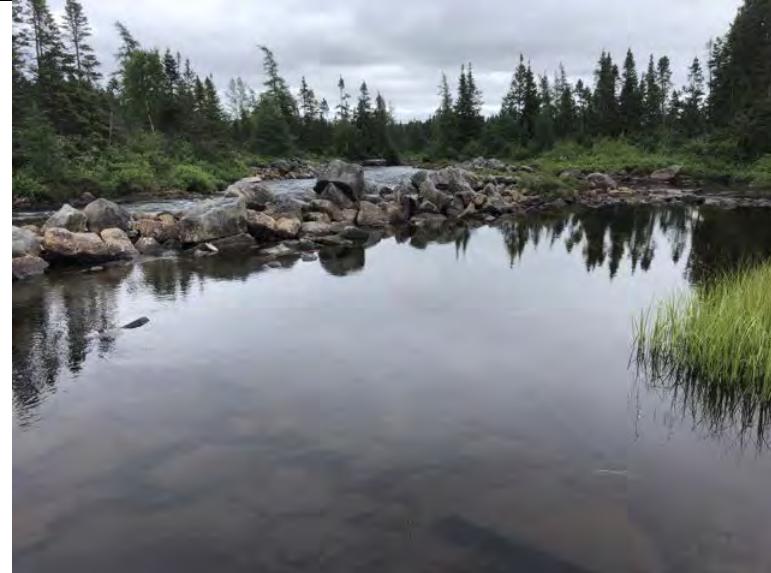
**Photo 260** North Twin Brook Area 2 – Rock Wall

Five locations on North Twin Brook that have been modified for historical logging operations were visited on July 30, 2020. The locations consisted of rock walls to channelize flow and divert logs away from side channels and concentrate flow within the main river channel. In some areas, the rock walls and channelization resulted in dewatering of side channels or substantially reduced flow (Appendix C, Photos 254 to 289). The channelized area of the main river was observed to have high velocities, even when water levels were very low. The modification or removal of the rock walls would facilitate flow to areas of North Twin Brook which were historically wetted, even during low flow periods. As the majority of substrates consists of small and large boulders the addition of small and large gravel would increase the available spawning habitats or provide additional areas for benthic invertebrates (i.e., food for salmonids). Small and large boulders which make up the rock walls could be used to create boulder clusters within slower moving areas or the main channel to reduce flows, provide resting places and structure for fish, and additional areas for food production. Remediation of channelized areas of North Twin Brook has high potential as an offsetting project.

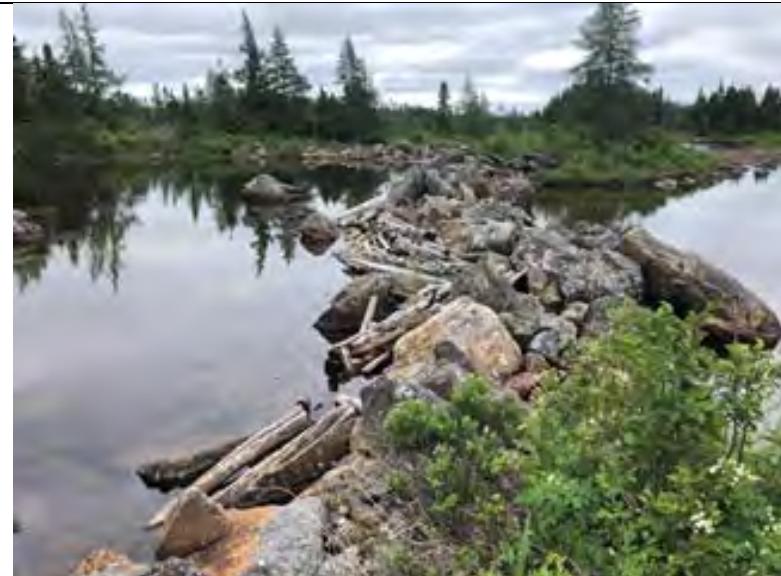
Photo 266 North Twin Brook Area 3 – Rock Wall

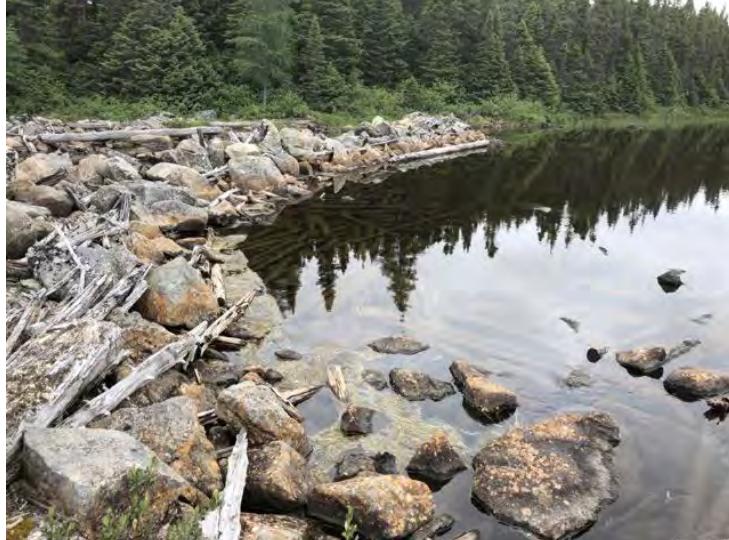
Photo 269 North Twin Brook Area 4 – Rock Wall and Old Pulpwood at Head of Riffle on Right Bank

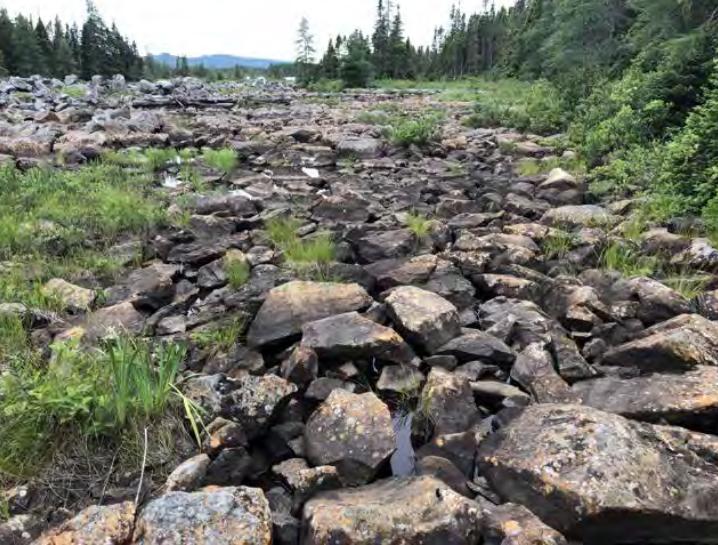
Photo 281 North Twin Brook Area 5 – Old River Channel on Right Hand Bank		Photo 282 North Twin Brook Area 5 - Old River Channel on Right Hand Bank

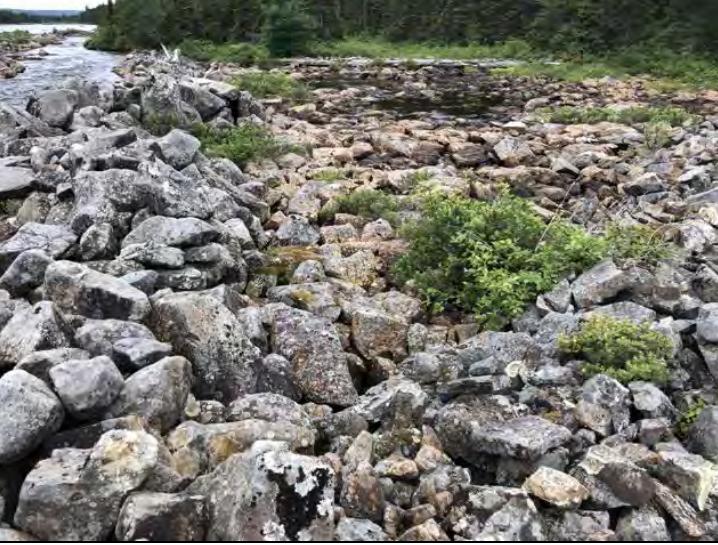
Photo 283 North Twin Brook Area 5 - Old River Channel on Right Hand Bank		Photo 284 North Twin Brook Area 5 - Old Side Channel on Right Hand

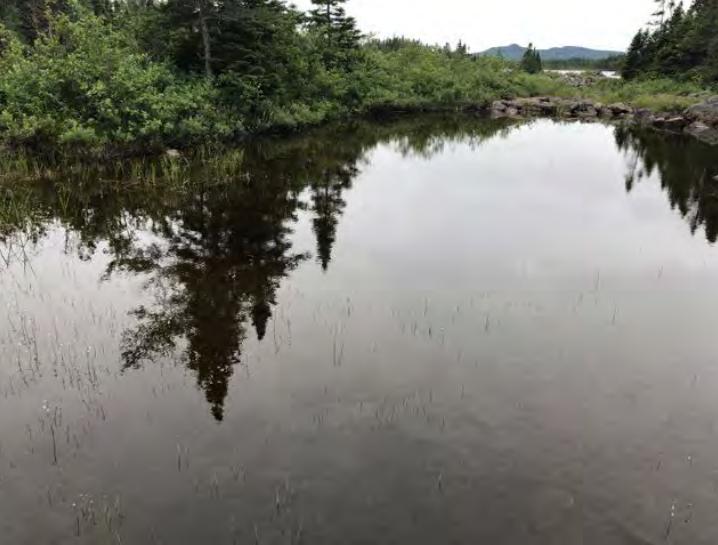
<b>Photo 285</b> North Twin Brook Area 5 – Old Steady With No Flow		<b>Photo 286</b> North Twin Brook Area 5 - Old Side Channel on Right Hand Bank

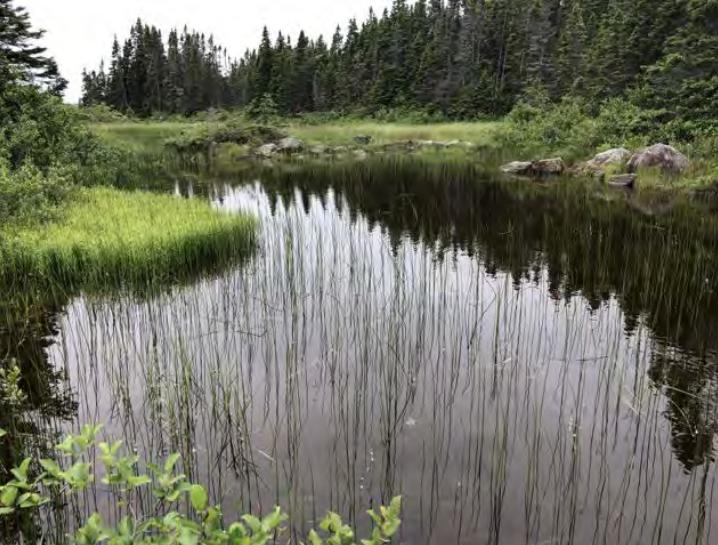
<b>Photo 287</b> North Twin Brook Area 5 - Old Steady With No Flow		<b>Photo 288</b> North Twin Brook Area 5 – Old River Channel on Right Hand Bank

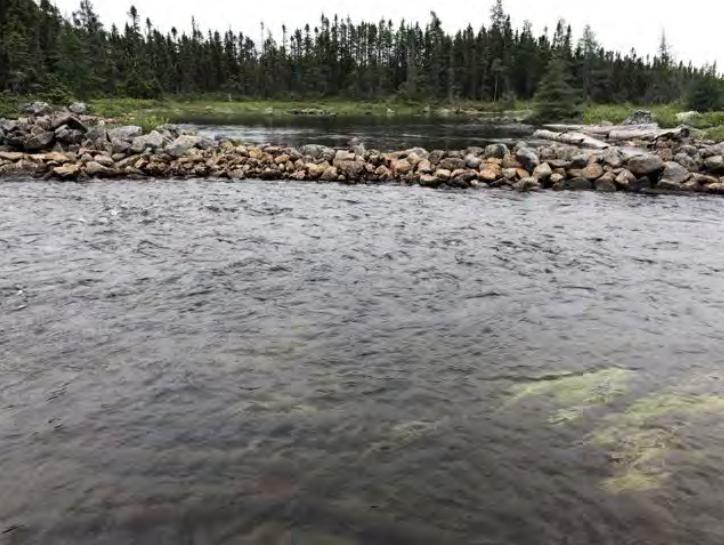
<b>Photo 289</b> North Twin Brook Area 5 – Wall Keeping Flow in Main Channel
