# Real Time Water Quality Deployment Report

## Learys Brook at Prince Philip Drive

### NF02ZM0178

2024-02-28 to 2024-04-12

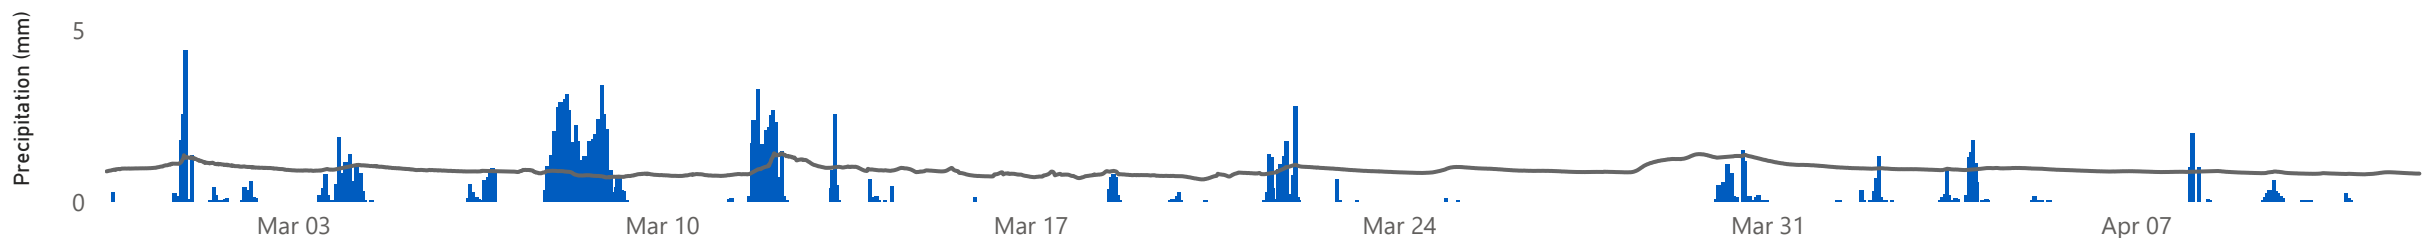
## Precipitation from Pippy Park in St. Johns and Stage from Learys Brook at Prince Philip Drive

● Precipitation (mm) ● Stage (m)
