TECHNICAL MEMORANDUM

Re: Phase 3: Preliminary Basis of Design for Parker's Brook, Newfoundland

This memorandum summarizes the preliminary basis of design for the Parker's Brook habitat restoration project in Newfoundland.

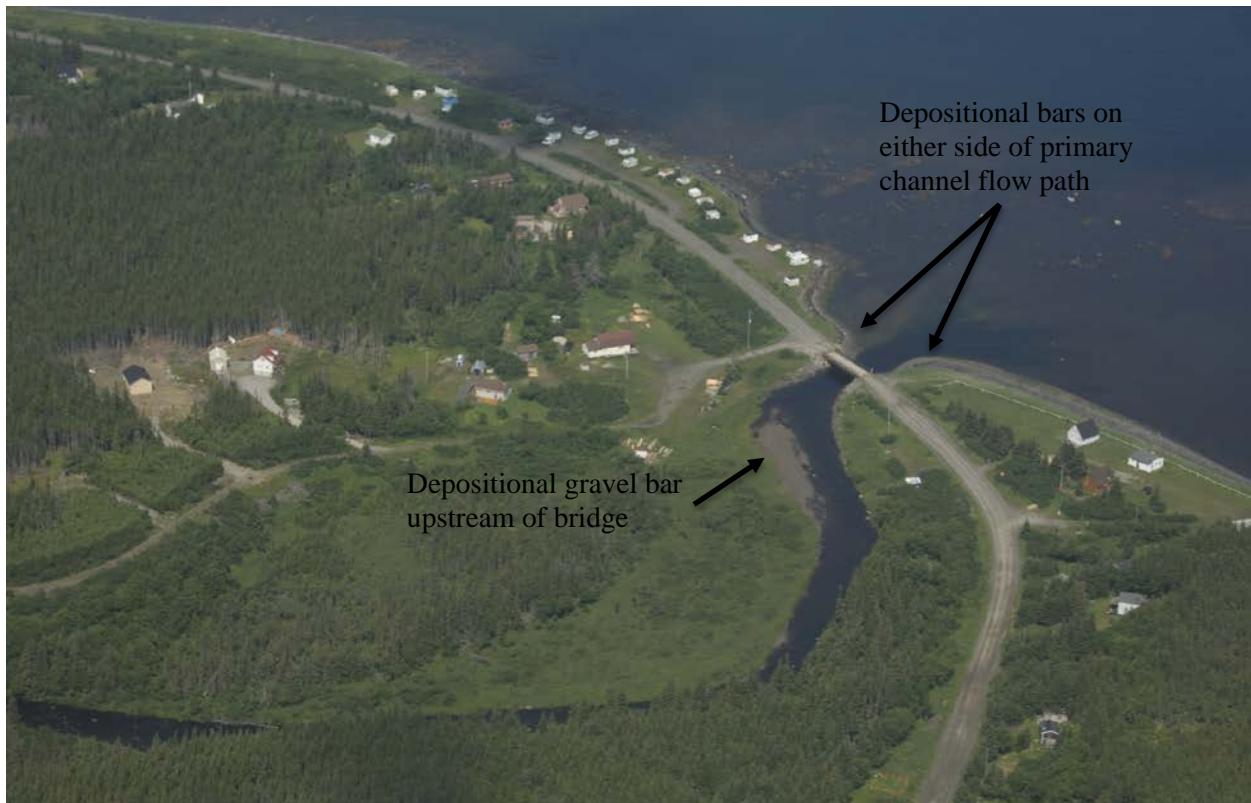
Figure 1. 2009 aerial photo provided by Sheldon Eddison showing depositional patterns.

Dramatic increases in sediment deposition have been perceived at the delta since the flood event (R. Hedderson, pers. comm.). However, it is likely that the area has been in flux for decades, filling and scouring in response to the flow and sediment conditions of each year. Figure 1 shows that in 2009, similar depositional patterns existed at this site upstream of the bridge and in the delta. The more recent deposition occurring over the last 5-10 years may have created a larger bar that is less frequently covered by high tide, and composed of larger and more stable sediment that is slow to mobilize out onto the delta.

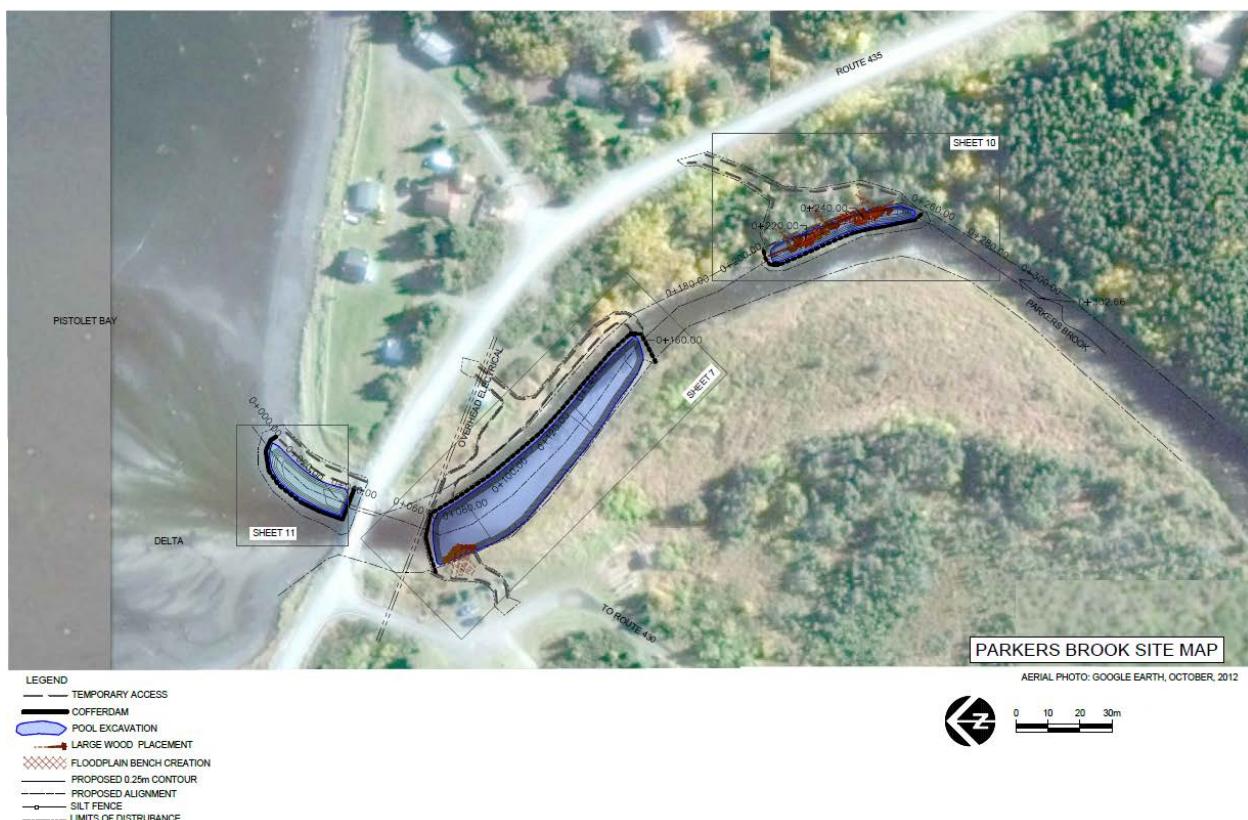
Figure 2. The three areas of proposed pool creation in the lower Parker's River as shown in the preliminary design drawings.

The preliminary restoration design includes channel dredging to address immediate impacts to fish movement in and out of Parker's Brook. Three primary project areas have been developed in the preliminary design phase and are described in more detail below (Figure 2). The preliminary restoration design drawings are provided in Appendix A.

The location of the proposed lower pool is where a large gravel bar has developed and filled in the channel from approximately 30 to 100 meters upstream of the Route 435 bridge. The proposed excavation of the lower pool would remove these sediments to widen and deepen the channel in this area creating a long and deep holding pool for migrating salmonids.

The upper pool is located at a bend in the Parker's Brook channel near the head of tide approximately 200 meters upstream of the bridge and should offer additional pool area and volume for migrating salmonids. The upper pool design is approximately 50 meters long, extends five (5) meters into the channel from the toe of the right bank and excavated between 1 – 1.5 meters below the existing channel bed elevation.

The proposed delta pool excavation would deepen and widen the existing channel along the right edge (looking seaward) of the delta downstream of the Route 435 bridge. The proposed delta pool is designed to be 28 meters long and extends approximately eight meters into the channel from the right bank downstream of the bridge. Proposed pool depth is one meter below the existing bed elevation. This location along the right bank of the delta head is the farthest away from the effects of ocean ice, longshore drift, and the sediment pushed onto the delta from storm driven wave action. Its location also falls within the suspected migration pathway of charr into Parker's Brook. The proposed delta pool is separated from the bridge pool to allow site isolation with a cofferdam during pool excavation. The small wedge of sediment between the pools may need to be excavated without site isolation (cofferdam) if permits allow.
