### **Hydrogeological Report DSO2 and DSO3 Sectors Schefferville (Québec) and Elross Lake (Newfoundland and Labrador)**

**NEW MILLENNIUM  
CAPITAL CORP.**

## **DIRECT-SHIPPING ORE PROJECT**

**Survey of Fish Habitat along the Railway Line and Main  
Access Road, DSO Project**

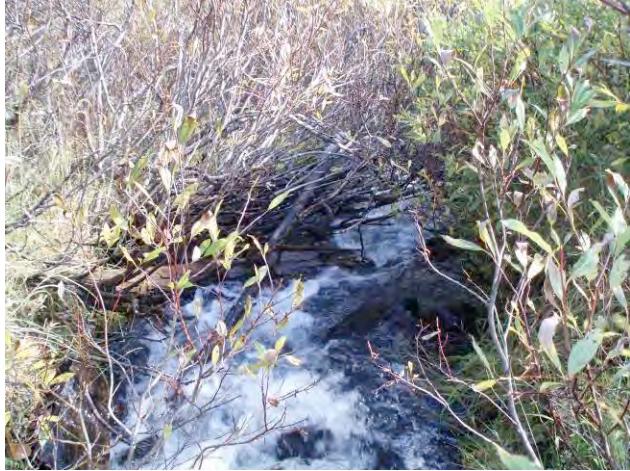
(56)

AR-1 Upstream-2 (view looking downstream)
